Advanced Event Analysis Tutorial

Part 2: Answer Key

Karl Zimmerman, *Schweitzer Engineering Laboratories, Inc.*

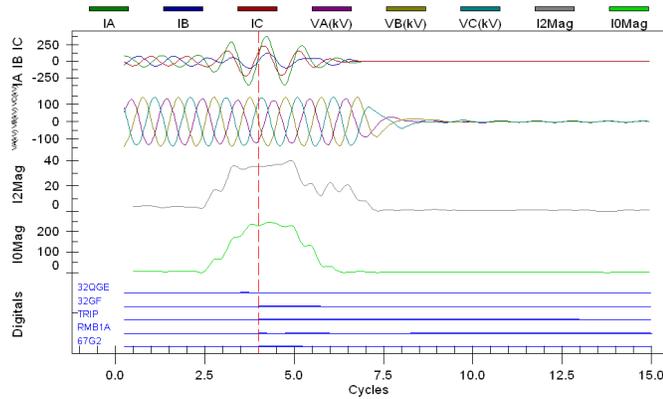
The following screen capture of the event report from ACSELERATOR Analytic Assistant shows element 67G2 asserted with a received PT1 input to produce a POTT trip.

This appears to be a low-level reverse AG fault, based on the relative position of VA and IA. Thus, 67G2 misoperated.

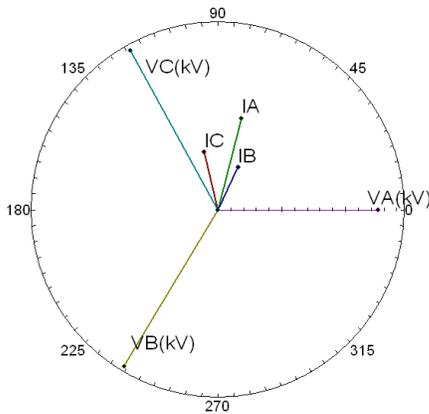
Also, this appears to be a sole zero-sequence source with very little positive- or negative-sequence contribution because all three currents (IA, IB, and IC) were nearly in phase, as shown in the following screen capture.

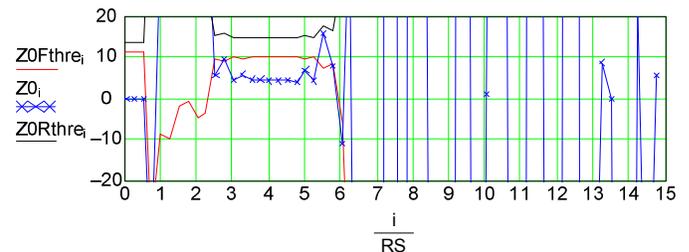
Once the relay switched to zero-sequence quantities, the relay compared the measured Z_0 (V_0/I_0) against the threshold settings Z0F and Z0R. Using a Mathcad® or Microsoft Excel® spreadsheet to model the directional element can be helpful in these cases. As we can see in the following Mathcad screen capture, the measured Z_0 element (Z_0i declared a forward fault based on the Z0F and Z0R settings (Z_0i plot below the Z0 forward and reverse thresholds).

The root cause of the problem is that the Z0F and Z0R settings are biased too far in the forward direction.

In the following figure, the Z0 element simulation correctly declared reverse after the Z0F and Z0R settings have been changed to -0.3 and +0.3, respectively. As we can see, Z0_i plots above the Z0F and Z0R thresholds.

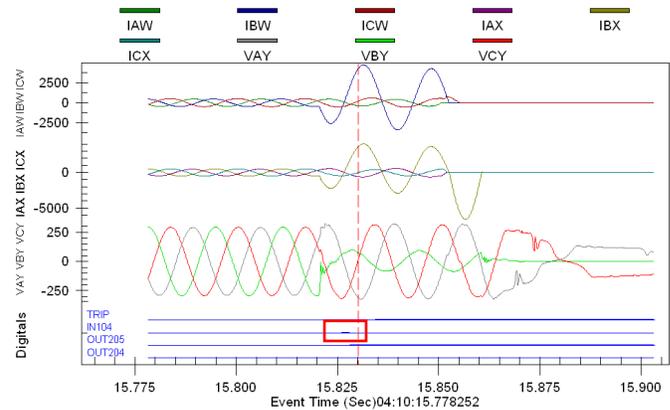
The currents were slightly offset and interrupted, as expected. The voltages demonstrate significant capacitive ringdown voltage that lasted almost 6 cycles. Based on the

line voltage (345 kV), it is not unusual to see this, and the shunt capacitance was further increased by the use of capacitor voltage transformers (CVTs). However, it is noteworthy, and time delays for automatic reclosing should take this into account. The following screen capture of the local COMTRADE event shows ringdown and momentary block trip (BT) input assertion, as denoted by input IN104.

However, in the previous event report screen capture, we observe the BT input asserted momentarily on the COMTRADE event, which is not seen in the filtered event. This could have been produced by a remote block or a noise burst seen by the carrier receiver (somewhere from 60 to 250 kHz) and created by the fault transient. In order to be sure, we must evaluate the remote relay.

So the momentary assertion of IN104 was likely caused by the carrier receiver responding to a high-frequency transient produced by the fault itself.

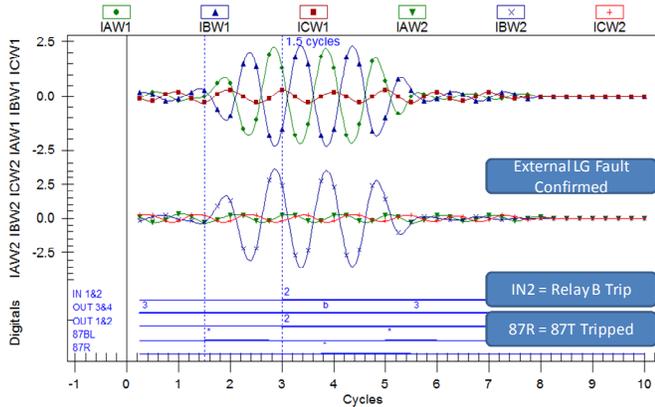
Yes, Relay B operated, which is shown both in the Relay B event report and from input IN2 to Relay C. The following transformer differential event report confirms the external fault, undesired 87R trip, and undesired Relay B trip.

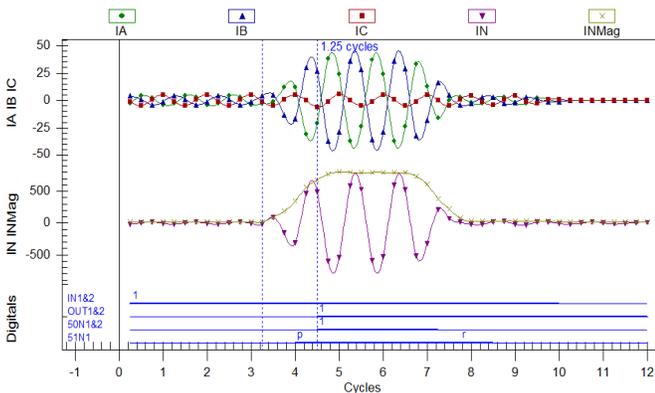
The following neutral overcurrent relay event shows the trip.

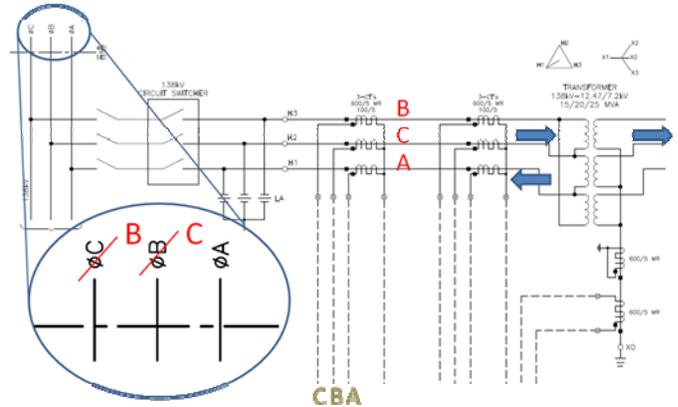
Problem #1: The as-built prints did not match the phase wiring in the field. The following three-line diagram shows primary B and C phases rolled in the field.

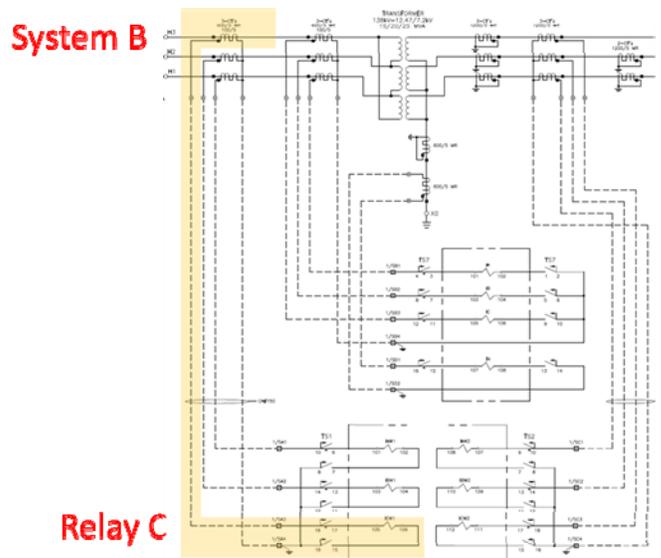
Problem #2: The wiring between the CTs and the relays was incorrect, as shown in the following print.

The answer is yes, but the system phases and phase rotation will not match the relay. The solution is to fix the wiring.

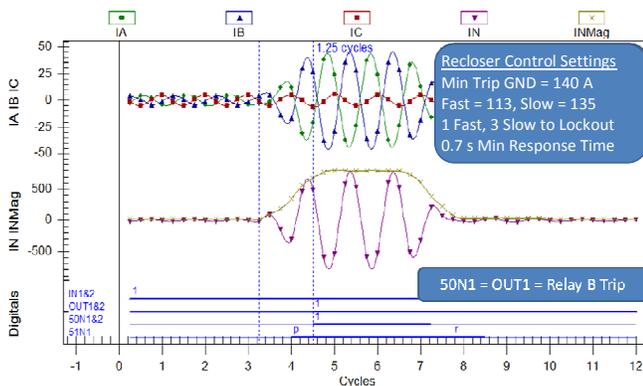
Problem #3: The SEL-551 Overcurrent/Reclosing Relay X0 bushing 50N element was not coordinated with the feeder. As shown in the following screen capture, Relay B (SEL-551) was set to trip instantaneously, and the feeder (Relay A) minimum trip time was 0.7 seconds.

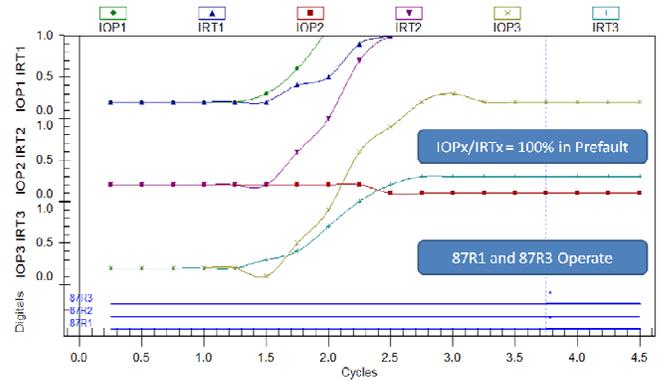
Problem #4: Standing differential operate current in prefault current means the transformer differential system was not sufficiently tested. In the following screen capture,

differential current in the prefault data shows that 87T was not properly commissioned.

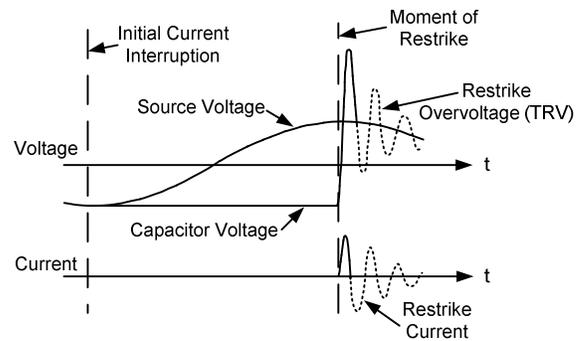
The following figure shows a likely possibility. In this scenario, when the capacitor bank was de-energized, it was followed by a circuit breaker restrike. The current was interrupted at the zero crossing, and at that instant, the system voltage and the capacitor voltage were at negative maximum value. The capacitor voltage stayed at the negative maximum value due to the trapped charge left on the capacitor. One-half cycle after the interruption, the system voltage reached its positive maximum value, resulting in twice the maximum voltage value appearing across the circuit breaker. The high-voltage potential across the contacts exceeded the dielectric strength of the gap at that moment. The breakdown of the dielectric strength resulted in an arc that reestablished current flow (i.e., a restrike).

The surge arrester then started conducting because of the 2 pu nominal voltage. In this case, the arrester was rated to conduct at 1.75 pu of system voltage. The surge arrester current was enough to produce the bus differential operation.

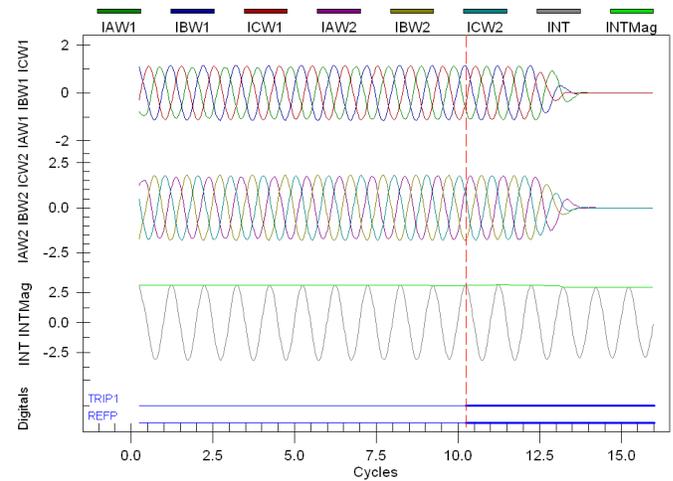
In the following screen capture, the initial trip indicates an REF trip.

The relay user noticed a setting problem on the first trip where Winding 1 was designated as the REF winding. However, the physical neutral connection was on Winding 2 (the X winding).

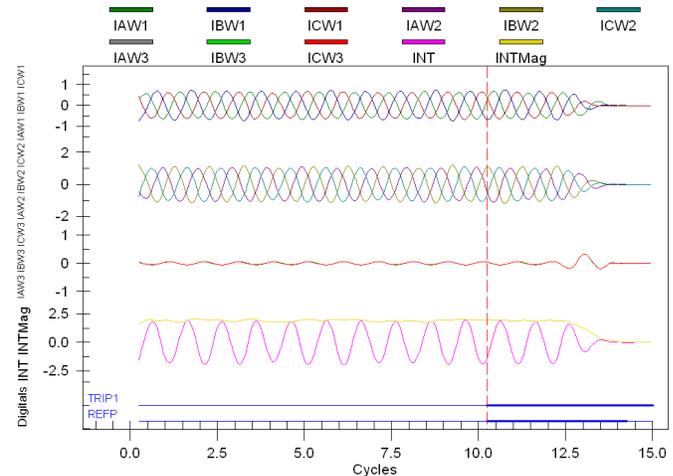
After the setting change, the transformer was energized with the same result—a trip produced by the REFP element. The following screen capture shows the second trip also caused by the REF element.

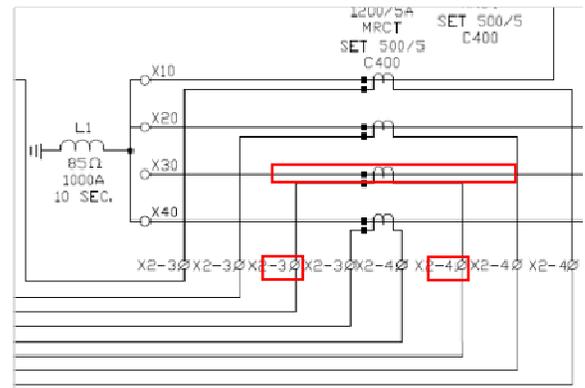
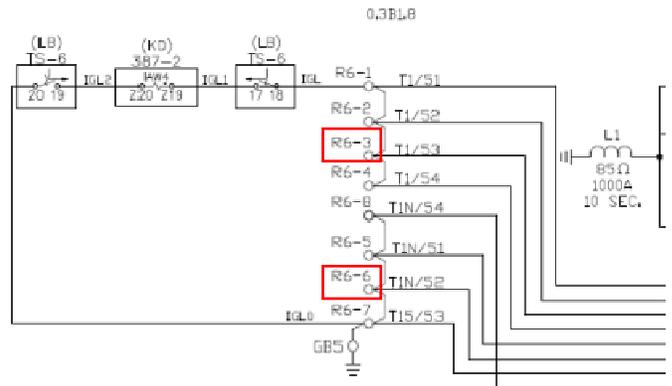
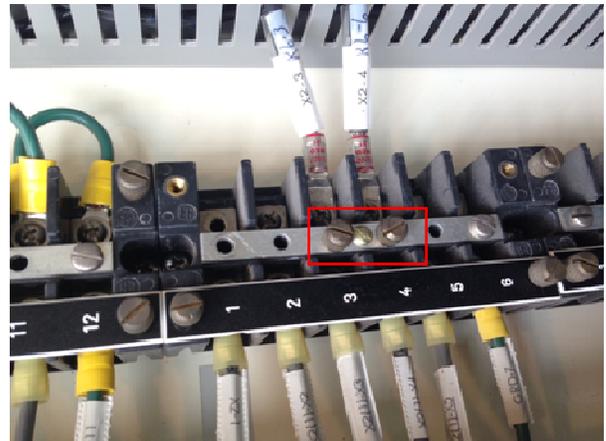
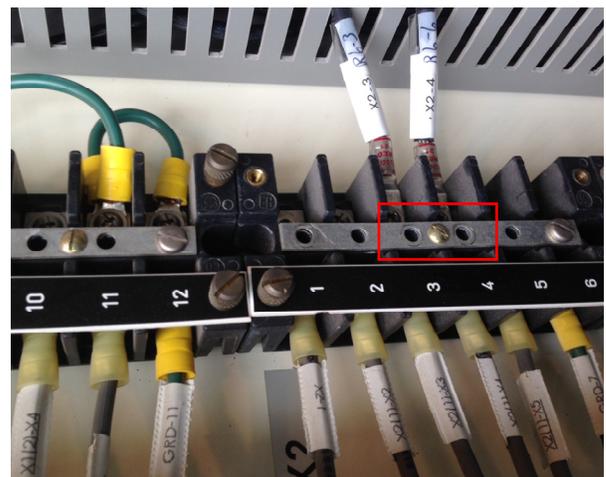
After investigation, it was noticed that shorting screws were left in the CT shorting block at the transformer on one of the neutrals. One shorting screw was loose. The second shorting screw created multiple grounds in the CT circuit,

resulting in the false neutral current at the relay. The following wiring diagrams and photos show shorting screws in place on one phase (B).

Note in the drawings that the X30 transformer is shown as a spare, not connected. At some point during the testing or operation, this spare transformer had been placed in service. This is likely why the shorting screws were left in place.

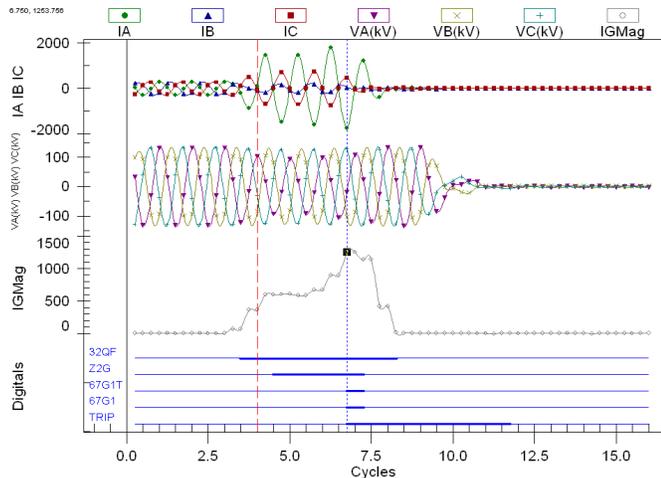
The following screen capture of an event report shows 67G1T assert.

The trip was produced by the 67G1T element. Furthermore, the actual trip occurred several cycles into the event. The following screen capture shows the settings associated with 67G1T.

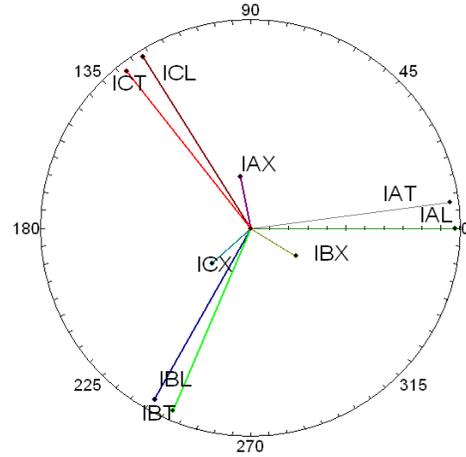
The following figure shows standing phase differential current in the pre-fault.

We can see significant differential current in the pre-fault. One of the prominent characteristics of high-voltage cables is the presence of line charging current caused by the electrical shunt capacitance. Even on short lines, this can be an issue.

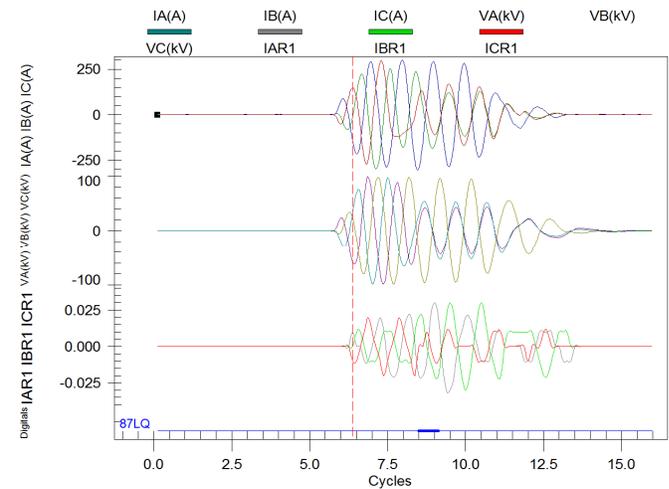
We can see the 87LQ element trip. The following screen capture shows the SEL-411L 87LQ trip without line charging compensation enabled.
