Open-Circuited CT Misoperation and Investigation

David Costello

Schweitzer Engineering Laboratories, Inc.

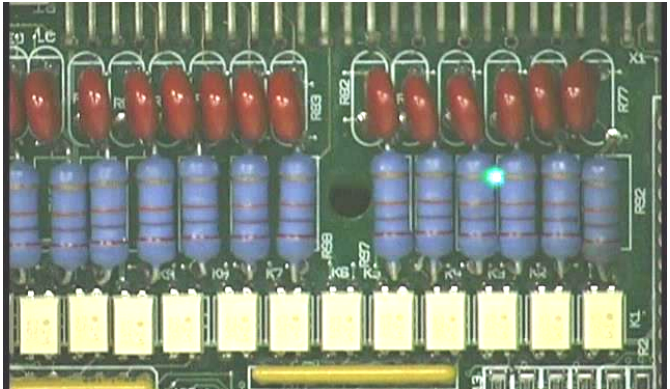
Fig. 8. Dielectric Breakdown of Relay B at 1,500 V

recommended that they do, either directly or through a third-party validated test laboratory. Fig. 8 shows the dielectric breakdown of Relay B at 1,500 V.

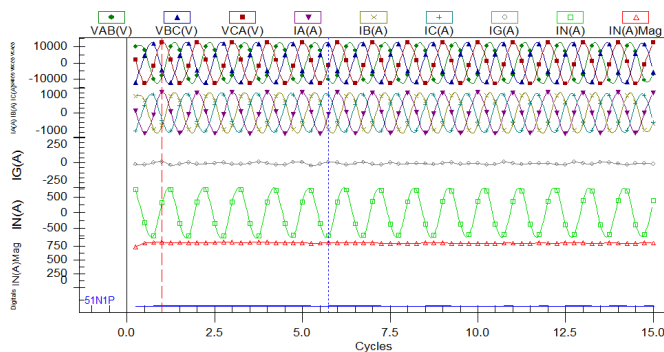
Fig. 12. 51NIP Picking Up and Dropping Out

Industrial plant personnel requested assistance from the relay manufacturer to help determine root cause of the original trip. Event records were downloaded and analyzed. Fig. 12 shows one of the first records. The phase-to-phase voltages are balanced, the three phase currents are balanced, the calculated IG current is zero, but the measured IN current is about 800 A primary. The 51N element is shown picking up and dropping out.

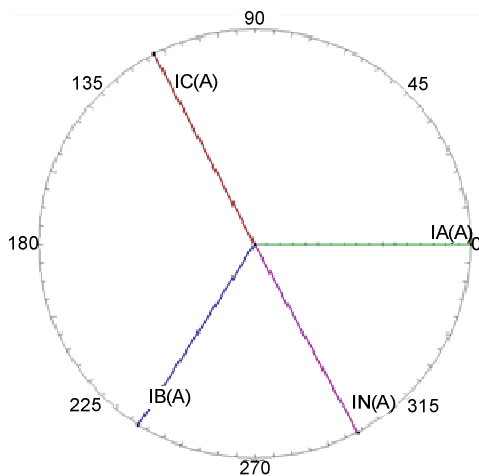
Fig. 13. Phasors at Cycle 5.75 in Fig. 12 Event

Fig. 13 shows the phasors at Cycle 5.75. Note that IN is equal to the sum of IA and IB currents (or $-IC$).

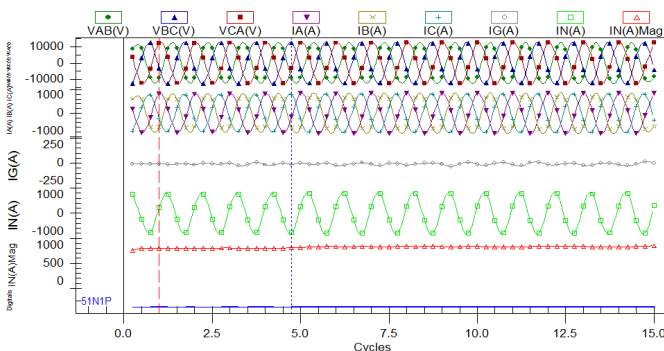
Fig. 14. 51NIP Element Timing to Trip

As the load was increased, the 51N element eventually picked up continuously and started timing to trip. Fig. 14 shows the element timing to trip.

When 51NIP finally asserted continuously, IN was equal to 817 A primary, just above pickup. At this current level and with an IEEE very inverse curve and a time dial setting of 5, the 51N element would take over 7.5 minutes to trip (see Fig. 15). Load current continued to increase, however, and IN increased in magnitude to over 900 A primary at the time of the trip. This sped up the trip time.

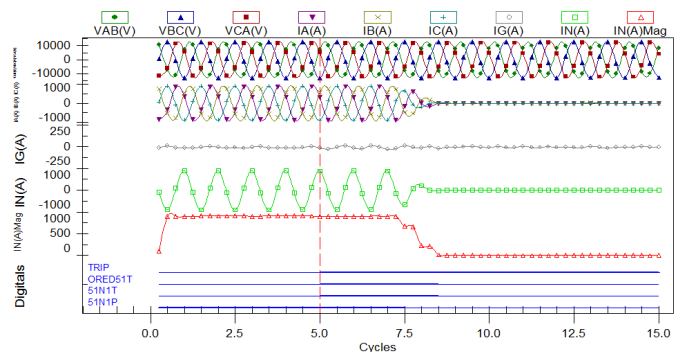
Fig. 16. 51NIP Trip

At the time of the trip in Fig. 16, note that the phase-to-phase voltages are balanced, the three phase currents are balanced, the calculated IG current is zero, and the measured IN current is near 1,000 A primary. The balanced phase voltages and currents indicate that there was no fault at the time of the trip.

There are two questions to be answered concerning the trip event. *First, why was the relay measuring IN neutral current while the three phase currents were balanced?* Because the 51N element caused the trip, this question understandably became the first priority and focus of the initial investigation. *Second, how can IG be zero while IN is large?* This question only was asked and noticed later in the investigation.

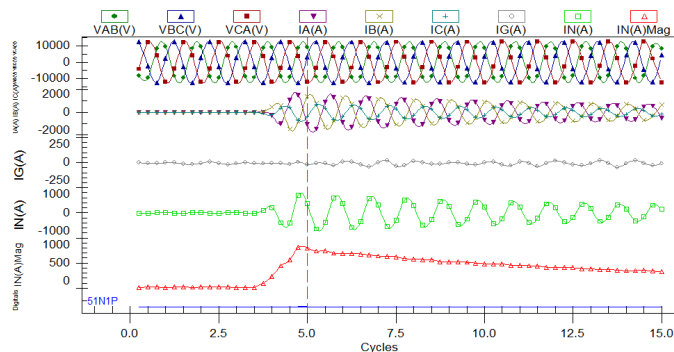
Fig. 17. Breaker Is Closed Without Root Cause Known

Event records confirm that the breaker was closed before the theory of an IN wiring problem was developed and resolved (Fig. 17). IN measuring significant current when no fault existed on the system led investigators later to suspect a wiring problem. As is the case too many times, operators were urgently trying to restore power to critical loads, and in their haste, the breaker was closed before root cause was known. After the breaker was closed, significant IN current was still present while phase currents were balanced. This led to a subsequent relay trip.

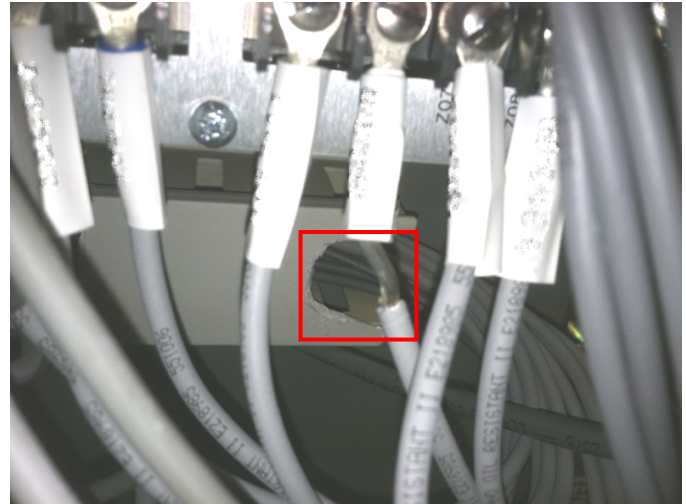
Fig. 18. Photograph of the Open-Circuited CT Circuit

After several days of investigation, the source of the IN current was discovered. A ring lug on the nonpolarity or neutral terminal of IC on the relay had not been crimped during the initial switchgear installation. For almost one year, the stripped wire end had made good enough contact to carry current. All of the ring lug barrels had a wire label on them. The IC nonpolarity terminal appeared to be heat shrink-wrapped around the barrel of the lug, whereas all other labels were loosely wound around their lugs. It is suspected that heat generated by load current through this loose connection heat shrink-wrapped the label tightly around the barrel.

After about one year of service in this condition, and two weeks prior to the misoperation, a metallic EIA-232 serial cable was connected between the relay and an automation controller to enable SCADA control and communication. It is suspected that this data cable was touching the C-phase current wire and put enough pressure on it to cause the wire to push free of the ring lug barrel and the shrink-wrapped label (see Fig. 18).

Once the wire slipped and fell free of the barrel, an open circuit in the C-phase circuit (downstream of the IC nonpolarity terminal and before the neutral bus) was created.

This explains why IN equaled the sum of IA and IB currents (or $-IC$). About 2.5 A secondary current was flowing through each phase at the time. Fig. 18 is a photograph of the open-circuited CT wire after the misoperation.

The wire labels installed over the barrel of the ring lugs likely made visual detection of the original problem (no crimp) difficult. Subsequent relay testing, commissioning tests, and normal metering did not expose the problem because the stripped wire made decent enough electrical contact. Nonetheless, these tests should be performed because they do catch the majority of wiring problems.

Once the open circuit was discovered, the ring lug was crimped correctly, the wire was reinstalled, and the breaker was closed. Fig. 20 shows an event report that was triggered 11 days after the initial trip. The voltages and three phase currents are balanced, and I_G and I_N are both near zero. Now that everything appeared normal, some assumed that the work was over and that the problem had been solved. The breaker and relay remained in service for over two weeks.

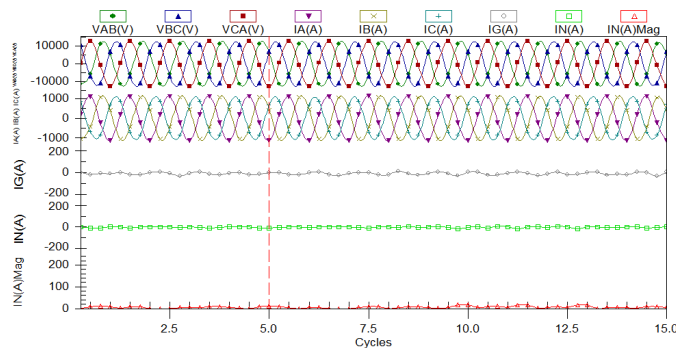
Fig. 20. Event Triggered After Crimp Fixed

The second question from the event analysis remained unnoticed and unanswered at the time that the crimp was fixed and the breaker was closed again. Only during later investigation did engineers focus on how I_G could be zero while I_N was so large during the events that showed the relay trip (Fig. 12, Fig. 13, Fig. 14, Fig. 16, and Fig. 17). After all, I_G is equal to the mathematical sum of the three phase currents, while I_N is equal to the physical summation. *More to the point, how could the relay measure C-phase current when a physical open or break in its circuit was visible* (Fig. 18)? Further, once the open circuit was fixed and restored to service, how was the relay measuring normal and expected values for I_G and I_N (as in Fig. 20)?

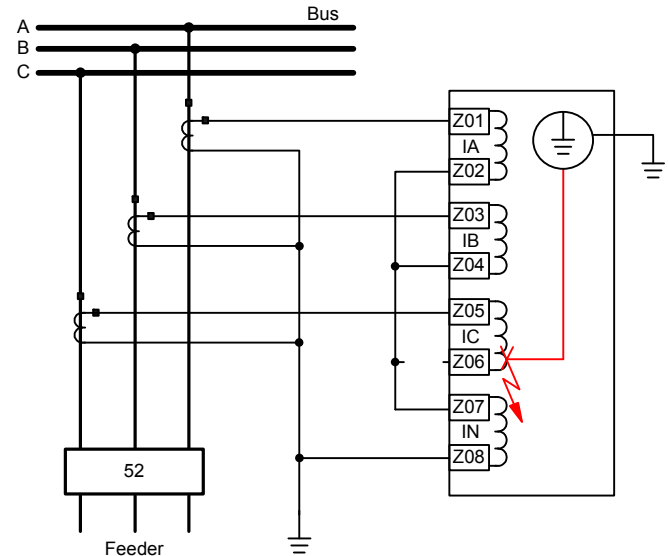
Fig. 21. Theory of Why I_G and I_N Did Not Match

Recall from the review of CT concepts that an open-circuited CT can develop dangerously high voltages. At the time of the relay trip, the C-phase CT was carrying nearly 1,000 A primary, or 2.5 A secondary, current. When the C-phase neutral connection became open-circuited, the only load or path for the CT secondary current to flow through was the very high magnetizing branch impedance (Table I, Point 1). This would have developed a very high voltage spike, driving the CT deep into saturation and decreasing the magnetizing impedance. During the next half cycle, this process would start all over again.

A theory was developed that would explain why the relay measured C-phase current while simultaneously having an open C-phase circuit external to the relay (see Fig. 21). The dangerously high voltages must have exceeded the dielectric strength of the relay, damaged the relay, and created a short circuit. In order for the relay to measure C-phase current, the short circuit to ground must have developed internal to the

relay, downstream of the C-phase current-sensing element but upstream of the open circuit at the relay terminal block.

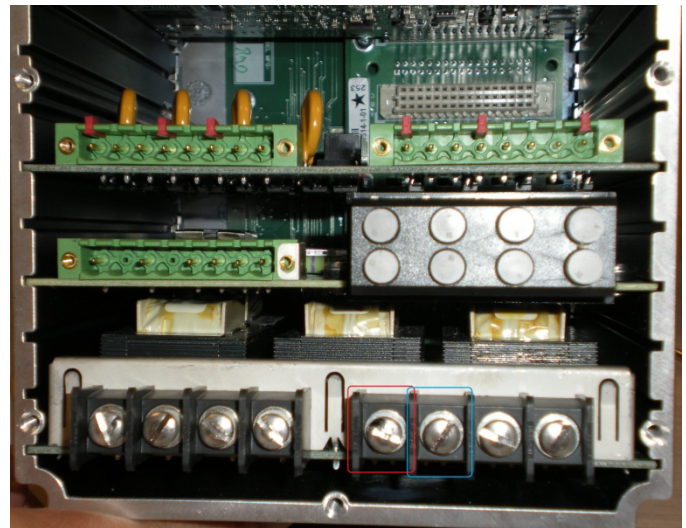
Fig. 25. Relay Rear Panel Removed to Expose Inside

Fig. 25 shows a photograph of the relay involved in this event with its rear panel removed. Compare Fig. 24 and Fig. 25. The CT terminals are visible, as are the internal instrument transformers themselves. The internal magnetics are mounted to the top of a circuit board identical to that in the video shown in Fig. 22.

With a theory and a dielectric test on a like make and model relay in hand, the industrial plant was advised that they had a damaged relay in service that needed to be removed from service and repaired immediately. After switching loads to an alternate source, the breaker and relay were removed from service for thorough inspection.

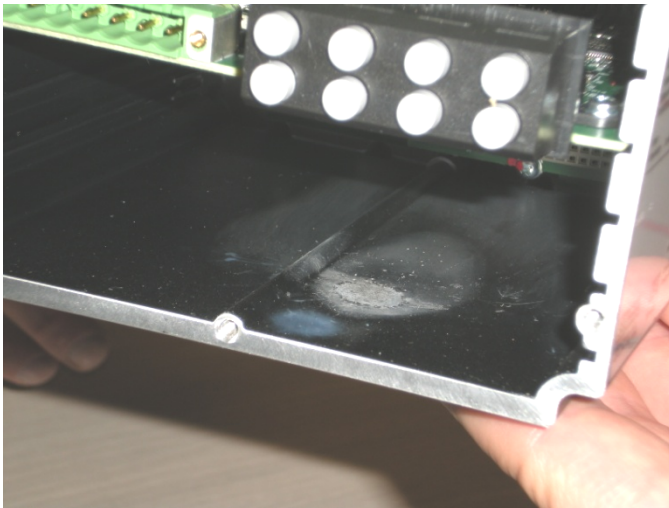
Fig. 26. With CT Board Removed, Heat and Arc Damage Evident

When the CT board was removed from the relay, the first obvious sign of damage was the heat and arcing evidence on the bottom inside of the relay chassis, directly under the CT board (see Fig. 26).

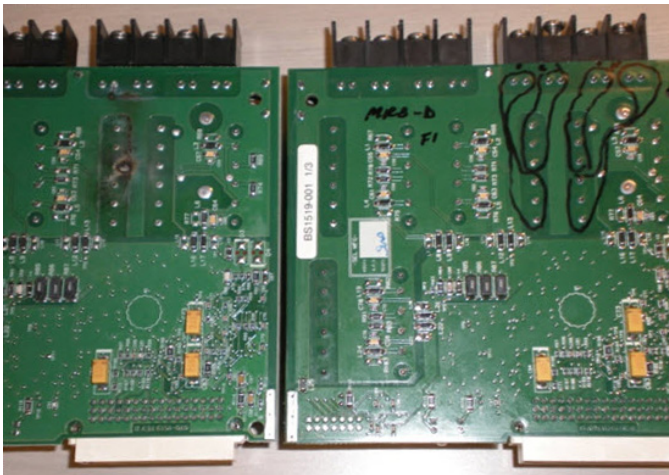
Fig. 27. Damaged Relay Board (Left) and Board From Dielectric Strength Test Video (Right)

Once the CT board was out of the relay, the circuit board damage and arc-induced short circuit were clearly visible (see Fig. 27). The circuit board on the left in Fig. 27 is the damaged board. On the right is the sample board used in the laboratory test and video.

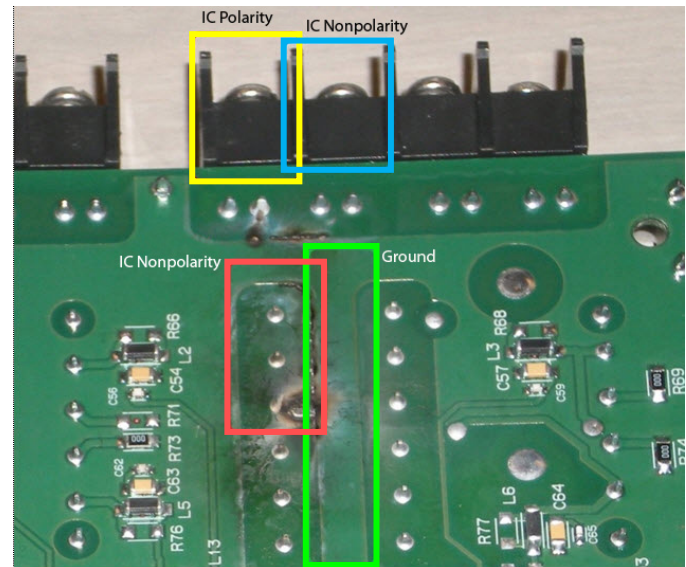
Fig. 28. Closer View of Damaged Board and Arc-Induced Weld Between Z06 and Ground

Fig. 28 is a close-up view of the damaged board. The relay transformers are mounted on the opposite side of the board. The red highlighted area, where the worst damage is, shows three through-hole pins that connect the nonpolarity Z06 terminal side of IC. The arc-induced weld from the third pin connects to a slightly lighter shade of green vertical area, which is a copper ground or reference plane in the printed circuit board. The open-circuited CT did indeed develop dangerously high voltage spikes, and these caused a dielectric breakdown, damage, and a short circuit to ground inside the relay. Once established, this short circuit to ground provided the path for current to flow through the C-phase-measuring

element within the relay to ground, while external to the relay, the neutral element only saw the sum of I_A and I_B currents.

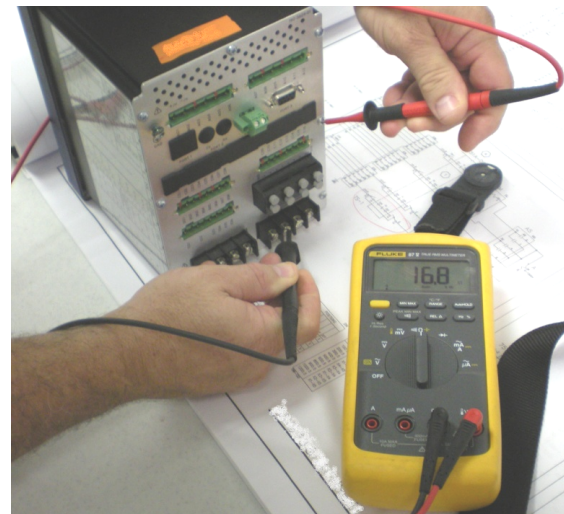
Fig. 29. Impedance Between Z06 and Ground

The impedance from Z06 to ground was measured at 16.8 ohms. This represents the impedance of the arc-induced weld on the circuit board (see Fig. 29).

On all of the other current channels, this should and did measure as an open circuit (infinite ohms). This explains why the relay, when returned to service as shown in Fig. 20, appeared normal. The external CT path wiring had a much lower impedance than the arc-induced weld to ground, so most of the current flowed through IC and on to the neutral bus.
