Simultaneous Faults on the 11 kV System of an Offshore FPSO Vessel

Presented at the
PCIC Europe Conference
Rome, Italy
June 7–9, 2011

Abstract—This paper provides a case study of simultaneous faults that occurred December 5, 2009, within the 11 kV power system of a floating production, storage, and offloading vessel located in the Norwegian sector of the North Sea. The event resulted in severe damage to a 9.2 MW compressor drive motor, damage to the transformer feeding an adjustable speed drive, and interruption of many loads on the ship. Background regarding the power system on the vessel and the state of the system at the time of the event is provided in Section I and Section II. This paper shares an exhaustive analysis of the event, including initial responses and findings of the offshore technicians, event reports from two microprocessor-based motor protection relays, subsequent analytical work, and forensic work performed on the failed equipment.

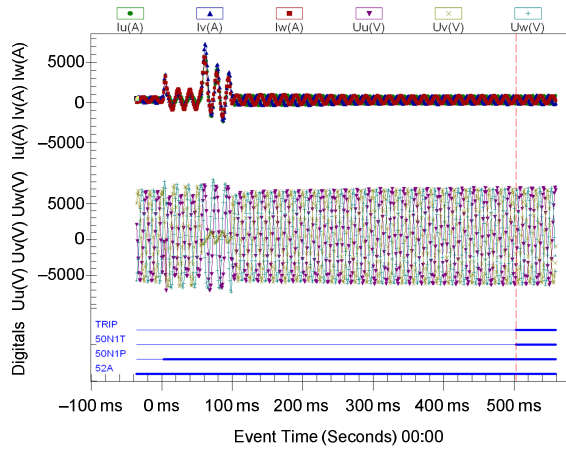
Fig. 4 Event Profile From E200 Protective Relay

Early engineering observations were crucial to further understanding. First, the earth fault current recorded by the E200 protective relay was over 17,000 A, which is well in excess of the system design maximum of 112 earth fault amperes. Hence, it was quickly concluded that this was not an incident involving a single zero-sequence current source. Second, high fault current had flowed through the FCL, causing it to activate on Phases U and V. This supported a conjecture that a second zero-sequence current source had existed on the port side of the power system (i.e., on the opposite side of the FCL from the E200 motor). Offshore efforts were then focused on searching for this phantom second earth connection. In particular, the search was focused on confirming that neutral earthing systems and associated connections were properly configured and functional. One possible theory was that this second earth connection had unknowingly existed for some time and its existence was highlighted when the E200 motor fault occurred. Event profiles from the E100 and E200 protective relays can be seen in Fig. 3 and Fig. 4, respectively. Note that the currents and voltages displayed in these figures are divided by a factor of $\sqrt{2}$.

We begin by looking at the protective relay for the E200 motor. It did trip on a neutral time-overcurrent element with a definite-time delay, as indicated in Fig. 4. The pickup setting for the neutral time-overcurrent element, 50N1P, is 2 A primary. The measured current exceeded this value. In addition, the definite-time-delay setting, 50N1D, is set to 0.5 seconds. As was pointed out previously and shown in Fig. 5, the fault current cleared well before 0.5 seconds. However, the neutral current did not go to zero immediately but exhibited a unipolar decay, or subsidence current, as described earlier. It is this decay that allowed the neutral overcurrent element to time out and trip for the fault. Had the current dropped instantly to zero when the fault was cleared by operation of the FCL, the motor relay would not have operated. The relay operated as it was set and was consistent with the published literature. Was it a correct operation of the protection system?

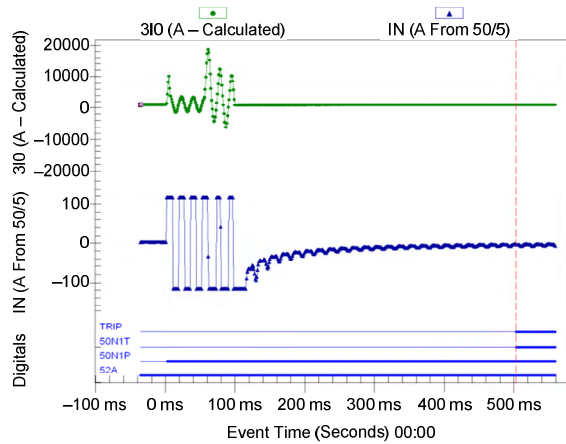
Fig. 5 Event Profile From E200 Protective Relay Showing Neutral and Ground Current

Another puzzling early observation was seen in the current profile associated with the E200 event record. While the earth fault current exceeded 17,000 A for a few cycles, the measured current from the 50:1 core-balance current transformer appeared to indicate that the fault had cleared itself and the E200 motor was returning to normal operation. In fact, earth fault current as detected at the protective relay was returning to near zero, and the relay barely timed out, causing the motor trip, as shown in Fig. 5. The motor nearly rode through this event, yet it tested with a solid earth fault on one phase. This was particularly puzzling.

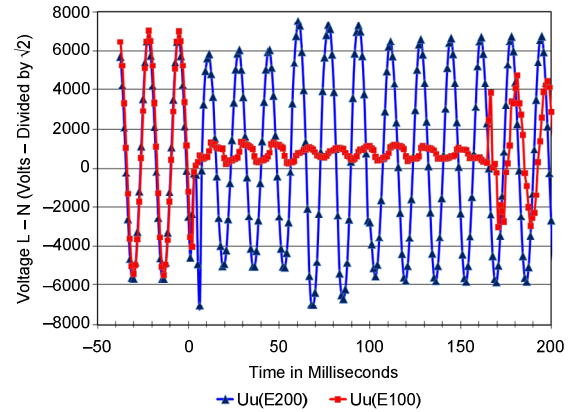
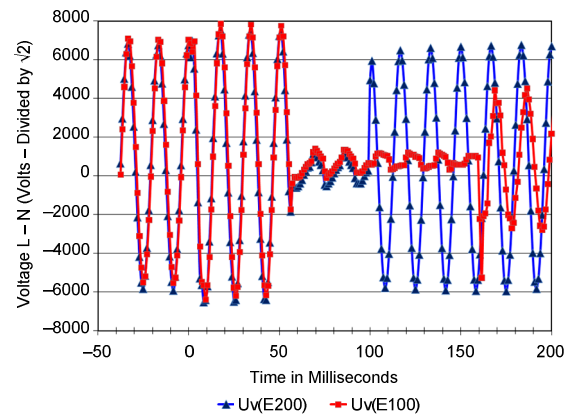
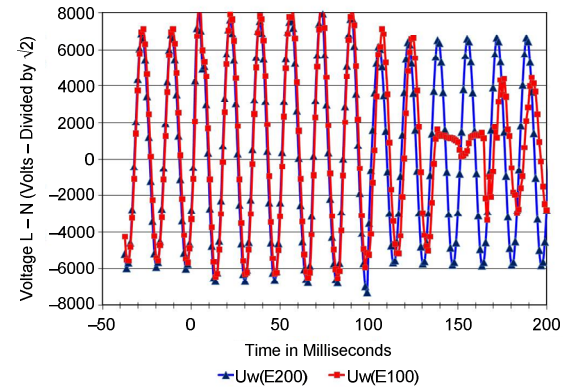
From the plots in Fig. 6, Fig. 7, and Fig. 8, the following points are clear:

- The Phase U element of the FCL cleared first at $t = 5$ milliseconds.
- After the Phase U element opened, Phase U voltage collapsed on the port side of the power system until $t = 165$ milliseconds, when voltage restoration began and the fault cleared.
- The Phase V element of the FCL cleared second at $t = 95$ milliseconds.

- Phase V voltage collapsed system-wide at $t = 55$ milliseconds. When the FCL opened Phase V at $t = 95$ milliseconds, voltage was instantly restored on the starboard power system. After the Phase V element opened, Phase V voltage collapsed on the port side of the power system until $t = 165$ milliseconds, when voltage restoration began.

- Phase W appears to have separated between the port and starboard power systems at $t = 135$ milliseconds, which was the last phase to separate. Once Phase W was the only connection between the port and starboard power systems, it appears a torque angle was developing between the two power systems. Because FCL controls are interlocked such that FCL activation opens circuit breaker H37, it is asserted that this Phase W separation was due to the three-pole opening of breaker H37.

- After Phase W opened, Phase W voltage collapsed on the port side of the power system until $t = 165$ milliseconds, when voltage restoration began and the fault cleared.

It is believed that on December 5, 2009, a new earth fault developed in the WI-A transformer (at time $t = 0$ in Fig. 6 through Fig. 8), most likely in the Phase U primary winding as indicated by the data. With two earthed points in the power system, high levels of short-circuit current instantly resulted and caused significant damage. The FCL was the first protective device to act by opening Phase U in 5 milliseconds, thereby breaking fault current flow and dividing Phase U into a starboard island and a port island. Phase U voltage on the port side of the power system subsequently collapsed, while starboard voltage remained reasonably healthy. At $t = 55$ milliseconds, a large increase in fault current is evident; this is believed to have occurred as the fault escalated to Phase V of the transformer, creating a phase-to-phase-to-earth fault. Generator excitation systems were unable to maintain voltage on Phase V with this increased fault current, and Phase V voltage collapsed. Shortly thereafter at $t = 95$ milliseconds, the FCL opened its Phase V element because of the increased Phase V flow of current. Once the Phase V pole of the FCL was opened, Phase V voltage recovered on the starboard system where the majority of power generation capacity was connected; port-side voltage on Phase V remained collapsed due to the active fault that was present. With only Phase W connecting the port and starboard systems, a torque angle began developing between the two systems (between $t = 95$ milliseconds and $t = 135$ milliseconds, as shown in Fig. 8). Next, it is believed that the interlock between the FCL and its adjacent three-pole circuit breaker, H37, caused breaker H37 to open at $t = 135$ milliseconds, which fully separated the port and starboard power systems. At this point, the port and starboard power systems are discussed separately in the following paragraphs.

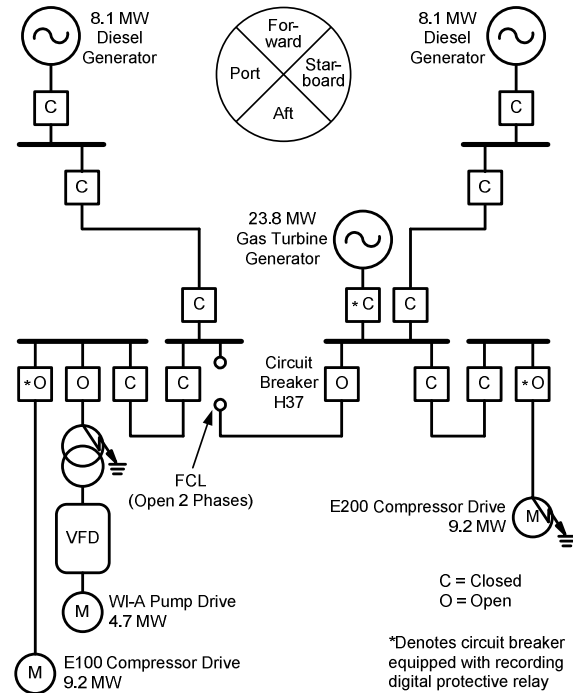
Fig. 9 Simplified Configuration Following Incident With Fault Sites Identified

Approximately two days later, after partial production had been restored, the electrical integrity testing process reached the A water injection pump (WI-A). Offshore electrical technicians discovered that the complex 11 kV phase-shifting dry-type transformer that serves as the input to the VFD for WI-A was faulted. Both Phases U and V were found shorted to earth. Upon disassembly and physical inspection, several signs of damage and flashover were observed.

Fault sites are labeled on the post-incident simplified diagram in Fig. 9.

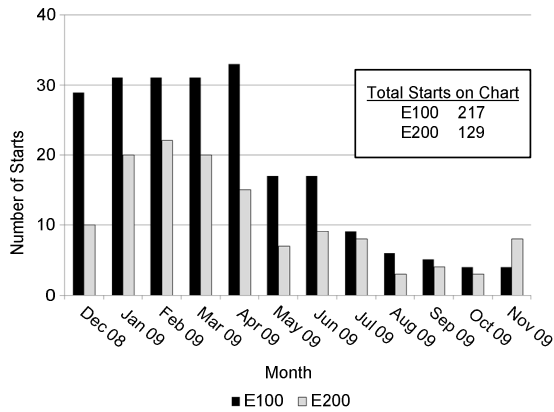
Fig. 10 Comparison of Number of Starts for E200 and E100 Motors by Month

The E100 export compressor package was placed into service in June 2008. From December 2008 to the moment of failure in December 2009, the E200 motor was started 129 times. The sister machine, E100, had been started 217 times in the same time period (see Fig. 10 for monthly data). Some asserted that this high number of starts contributed to premature motor failure. The digital relays for both E100 and E200 had thermal overload protection enabled. Analysis of this protection is provided in Section VI. Unfortunately, this theory does not explain the simultaneous transformer failure nor the apparent recovery of the motor to normal operation, as depicted in Fig. 5.

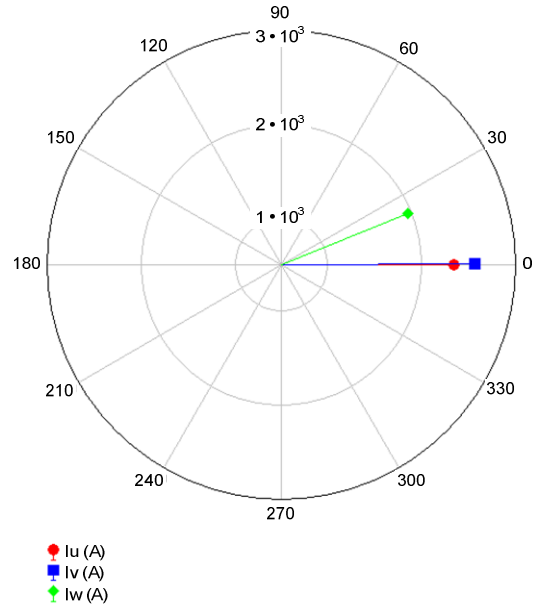
Fig. 11 Polar Plot of Phase Currents From E200 Event

Phases U, V, and W are all nearly in phase. To further illustrate this point, the U, V, and W currents from the E200 event report are plotted on a phasor diagram in Fig. 11.

This observation leads to the question, “Why would an ungrounded machine ever see nearly pure zero-sequence current?” Even if the fault were in the machine, such as a ground fault on one of the windings, we would expect the system to supply positive-, negative-, and zero-sequence currents to the faulted motor. It seems just from the current plots that the motor is acting as a zero-sequence source to a fault elsewhere in the system, similar to the way a grounding transformer is a source of zero-sequence current.

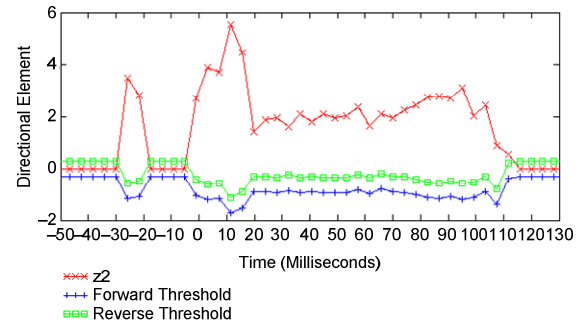
Fig. 15 Plot of $z2$ and Thresholds Versus Time for Simulation of Negative-Sequence Voltage-Polarized Directional Element

It is clear from Fig. 15 that the calculated $z2$ is above the reverse threshold, indicative of a reverse fault.

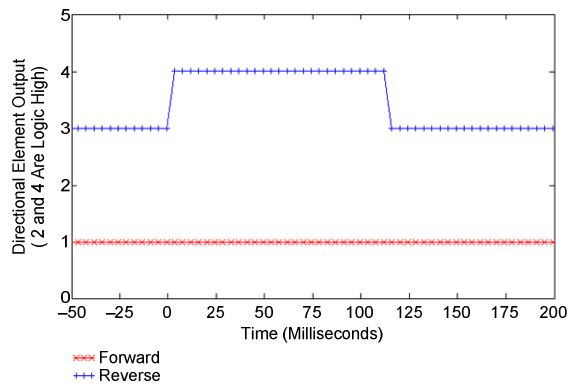
Fig. 16 Response of the Zero-Sequence Voltage-Polarized Directional Element

The simulation was performed again for the zero-sequence voltage-polarized directional element. For the sake of brevity, only the results are given in Fig. 16. The zero-sequence voltage-polarized directional element also determined a reverse direction.

Having a reverse decision from both algorithms offers some support to the theory that the fault in the E200 motor occurred at the neutral point, making the second ground fault elsewhere in the system a reverse fault. While this analysis does not prove a fault location, it does highlight two important points. First, installation of multiple digital relays capable of recording events can aid in troubleshooting. Second, event reports can be replayed into relays or analyzed in mathematical tools to help analyze how different protection elements would have responded to a particular event.

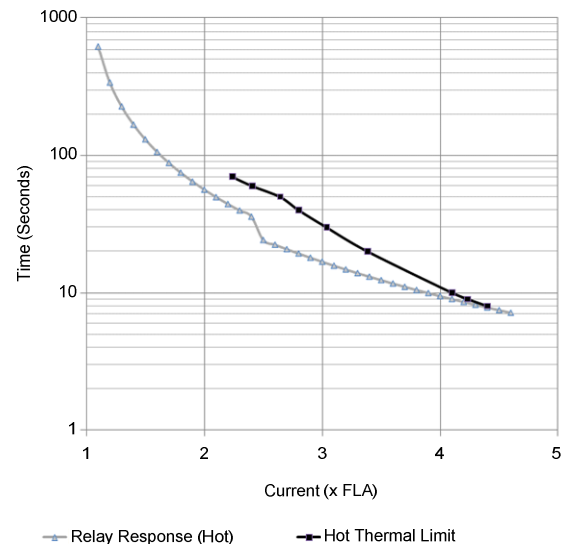
Fig. 17 Hot Thermal Limit Curve and Thermal Overload Element Response

In Fig. 17, the stator thermal damage curve from the motor manufacturer is plotted, as well as the relay thermal element response for both “hot” stator and rotor conditions. While this is not a complete dynamic simulation, the curves provide some verification that the relay thermal overload element is protecting the machine adequately.

In addition to verifying the relay response again, the motor manufacturer thermal damage curve, motor start reports, and trending data were reviewed. The data gathered showed no evidence of overloading, despite the large number of starts. This particular motor protection relay was also available with an algorithm to limit the number of starts per hour and number of consecutive starts based on simple timers and counters, without any dependence on the calculated thermal capacity. Enabling these elements could address the concerns about the large number of starts and provide an additional assurance that the machine is not being subjected to any thermal overloads.

While the thermal overload element was proven to be adequately protecting the motor against thermal overloads, enabling additional elements to limit the number of starts per hour and the number of consecutive starts enhanced the overall protection.

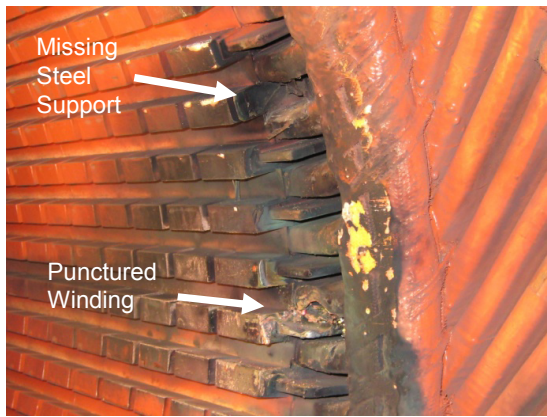
Fig. 18 Photo of E200 Stator Point of Failure

- Initial testing confirmed that Phase V was shorted to earth. Other phases were not shorted to earth.
- A clear burn mark was observed inside the stator once the rotor was removed. At the center of the burned area, a stator winding was found to be mechanically punctured, as shown in Fig. 18.

- Detailed examination of stator winding connections confirmed that the winding puncture described in Fig. 18 was electrically in the first turn nearest the star point.

- One of the steel supports for the stator core pack was missing, and there were signs of a fatigue failure at the point of separation. Dimensions of this missing component were approximately 6 mm x 30 mm x 147 mm. This missing steel support was situated just a few degrees rotationally ahead of the burn mark (see Fig. 18).

- It was theorized that the remnant of the missing steel support that was wedged into the stator winding was melted and destroyed during the fault event and that the molten steel, described in Bullet 5 above, originated from the missing steel support.

Some time before the moment of the large fault event on December 5, 2009, a steel component inside the E200 electric motor became dislodged, wedged between the stator and rotor, punctured a stator winding, and shorted the winding to earth. By coincidence, the puncture occurred on the first turn nearest the star point of the Phase V

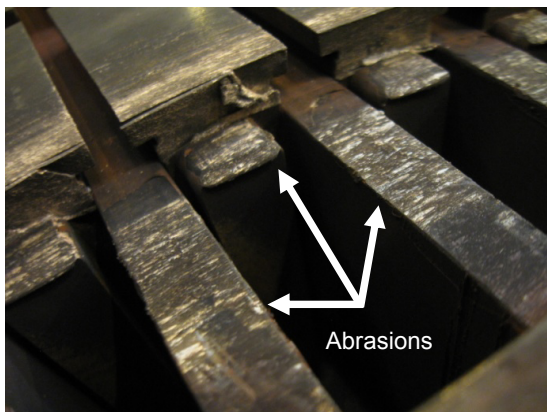
Fig. 19 Photo of E200 Rotor Opposite Stator Damage

- Clear mechanical abrasions were observed on the rotor opposite the burned area on the stator, as shown in Fig. 19.
- Several small hardened droplets of what was previously molten steel were found on the inside of the stator rotationally following the fault site.

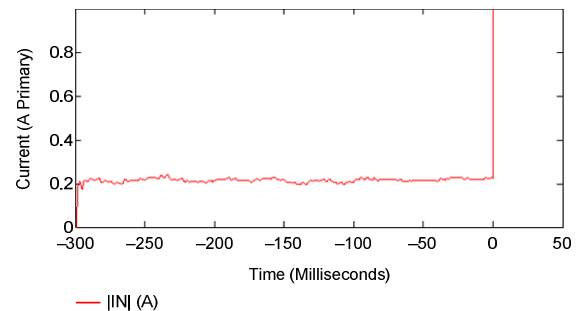
Fig. 20 Neutral Current Magnitude at E200 Motor Relay

If we assume that the best theory of what happened is correct and there was an existing fault on or very near the neutral of the motor that went unnoticed for some time before a second ground fault occurred, the ideal operation would have been to detect that fault and alarm or trip the machine before a second ground fault occurred. A fault exactly at the neutral point of an ungrounded motor in an impedance-grounded system would draw very little, if any, measurable current during normal operating conditions. Because the digital event records contain pre-fault data, we can look at what the measured neutral current is prior to the fault. In Fig. 20, we see there is approximately 0.2 A primary of neutral current measured by the relay before the event. This could certainly be indicative of a fault at or near the neutral.

a balance between different principles and, in this particular case, a balance between sensitivity and security. Saturation and false residual currents are generally not a problem when using a ground fault current transformer; however, setting a neutral overcurrent element derived from a ground current transformer too low could present a sensitivity concern. It is also important to note that even the most sensitive neutral overcurrent setting will not detect a fault exactly at the neutral point.

A very sensitive time-delayed neutral overcurrent element could have been enabled to detect this. The minimum pickup setting for the neutral overcurrent element in this particular digital relay is 0.01 A primary. Protection is
