A Current Story – When Primary Met Secondary

Genardo Corpuz
Lower Colorado River Authority

Swagata Das and Ariana Hargrave
Schweitzer Engineering Laboratories, Inc.

Abstract—Protective relays require accurate voltage and current measurements from potential transformers (PTs) and current transformers (CTs) to reliably protect the power system. In this paper, we describe a unique event in which the secondary wiring of two CTs, one going to a bus differential relay and the other to a transformer differential relay, made contact with the primary system and caused a fault. This subjected both relays to primary-level currents, causing them to measure false differential current and operate. The paper discusses the outage that occurred and the investigation the utility performed, followed by how relay event reports were used to substantiate the utility’s findings and gain additional insight into the fault. The paper also discusses the damage that can occur to a relay when CT secondary wiring comes in contact with the primary system.

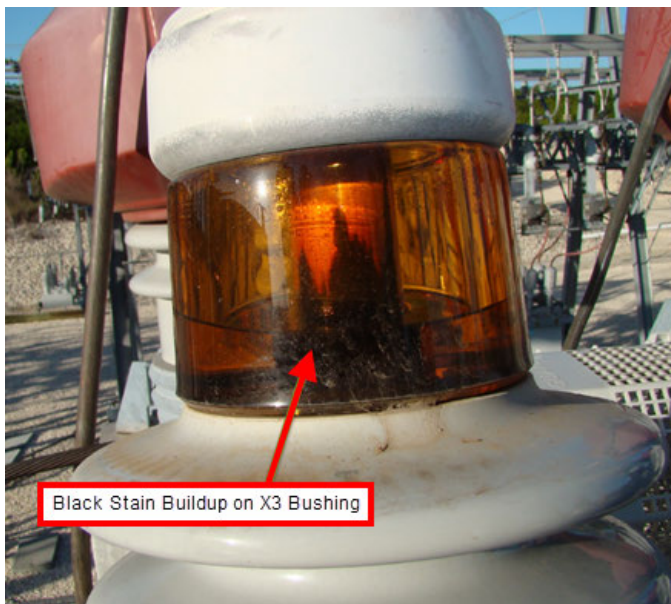
After the test, a visual inspection of the bushings was performed. Although the low-side bushings had tested normal, a black stain was visible through the sight glass on the X1 and X3 bushings, as shown in Fig. 9.

Fig. 9. Black stain buildup observed through the sight glass of the X3 bushing

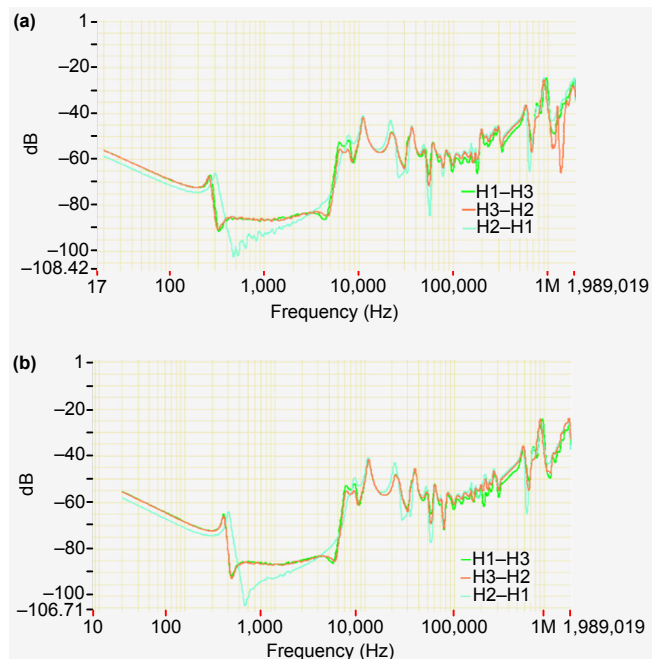
A sweep frequency test assesses the mechanical integrity of the transformer and detects core and winding problems [10]. The test is based on the premise that a transformer winding is nothing but a complex network of distributed resistance, inductance, and capacitance. The resistive-inductive-capacitive (RLC) network produces different output voltages at different frequencies that act as a unique signature. Any deviation of this signature from baseline tests conducted at the factory, during commissioning, or during a regular maintenance cycle provides a strong indication of a problem with the core or the winding. In this event, the sweep frequency test conducted by the utility in 2012 as part of its routine maintenance served as the baseline case and is shown in Fig. 10a. The sweep frequency test conducted after the transformer trip is shown in Fig. 10b. Both traces match and no problem was found.

Fig. 10. Sweep frequency test performed during a maintenance test in 2012 (a) and after the fault in 2015 (b)

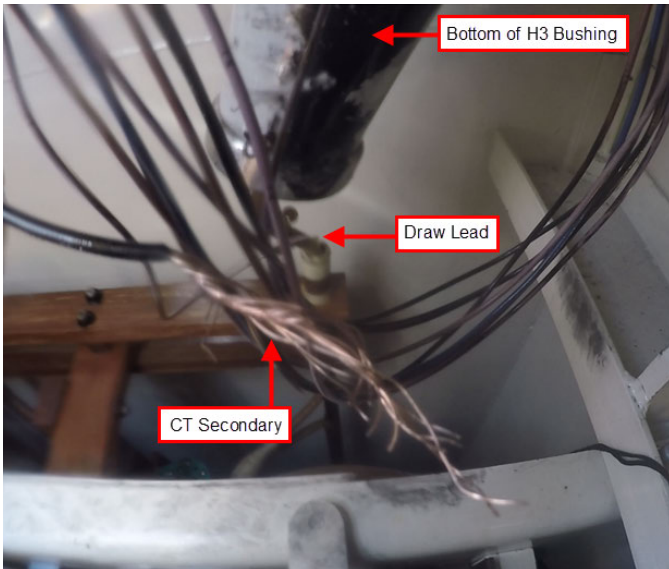
Although the electrical tests described in Subsection C indicated a problem with the H2 bushing, internal inspection found no visible damage on that bushing. Internal inspection did, however, find significant damage on the H3 bushing. In addition to the damage on the H3 bushing, there was also significant damage to the CT secondary wiring associated with that bushing. Three of the CT wires were damaged, broken, and had bare wire exposed, as shown in Fig. 11. The coloring of the wires is no longer visible due to the carbon coating from the fault. It was also noted that the CT wires associated with the H3 bushing had more slack than the CT wires associated with other bushings and were not bundled together. The bottom of the H3 bushing, which showed pitting and carbon deposits from an arc on the lower end shield, is shown in Fig. 12.

Fig. 11. Broken CT wiring and damaged H3 bushing

It was theorized that the excess slack in the CT wiring allowed the wires to fall low enough to make contact with the lower end shield at the bottom of the H3 bushing (see Fig. 16). Because the lower end shield is at line potential (80 kV) and the insulation of the CT secondary wiring is rated for only 600 V, a catastrophic insulation failure occurred when the CT secondary insulation made contact with the lower end shield. The insulation failure subjected the secondary CT wiring, along with the CT junction box, to primary-level voltage and caused an arc to ground at the junction box.

Once the root cause of the transformer failure was identified, the process of repairing the transformer began. The utility replaced two 88 kV bushings (H2 and H3), the pressure relief device, and the secondary wiring for all of the CTs. The utility decided not to replace the low-side bushings because they believed that the staining found on those bushings was likely there before the fault occurred and would have been found during routine five-year maintenance testing. The cost of procuring all of this new equipment amounted to thousands of dollars. Other significant costs to the utility included rolling trucks; testing, draining, repairing, and refilling the transformer; personnel time; and revenue lost during the outage.

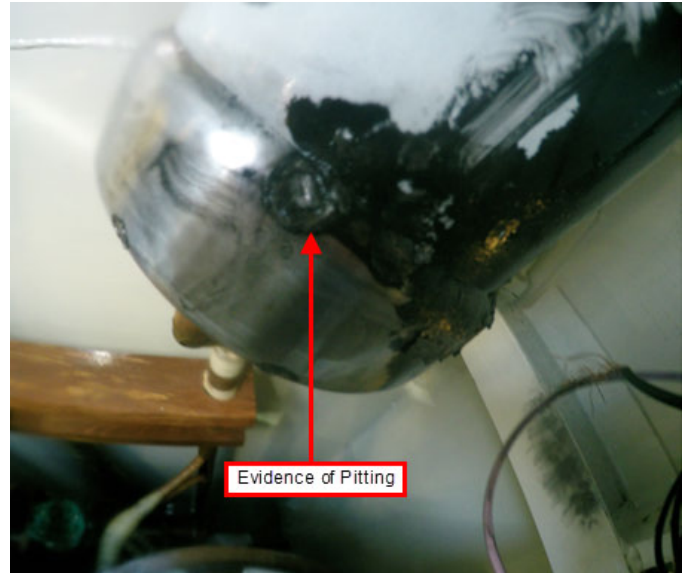
Fig. 12. Close-up view of the pitting observed in the bottom of the H3 bushing

Physical damage was clearly evident on the H3 bushing, so why did the H2 bushing fail the power factor test while the H3 bushing passed? It is important to understand that a lower power factor measurement does not necessarily mean that the bushing experienced a fault and could simply be a result of regular deterioration. In the case of the H3 bushing, the fault was located at the lower end shield and did not affect the insulation or the results of the power factor test.

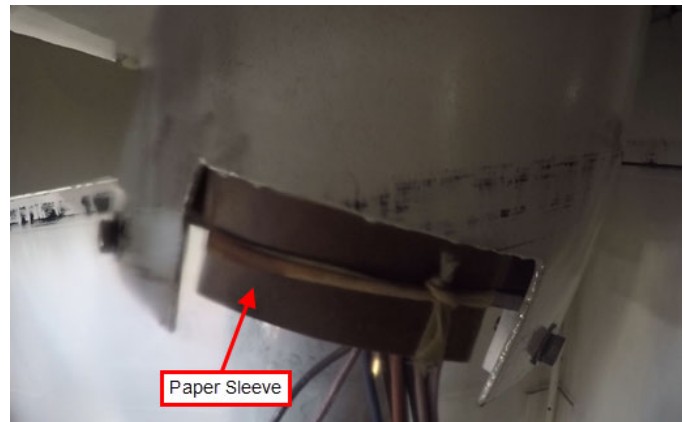
The utility reported that extensive cleaning would need to be completed before the transformer could go back in service. Fig. 13 shows a line of carbon at the top of the tank, where carbon was floating on the surface of the oil. There was also some carbon sediment sitting on the core and at the bottom of the tank. Although the bushing itself is removed, Fig. 13 still shows the metal casing that holds the CTs at the top of the tank, along with the paper sleeves where the CT wiring is routed out and away from the bushing.

Fig. 13. Carbon at the top of the transformer tank

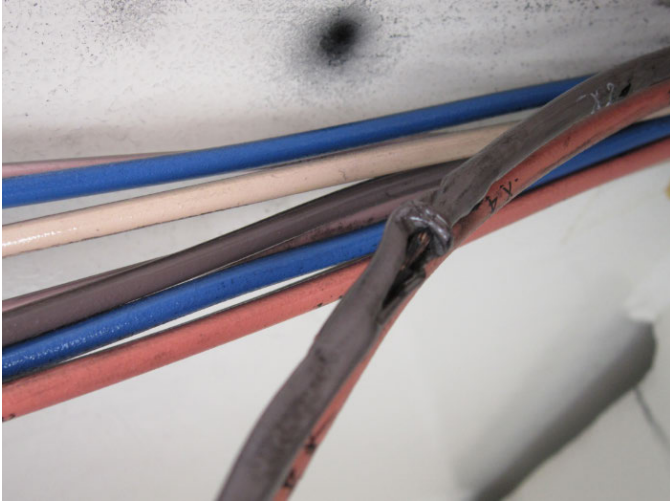
Evidence of arcing and insulation punctures was found in the CT secondary wiring going toward the junction box, as shown in Fig. 14. High-side CT Junction Box J1 was completely burned, as shown in Fig. 15. CT wiring from this box is routed to the current inputs of the transformer differential relay (Relay Y) and the backup overcurrent relay (Relay Z). The other three junction boxes were not damaged.

Fig. 14. Arcing to the tank and punctures on CT secondary insulation

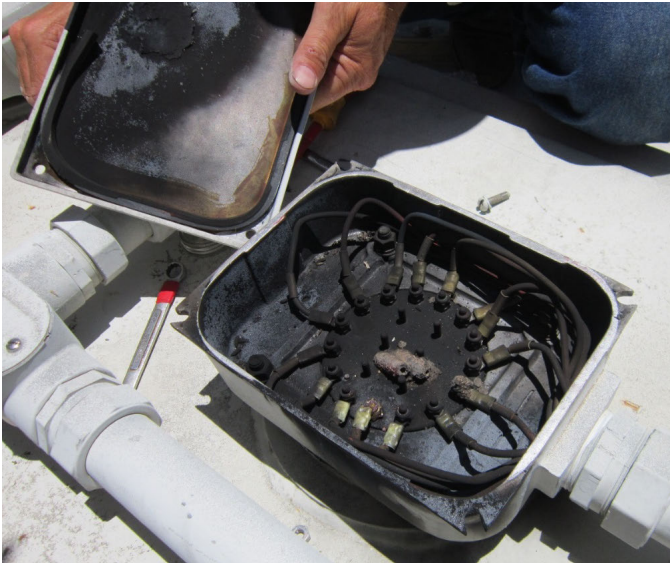
Fig. 15. Damage to high-side Junction Box 1

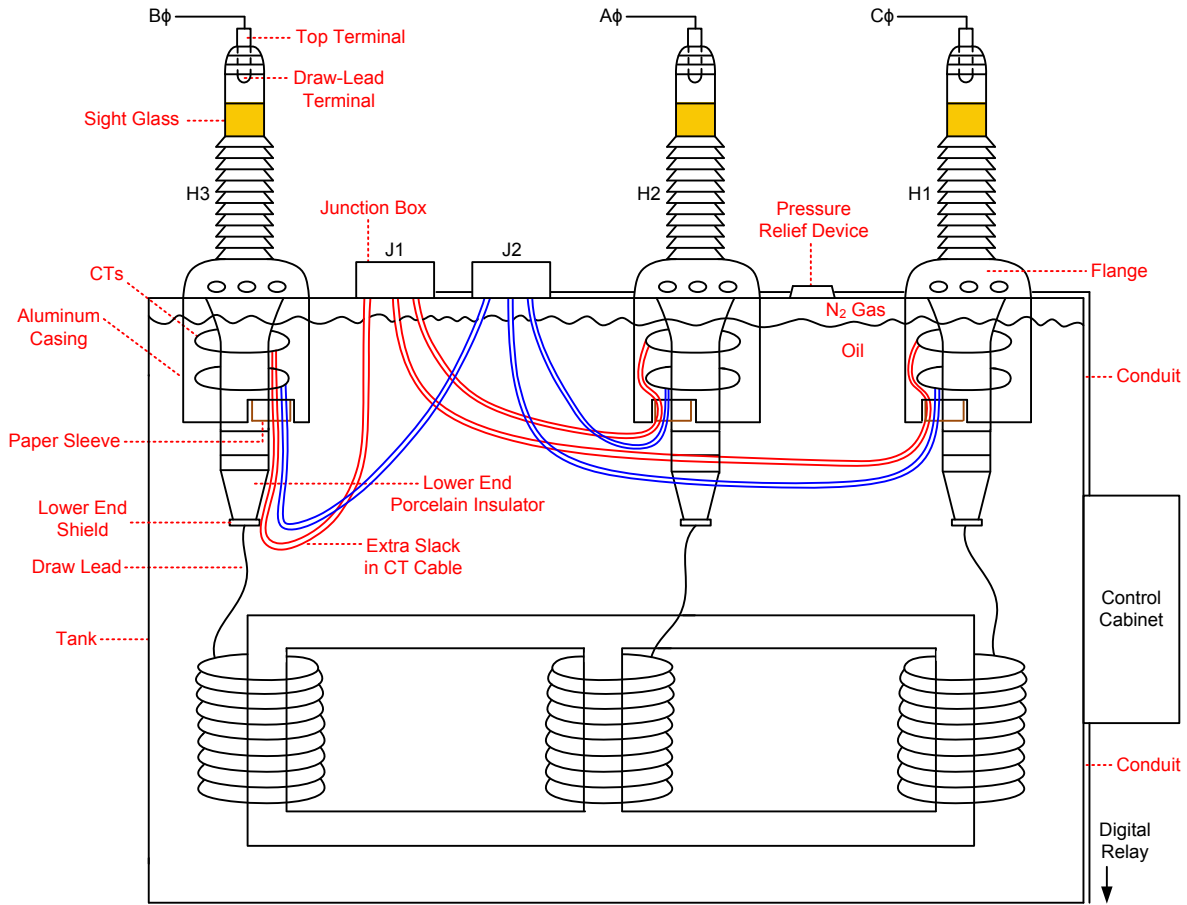
The internal inspection described previously led to additional questions. What caused this excess slack in the CT secondary wiring? Why was the wiring not bundled? Initially, the utility thought that the CT secondary wiring could have been moved if a bushing had been replaced, but their records showed that no such maintenance had been done. Therefore, the utility concluded that the lack of bundling and excess slack must have been a manufacturing defect. However, the transformer had been in service since 1994. If this was indeed a manufacturing defect, why didn't this fault occur sooner? What changed between 1994 and 2015?

It is possible that the oil circulating in the transformer tank moved the secondary wires over time until the wires eventually made contact with the bottom of the bushing. Through faults also cause movement inside of a transformer and may have been responsible for moving the wires. In addition, fans are used to cool the transformer and a pump is used to circulate oil in the tank. It is possible that either of these devices turning on or off could have jostled the transformer enough to displace the secondary wiring. However, without data showing when the pump and fans were in operation, the exact cause could not be identified.

Fig. 16. CT secondary associated with the H3 bushing has excess slack and was not bundled

- The fault described in this paper was caused by excess slack and a lack of bundling in the CT secondary wiring, which the utility deemed to be a manufacturing defect. Such defects can easily be identified through visual inspection at the time of installation, before the transformer has been fully assembled or filled with oil. Transformers are very expensive pieces of equipment, and requesting a visual inspection before accepting ownership may be worthwhile if it means avoiding a costly and dangerous fault.

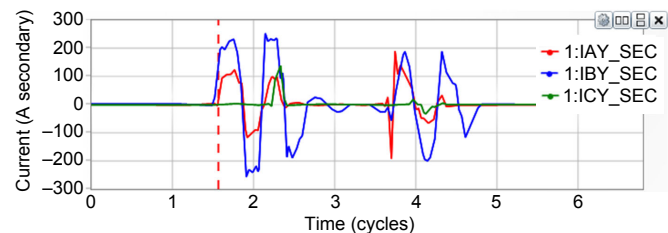
The event report shows that B-phase current (IBY_SEC) spiked first, followed shortly thereafter by A-phase current (IAY_SEC), and then the C-phase current (ICY_SEC) a cycle later. This corresponds to the transformer high-side B-phase CT, located on the H3 bushing, making contact with the primary system first. The fault then quickly propagated to the A-phase and C-phase CTs. Because all CT secondary wiring is routed together from the CTs to the junction box, it makes sense that a fault involving one lead would quickly propagate to the others nearby. Recall that the high-side CTs connected to the transformer relay were routed though Junction Box 1, which is the box that was severely burned after the fault.

Fig. 20. Raw currents on high side of transformer

Note in Fig. 20 that the peaks of the B-phase waveform are flat. The analog-to-digital (A/D) converter of the relay in Fig. 20 is rated for a maximum peak value of 230 A secondary. When the A/D converter is exposed to current above this limit, it reports its maximum value (230 A), resulting in a waveform that looks clipped. This means that the event report cannot tell us the maximum current that the relay actually saw, but we do know that it had to be higher than 230 A. Recall that the values in the raw event report are the same values that were filtered and reported in the filtered event report in Fig. 18, so the magnitudes and angles in Fig. 18 are also affected.

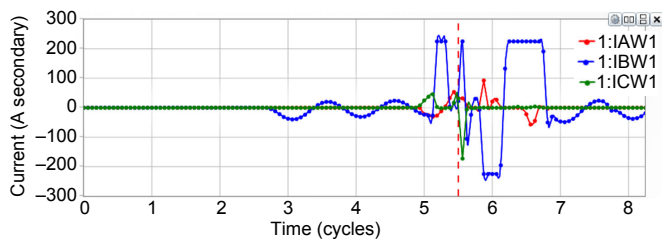
The raw event report from the bus relay, shown in Fig. 24, confirms our theory. For the first couple of cycles, the bus relay sees an external fault and restrains. Then, around Cycle 5, the external CT wiring fault evolved to include the B-phase bus relay CT. A/D clipping occurs on this relay as soon as the amplitude reaches a peak of 225 A secondary. Note that the time axes on raw and filtered event reports cannot be directly compared because of the delay caused by the internal relay filters that produce the filtered event report.

Fig. 24. Raw currents on W1 (corresponding to high side of Transformer T1) reported by the bus relay

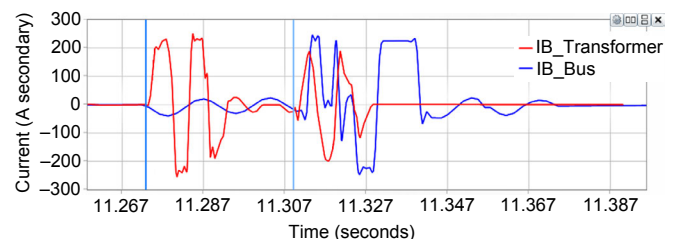
Fig. 26. Raw signals from the B-phase transformer CT (red) and B-phase bus CT (blue)

The first section of the fault, between the two blue vertical lines, shows where the transformer CT wiring made contact with the bottom of the bushing. The bus CT sees the current passing through it to the external fault. The fact that current on the transformer CT changes in magnitude throughout this first section of the fault points to possible arcing. The second

section of the fault, after the second blue vertical line, shows where high currents again began to flow in the transformer CT, and the bus CT also got involved. It is interesting that the current went to zero completely on the transformer CT while the bus CT was still arcing, meaning the circuit switcher had not yet fully broken the fault current. The drop in the transformer CT current is likely a result of the transformer CT wiring burning open and therefore being unable to deliver current to the relay while the bus relay CT wiring was still in the process of melting. The fault current measured by the bus CT goes away exactly 6 cycles after the beginning of the fault, which happens to be the maximum clearing time of the CS1 circuit switcher. This suggests that the circuit switcher was able to clear the fault before the bus CT wiring melted completely.
