# Event Investigation of 69 kV Double-Circuit Faults

Ahsan Mirza, Christopher Bolton, Girolamo Rosselli, and Sergio Flores  
*San Diego Gas & Electric<sup>®</sup>*

Presented at the  
23rd Annual Georgia Tech Fault and Disturbance Analysis Conference  
Virtual Format  
April 26–27, 2021

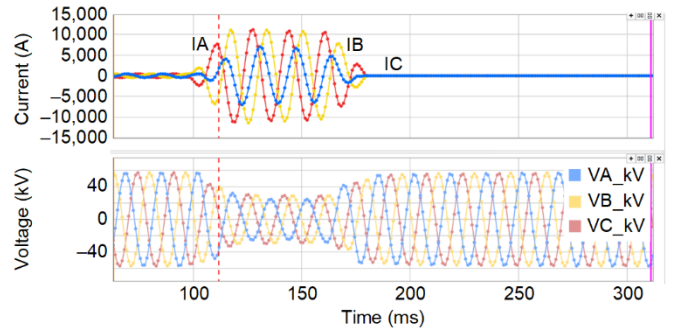
Fig. 2. T7P Relay Current and Voltage Oscillography

It is immediately clear that this oscillography reflects fault conditions, as all three phase voltages are depressed and currents are as high as 10 kA peak value. Something that also catches the eye is the unbalance in currents, even though there is high current in all three phases (reflecting that all three phases are faulted). There is slight unbalance in the voltages as well. All three phases are involved in the fault, but a conventional fault involving all three phases is a three-phase fault, which is mostly balanced in nature (ignoring the effects of line untransposition). That is not the case here, so a natural question arises: What kind of three-phase fault would create such significant current unbalance? There is little doubt that we are dealing with an unorthodox fault type.

It is interesting to see that at the intersection of the IA and IB waveforms lies the peak of the IC waveform. This waveform oddity manifests itself in the form of a clue from the current phasor diagram of Fig. 3. In the top pane, we see that the IC phasor is acting as an angular bisector of the IA and IB phasors. An additional hint as to the fault type and location is disguised in the ambiguity presented by unequal current magnitudes, where IA and IB are equal yet larger than IC. We compare this

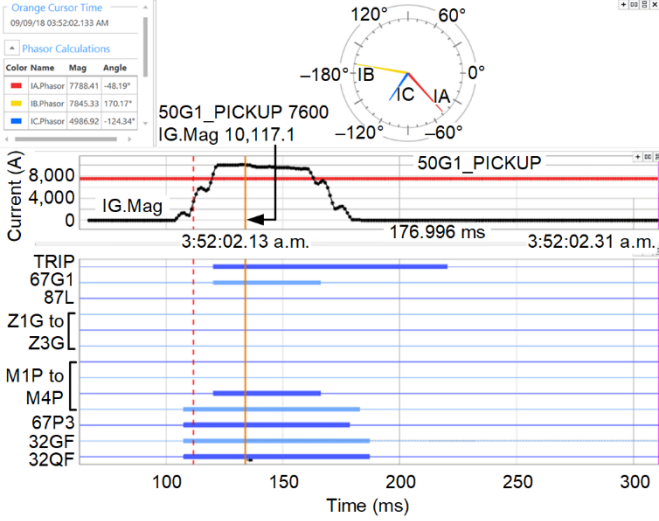
Fig. 3. T7P Relay Phasors and Protection Element Response

For a classic three-phase fault, the current magnitudes of all three phases are equal. The fact that we have equal A-phase and B-phase magnitudes but an unequal C-phase magnitude implies that A-phase and B-phase are faulted together at one location, while C-phase is faulted at another location.

Further, if the IC phasor was flipped 180 degrees from its position in Fig. 3 (and made equal to IA and IB), it would have represented a forward three-phase fault flow. (The same phasor diagram in Fig. 3 is also shown in Fig. 13 along with voltage phasors). But in reality, IC lies opposite of this forward three-phase fault position, or simply, the IC phasor lies in a reverse flow position compared with the IA and IB phasors.

What this suggests so far is a case of double faults: a forward fault from the relay location involving A-phase and B-phase, and a fault in another location behind the relay (reverse) involving C-phase.

The 67G1 bit (ground directional overcurrent element) asserted at the exact same time as the TRIP bit. The 67G1 assertion suggests ground involvement for this unusual fault. If we look at the phasor diagram in Fig. 3, the way IA, IB, and IC

- The 67G1 element of the T7P relay protecting Line L567 operated because it was set too sensitive and because of the nature of the fault. The double-circuit fault caused forward flow on A-phase and B-phase and a reverse C-phase flow, which led to higher ground current (calculated by the relay) than there actually was. This is because of the spatial arrangement of IA and IB and the reverse flowing IC current was additive in nature, hence the larger-than-actual IG ground current (Fig. 3).

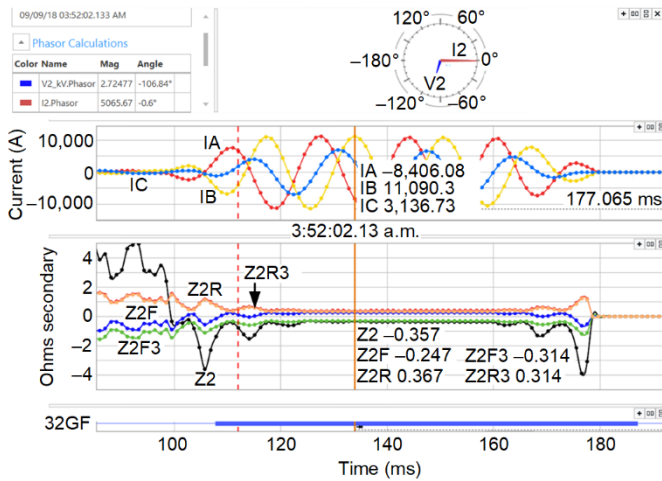
Fig. 5. Negative-Sequence Impedance Plot of T7P Relay

The plot of calculated negative-sequence impedance  $Z_2$  and the T7P relay  $Z_2F$  and  $Z_2R$  threshold settings are shown in Fig. 5. Clearly, the calculated  $Z_2$  (black) was well below the  $Z_2F$  (blue) threshold. And even if  $Z_2F$  and  $Z_2R$  were moved  $-0.3$  and  $0.3$  ohms, respectively (shown by  $Z_2F3$  and  $Z_2R3$  analog quantities), the calculated  $Z_2$  still lies beneath the  $Z_2F3$  (green) trace, but barely. Note that the relay adds dynamic boosts to these fixed thresholds of  $Z_2F$  and  $Z_2R$ , which is why traces of  $Z_2F3$  and  $Z_2R3$  are not seen at values of  $-0.3$  and  $0.3$ .

With  $Z_2$  calculated at  $-0.357$ ,  $Z_2F$  at  $0.247$ , and  $Z_2F3$  at  $-0.314$ , it is clear the  $Z_2F3$  did far better than the  $Z_2F$  threshold and missed, by a fine margin, safely not declaring this fault as forward.

- The directional element at the T7P relay saw the reverse CG fault on Line L12 as forward. This is because the  $V_2$  and  $I_2$  relationship observed by T7P is surprisingly the signature of the  $V_2$  and  $I_2$  relationship for a conventional forward SLG fault. It should not be

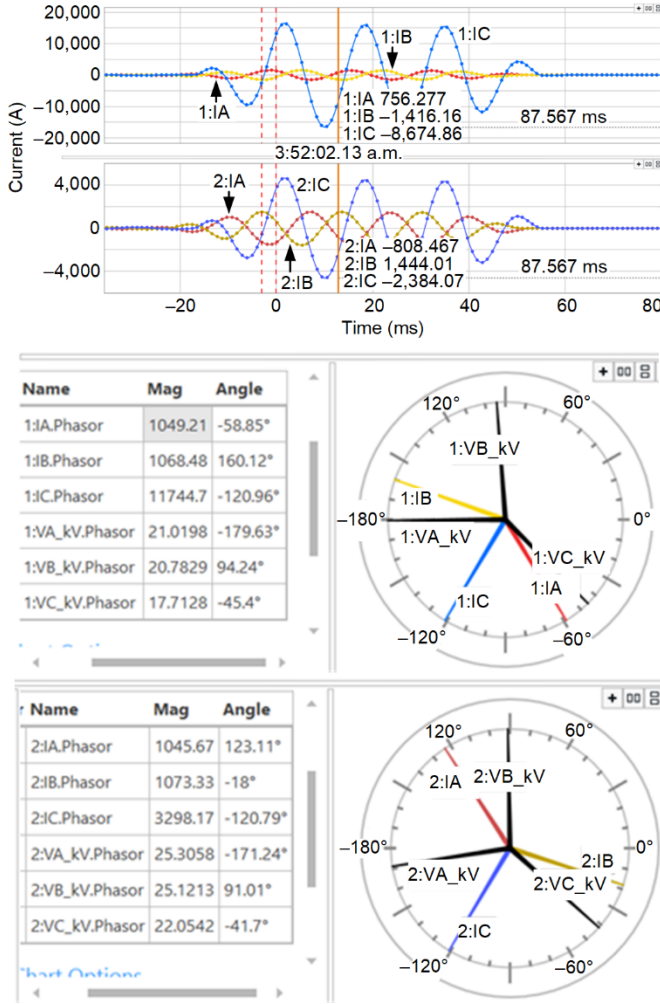
Fig. 6. T1S and T2S Combined Event Reports

Fig. 6 shows the oscillography and phasors from two combined event reports of the T1 secondary (T1S) and T2 secondary (T2S) relays. The C-phase currents are high at around  $11.7$  kA and  $3.29$  kA for the T1S and T2S relays, respectively. Moreover, both IC phasors lag their respective VC phasors by roughly  $75$  degrees. This pointed toward an internal fault on Line L12 involving at least C-phase. On the other hand, A-phase and B-phase seem unfaulted. This is evident from their relatively low magnitudes compared to C-phase and the fact that IA at T1 ( $1,049.21 \angle -58.53^\circ$  A) is roughly equal in magnitude to IA at T2 ( $1,045.67 \angle 123.11^\circ$  A), but near  $180$  degrees out of phase in angle. The same observation could be made for the B-phase current phasor.

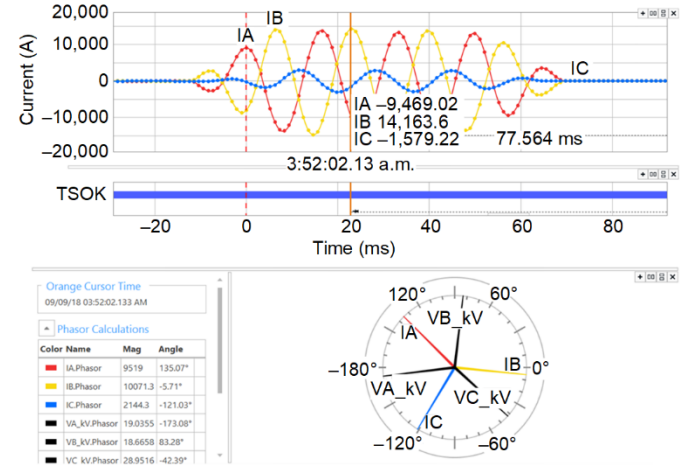
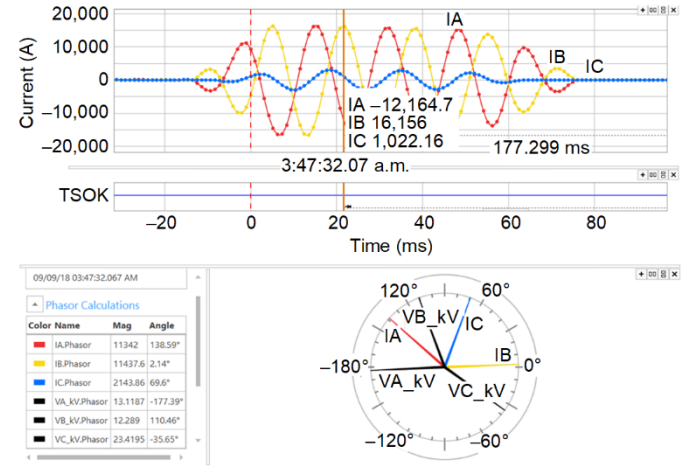
Next, we examine the fault oscillography captured by the T3 secondary (T3S) and T4 secondary (T4S) relays protecting Line L34. These are shown in Fig. 7 and Fig. 8, respectively. The T3S and T4S relay event reports could not be combined because the T4S relay was not time-synchronized when the fault occurred. This was evident from deassertion of TSOK in the T4S event report. However, this does not prevent us from concluding that A-phase and B-phase are faulted and C-phase is not. This can be deduced by comparing C-phase current phasor magnitudes in Fig. 7 (IC is at 2,144.3) and Fig. 8 (IC is at 2,143.86 A). Additionally, IC is lagging VC by 78.6 degrees at Terminal T3, whereas IC is leading VC by 105.25 degrees at T4. This implies current IC flows in through T3, lagging VC by 78.6 degrees, and flows out of T4, lagging VC by 74.75 degrees ( $180 - 105.25 = 74.75$  degrees). On the contrary, A-phase and B-phase current magnitudes are different on either terminal and significantly larger than IC. IA is 9.5 kA at T3 and IA is 11.3 kA at T4, with similar magnitudes for IB. The IA and IB angular relationship with its corresponding phase voltages (VA and VB) is not immediately clear to explain the type of fault on Line L34. However, the closest resemblance of a fault type would be an A-phase-to-B-phase-to-ground (ABG) fault, but we cannot say with certainty if that is indeed the fault type.

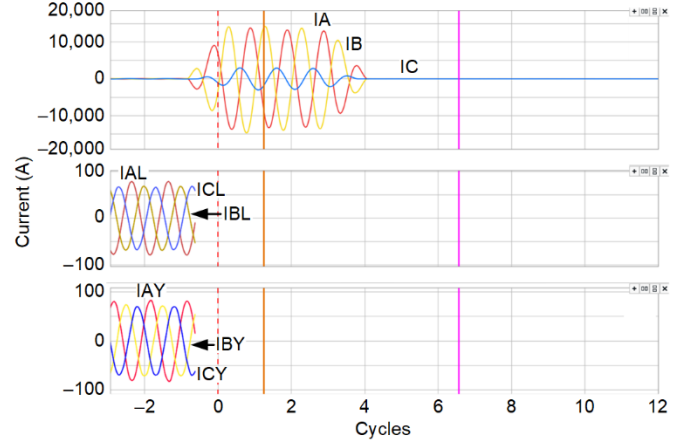
Fig. 10. T3P Event Report Showing Local and Remote 87L Currents

However, the T4P relay is the remote 87L partner relay for T3P (to protect Line L34), so the T3P event report should have captured remote 87L currents as well. So, an attempt was made to obtain IAT4 and IBT4 currents by opening T3P's event report (shown in Fig. 10). Surprisingly, both of T3P's local (IAL, IBL, and ICL) and remote (IAY, IBY, and ICY) 87L currents abruptly disappeared after the first two cycles.

IAY would have given us time-shifted IAT4 and IBY time-shifted IBT4 because the T3P and T4P relays did not require the use of the GPS time signal for their 87L function. The 87L function was instead based on the ping-pong method, which relies on fixed and deterministic 87L channel latency between T3P and T4P. The 87L current values are time-shifted based on the channel latency.

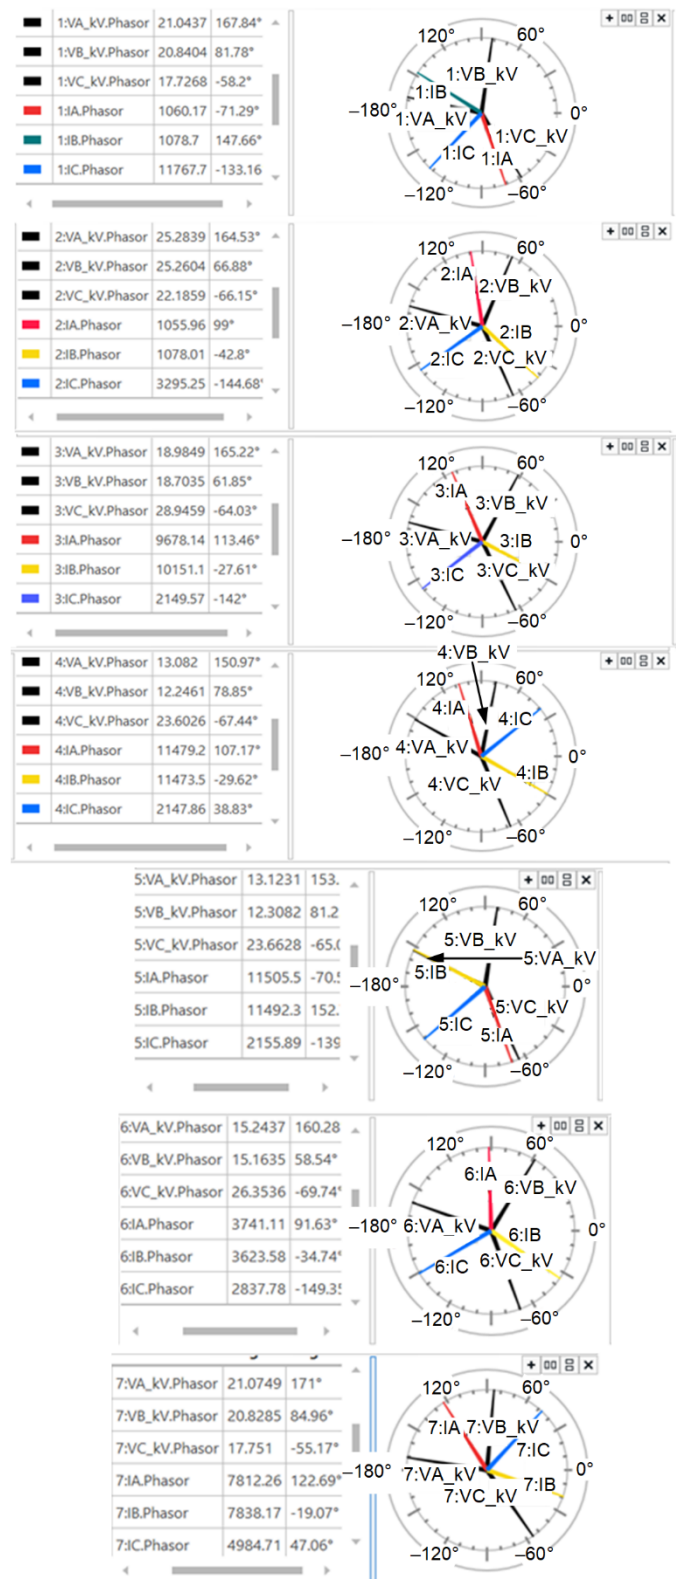
Fig. 13. Global Phasor View From Combined Time-Aligned Event Reports of All Seven Terminals

Not surprisingly, we still have roughly the same magnitudes of 8,453 and 8,454 A of IfT123 and IfT4, respectively, just like we saw in Fig. 11. But now we know their respective angles (now that all the event reports have been time-aligned) as well. IfT123 and IfT4 are roughly 170 degrees apart from each other. The 10-degree difference (180–170 degrees) is enough to reveal the existence of ground current of ~1,423 A.

If it was strictly a phase-only intercircuit fault, then IfT123 and IfT4 would have been 180 degrees respective of each other, and no current would have escaped to ground.

- Taking a system-wide view in the event viewer software by combining event reports from all of the terminals (Fig. 13) corroborated the current flow distribution presented in Fig. 12. This approach and the custom calculations were key in determining the fault type and whether ground was involved in the double-circuit fault.

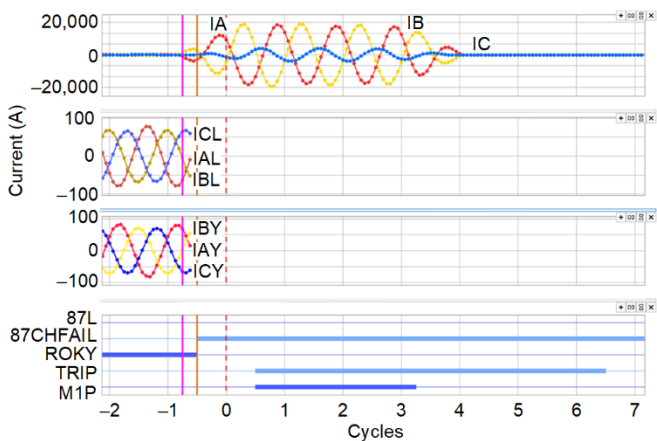
Fig. 15. T3P Event Report Showing 87L Element Behavior

As noted in the previous section, the T3 and T4 relays did not operate on their 87L elements for the internal fault on Line L34 like they should have. Upon further investigation, it was found that the Receive 87L data OK from Channel Y (ROKY) bit in the T3P relay had deasserted just a few milliseconds after fault inception (Fig. 15). Channel Y is the communications channel through which T3P exchanged 87L data with T4P on the other end of L34. ROKY deassertion is an indication of a potential communication problem with Channel Y, which causes the 87L element in the T3P relay to be disabled. One manifestation of 87L disablement appears in the form of the vanishing of IAL, IBL, and ICL (87L local phase currents of T3P) and IAY, IBY, and ICY (87L remote phase currents of T3P; that is, local current of T4P obtained via Channel Y), as shown in Fig. 15.

While 87L disappears right when the fault starts, M1P (Zone 1 phase mho distance element) fortunately comes to the rescue and operates in about 1.25 cycles, clearing the fault. This showcases the importance of having local backup protection elements.

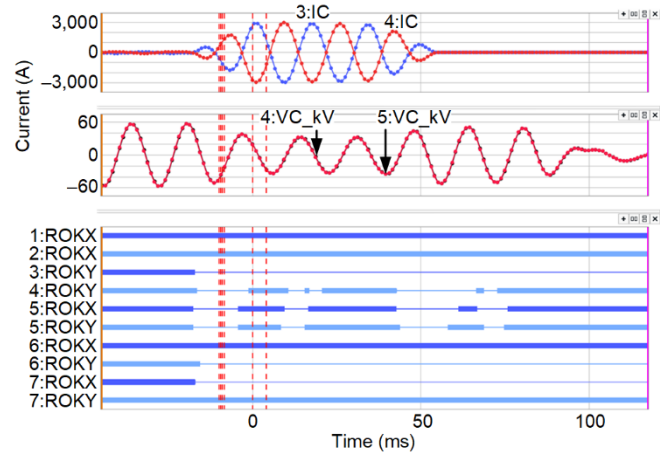
Fig. 16. Combined Event Report of All Seven 87L Relays Showing ROK Bits

To get to the root of the issue, we decide to plot ROK bits of all seven relays together. The bottom portion of Fig. 16 shows the pertinent ROK bits of all seven 87L relays (T1P, T2P, and so on) combined.

Based on this behavior, we look for the commonality in the data and observe that channels connecting the T4P and T5P relays are the ones affected. The T4P and T5P relays belong to the same substation and therefore must be using the same communications equipment or technology—perhaps the root cause behind the 87L element disruption at multiple relays. The 87L elements of T1P and T2P were intact perhaps because they used a communications channel independent of communication equipment and media at the B45 substation.

- The 87L scheme for both Lines L567 and L34 disabled right after the double-circuit faults started. We took advantage of the already combined and time-aligned event reports to lay out the 87L communications channel health indicator bits (ROKX and ROKY) for all the relays. Systematically examining the ROK bits suggested issues with the communications equipment at the N45 substation housing the T4 and T5 relays. It was later found that these 87L schemes indeed used leased copper telecom lines at the N45 substation, which would be affected during nearby system ground faults. There is a project underway to upgrade 87L communication technology for these 69 kV lines.

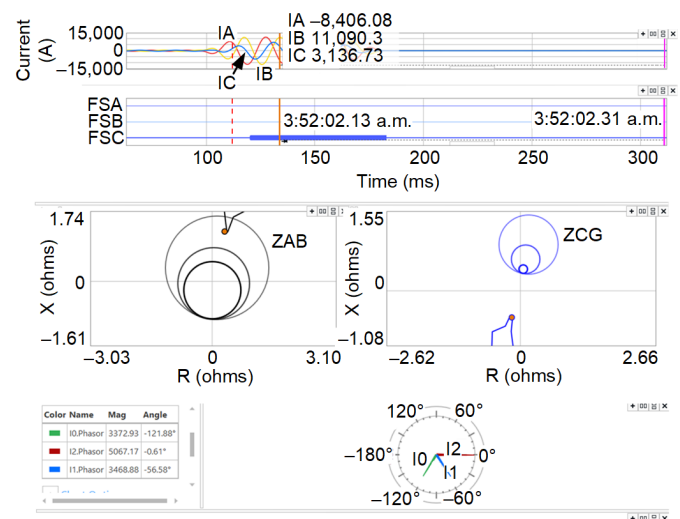
Fig. 17. T7P Mho Element Response

Fig. 17 shows the mho element response for the Zone 1, Zone 2, and Zone 3 mho phase elements of ZAB and the mho ground elements of ZCG. The reason we show ZAB and ZCG (and not ZBC, ZCA, ZAG, and ZBG) is because only ZAB and ZCG are enabled by the relay during the fault. This is evident by FSC assertion and deassertions of FSA and FSB.  $FSn$  ( $n=A, B, \text{ or } C$ ) is the output bit of the FIDS algorithm described in [7] that determines which two mho elements out of six to enable. The FSC assertion from a relay standpoint represents the fact that either there is a CG fault *or* there is an ABG fault. Interestingly, FSC has asserted when *both* fault types are present. This correct determination can be attributed to the spatial displacement of the  $I_0$  and  $I_2$  phasors. For a CG or ABG fault,  $I_2$  leads the  $I_0$  phasor by roughly 120 degrees. And in this case of a double-circuit fault, the same angular relationship between  $I_2$  and  $I_0$  is observed (Fig. 17) at T7.

First, we break down the double-circuit fault(s) into two individual faults, one on Line L34 and one on Line L12. The fault on L34 involving A-phase and B-phase is forward with respect to T7P. This manifests in the R-X impedance plane (ZAB in Fig. 17) with the operating point (orange dot) lying in the first quadrant. The first quadrant of the R-X plane symbolizes forward direction of fault current flow. The operating point is well outside the Zone 1 and Zone 2 mho circles but within Zone 3.

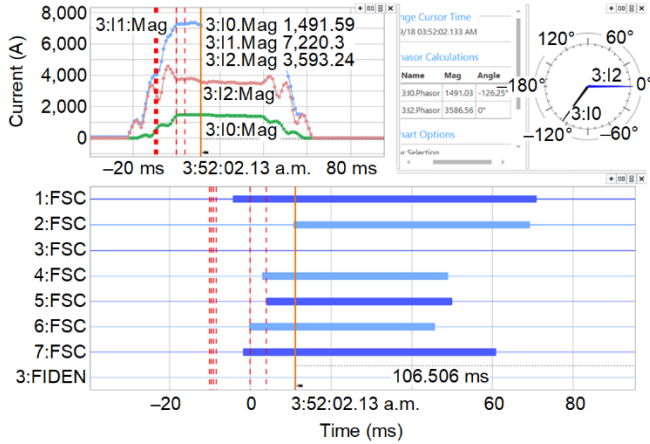
Fig. 18. Combined Event Report of All Seven Terminals Showing Respective FIDS Logic Response

Fig. 18 shows the FIDS logic response in the form of FSC bits for all seven relays (only primary relays shown). Not shown in Fig. 18 are the FSA and FSB bits, which remained deasserted. Once again, FSC assertion indicates either a CG or ABG fault from a relay standpoint. Every relay asserted its FSC bit (which was arguably a correct assertion) except the relays at Terminal T3.

Fig. 18 also shows that I2 leads I0 by roughly 120 degrees, but still FSC did not assert. Why? The fault identification logic is designed to detect faults that involve ground. The zero-sequence current and zero-sequence voltage measured by T3P for this fault were not of sufficient magnitude to enable the FIDS logic. This is evident by the FIDS enable bit, 3:FIDEN in Fig. 18, never asserting.

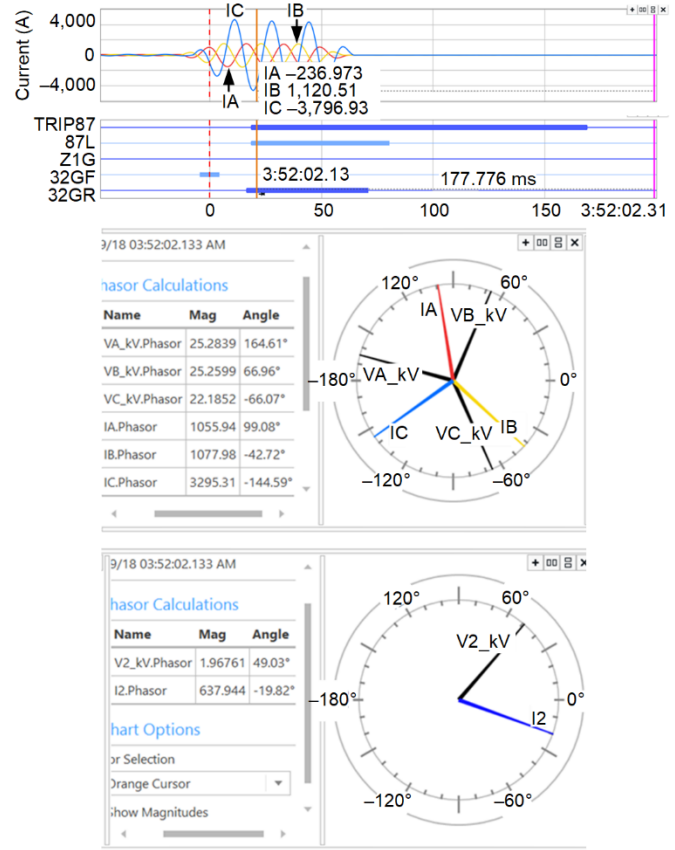
Fig. 19. T2P Event Report Showing Mho Ground Zone 1 (Z1G) Element Remaining Deasserted

We observed that the mho elements of relays at T5 and T6 remained secured, as expected. Mho elements of relays at T1, T3, and T4 operated as expected. What was not expected was the mho element dormancy for the T2 relays. There was an internal fault on Line L12 protected by T2P and T2S, so their mho elements should have operated. Fig. 19 shows Z1G in T2P remaining deasserted throughout the event duration. Why?

The answer lies in the negative-sequence voltage ( $V_2$ ) and current ( $I_2$ ) values seen by the relay for the double-circuit fault. In Fig. 19, which shows  $V_2$  and  $I_2$  phasors as seen by T2P,  $V_2$  leads  $I_2$  with an angle less than 90 degrees. This is, in fact, the  $V_2$  and  $I_2$  relationship expected for a reverse single-line-to-ground (SLG) fault! This rare double-circuit fault has been successful yet again in challenging the relay directional element, this time by hiding the forward directionality of the fault.

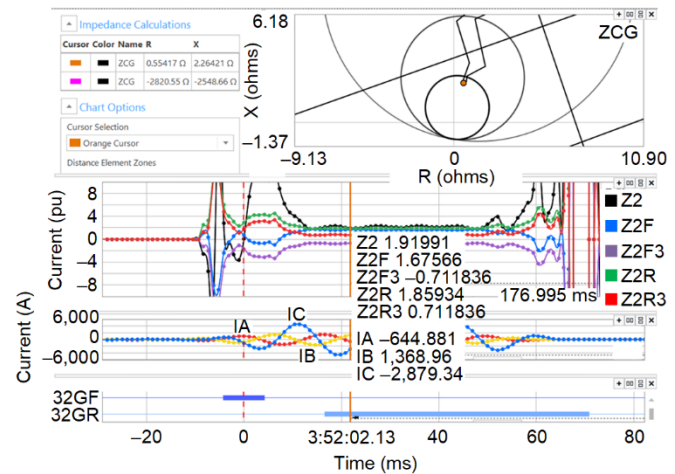
Fig. 20. Negative-Sequence Impedance Calculation of T2P Relay

direction) and 32GR (reverse direction) bits of the T2P relay. Unbeknownst to us, T2P's directional evaluation was challenged as well, although in a contrary fashion to T7P. T2P saw the forward (internal) fault on Line L12 as a reverse fault (evident by 32GR assertion), and therefore did not allow supervision for the Z1G mho element. The negative-sequence impedance ( $Z_2$ ) calculation for T2P's directional element is also shown in Fig. 20.  $Z_2$  is computed as 1.919 secondary ohms by T2P and is barely (yet clearly) above the  $Z_{2R}$  setting value of 1.859. Why?
