The Missing Link: How CT and VT Connection Errors Affect Protection

Marcel Taberer, Praveen Iyer, and Karl Zimmerman
Schweitzer Engineering Laboratories, Inc.

Presented at the
75th Annual Georgia Tech Protective Relaying Conference
Atlanta, Georgia
May 4–6, 2022

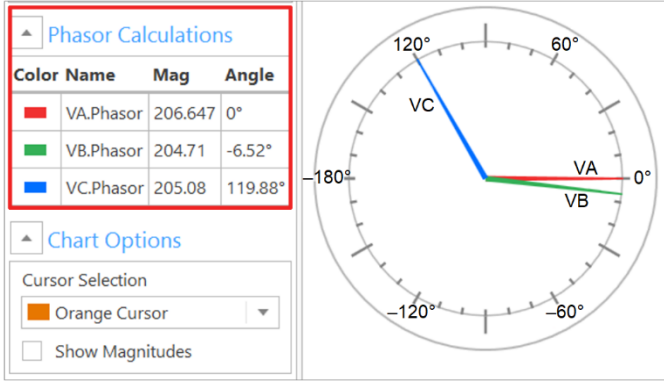
For Case 1, Fig. 15 shows the voltage phasors at the time the relay was placed in service. Note that VA and VB are similar in both magnitude and angle. The root cause was a wiring error introduced while the line was out of service, thus resulting in similar VB and VA measurements.

Fig. 15. VB incorrectly measuring actual VA.

Summary—In both cases, a meter check could have been used to validate healthy voltages.

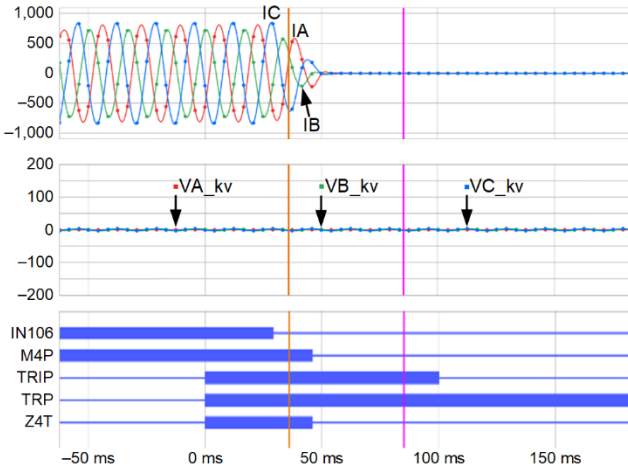
In Case 2, a relay was placed in service with zero voltage connected to the relay. Subsequent load caused a Zone 4 time-delayed distance element to assert undesirably as shown in Fig. 16.

Fig. 16. Case 2 relay placed in service with no voltages connected.

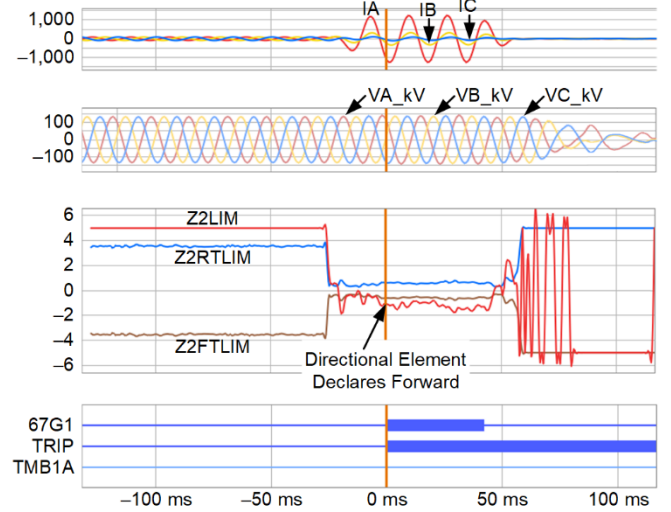
To evaluate why this happened, we plot the measured Z2 against the expected forward and reverse thresholds as shown in Fig. 18. When the measured Z2 (Z2LIM) dropped below the forward threshold (Z2FTLIM), the directional element declared forward to produce a 67G1 trip with no blocking signal (TMB1A) sent.

Fig. 18. Directional element incorrectly declares forward fault, relay trips, no block is sent.

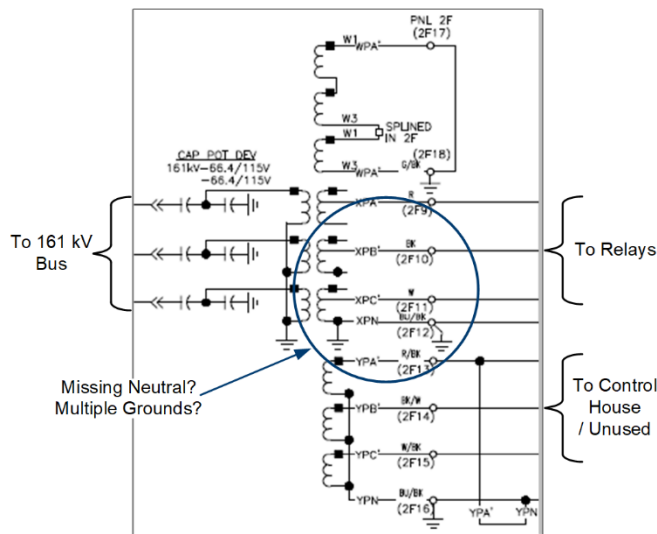
The original three-line diagram of the CVT indicating the secondary wiring and grounding with notable errors is shown in Fig. 20.

Fig. 20. Original three-line diagram showing possible errors.

Field staff found several drawing and wiring errors at the site which may have been introduced when the A-phase CVT had been replaced. Upon investigation, the field crew found only

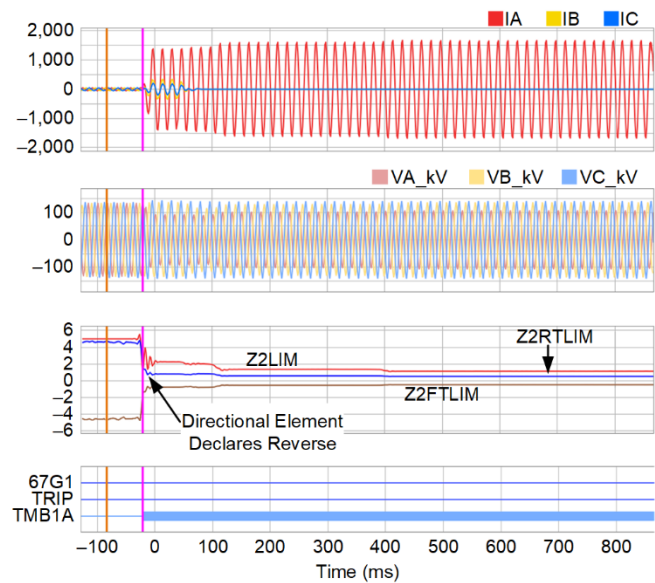
Summary—A floating neutral point in the secondary VT circuit produced incorrect voltage supplied to the A-phase of the protective relays, which caused the ground-directional element to declare forward for a reverse fault. Wiring and drawing errors were corrected and tested and the directional relay scheme performed correctly thereafter.

Fig. 21. Directional element correctly declares reverse after field staff correct wiring and drawing errors.

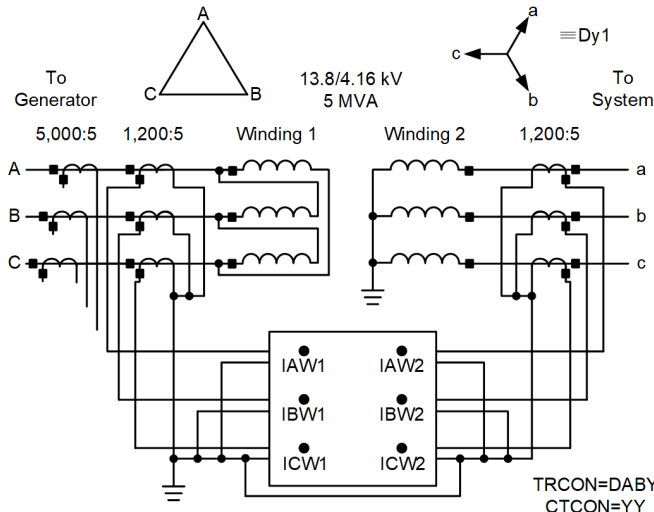
Fig. 23. DABY transformer three-line diagram with intended CT connections.

Field staff suspected a wiring error. As shown in Fig. 23, there were also 5000:5 bushing CTs on the 13.8 kV Winding 1. Secondary wiring was terminated for this 5000:5 CT at the same relay panel as the 1200:5 CTs. Field staff quickly determined that they had indeed found the root cause because the currents were off by a factor of approximately four (5,000/1,200). The current inputs of the relay for Winding 1 were connected to the 5000:5 CTs instead of to the intended 1200:5 CTs.

Summary— Discrepancies between the drawings and the actual field wiring resulted in incorrect CT connections to the relay, which caused the undesired operation.

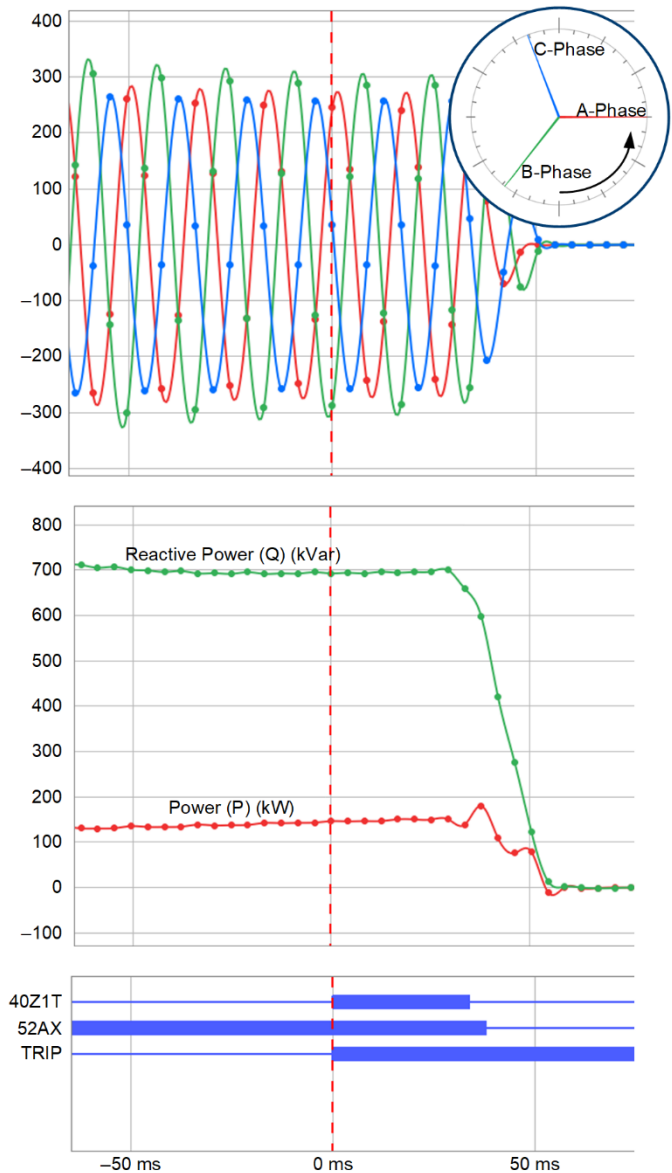
Fig. 27. Current trace with the power and reactive power plot for an LOF event.

The problem was that an LOF trip occurred when the generator breaker was closed on the bus, at which point the power exported to the system was approximately 150 kW of P and 700 kVar of Q, as shown in Fig. 27. The digital bit 40Z1T indicates that there is an LOF trip in Zone 1, and the status change of the 52AX breaker contact indicates that the breaker is tripped.

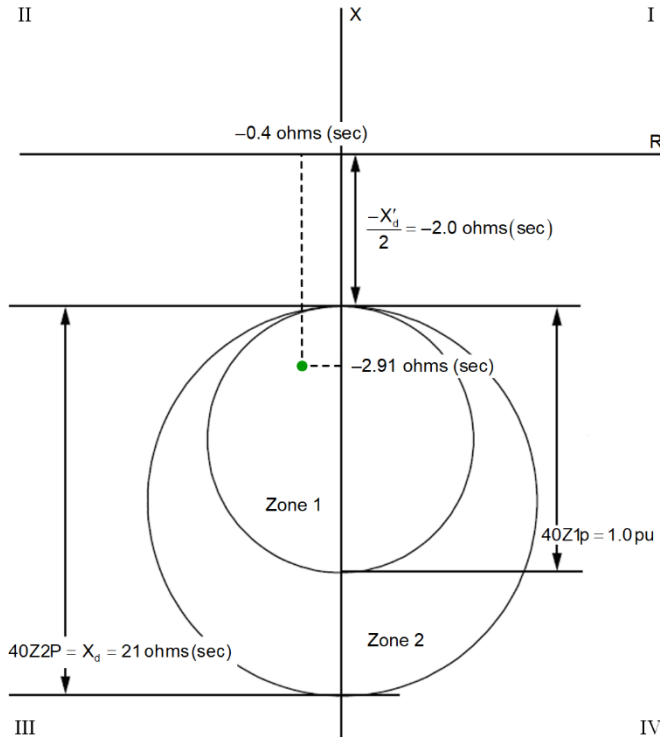
Based on this unusual behavior and the resulting trip event, an impedance plot is derived to validate the LOF, shown in Fig. 28. Note that Z1 plots within the Zone 1 Mho characteristic, which confirms the 40Z1T digital status assertion shown in Fig. 27.

Fig. 28. Z1 during the case study LOF event.

Furthermore, based on the P and Q signatures shown in Fig. 27, it is evident that this was not an LOF event. However, the Z1 plot shown in Fig. 28 proves that the relay thought it was. The sequence components for voltage and current calculated by the relay are shown in Table 2, and can be used to understand the Z1 calculation taking place within the relay's algorithm. The expectation for normal, healthy operation when phase rotation is correct is such that the V1 and I1 should be similar to the phase voltage and current, respectively, and the negative-sequence voltage (V2) and current (I2) should be relatively low. V1 and V2 and I1 and I2 seem to be swapped, which is an indication that something is not correct for healthy generator operations. Recall that Fig. 27 shows the phase rotation to be ABC, per the generator wiring, but the phase-

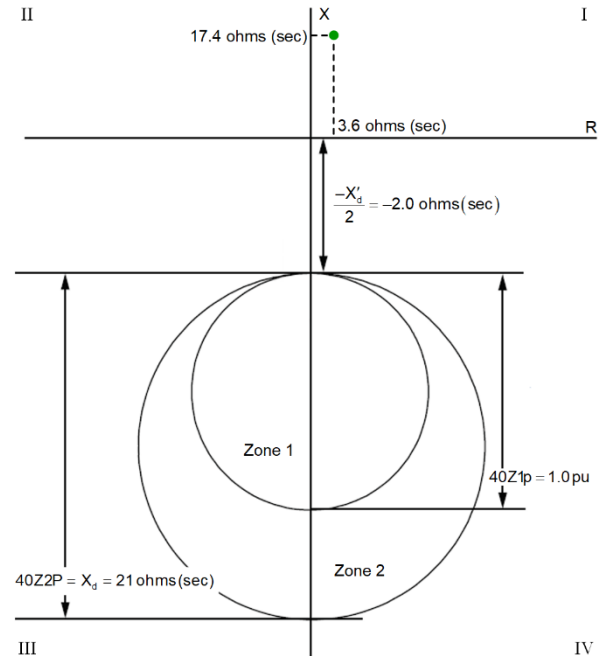
Summary—In this instance, incorrect phase-rotation setting was the root cause of the event, resulting in the relay calculating an incorrect Z1 which led to a trip. Fig. 30 indicates the correct Z1 calculation that the relay would have seen if the correct phase rotation had been applied in the relay settings to match the generator phase sequence. Note that the Z1 is outside of Zone 1 and Zone 2 Mho characteristic.

Fig. 30. Z1 plot during the case study LOF event with the correct phase rotation applied.

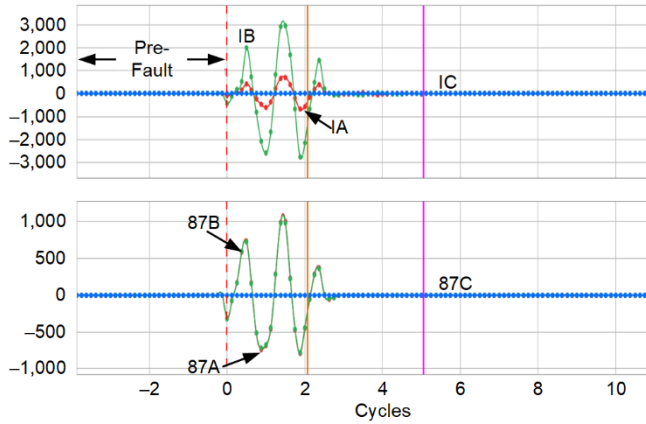
differential current waveforms (top oscillography in Fig. 33) and voltage waveforms (bottom oscillography in Fig. 33), we noticed that the pre-fault oscillography appeared as expected, wherein the differential current and the differential voltage across the 87Z relay were both zero.

Fig. 33. 87Z relay, showing differential current and voltage waveforms.

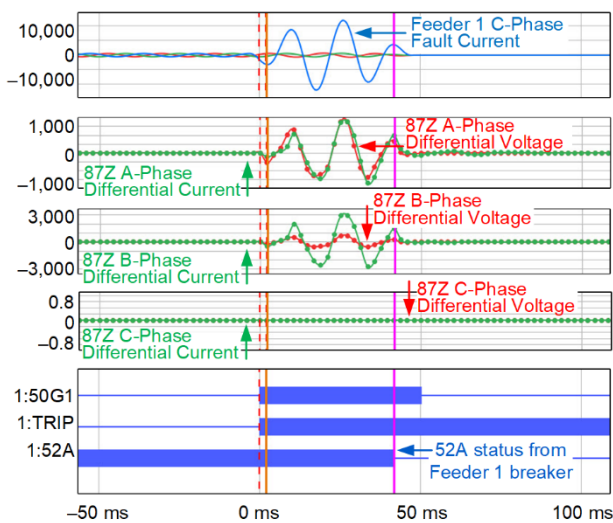
Fig. 34 shows the currents seen by the Feeder 1 relay, with the differential voltages and currents measured by the 87Z relay. Note that the C-phase-to-ground fault causes an increase in C-phase current measured by the Feeder 1 relay, as expected, but causes the A- and B-phase-differential voltages and current to spike in the 87Z relay.

Fig. 34. Combined events from Feeder 1 relay and 87Z relay.

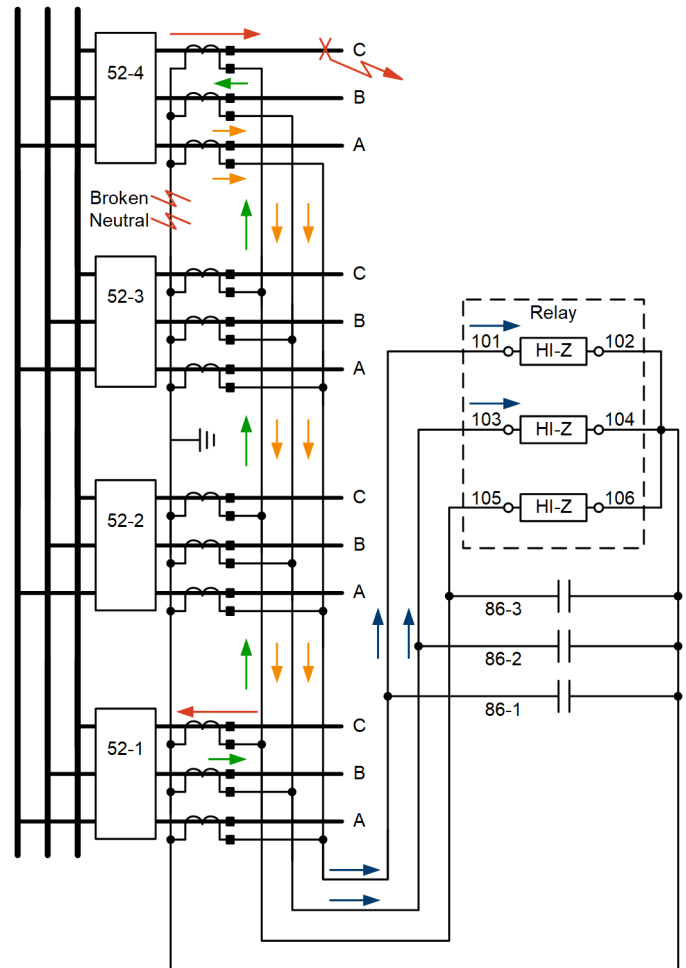
A missing neutral-to-ground connection will cause the fault current to circulate through the non-faulted phase instead of flowing into the ground. Such a scenario is similar to what had been observed in this case. Fig. 35 depicts a C-phase-to-ground out-of-zone fault, much like in the case study. The red arrows show the flow of primary fault current, the green arrows show the flow of CT secondary fault current, the blue arrows show the differential current flowing into the 87Z relay, and the orange arrows show the secondary fault current in C-phase flowing through the non-faulted phases (A and B), which was due to a missing neutral-to-ground link. This hypothesis falls in line with the oscillography shown in Fig. 34.

Fig. 35. Scenario of missing neutral link during an out-of-zone fault.

Indeed, after thoroughly investigating the wiring, a missing neutral link was found to be the root cause.

Summary—A missing neutral link can cause fault current to flow through a non-faulted phase, thereby simulating a pseudodifferential current during through-fault conditions in a differential protection scheme. Such an occurrence can only be detected during unbalanced faults. Single-phase primary injection, as described in Section III and simulating unbalanced primary currents during commissioning or maintenance, would have caught this error and prevented this misoperation from happening.
