Lessons Learned Through Commissioning, Livening, and Operating Switchgear

Matthew Watkins and Kamran Heshami
Schweitzer Engineering Laboratories, Inc.

Michael T. Mendiola and Nilushan K. Mudugamuwa
Tengizchevroil

Presented at the
2022 PCIC Europe Conference,
London, England
June 2022

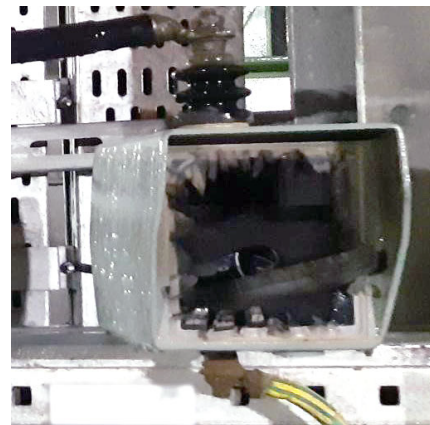
In this event, a line current differential (87L) relay detected a line fault and tripped both line terminals. Power system operators quickly identified the root cause as a failed surge arrester. Fig. 4 is a photo of the failed surge arrester counter. Although this was a correct trip event, further analysis found that both the primary and backup 87L relay detected the fault, but only the backup 87L relay tripped. Fig. 5 and Fig. 6 show the backup and primary relay performances, respectively. Fig. 5 shows a trip issued by the backup relay and Fig. 6 shows that the primary relay did not trip.

Fig. 4 Failed surge arrester counter

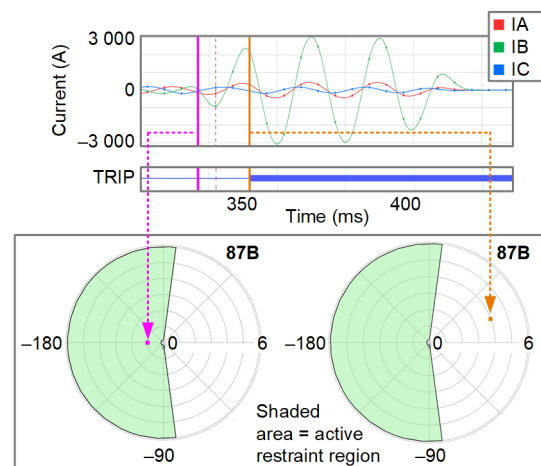
Fig. 5 Backup relay performance

Reference [1] describes the current-based alpha plane characteristic. In both Fig. 5 and Fig. 6, the pre-fault condition accurately plots at -1 , indicating that the relay is secure (no trip condition). However, during the fault condition, both relays plot in the tripping region of the alpha plane, yet only the backup relay issued a trip.

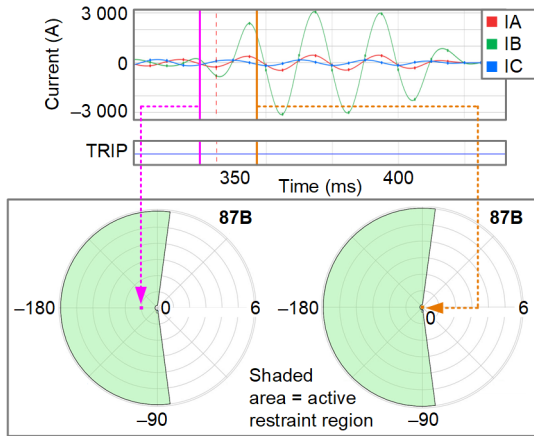
Fig. 6 Primary relay performance

After further investigation, the relay technician found that a communications channel watchdog alarm disabled the primary relay 87L protection. The communications channel watchdog alarm warns the user when an 87L protection element operation is repeatedly avoided by the disturbance detector or if the relay repeatedly receives an 87L direct transfer trip without an accompanying pickup of the disturbance detector. This alarm can occur during local or remote relay testing and, if not reset, can result in a disabled 87L relay element. The addition of the communications watchdog alarm is a security improvement in the relay design to help prevent undesired operations that can occur from communications-channel-based single event upsets (SEUs), as detailed in [1].

As a result of this event, the engineering team implemented several report changes to monitor the alarm counters and watchdog alarm status. Relay test engineers now include this report in the relay test documentation and verify proper operation prior to putting a relay into service.

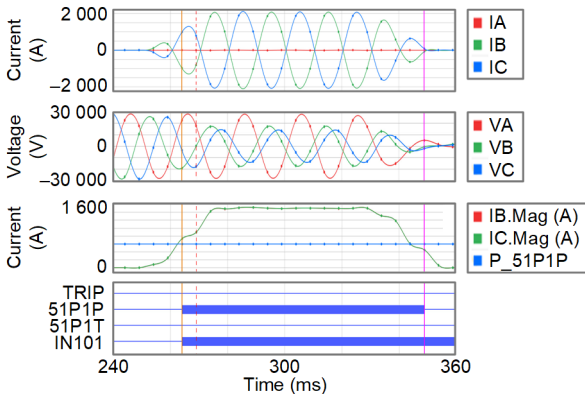
Event reports for each relay were extracted by the commissioning team to further understand the event. Fig. 9 shows the fault current waveform recorded at the feeder. It clearly shows the magnitude of the fault current around 1 500 A in Phase B and Phase C, lasting for five cycles. However, the trip (TR) Relay Word bit was not asserted either from 51P (600 A pickup) or 50P (2 700 A pickup). Instead, the incomer cleared the fault, suggesting a discrimination issue between Incomer B and Feeder B.

Fig. 9 Feeder event report

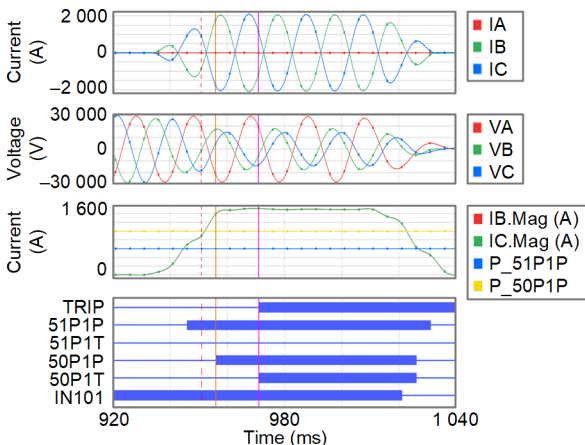
Fig. 10 shows the waveform recorded at the 35 kV Incomer B relay, where fault current with a magnitude of 1 500 A was seen on Phase B and Phase C, lasting close to five cycles. The 50P1P element picked up as soon as it hit the set point (1 000 A) and triggered a trip on 50P1T after 15 ms. The breaker opened (52A deasserted) 50 ms later.

Fig. 10 Incomer B event report

Fig. 10, the Incomer B relay event report, shows a trip triggered from the instantaneous overcurrent (50P1T) set point. The incomer relay should not clear a downstream feeder fault; instead, the downstream feeder protection should clear the fault to maintain trip discrimination and allow the remaining feeders to continue to supply their load.

After a design review, the team confirmed that the instantaneous element was supposed to block the automatic transfer scheme operation. However, the element was mapped to the trip equation incorrectly in the logic diagram. It was subsequently removed from the trip equation and the logic diagrams were updated.

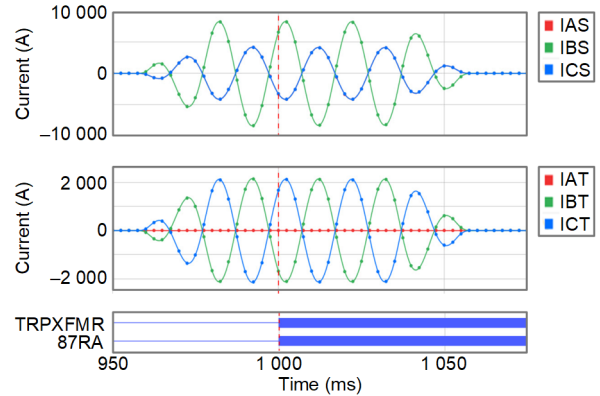
A similar pattern can be seen when reviewing the event record on the transformer protective relay. The fault current was experienced in both the primary and secondary windings, and it was cleared within 60 ms after the Phase A restrained differential element (87RA) Relay Word bit was asserted, as shown in Fig. 11.

Fig. 11 Transformer relay event report

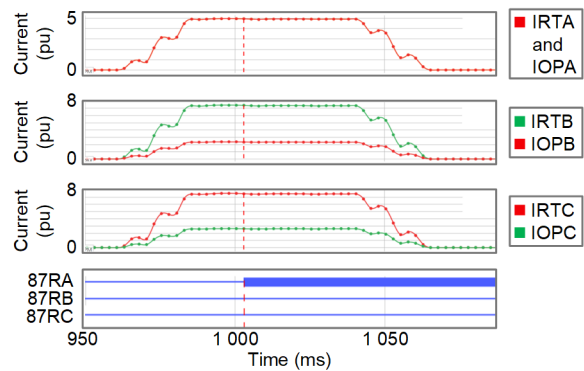
Fig. 12 Further exploration of 87RA assertion

Detailed analysis of this fault showed that the transformer protective relay determined an in-zone fault where Phase A operated, as the operating and restraint current pair plotted in the trip region of the percentage differential element. After performing basic tests, the team confirmed that the transformer was fault-free. Simultaneously, a detailed review of the set points was performed on the transformer protective relay.

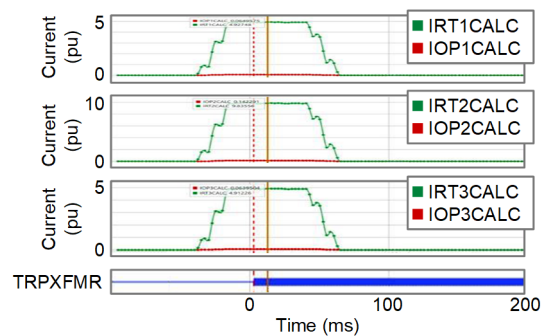
modified compensation settings, shown in Fig. 16, proves that the relay would have been secure (all operate current would be approximately 0 and restraint current would be 5 to 10 pu on all phases) for this operation [4].

Fig. 16 IOP and IRT based on custom calculations using modified compensation setting TTCTC = 1

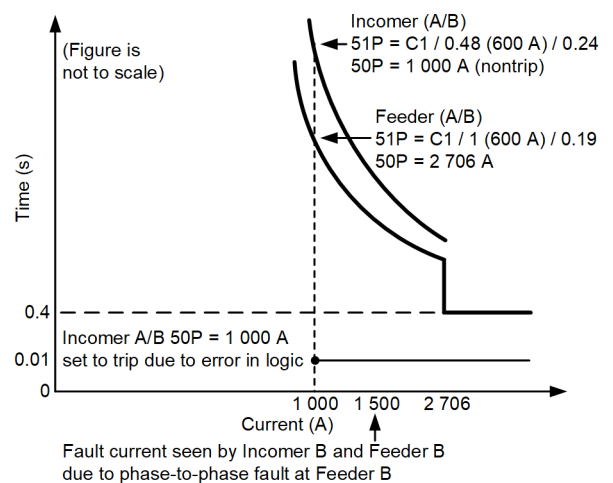
Fig. 17 shows the trip curve for both the incomer and feeder relays on this switchboard (not to scale). The instantaneous pickup (1 000 A) was mapped incorrectly to the trip equation of the incomer relay. The Feeder B instantaneous protection pickup (50P) was set at 2 706 A with a 400 ms time delay; however, the fault current seen in this scenario would not trigger a trip for 50P. Instead, a 51P element set at a standard inverse curve (IEC Class A) would have triggered in approximately one second to maintain discrimination between the upstream and downstream feeders with no changes to the set points.

Fig. 17 Trip curve for incomer and feeder relays

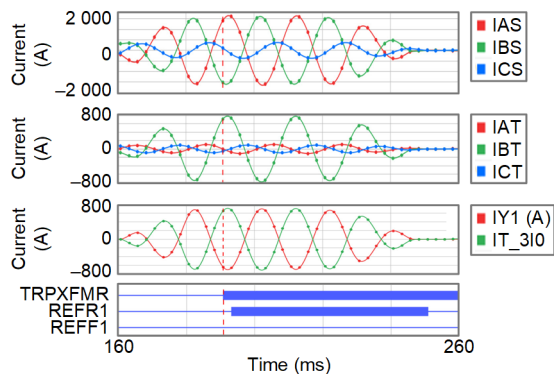
Prior to the implementation of changes to the transformer protective Relay A and the Incomer A relay, the Incomer A breaker tripped while it was single-ended, and power to all downstream feeders was lost. However, unlike the previous event on Incomer B, ground current was observed in this scenario. Analysis of the transformer relay event record shown in Fig. 18 revealed a through fault on the ground. The 35 kV wye-winding zero-sequence current and the transformer neutral current were 180 degrees apart with identical magnitudes, confirming that the fault was out-of-zone.

Fig. 18 Transformer relay event report

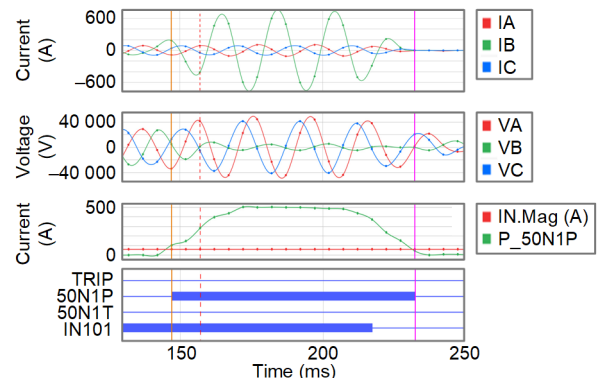
Analysis of the event report shown in Fig. 19 further confirmed that a downstream Phase-B-to-ground fault was experienced by the incomer relay. The incomer relay 50N1 protection picked up without issuing a trip. No trip was recorded in the feeder relay for the first trip event. This was due to the 600 ms time delay set on the ground protection; the fault was cleared by the transformer protective relay before 600 ms elapsed. Further investigation showed that the sequential event recorder

feature in the protective relay used in this project to record the event was not set correctly to record ground fault pickups.

Fig. 19 Incomer A trip event report

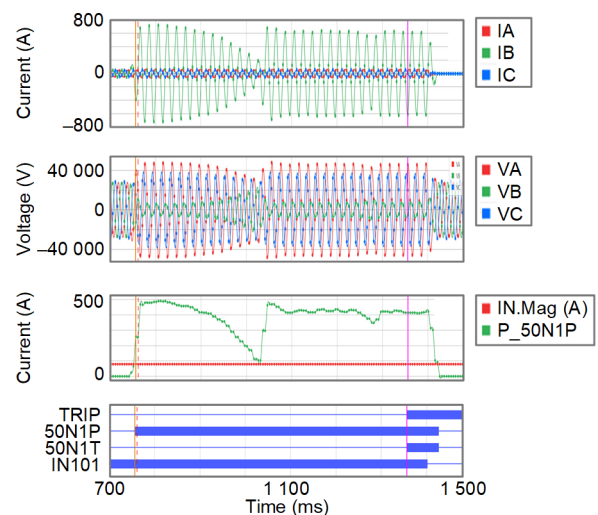
Fig. 8 shows the switchgear arrangement and the possible fault location on Feeder A. Fig. 20 shows the fault current recorded at the feeder relay for the first of the two Feeder A trips. The fault current gradually declined, then increased and remained stable until the fault was cleared. The fault was cleared soon after the 600 ms time delay included for discrimination purposes.

Fig. 20 Fault current recorded for first Feeder A trip

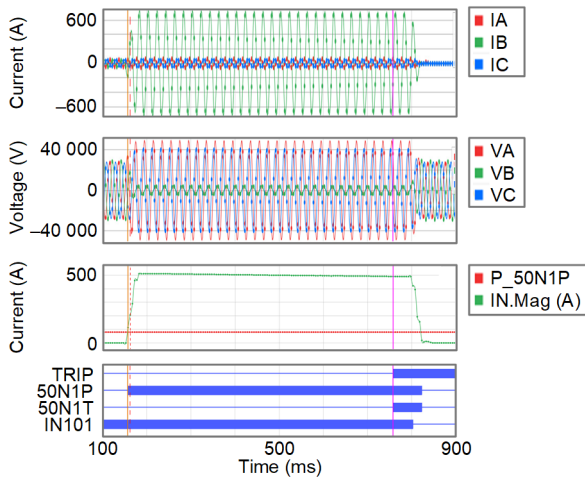
Fig. 21 shows the fault current recorded at the feeder relay for the second Feeder A trip.

Fig. 21 Fault current recorded for second Feeder A trip

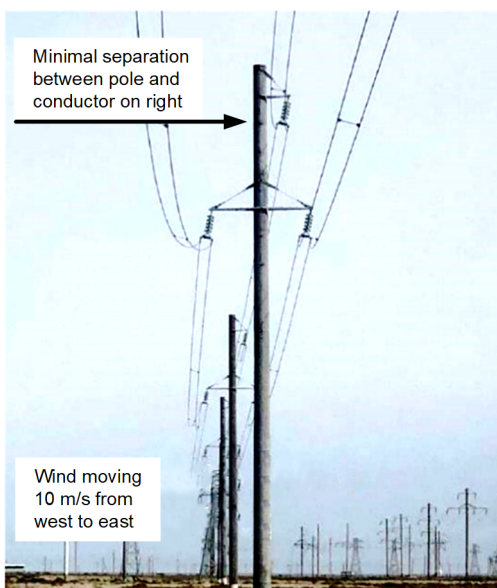
Similarly, the second trip on Feeder A was cleared soon after the 600 ms time delay. Because there was no conclusive evidence of equipment failure, the team walked the overhead line span to observe any physical damage. Initial investigation found nothing. After another walk of the line on a windy day (with westerly winds moving from west to east), the team observed that the separation between the overhead line for Phase B and the concrete poles was minimal, as shown in Fig. 22.

Fig. 22 Concrete pole with minimal conductor separation

The minimal separation meant that it was possible for the Phase B line to flashover to the pole. Analysis of wind data also confirmed that this geographical location is prone to receiving high-speed winds. With this information in hand, the operations team walked the line again and visually inspected poles using binoculars. They found signs of flashover damage on a couple of the concrete poles. Fig. 23 shows one example.

The feeder relay's sequential event recorder feature was updated to identify pickup fault current prior to trips, to help investigate any future trips. The team concluded that a combination of short crossarm length on the concrete poles and high westerly winds was the cause of the trip, although the existing installation did meet the project specifications. The construction team replaced the crossarms of the concrete poles with longer lengths to resolve the issue.

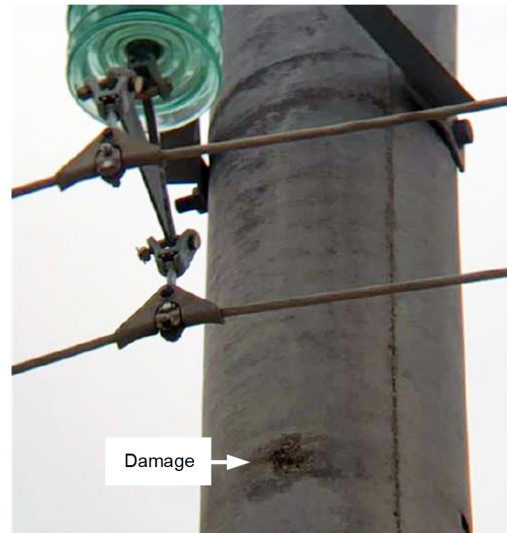
Fig. 23 Flashover damage on concrete pole

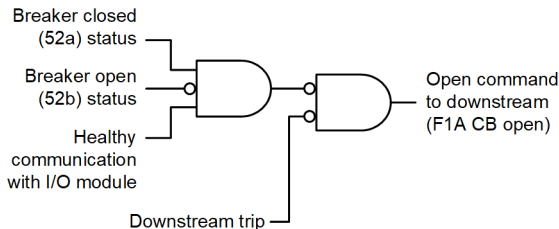
shown in Fig. 27. This is not a fail-safe logic, because the scenario described above would result in a false open command being issued to the downstream relay. Additionally, a failure of an I/O module, or a failure of the communications media between the relay and the I/O module, would also result in a false open command being issued to the downstream relay. The logic needs to be improved to remain secure for such conditions.

Fig. 27 F1A relay open-command-to-downstream logic

The desired relay operation for both Event 1 and Event 2 was for the relays to remain secure and not issue an open command on either end of the feeder. The corrective action was to make this logic fail-safe for the scenarios described: sending settings to the relay, the failure of an I/O module, the failure of communications between a relay and I/O module, and the loss of control voltage supply. The logic depicted in Fig. 30 was implemented to address this. The logic does not use the

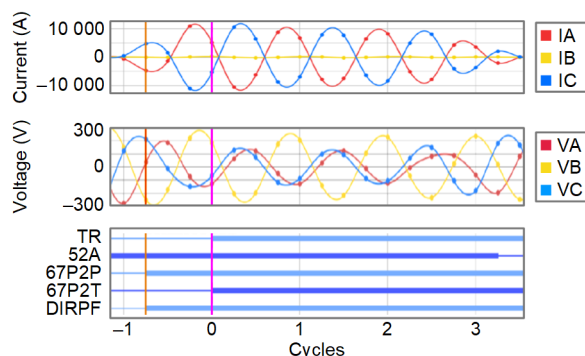
Fig. 32 Breaker CG2 relay event report

After analyzing the event report, commissioning engineers reviewed the cable connections from the load bank to Incomer B. Due to the temporary 1 MW load bank test connections to the motor control center (MCC), the commissioning contractor used two cables per phase to connect the load bank to the incomer. Two cables were correctly connected from the load bank Phase B to the incomer Phase B. However, when the four remaining

cables for Phase A and Phase C were connected, two of the cables were swapped, creating a 10 000 A phase-to-phase fault upon energization. Although this was the root cause of the trip, further analysis of the tripping times revealed another problem.

The protection for Breaker CG2 consists of two relays: a generator protective relay and a directional relay designed to trip for faults on the SDG side of the breaker. According to the event report, the directional relay asserted a trip in 15 ms. The directional element was set to the forward direction and based on the phase-to-phase fault on the Incomer B load bank; the directional relay should not have tripped. For this specific fault, Bus Tie BC should have tripped. Although the Bus Tie BC relay did pick up, the definite time (50) element of the CG2 backup directional relay was faster than the 51 element in the Bus Tie BC relay.

Upon review of the drawings, the engineering team found a discrepancy: the side (bus or generator) to which the CT star point was connected changed between design revisions (typical drawings, versus as-built). The relay settings engineer developed the settings based on the relay typical drawings and not the as-built drawings. Following this event and a review of the CT wiring, the commissioning team updated the settings to match the relay's intended zone of operation.
