A Tale of Two Out-of-Phase Synchronizing Events at BC Hydro

Mukesh Nagpal and Lesley Gu
BC Hydro

Presented at the
77th Annual Georgia Tech Protective Relaying Conference
Atlanta, Georgia
April 24-26, 2024

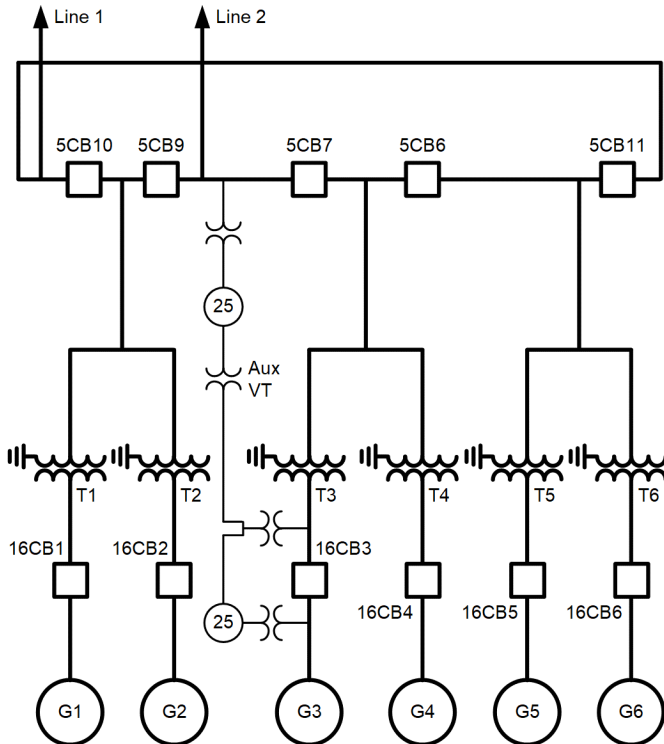
Fig. 1. Simplified one-line diagram of generating plant on ring bus.

The simplified generation station ac one-line diagram is shown in Fig. 1. Fig. 1 also illustrates the secondary circuit that is used by the G3 synchronizing system. Generator G3 is primarily synchronized across a 16 kV unit breaker (16CB3), but synchronization can also be performed across a 500 kV breaker (5CB6 or 5CB7) as backup control when the primary synchronization is not available. In the 500 kV breaker (backup) synchronizing circuit, a 1:1 auxiliary voltage transformer (VT) is provided for isolation of the ground reference between the yard and the synchronizing panel. Because this auxiliary VT was replaced and reconnected during the unit modernization, functional testing of the 500 kV breaker sync-close was required.

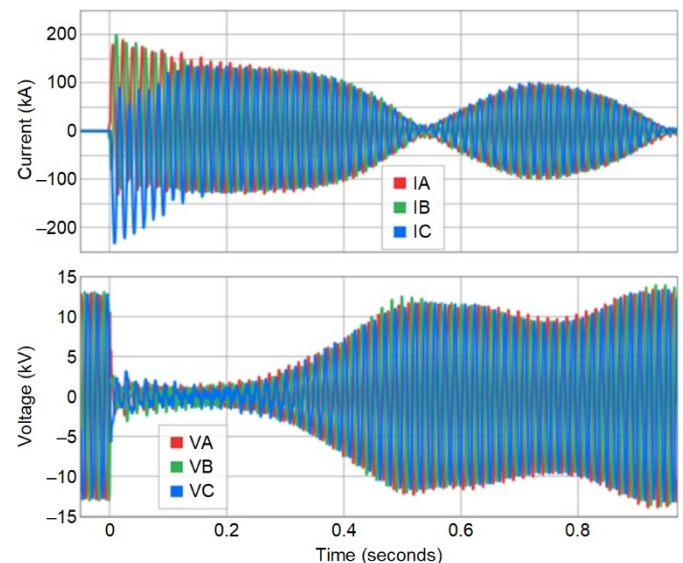
Fig. 2. Second OOPS event (December 7, 2021).

After the 30-hour-long T3 Heat Run Test completed, G3 was taken offline. The commissioning crew started to suspect that something had gone wrong, because there should have been minimal transient from the perfect manual closing via synchroscope. However, the transient data measured by the generator relay illustrated the opposite—a disturbance that was well beyond the size of a typical synchronization disturbance, with 232 kA peak current. This event report is shown in Fig. 2.

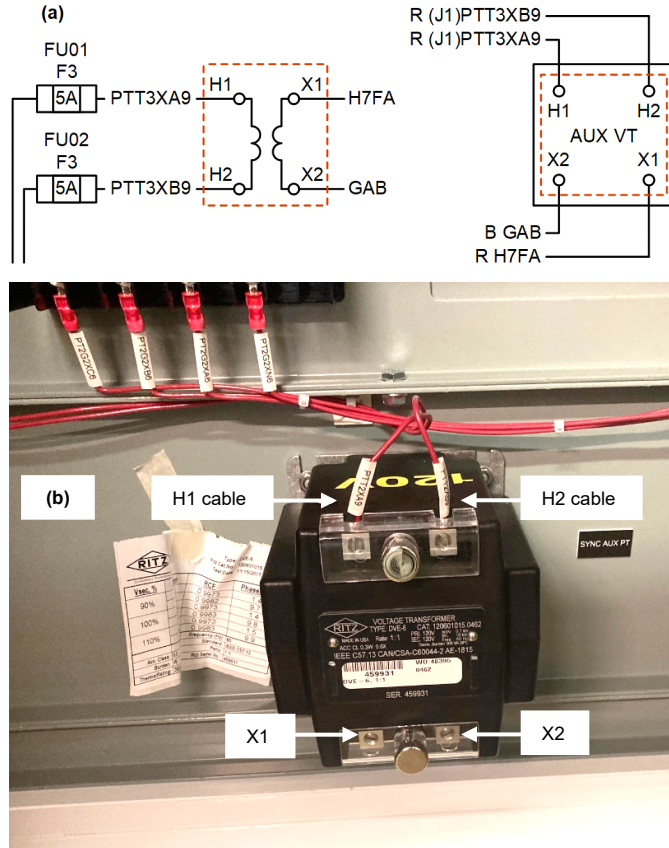
Fig. 3. Wiring drawing (a) and photo of terminal connections with error (b).

auxiliary VT replacement. It found that the polarities of the VTs had been connected backward. Unfortunately, all three devices (autosynchronizer, synchroscope, and sync-check relays) shared the same auxiliary VT source, which introduced a common-mode failure among all the synchronizing devices and caused them to fail simultaneously. The inverted polarities of the auxiliary VT resulted in a 180-degree OOPS event, despite an ideal synchronizing indication from the synchroscope.

The investigation then focused on why the wiring error occurred in the first place, and why it was not caught during commissioning. Fig. 3a shows the auxiliary wiring drawing and Fig. 3b shows a photograph of the auxiliary VT in the panel before the panel was installed. The VT is mounted at the bottom of the panel, which makes the terminal labels hard to see. The installer, instead of confirming the physical labels on the VT terminal block, assumed that the wiring drawing represented the actual physical layout. In the wiring drawing, X2 is below H1 and X1 is below H2. However, the physical layout on the VT terminal block is actually the other way around—X1 is below H1 and X2 is below H2.

- The synchronizer and any synchronism-check devices should be connected to independent circuits and separate VTs. This helps eliminate a common-mode failure from wiring and VT polarity errors.
- After modifications, wiring and polarity integrity should be verified before the synchronizing system is exercised for the first synchronization. The wiring and polarity can be checked by measuring the voltages at the terminals of the synchronization system (as supplied by VTs) when the unit is running and is synchronized using another system that is known to be functional.

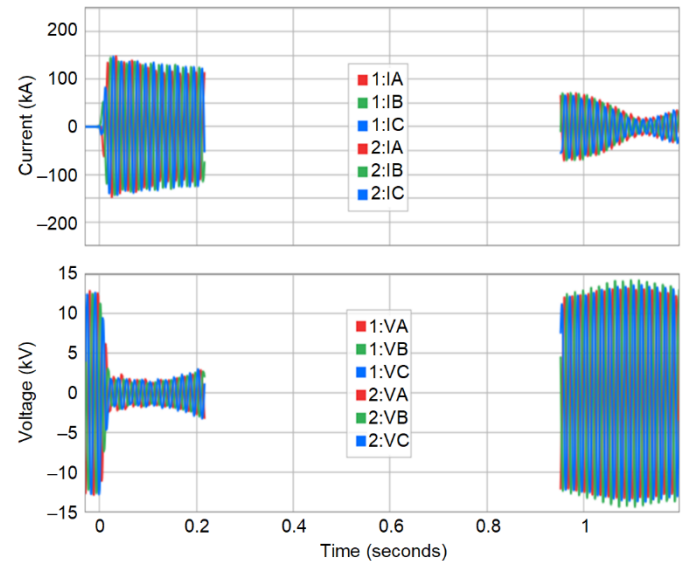
Fig. 4. First OOPS event (December 3, 2021).

The event data for the first event were from a filtered record, which does not capture the dc offset or harmonics. This event report is shown in Fig. 4. Because better data were required for some of the analyses, the event record for the second OOPS event (Fig. 2) is used for the rest of the discussions in this paper.

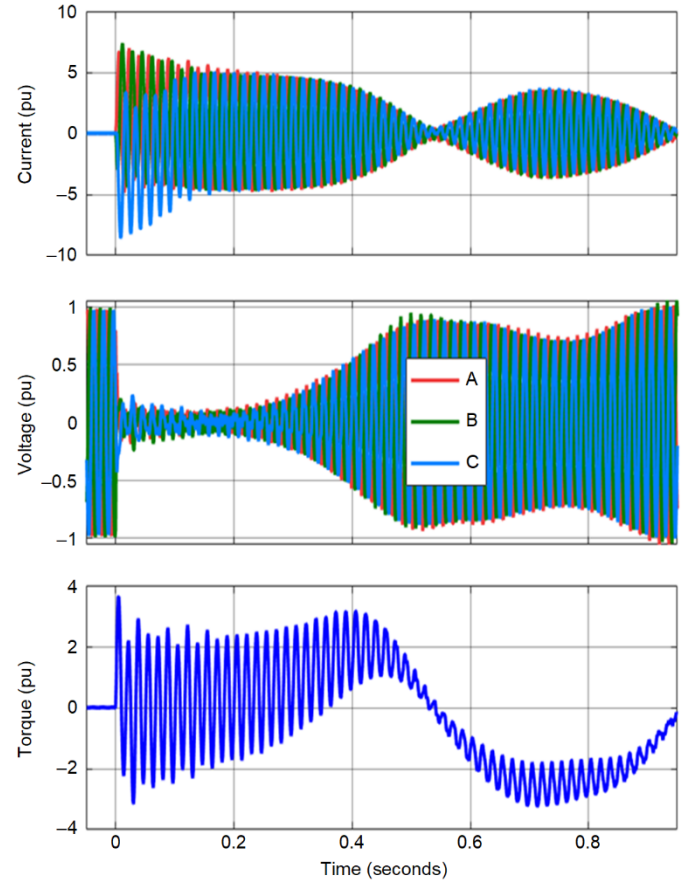
Fig. 8. Calculated torque during OOPS event.

With the use of the Z_{1SYS_MIN} parameter, the associated torque is 0.972 pu. If the system is made infinitely strong, with a Z_1 of 0 pu, then the associated torque is 1.06 pu. A 10-degree synchronizing angle, considering the impedances of the generator and the GSU, results in a transient torque that is very close to the generator rated torque. Therefore, using a per-unit torque calculation to get an indication of the severity of an OOPS event to the generator shaft and prime mover is a reasonable approach.

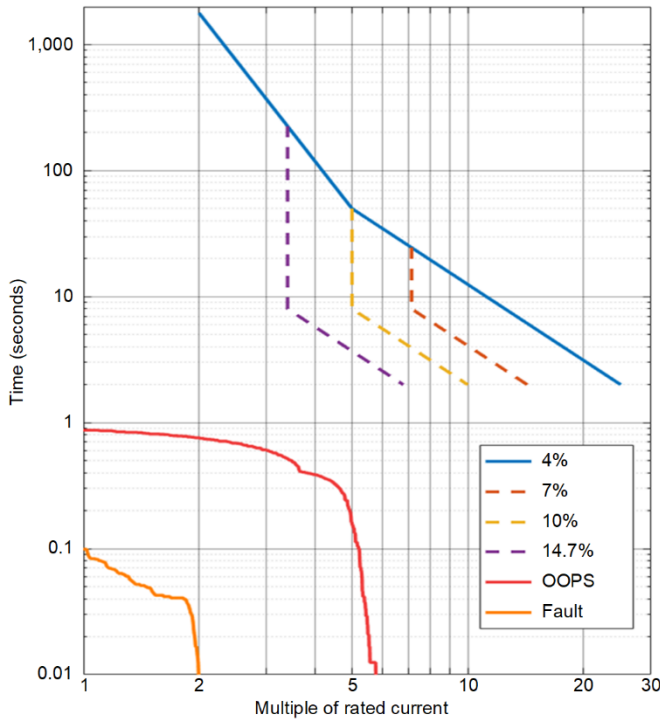
Fig. 9. Time overcurrent during events plotted, with respect to the standard Category IV transformer characteristics.

The standard characteristic in this figure, which the transformer is designed to withstand, has multiple curves for high currents because the transformer impedance limits the fault current from exceeding the upper values. For instance, for a transformer with a 10-percent impedance, the upper limit of the withstand characteristic ends at 10 times (100-percent voltage/10-percent impedance) the transformer rated current.

Considering the margin with the withstand characteristic, and considering through ground faults that can result in high fault currents in a GSU winding, this paper concludes that the torsional damage to the shaft is possibly a bigger concern [5] than overcurrent damage to the GSU winding during OOPS

events. However, it should be recognized that mechanical damage because of high currents is cumulative, similar to torsional damage to the shaft, and multiple OOPS events can eventually lead to a failure [5].

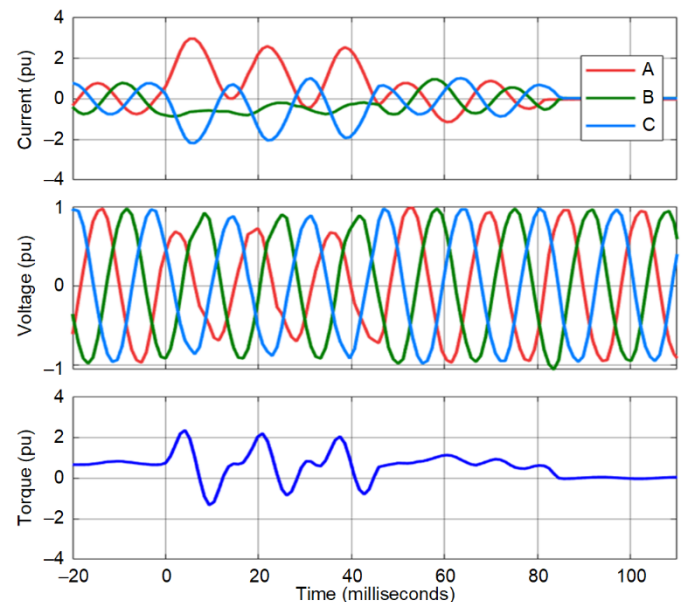
Fig. 10. External CAG fault that occurred 91 kilometers (56.5 miles) from the generating plant.

The event report and the calculated torque in per-unit quantities for the CAG fault are shown in Fig. 10.

An important and relevant characteristic of the fault shown in Fig. 10 is that, unlike most faults (which occur near a voltage peak), this fault occurred near a zero-crossing of the fault loop voltage, V_{CA} . Because of the point-on-wave of fault inception, the faulted phase currents had a very high dc offset. This high dc can contribute to delayed zero-crossings and is a much more important consideration for OOPS events. This is discussed further in Section IV.

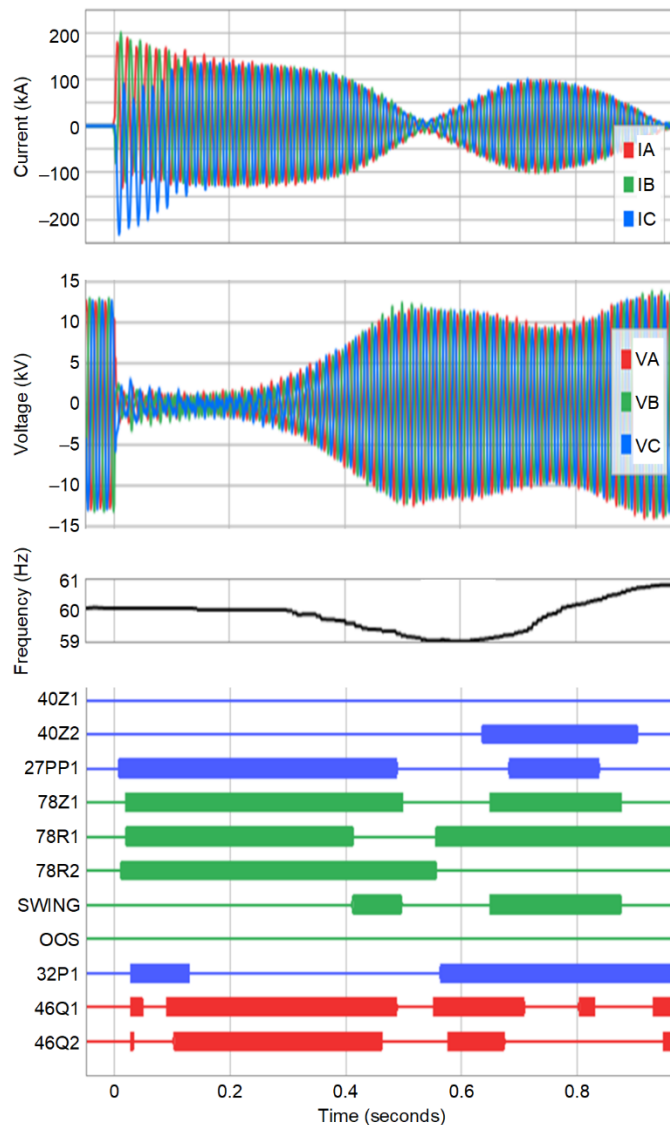
Fig. 11. Response of protection elements during OOPS event.

During both OOPS events, several of the common generator protection elements [9] [10] picked up. However, none of these elements tripped. The behaviors of the different generator protection elements are discussed in this subsection [11]. An event report with the response of the protection elements is shown in Fig. 11.

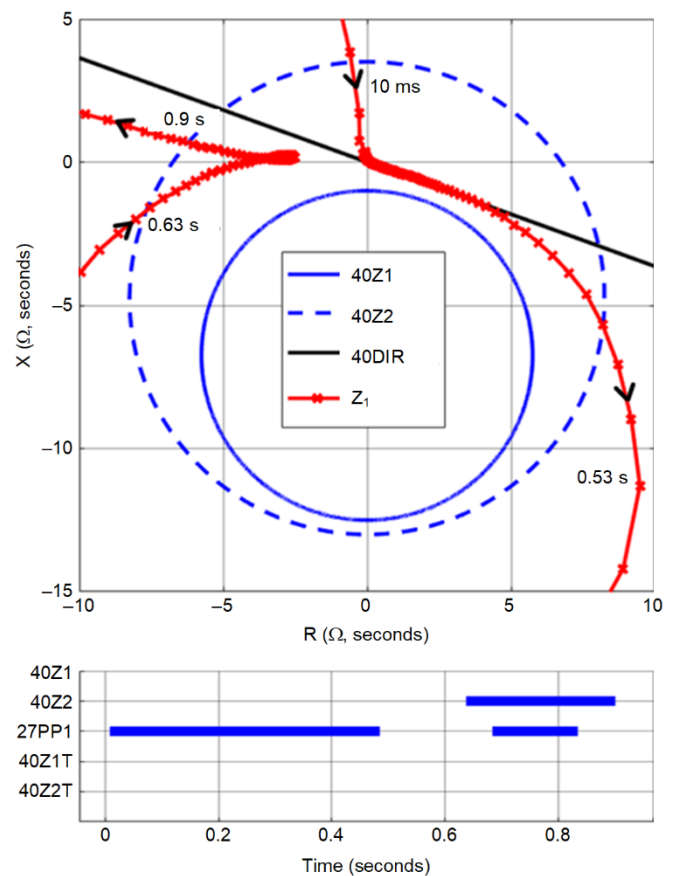
Fig. 12. Loss-of-field element response during OOPS event.

Immediately after the OOPS event, the impedance locus entered the Zone 2 mho characteristic but remained above the directional line; therefore, Zone 2 did not assert. If the directional line were set with a lower tilt of -10 degrees, then Zone 2 could have tripped on the accelerated path, because the undervoltage lasted about 0.47 seconds. The impedance locus never entered Zone 1.

After 0.63 seconds, the impedance locus entered Zone 2 from the left. This time, the directional check was satisfied, but the undervoltage condition lasted about 0.15 seconds; therefore, the element did not trip on the accelerated path.

This was not a loss-of-field event, and the protection element did not trip. However, it is clear that the element could have tripped on Zone 2 if the conditions were slightly different or if the directional element was set with a lower tilt of -10 degrees.

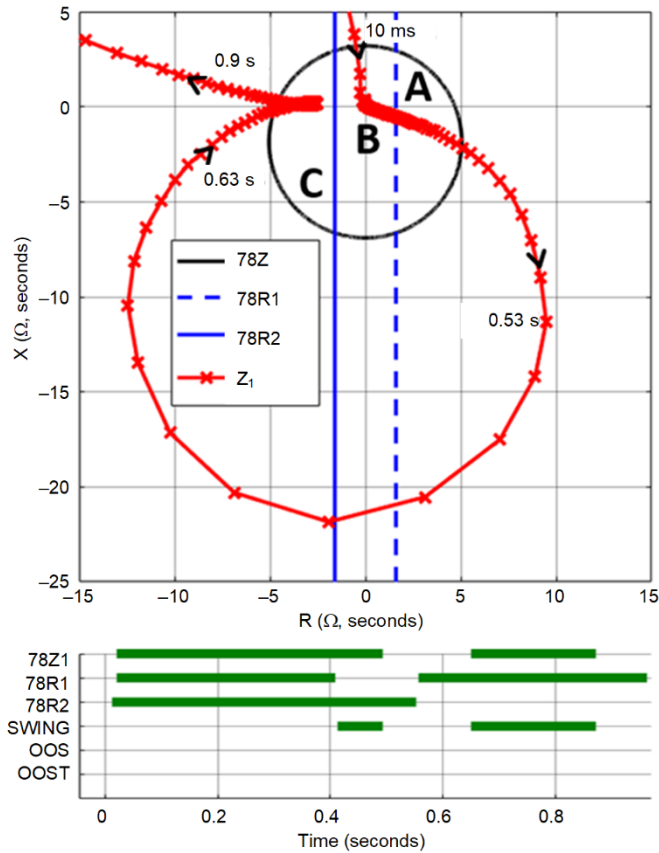
Fig. 13. Out-of-step element response during OOPS event.

The out-of-step element was configured as a single-blinder scheme, as illustrated in Fig. 13. The element trips if a swing is detected when the positive-sequence impedance enters Region A or Region C, then moves to Region B, then exits in the opposite direction of Region C or Region A. The 78Z1 bit asserts when the impedance enters the 78Z mho characteristic, 78R1 asserts when the impedance is to the left of the associated blinder, and 78R2 asserts when the impedance is to the right of the associated blinder. Every data point in the impedance locus of Fig. 13 corresponds to a 4-samples-per-cycle record that is a downsampled version of the higher-resolution record shown in Fig. 11.

The generator had no load prior to switching and was subjected to out-of-phase closing (the initial rotor position was 180 degrees). Immediately after the breaker closed, the impedance locus entered Region B from about 90 degrees. Even if it had entered from the right, the scheme requires the impedance locus to remain in Region A for at least three samples to ensure that it is a swing with slow trajectory and not a fault with fast trajectory. Because the initial change associated with the OOPS event was sudden, as it would be for a fault, the element did not classify it as a power swing.

After 0.65 seconds, the swing locus entered Region C. The impedance locus moved slowly and behaved like a swing; therefore, the SWING bit asserted. However, the characteristic never entered Region B and, therefore, was not classified as an out-of-step condition because the swing remained stable. This is also visible in the currents and voltages of Fig. 11, where the system recovered. If the swing had become unstable, and the associated impedance locus moved from Region C to Region B and then exited from Region A, the single-blinder scheme would have been expected to trip.

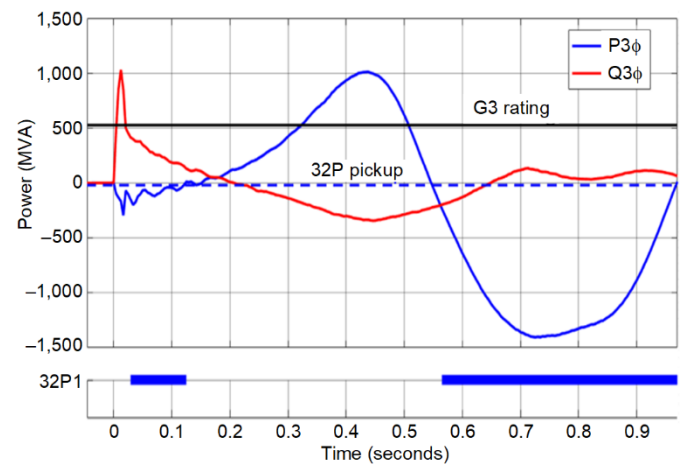
Fig. 14. Reverse power element response during OOPS event.

The reverse power element response is shown in Fig. 14. It asserted initially for about 100 milliseconds when the machine motored slightly. Then, after 0.56 seconds, when G3 absorbed nearly 3 pu real power, the element asserted for about 0.42 seconds. The element never timed out to alarm or trip during this event because of the oscillations.

The reverse power element did not trip during the transient, but it could trip later, during load, for OOPS events caused by other wiring errors. If the VTs used by the generator relay are inverted in polarity and the machine starts generating, it can appear as if the machine is motoring to a reverse power relay. However, this is not a reliable indicator. As was the case here, the VTs used by the generator relay could be wired correctly.

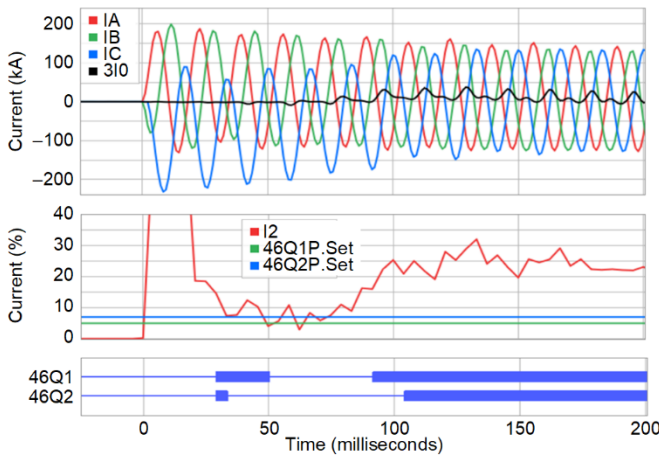
Fig. 15. Presence of I_2 and I_0 due to CT saturation during OOPS event.

The response of the element is shown in Fig. 15. This event had balanced currents, but there is evidence of dc CT saturation at about 50 milliseconds, where the C-phase current lost its dc component quickly. In this raw event record, the other set of phase CTs associated with the differential was not available, so the residual current ($3I_0$, shown in black in Fig. 15) was used to get a clearer indication of saturation. This is a sound approach for analysis because the high-impedance grounding meant that $3I_0$ was not expected. The $3I_0$ crept up when the CT saturated, as shown.

The I_2 magnitude associated with the saturation, ignoring the initial filter transient and pole scatter, increased to a value of about 30 percent of the generator rating, before it started to decrease and eventually dropped to zero at about 0.5 seconds (not shown). The protection worked correctly because it was intended to not operate on switching operations introducing I_2 transiently from unequal saturations of three-phase CTs. A value of about 30 percent is associated with a current unbalance element trip time of about a minute. CT saturation should not be relied on to detect this condition, even though (as explained later in Section IV.D) it sometimes causes a sympathetic trip during an OOPS event.
