Catastrophic Breaker Failures Due to Missing Current Zero-Crossings in Highly Shunt-Compensated 500 kV Lines—Point-on-Wave, Reclosing, and Protection Considerations

Mukesh Nagpal
Burns & McDonnell

Kenan Hadzimahovic, Tyler Scott, and Tony Jiao
BC Hydro

Presented at the
50th Annual Western Protective Relay Conference
Spokane, Washington
October 10–12, 2023

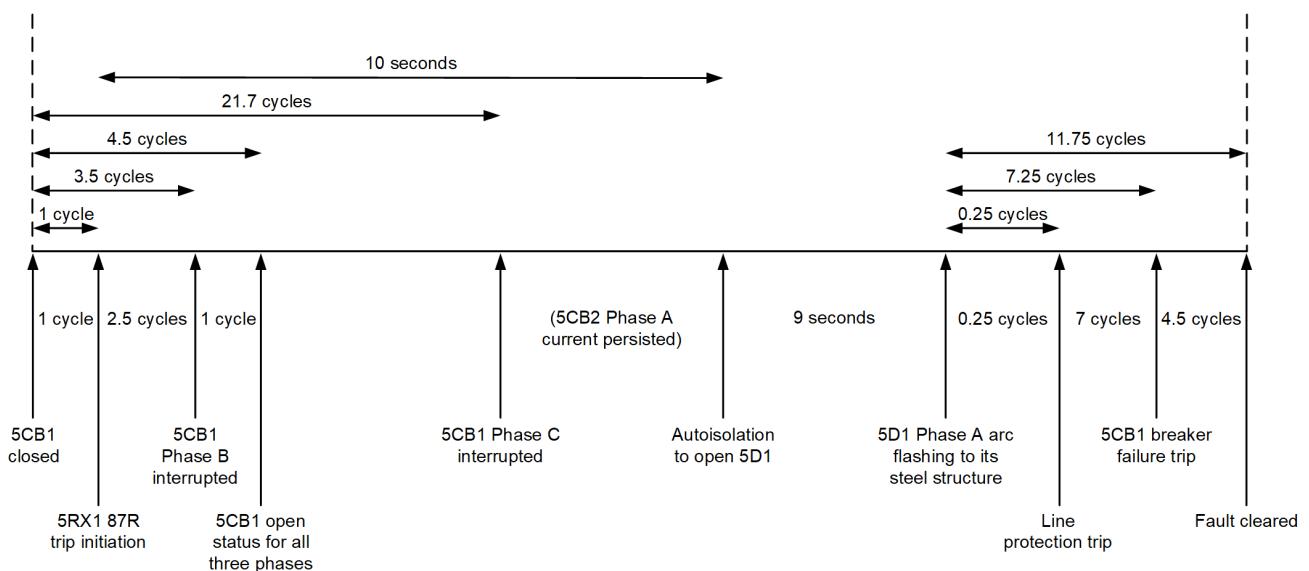
Fig. 10 details the sequence of events. One cycle after the line energization from 5CB1, the high-impedance differential protection (87R) of 5RX1 operated. The 5CB1 power contacts physically opened on all three phases after receiving the protection trip. Because there was no fault, the shunt-compensated line charging current was below 300 A, which is the relay's minimum breaker failure protection pickup setting. Hence, 5CB1 breaker failure protection was not activated. The Phase C current was eventually interrupted more than 21 cycles after trip initiation. However, the current in Phase A continued to flow. Approximately 10 seconds after the trip initiation, 5RX1 differential protection sent an open command to the disconnect (5D1) to isolate the reactor. Since the uninterrupted Phase A current was still flowing in 5RX1 when the disconnect was opening, a large arc formed and flashed to the steel structure, causing a low-resistance line-to-ground fault. This fault allowed the line protection to trip, resulting in the de-energization of the line and the associated reactor due to the activation of the breaker failure protection because the resulting fault current was above the breaker failure pickup setting.

Fig. 10. Detailed sequence of events during the failure of the 5CB1 breaker at the lead terminal on May 14, 2021.

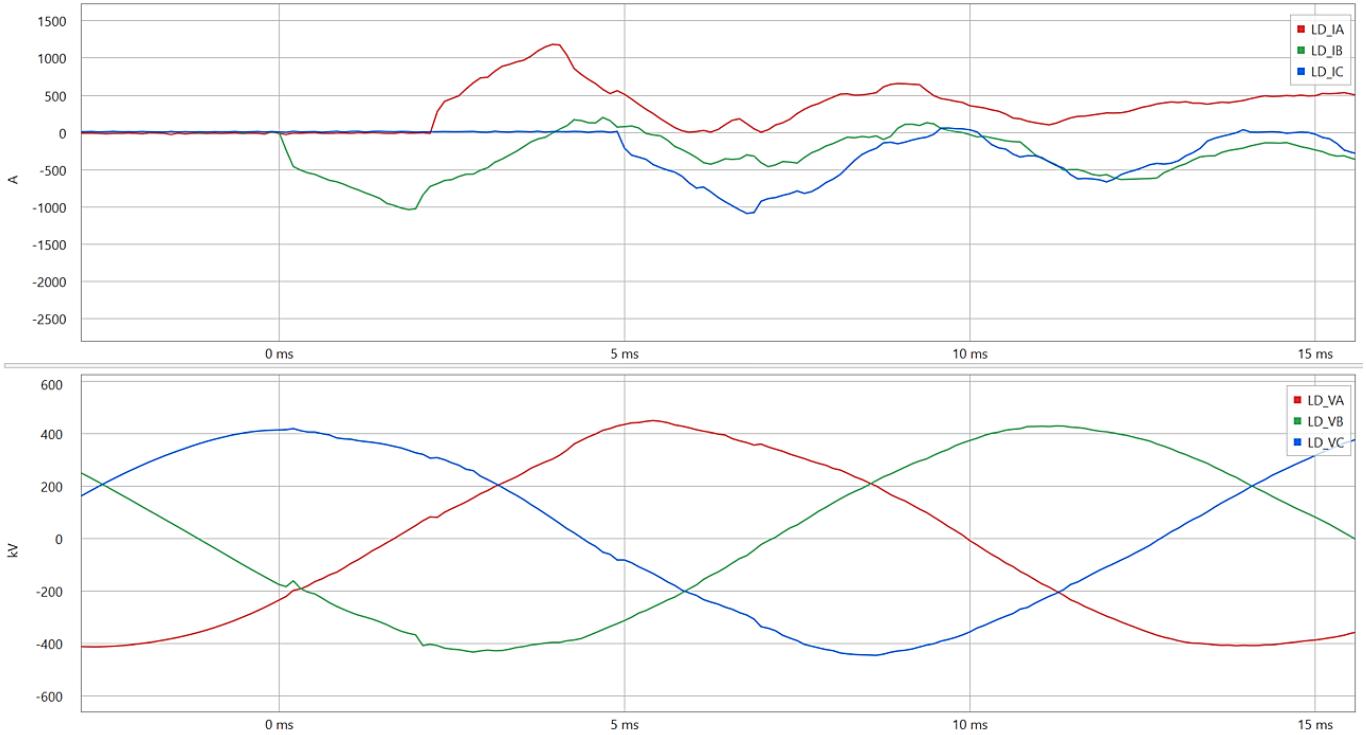
Fig. 11 displays waveforms of the three-phase line currents and source voltages at the lead terminal. Phase B closed first, approximately 1.1 milliseconds after a bus voltage zero-crossing. Phase A closed about 0.5 milliseconds after a bus voltage zero-crossing, and finally, Phase C closed approximately 0.5 milliseconds after a bus voltage zero-crossing. It should be noted that, compared to the programmed settings, the closing performance on Phase B was the worst, while the closing of Phases A and C occurred close to their target points. These discrepancies were likely due to mechanical dispersion in the operation times of the circuit breakers. For breakers with POW-controlled switching schemes, a closing time accuracy of ± 1 millisecond (corresponding to three standard deviations) is generally considered acceptable [2] [9]. Overall, the near zero-degree closures on Phases A and C resulted in the observed high dc offset current.

Fig. 11. Three-phase line currents and voltages at the lead terminal during manual energization via POW on May 14, 2021.

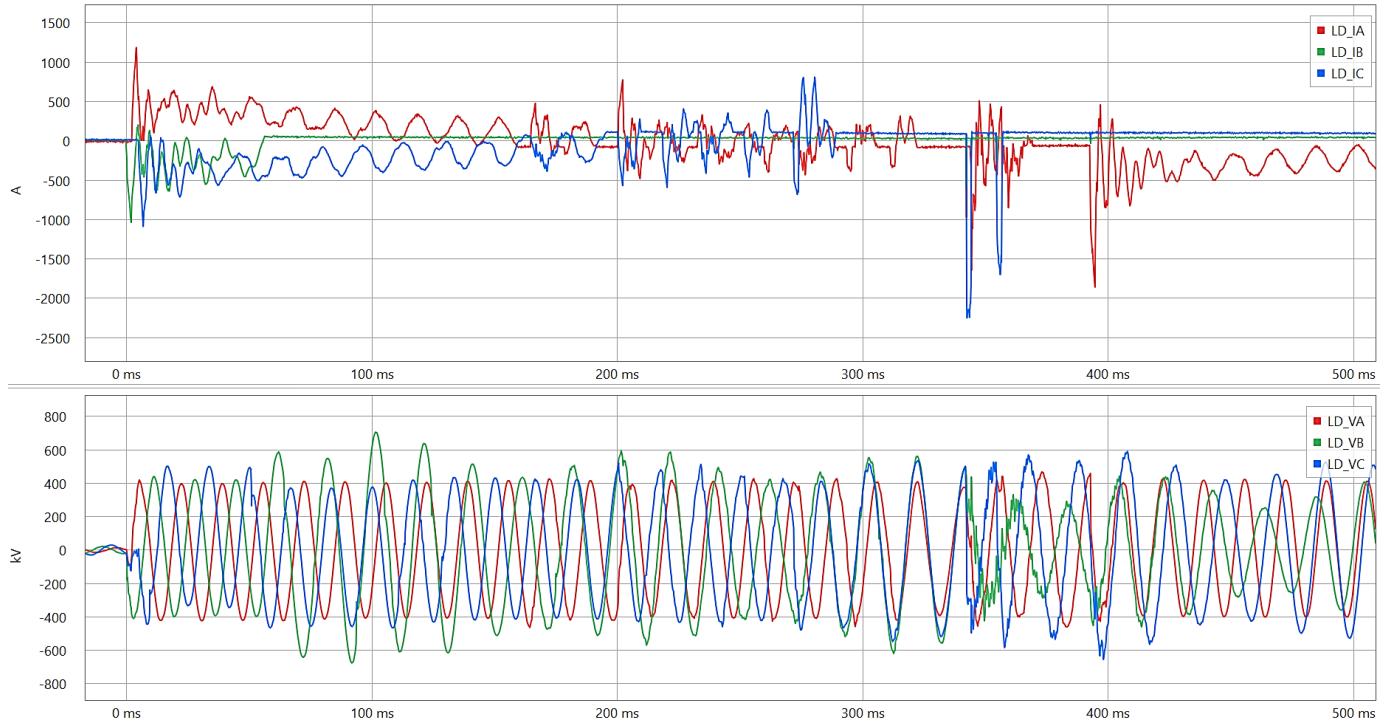
Fig. 12. The first 30 cycles of 5CB1 currents and terminal voltages after breaker closing on May 14, 2021.

As shown in Fig. 12, all three phases of 5CB1 currents exhibited high dc offsets. There were no zero-crossings on Phases A and C for approximately 9 cycles after the closing of 5CB1. Two zero-crossings were observed on Phase B, and the current was successfully interrupted within 3 cycles. Phase C current was finally interrupted after approximately 21 cycles from the trip, after multiple contact restrikes. However, Phase A failed to interrupt the current, and the current in

Phase A persisted. The nearly perfect performance achieved by the POW control, designed to minimize voltage transients, caused the missing current zero-crossings, which persisted even after 30 cycles from the line energization. These missing zero-crossings were the root cause of the breaker failure when the protection incorrectly tripped during line energization.

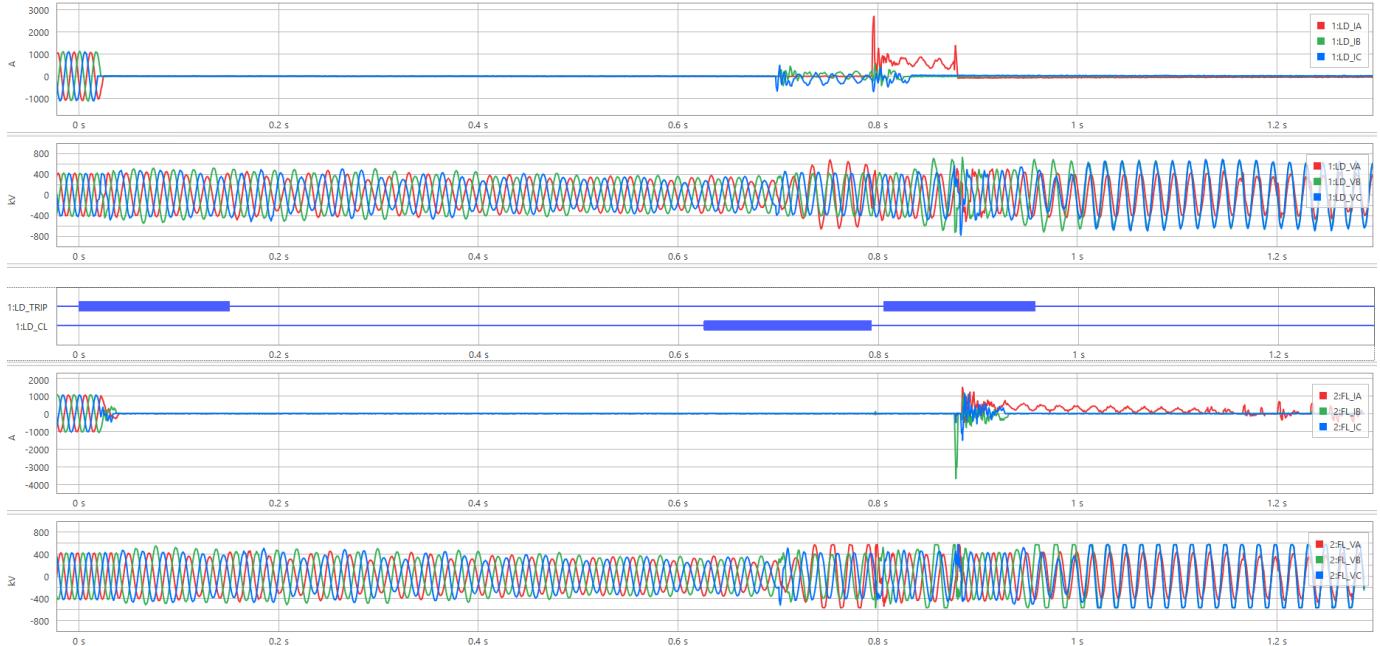
The incorrect isolation and shorting of the CT under the load caused the primary protection of the line to operate, tripping the lead terminal and sending a DTT to the follow terminal. After the line trip from both terminals and the expiration of the three-phase open time interval, the high-speed autoreclose was initiated. At the lead terminal, the POW controller reclosed Phases B and C, but the closing of Phase A was delayed due to the POW algorithm facing challenges in predicting the beat minimum and its switch to backup mode. Phase A reclosed suboptimally, not at the beat minimum, by about 90 milliseconds. Immediately after Phase A closing, the high-speed distance (Zone 1 phase mho) element within the line standby protection transiently picked up and initiated the line trip. Another DTT was sent to the follow terminal.

Fig. 13. Protective relay records showing the Event B sequence in the lead and follow terminals. (Note: the follow terminal digitals are not available.)

During the short period where all three phases were closed at the lead terminal, the line developed sufficient positive-sequence voltages⁹ to initiate the autoreclose at the follow terminal before the arrival of the DTT. Consequently, 5CB3, the first breaker to close at the follow terminal, experienced trip-free operation, meaning it closed and tripped since it received the DTT from the lead terminal. In Fig. 13, the waveforms and digitals illustrated were recorded by the standby protective relay, which tripped during wide pole scatter created by POW-controlled closing at the lead terminal during the autoreclose. Wide pole scatter refers to the long delay (about 100 to 120 milliseconds) from the first to the last phase closing from POW-controlled close.

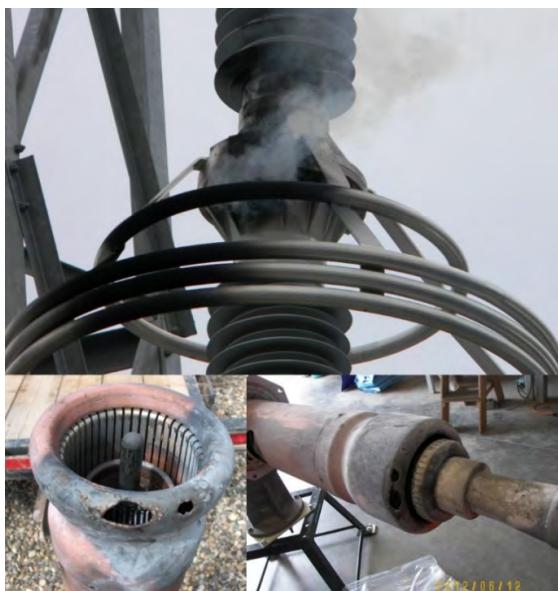
During the trip immediately upon autoreclose at the follow terminal, Phase A of circuit breaker 5CB3 failed to interrupt the current even though the breaker contacts had physically opened. The uninterrupted phase continued to conduct, keeping one phase of the line energized. This single-phase energized, highly shunt-compensated line created a resonant condition [13] [14], resulting in excessive voltage buildup on the floating phases and causing the Phase B surge arrester to fail from extended exposure to overvoltage. Approximately 6 seconds after the initial trip, the Phase A surge arrester protecting the shunt reactor at the lead terminal failed due to sustained multiple restrikes across the physically open circuit breaker, with an uninterrupted current from missing zero-crossings. The surge arrester failed, leading to a short circuit condition that caused a permanent line-to-ground fault and triggered the breaker failure protection to operate, clearing the fault and isolating the line. Fig. 14 shows the damage. The top picture shows the failed surge arrester, while the bottom photos show the damage to the interrupter mechanism inside the breaker due to the prolonged arc.

Fig. 14. The catastrophic failure of April 16, 2012.

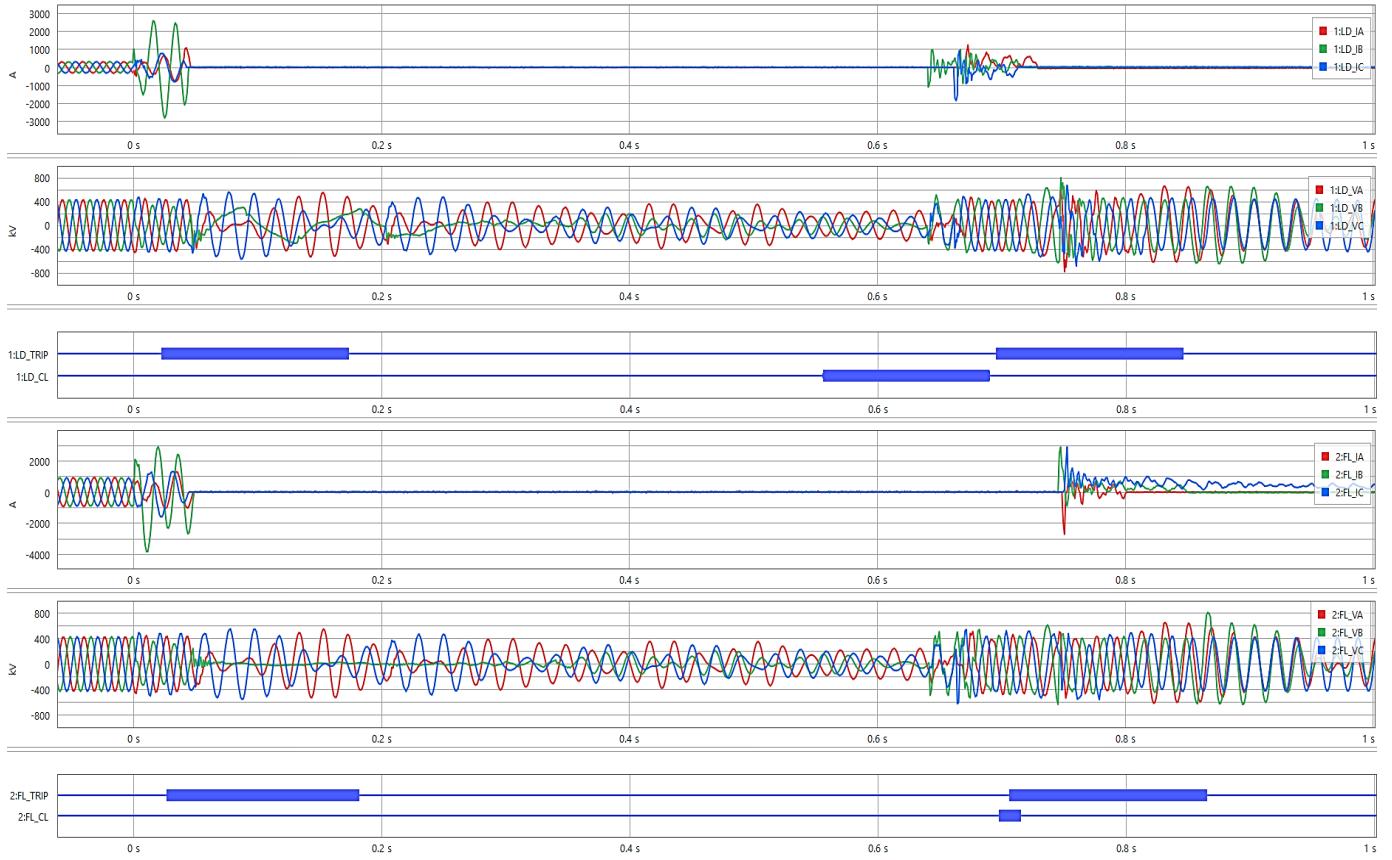
The failure occurred on a 330 km, 500 kV line with shunt compensation provided by two shunt reactors at the line terminals, as depicted in Fig. 9. On July 12, 2016, the line experienced a temporary Phase-B-to-ground fault induced by a lightning strike. The line protection system correctly tripped all three phases, de-energizing the line. During the three-phase open time interval, the fault arc was extinguished. After the open-pole interval time, the lead terminal breaker (5CB1) was closed using POW control. However, after 1.5 cycles, the Zone 1 phase mho relay unexpectedly asserted for under 2 cycles, tripping the lead terminal and issuing a DTT signal to the follow terminal. Fig. 15 presents records captured by the relay at the lead and follow terminals. It demonstrates the line voltage ringing down before autoreclose, the activation of phase distance protection elements, and the significant dc offsets in the unfaulted phase currents after the line was re-energized on autoreclose.

Fig. 15. Protective relay records showing the Event C sequence in the lead and follow terminals.

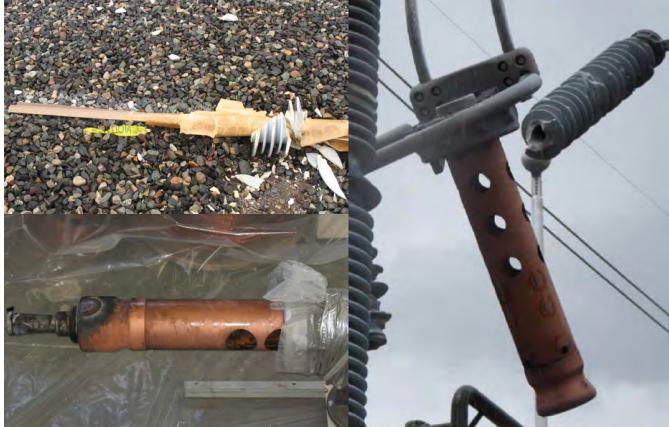
Fig. 16. The catastrophic failure of July 12, 2016.

In the figure, the top left picture shows the grading capacitor, which used to be in parallel with the failed interrupter. The bottom left picture shows the moving contact from the failed interrupter. The figure on the right shows the fixed contact from the failed interrupter hanging in the center of the picture.

Despite the failure to interrupt the current, the breaker failure protection did not activate for two reasons. First, the ac component of the breaker current was approximately 180 A, which was below the breaker failure relay pickup setting of 300 A. Second, the breaker failure initiation signal from the line protection dropped out 9 cycles after the transient keying of the Zone 1 phase mho element at the lead terminal.

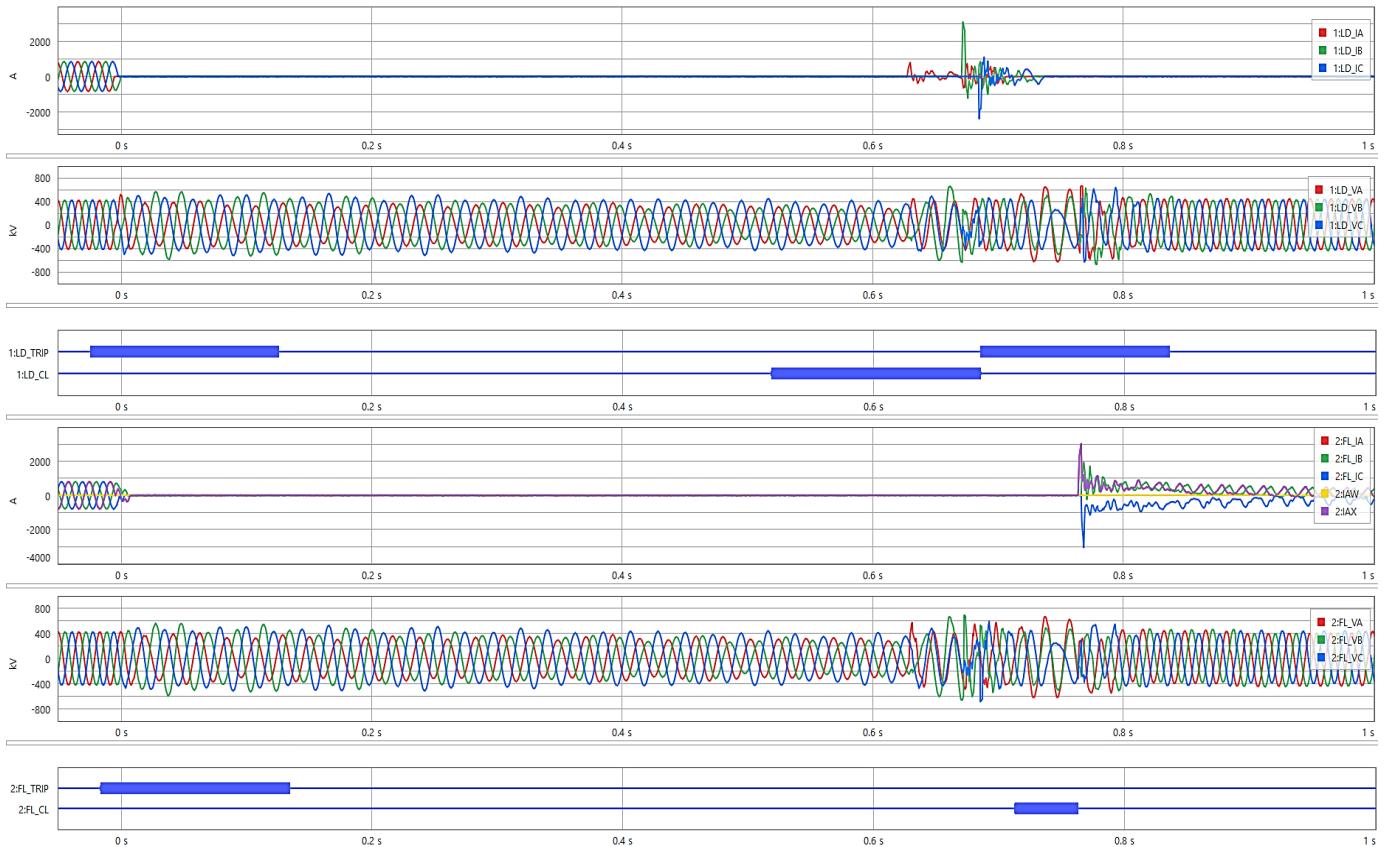
Fig. 17. Protective relay records showing the Event D sequence in the lead and follow terminals.

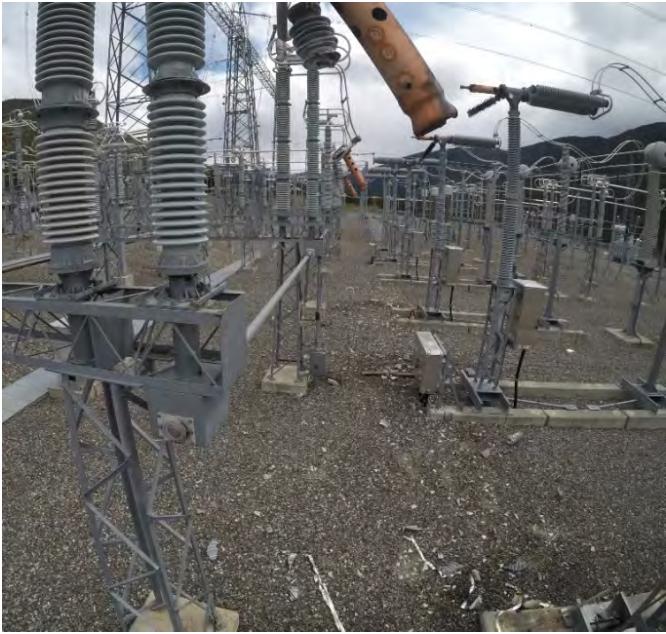
The breaker 5CB3 at the follow terminal closed 19 milliseconds after 5CB1 at the lead terminal opened. Because there is no POW control at the follow terminal, the close command to 5CB3 resulted in the simultaneous closing of all three phases, leading to an uncontrolled re-energization of the line from the follow terminal. Consequently, a significant dc offset was present in the line current once 5CB3 closed on all three phases simultaneously, causing missing current zero-crossings on all three phases for a duration of 170 milliseconds. During this time, the follow terminal received the DTT signal sent by the open terminal logic at the lead terminal. Due to the missing zero-crossings, 5CB3 failed to interrupt the current, resulting in catastrophic breaker failure. As explained previously, the breaker failure protection did not operate because the compensated line charging current was too low to be detected. This condition persisted for 12 seconds before a Phase-B-to-ground fault occurred, which activated the breaker failure protection and tripped the adjacent bus zone. Fig. 18 shows the damage.

Fig. 18. The catastrophic failure of May 13, 2022.

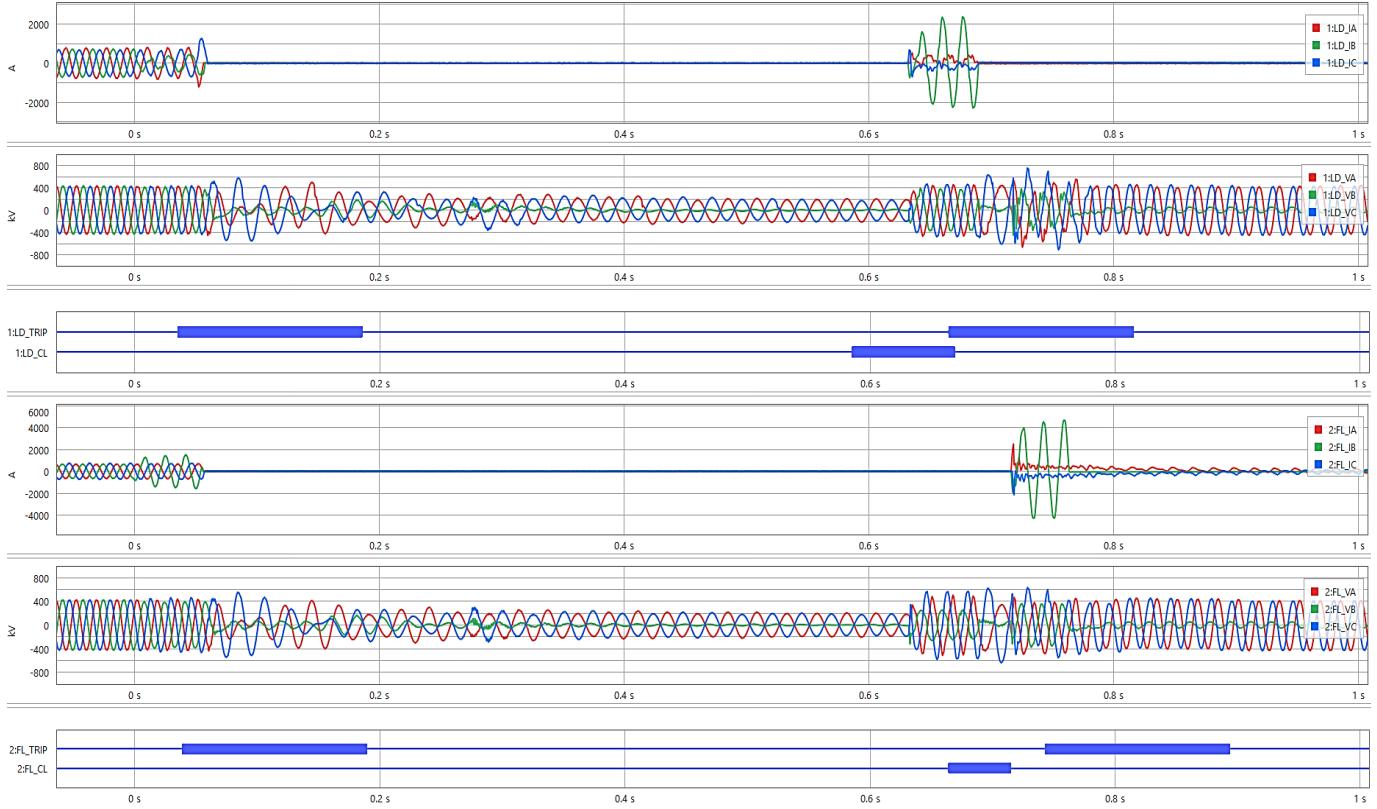
Fig. 19. Protective relay records showing the Event E sequence in the lead and follow terminals.

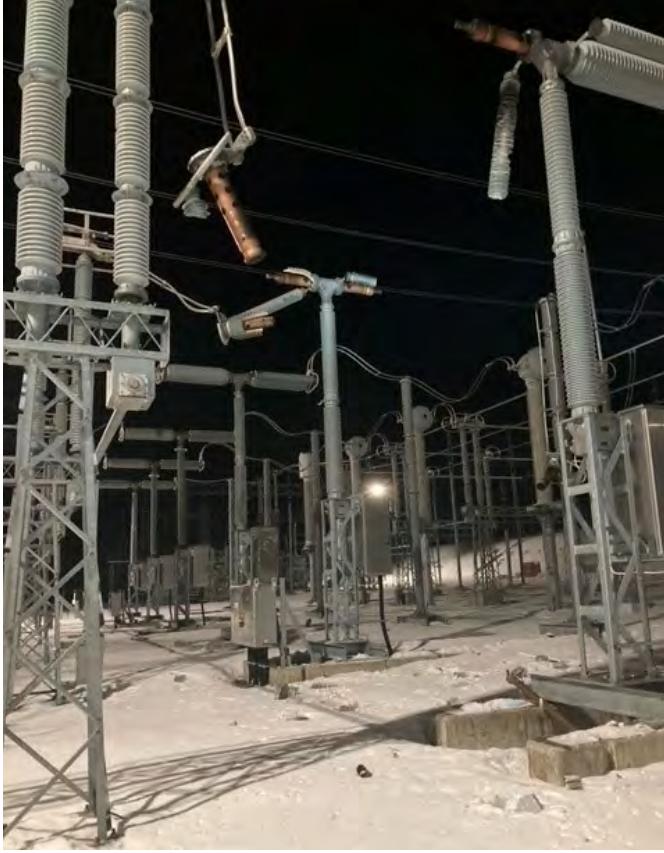
Following a three-pole open interval of 28 cycles, the lead terminal issued a close command to 5CB1. Since it was a permanent fault, the lead terminal was retripped by switch-onto-fault (SOTF) logic after 5CB1 autoreclosed. Fig. 19 shows synchronized recordings of the line protection relays at the lead and follow terminals during the autoreclose event. Due to the high-impedance nature of the fault, the line exhibited a healthy positive-sequence voltage (above 90 percent of the nominal voltage) at the follow terminal for the duration after 5CB1 reclosed and before it retripped by SOTF logic. This allowed autoreclosing to proceed at the follow terminal by sending a close command to 5CB3. However, the actual closing of 5CB3 at the follow terminal occurred only after 5CB1 had opened at the lead terminal,¹¹ resulting in the uncontrolled closing of all three phases simultaneously. Shortly thereafter, the follow terminal received the DTT signal from the lead terminal, initiated by open terminal logic. The uncontrolled closing of 5CB3 at the follow terminal introduced a high dc offset with missing zero-crossings in the unfaulted phases, and the breaker did not have a chance to interrupt the current in those two unfaulted phases. The breaker failure protection did not operate because the unfaulted phases were carrying only compensated line charging current, which was too low to be detected by the breaker failure protection. Once the dc current component dissipated, the breaker was no longer able to operate. This condition persisted for a period of 18 seconds before a Phase-A-to-ground fault occurred, triggering the operation of the breaker failure protection and tripping the adjacent bus zone. Fig. 20 shows the damage.

Fig. 20. The catastrophic failure of January 22, 2023.

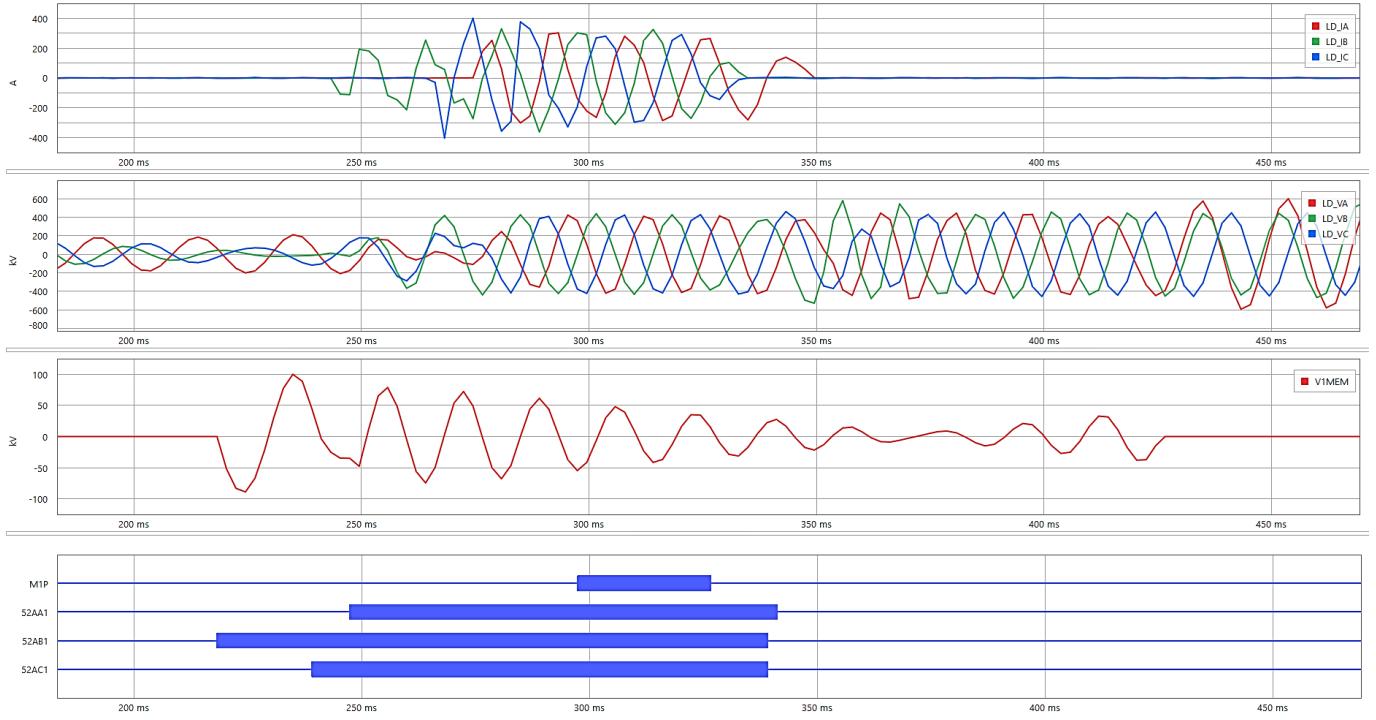
In Event C, the Zone 1 phase mho relay unexpectedly operated upon autoreclose where a temporary fault arc had extinguished during the three-phase open time interval. The element remained asserted for about 2 cycles at the lead terminal. The undesired operation was traced back to the

Fig. 21. The relay event record at the lead terminal showing memory charging upon closing of the auxiliary contact but before closing of the main power contacts on July 12, 2016.

opening of the breaker auxiliary contact, 52b,¹² approximately 2 cycles before the corresponding power contact closure (see Fig. 15). This led to an incorrect phase angle of the positive-sequence memory voltage relative to the source voltage when the line was autoreclosed.
