# Lessons Learned Through Commissioning, Livening, and Operating Switchgear: Part 2

Matthew Watkins and Kamran Heshami  
*Schweitzer Engineering Laboratories, Inc.*

Presented at the  
2024 PCIC Europe Conference,  
Rotterdam, Netherlands  
June 2024

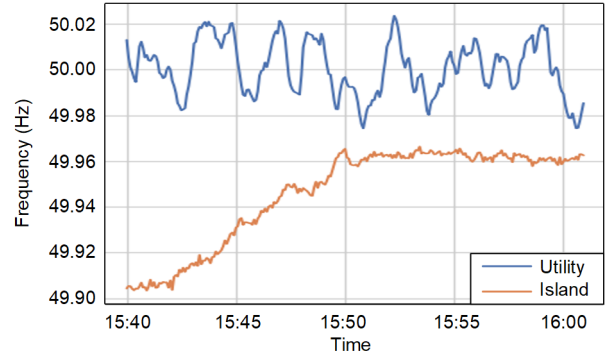
At approximately 15:40 local time, the autosynchronization test was initiated. As expected, the controller sent speed raise signals to the participating GTG until the island's frequency was within 0.05 Hz of the utility's frequency, as shown in Fig. 2. However, unexpectedly, the controller also sent multiple voltage lower commands to the AVR of the participating GTG. Quickly after autosynchronization began, at 15:41:30, the dispatchers received a low terminal voltage alarm from the participating GTG. The autosynchronization controller continued sending voltage lower commands, eventually lowering the central substation bus voltage from 111.5 kV to approximately 110.6 kV, as well as triggering a low-low alarm for generator terminal voltage at 15:44:52. The team soon realized that the utility voltage shown on the

dispatcher console is measured from the primary (utility-side) of the BT, whereas the autosynchronization controller is comparing the substation bus voltage to the secondary (facility-side) of the BT (refer back to Fig. 1). Indeed, the BT's tap, which is manually operated by power operations, was not in the 1:1 transformation ratio position, resulting in a significantly lower secondary voltage, as shown in Fig. 3. As such, the controller correctly tried to lower the island voltage.

Fig. 2 Autosynchronization initiated

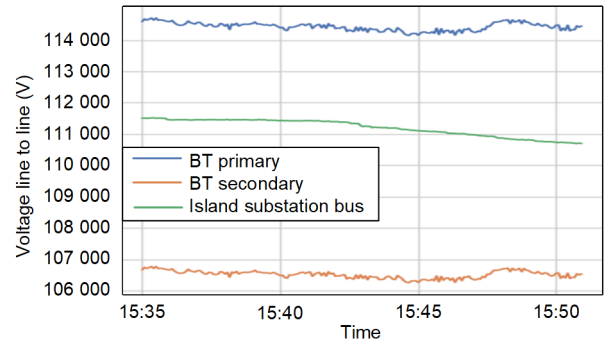
Fig. 3 Secondary voltage much lower due to tap position

After the team realized the problem, the dispatchers adjusted the tap position on the BT until the BT secondary voltage was closer to the substation bus voltage and returned the participating GTG back to a typical terminal voltage. The team reinitiated the autosynchronization, which sent no further GTG signals since the island voltage and frequency were now within the closing range. After waiting for the angle difference to come within the closing range, the system closed the utility breaker, and the facility was resynchronized, as shown in Fig. 4.

- Ensure the operating procedure begins with verifying the BT tap changer position, and, if necessary, change the tap position such that the BT secondary voltage is within a synchronizable range.
- Add a communications link to display both the utility-side and facility-side BT voltages on the dispatcher console.
- Add a blocking signal from the generator secondary control system to block autosynchronization raise or lower signals for an individual GTG if terminal voltage limits would be exceeded. (The transmission of a similar blocking signal from the governor had already been configured if speed or real power limits would be exceeded.)

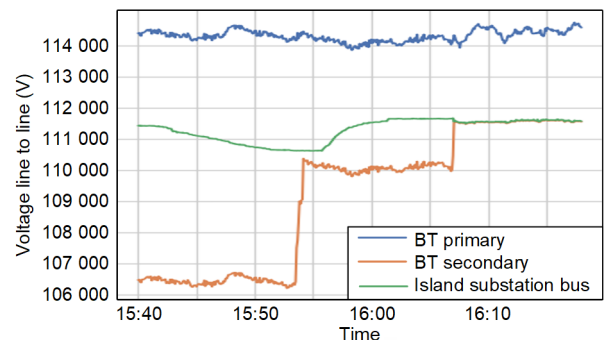
Fig. 4 Successful synchronization

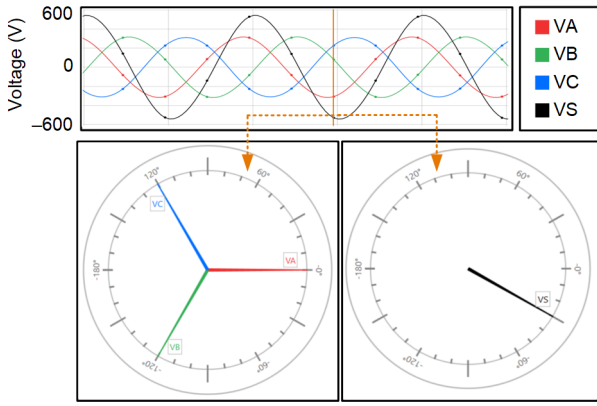
At this point in the commissioning, the bus-tie relay was already precommissioned. Prior to closing the bus-tie breaker, the relay performed a sync-check function to verify that both incomers were in sync. The bus-tie relay measured three-phase voltage from Bus A and a sync-check voltage from Bus B. In this case, the sync element was not asserted, and fortunately, the commissioning team trusted the relay and did not attempt to override the relay sync supervision. Fig. 9 shows the voltage phasors from the bus-tie relay. In this instance, the synchronizing voltage VS is lagging VA by 30 degrees. But based on relay settings, the VS voltage should be lagging VA by 330 degrees.

Fig. 9 Bus-tie voltage phasors—bus tie open

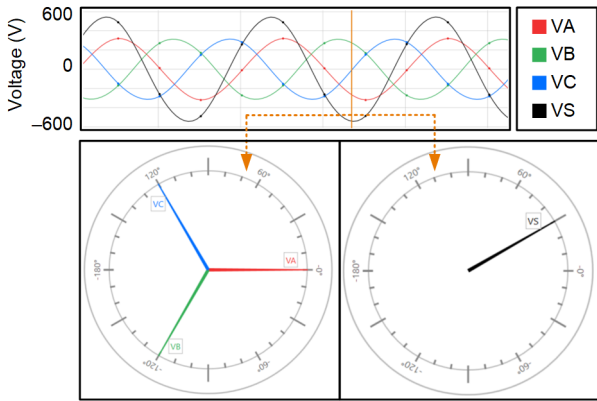
To quickly verify the expected phase angle, the commissioning team opened Incomer B and closed the bus-tie breaker. In this state, an event report was captured from the bus-tie relay to confirm the expected synchronizing voltage phasor. See Fig. 10 for expected phasors.

Fig. 10 Bus-tie relay expected phasors

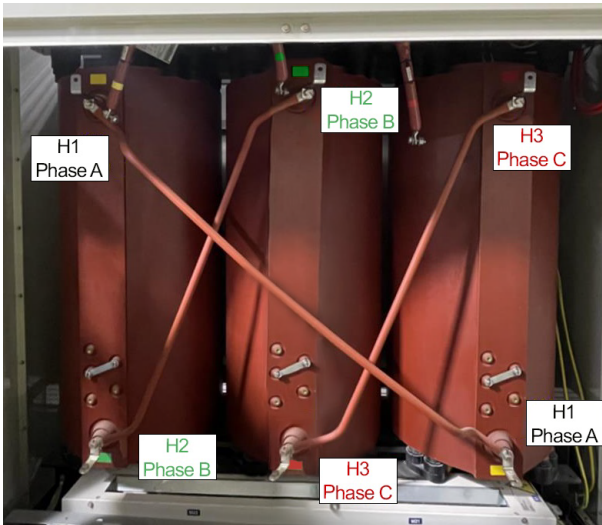
In reviewing the installation in detail, the commissioning team found that the delta links on the 10 kV transformer winding were installed incorrectly on Incomer B. See Fig. 11 for a typical installation showing the delta link placement (photo taken during precommissioning).

Fig. 11 10 kV delta links

Inconsistent delta link placements result in the Incomer B transformer connected in a Dyn1 transformer connection when the installation or design requires a Dyn11 transformer connection. While a Dyn1 transformer connection results in a 30-degree lead of the high-voltage winding to low-voltage winding, a Dyn11 connection results in a 30-degree lag of the high-voltage winding to low-voltage winding. See [3] for a complete review of the transformer delta connections, including the derivation of the phase shift, and the impact on the phasors measured by the relay. Fig. 12 highlights how transformer secondary side voltages differ based on the transformer's primary delta connection.

After commissioning over 100 switchboards, the field commissioning team was familiar with the synchronization function in the relay and never had it block closing. This was the only transformer found with incorrect delta link placement. It was important for the field team to trust the information provided and use that information to dig deeper into the root cause. Ultimately, the delta links were reconfigured to achieve the proper desired transformer connection and permit proper synchronization.

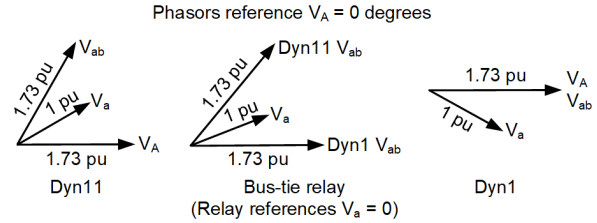
Fig. 12 Secondary side voltage phasors

With the incorrect delta link configuration, all three-phase voltages were 60 degrees out of phase. With both incomers energized, under normal conditions, the voltage across the open contacts is 0 percent of the phase-to-ground voltage. However, with the incomers 60 degrees out of phase, the voltage across the open contacts was 100 percent of the phase-to-ground voltage. See Equation (1) based on the actual synchronizing phasor in Fig. 9 and the expected synchronizing voltage in Fig. 10. While this voltage difference is no different than having one energized source and one de-energized source, the problem is the short-circuit current interruption. If operators attempt to close a normally open tie circuit breaker with two out-of-phase sources, there will be significant transient current between the two sources, which may exceed the capability of the circuit breaker to interrupt out-of-phase currents [4].

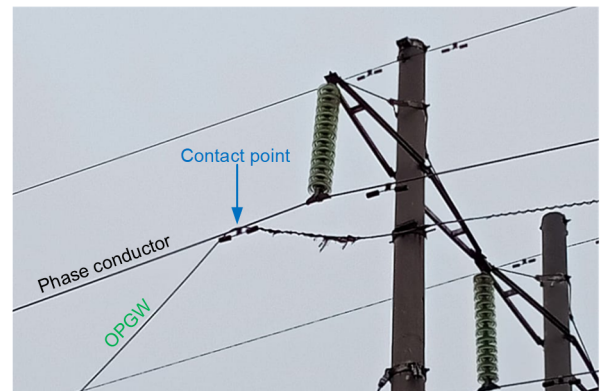
Upon review of the relay event reports confirming presence of a legitimate power system fault, the team conducted a walkdown of the transmission line. The OPGW was found to be broken on one of the transmission poles. This OPGW carried the line current differential fiber for the redundant line differential channels of the line relays. When it broke, it caused failure and disabling of the line current differential channel. This demonstrates the importance of routing each fiber channel in two physically separated paths. Alternately, an existing communications network and multiplexing technologies, such as a synchronous optical network (SONET), can be leveraged to establish a secondary line differential channel to complement a primary dedicated line differential channel [5].

The picture shown in Fig. 15 was taken during the walkdown of the tripped transmission line. The figure shows that the broken OPGW, which was suspended on one of the poles, had contacted one of the phase conductors. This established a sequence of events in which the initial report related to the bad utility circuit breaker was caused by the breakage in the OPGW. Then, a protective trip followed due to the broken OPGW making contact with one of the phase conductors.

Fig. 15 Broken OPGW contact with C-phase conductor

This event highlights the importance of monitoring the line current differential channels and generating alarms in case of a channel failure. A line current differential channel failure alarm would have asserted in this case and allowed the system operators to address the issue before the broken OPGW caused a line trip. Additionally, [1] describes advanced reporting functionalities that can be implemented in line current differential relays to enhance monitoring of the communications channel.

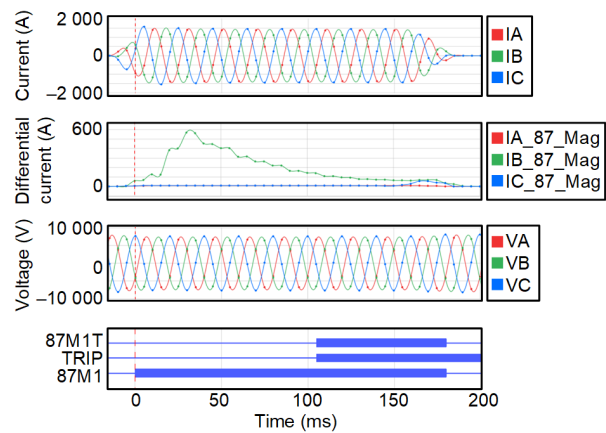
To analyze the unexpected differential trip, the commissioning team reviewed the event report generated by the relay. See Fig. 17 for the filtered event of the initial start and Fig. 18 for the raw or unfiltered event report of the same motor start. The event reports show an increase in current on the B-phase differential current, which results in

a trip 100 ms later. Based on the voltage waveforms (relay connections also include bus-side voltage inputs), however, there was no B-phase-to-ground fault on the power system. The current magnitude was also decreasing in the differential circuit leading up to the trip. This decaying differential current is a sign of false differential current and led the commissioning team to suspect CT saturation [6]. Raw or unfiltered event reports allowed the commissioning team to confirm CT saturation as the root cause.

Fig. 17 Initial start filtered event report

The differential current waveforms in Fig. 17 and Fig. 18 are classic signs of dissimilar CT performance. After a discussion with engineers, it was agreed to extend the 87 differential start pickup trip time to 500 ms and maintain the existing set point to permit a start. With the relay set to generate an event report when the 10 kV breaker changed state, the following waveform was captured during the successful start. Fig. 19 shows the filtered event report. In this case, the motor successfully started, but the false 87 differential current lasted for 364 ms. To make the relay secure during start, the starting differential element needs to account for this expected fault differential current. From the relay's sequential event report and motor start report, the motor remained in the starting state for approximately 2.5 s during this uncoupled run. From motor nameplate information, however, a normal coupled load start for the motor is expected to take 9 to 17 s, depending on the voltage (100 to 80 percent nominal voltage, respectively).

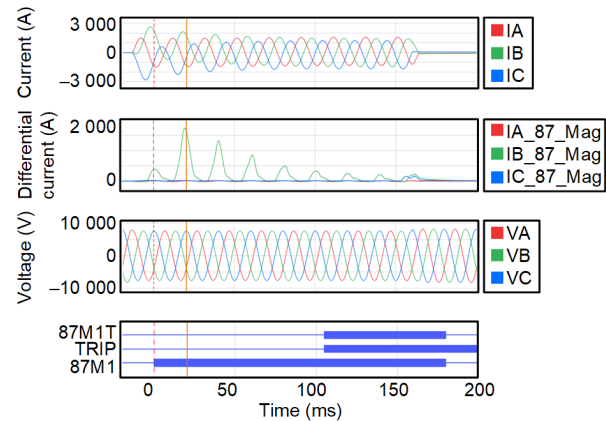
Fig. 18 Initial start unfiltered event report

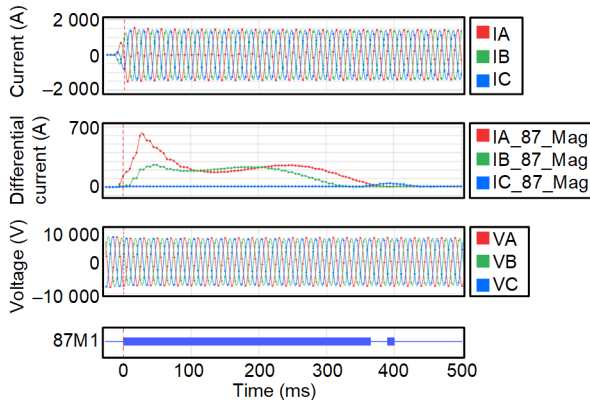
Fig. 19 Successful start filtered event report

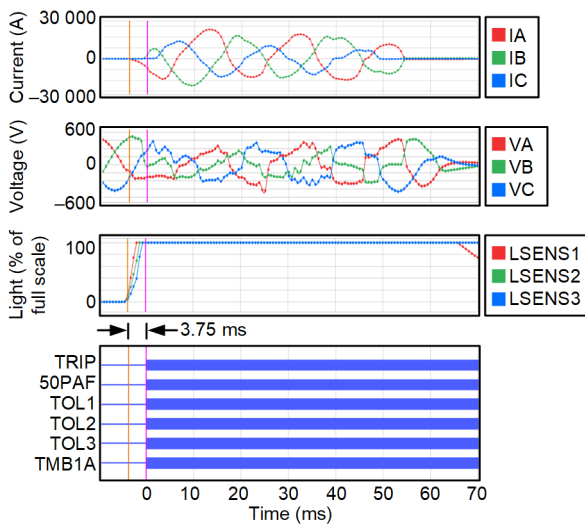
Fig. 22 is a screenshot from the event report, which was triggered by the incomer relay for the arc-flash trip. The third waveform from the top shows the single-phase voltage input from the busbar. This is the most accurate representation of the time the breaker was closed. For reference, the digital chart at the bottom shows the breaker status feedback (52a) that arrived in the relay about half a cycle after the appearance of the bus voltage. Shortly after the breaker was closed, the phase voltages became distorted and currents jumped to fault levels.

Fig. 22 380 V incomer relay response to an arc flash

As shown in the digital chart at the bottom of Fig. 22, both the over-light and overcurrent conditions were detected about 4 ms after fault inception (appearance of fault current). The TRIP output was issued within the same relay processing cycle to trip the incomer breaker. The upstream breaker tripped 54 ms after the trip command was issued for a total clearing time of 58 ms. Note that for the timing measurements mentioned previously, the fault inception is considered as the first appearance of fault currents and the breaker opening is defined as the time that the currents were reduced to zero.
