A Bus Cleared and a Hidden Breaker Insulation Failure Revealed

Robert Roman and Kevin Damron

Avista Utilities

Schweitzer Engineering Laboratories, Inc.

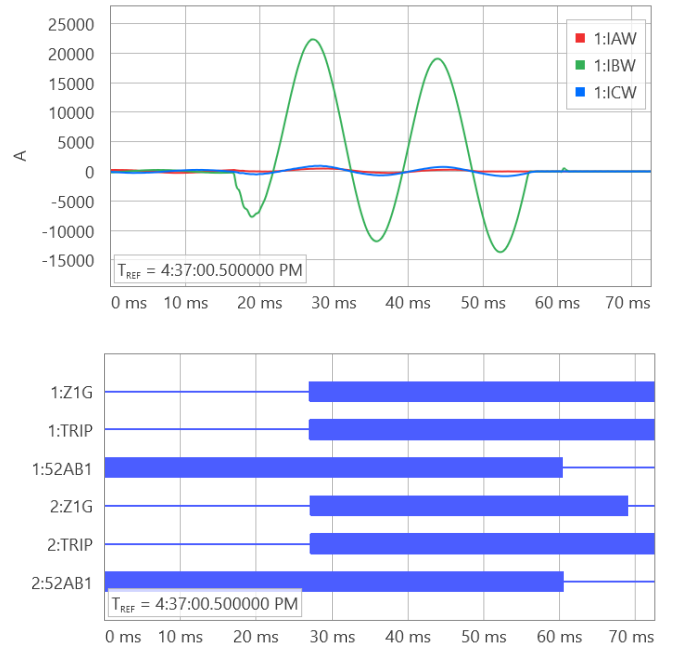
At 16:37:00 a B-phase-to-ground fault occurred on the Sub A–Sub B transmission line. Both modern line relays at Sub A detected the fault and tripped on their Zone 1 distance element, Z1G. Bkr 3 opened within about two and a quarter cycles, opening the line from the Sub A end. Both relays showed the 52A contact from the breaker deasserting, which also indicated that the breaker opened. Fig. 9 shows the current and binary values from the modern line relays for the fault. The currents for both relays are nearly identical so only one set of currents is shown. The relay estimated the fault location to be 0.73 miles from the substation. This is very close to Sub A since the total line length was approximately 70 miles. The other end of the line at Sub B also tripped quickly due to the permissive overreaching transfer trip scheme and opened the remote breaker.

Fig. 9. Initial fault detected by the modern line relays protecting the Sub A–Sub B line.

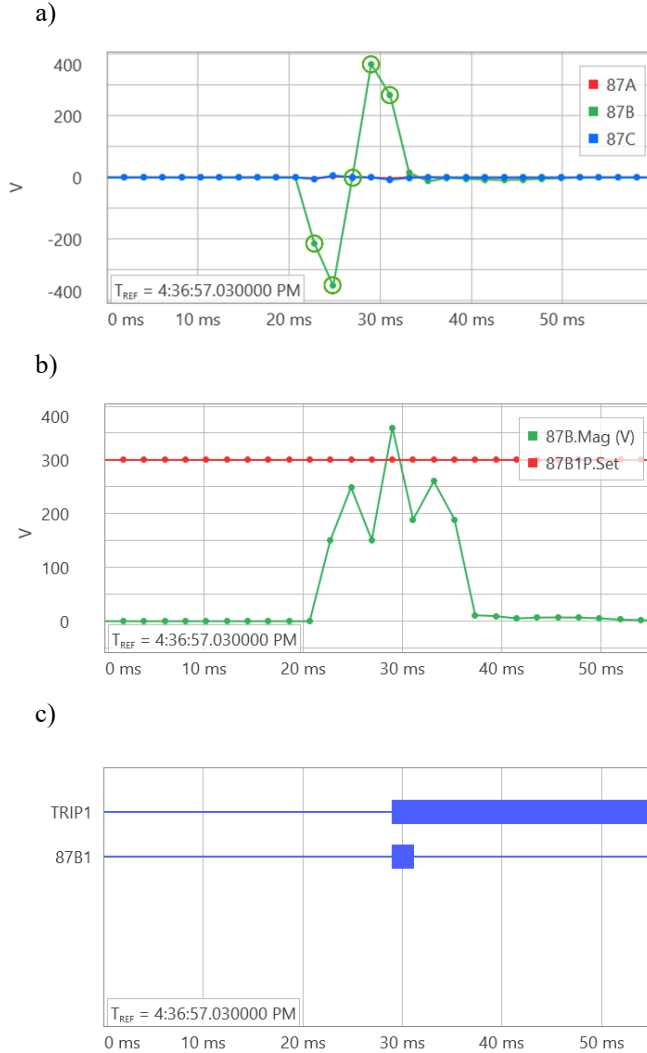
Digging deeper into the 87B1 relay's filtered compressed event report files, the engineers observed the voltage signal shown in Fig. 10a. This signal looks similar to an impulse response of the 87B1 half-cycle cosine filter. The impulse

response of a half-cycle cosine filter at eight samples per cycle should be four samples long. However, the signal shown in Fig. 10a has five samples. The reason for this signal in the 87B1 relay is discussed later in this section, after the signals shown by the 87B2 relay's COMTRADE files are discussed. The magnitude of this signal rose above the 87B1P setting in the 87B1 relay for one processing interval, causing it to trip, as shown in Fig. 10b and Fig. 10c.

Fig. 10. 87B1 relay tripped the Sub A bus.

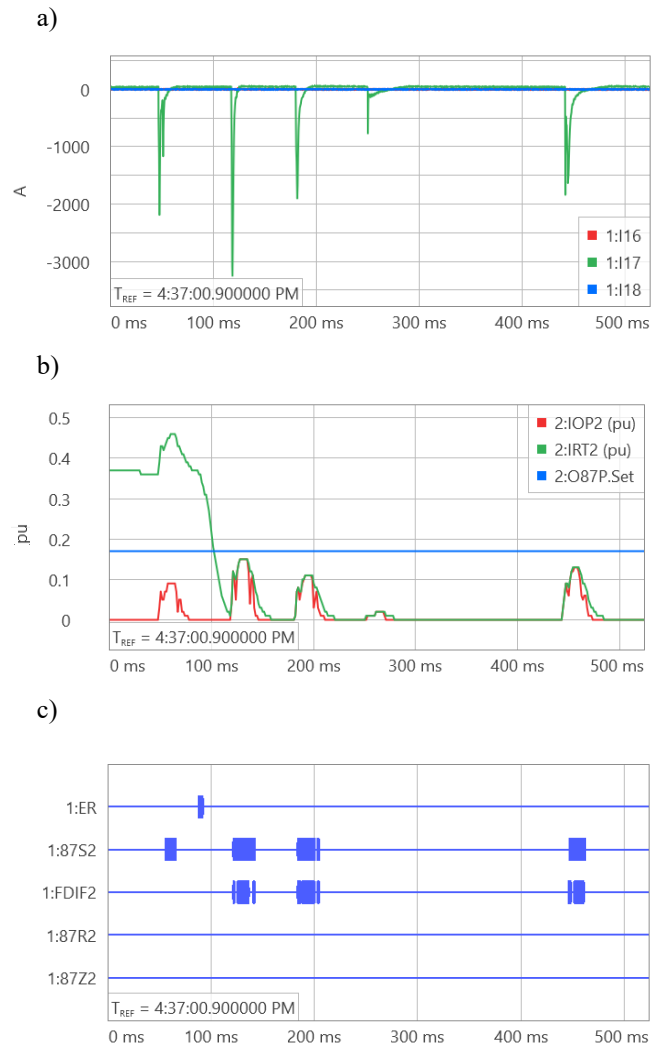
The protection engineers proceeded with the event analysis by looking at the 87B2 relay's COMTRADE event. An initial look at the currents and voltages in the 87B2 event showed the voltage at nominal voltage and the current at normal load current values with no sign of a bus fault. A more detailed look revealed that although the currents through Bkr 3 were zero at the beginning of the event, which started after Bkr 3 had opened, the B-phase current had several large, high-frequency transients. These transients were due to lightning strikes on the line, as shown in Fig. 11a. Somehow, Bkr 3 was open but current still flowed through the CT. Current is not supposed to flow through open breakers. This was the first indication that the breaker was damaged, which will be discussed more later.

Fig. 11. High-frequency current transients in the 87B2 currents.

It is evident from Fig. 11c that the 87S2 binary output, which is the sensitive differential element for the second B-phase zone in the 87B2 relay, picked up and dropped out when lightning struck the line and flashed over in the breaker. The time-delayed output of the sensitive differential element, 87ST2, is mainly used for alarming in the 87B2 for long-time standing imbalances from CT circuit failure. The pickup setting for the 87S2 binary output, S87P, was set to 0.07 per unit (pu) and the pickup delay setting, 87STPU, was set to 300 cycles. Since the operate current for B-phase, IOP2, went above the S87P setting, the sensitive differential element asserted momentarily, but it did not assert the alarm because the operate current was not above the pickup setting for 300 cycles.

Since the magnitude of the operate current due to the first lightning strike was at almost 0.1 pu and the load current caused the restraint current magnitude to be about 0.35 pu, the 87B2 relay did not operate, as shown in Fig. 11b and Fig. 11c. After the 87B1 relay tripped the bus and the load current went to zero, the subsequent lightning strikes caused the operate and restraint current to have about the same magnitude. The FDIF2 binary output asserted for these subsequent lightning strikes because the operate and restraint current percentage was greater than the slope setting. But the 87R2 binary output did not assert for the subsequent lightning strikes because the operate current did not exceed the minimum magnitude check of the O87P setting, which was set to 0.17 pu. The operate and restraint current rose up to 0.15 pu but never reached the 0.17 per-unit setting. Therefore, the 87R2 and 87Z2 binary output did not assert and the 87B2 relay did not trip.

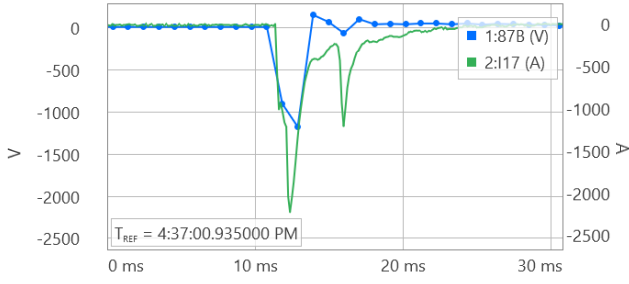
Before continuing to analyze the 87B2 relay's response to these high-frequency lightning strikes, recall the signal observed in the 87B1 relay's event report. Fig. 12 shows the first lightning strike from the 87B1 relay's unfiltered voltage, 1:87B, and the 87B2 relay's unfiltered current, 2:I17. The 87B1 relay's event record is a 16-samples-per-cycle (960 Hz when the nominal frequency is 60 Hz) unfiltered event record, and the 87B2 relay's event record is an 8 kHz COMTRADE event record. The 87B1 relay's lower 16-samples-per-cycle sampling rate caught only two data points that had a high value in the unfiltered event report. When these two points passed through the half-cycle cosine filter of the 87B1 relay and were downsampled to eight samples per cycle, the result was the five-point signal shown in Fig. 10a. The 87B1 relay samples data at 16 samples per cycle, but the filtered event reports it records are 8 samples per cycle. This analysis of the relay's filtering explains the nontypical signal seen in the 87B1 relay's event report.

The 87B1 relay only saw the initial lightning flashover in the breaker and not the subsequent ones because as soon as the 87B1 output to the LOR asserted the LOR shorted the inputs to the 87B1 to protect the internal MOV of the relay from thermal damage, as previously discussed.

Fig. 12. First lightning strike seen by 87B1 and 87B2 relays.

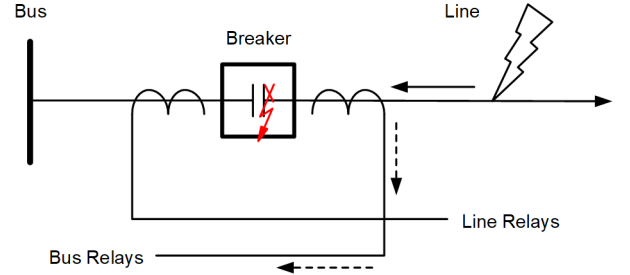
The CTs for the bus relays are on the line side of the breaker, and the CTs for the line relays are on the bus side of the breaker because the zones of protection for the bus and the line overlap at the breaker. The only way the bus relays' line-side CTs could see high-frequency current transients without the line relays' bus-side CTs seeing any current flow is if the current flowed from the line through the primary of the line-side CTs into the breaker and flashed over to ground through the tank of the breaker, as shown in Fig. 13.

Fig. 13. Internally faulted breaker.

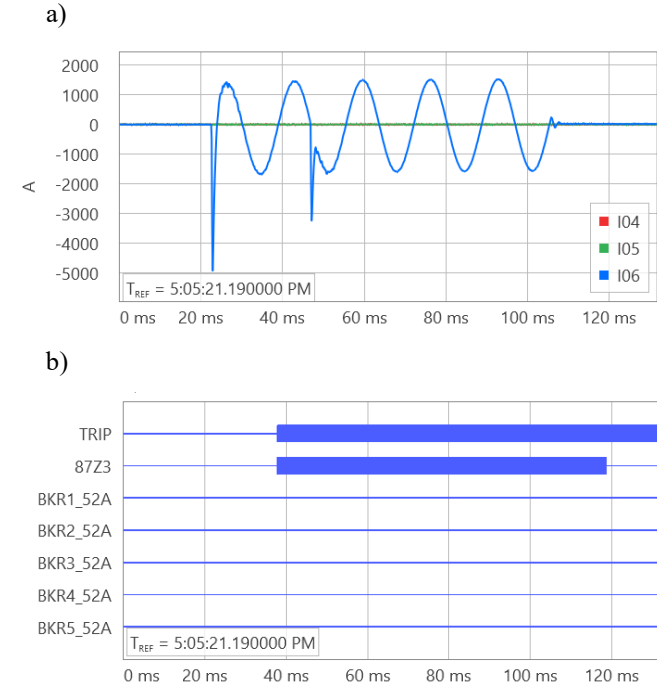
At 17:05:21 lightning struck the Sub A–Sub C line on C-phase, which was open at the Sub A end of the line and closed from the Sub C end of the line, as shown in Fig. 14. The lightning surge caused Bkr 2 to flash over. The 87B2 relay detected the internal fault and attempted to trip the Sub A bus even though the bus was already open. The fault was cleared after five cycles when the remote end of the line opened the breaker at Sub C.

The initial high-frequency current transient shown in Fig. 14a was due to a lightning strike on the line that flashed

over in the breaker. After the lightning surge initiated the flashover in the breaker, the remote end of the line continued feeding the fault in the breaker until the remote end of the line opened. Fig. 14b demonstrates that the 52A contacts of every breaker on the bus were open at the time of the fault in Bkr 2, showing that the bus was open at this time. The 87B1 relay did not see this second fault because it was still shorted by the 86B LOR, which was still rolled. At 17:05:22, Bkr 6 at Sub C successfully reclosed.

Fig. 14. Second fault while the Sub A Bus was open.

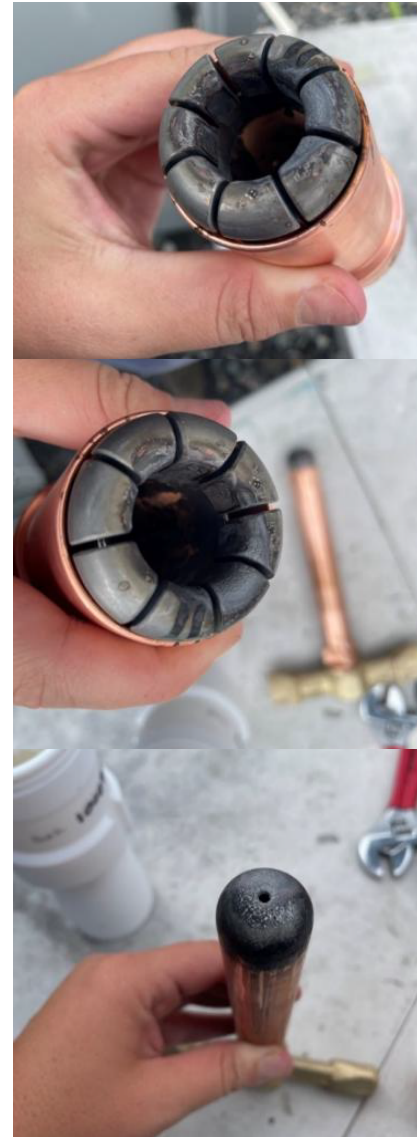
When Bkr 2 was removed from service and inspected, visible burn marks were observed on the breaker's C-phase contact, as shown in Fig. 15. The gas sample taken from this SF6 breaker indicated that the breaker was damaged. Unlike Bkr 3, Bkr 2 sustained not only the high-frequency current transients from the lightning strikes, but also five cycles of fundamental frequency fault current. This caused much more damage to Bkr 2 than the high-frequency current transients alone did to Bkr 3.

Fig. 15. Bkr 2 damage caused by lightning.

The breaker manufacturer was involved in the breaker failure analysis and recommended neither breaker be returned to service. Bkr 3 only experienced lightning flashover with no 60 Hz current reinforcing the breakdown to cause further damage to the breaker. Bkr 2 suffered lightning strikes as well as the internal fault for five cycles.

Prior to the event, the utility's standard practice was to not install lightning arresters on transmission lines due to the historically low total lightning density in their service territory. Based on this event, and the increasing lightning risk to the utility's 230 kV transmission system, a program was developed to install lightning arresters on breakers and to install shield wires on transmission lines.
