# A Bus Cleared and a Hidden Breaker Insulation Failure Revealed

Robert Roman and Kevin Damron  
*Avista Utilities*

Emma Clawson  
*Schweitzer Engineering Laboratories, Inc.*

Presented at the  
51st Annual Western Protective Relay Conference  
Spokane, Washington  
October 22–24, 2024

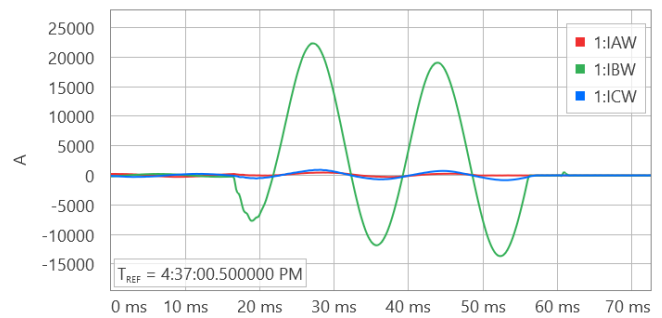
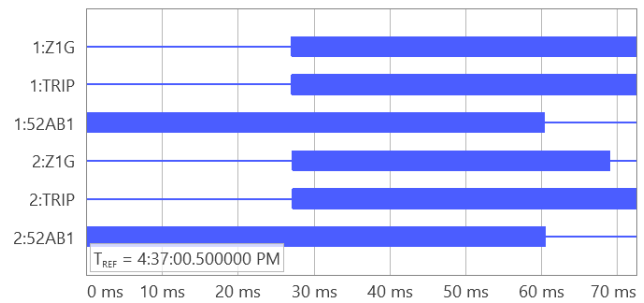
Fig. 9. Initial fault detected by the modern line relays protecting the Sub A–Sub B line.

At 16:37:00 a B-phase-to-ground fault occurred on the Sub A–Sub B transmission line. Both modern line relays at Sub A detected the fault and tripped on their Zone 1 distance element, Z1G. Bkr 3 opened within about two and a quarter cycles, opening the line from the Sub A end. Both relays showed the 52A contact from the breaker deasserting, which also indicated that the breaker opened. Fig. 9 shows the current and binary values from the modern line relays for the fault. The currents for both relays are nearly identical so only one set of currents is shown. The relay estimated the fault location to be 0.73 miles from the substation. This is very close to Sub A since the total line length was approximately 70 miles. The other end of the line at Sub B also tripped quickly due to the permissive overreaching transfer trip scheme and opened the remote breaker.
