# A Bus Cleared and a Hidden Breaker Insulation Failure Revealed

Robert Roman and Kevin Damron  
*Avista Utilities*

Emma Clawson  
*Schweitzer Engineering Laboratories, Inc.*

Presented at the  
78th Annual Conference for Protective Relay Engineers at Texas A&M  
College Station, Texas  
March 31–April 3, 2025

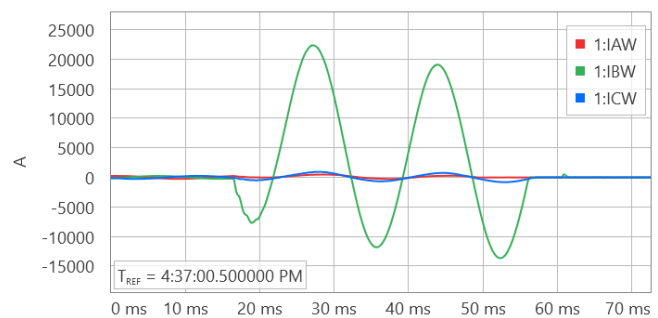
Fig. 9. Initial fault detected by the modern line relays protecting the Sub A–Sub B line.

At 16:37:00 a B-phase-to-ground fault occurred on the Sub A–Sub B transmission line. Both modern line relays at Sub A detected the fault and tripped on their Zone 1 distance element, Z1G. Bkr 3 opened within about two and a quarter cycles, opening the line from the Sub A end. Both relays showed the 52A contact from the breaker deasserting, which also indicated that the breaker opened. Fig. 9 shows the current and binary values from the modern line relays for the fault. The currents for both relays are nearly identical so only one set of currents is shown. The relay estimated the fault location to be 0.73 miles from the substation. This is very close to Sub A since the total line length was approximately 70 miles. The other end of the line at Sub B also tripped quickly due to the permissive overreaching transfer trip scheme and opened the remote breaker.

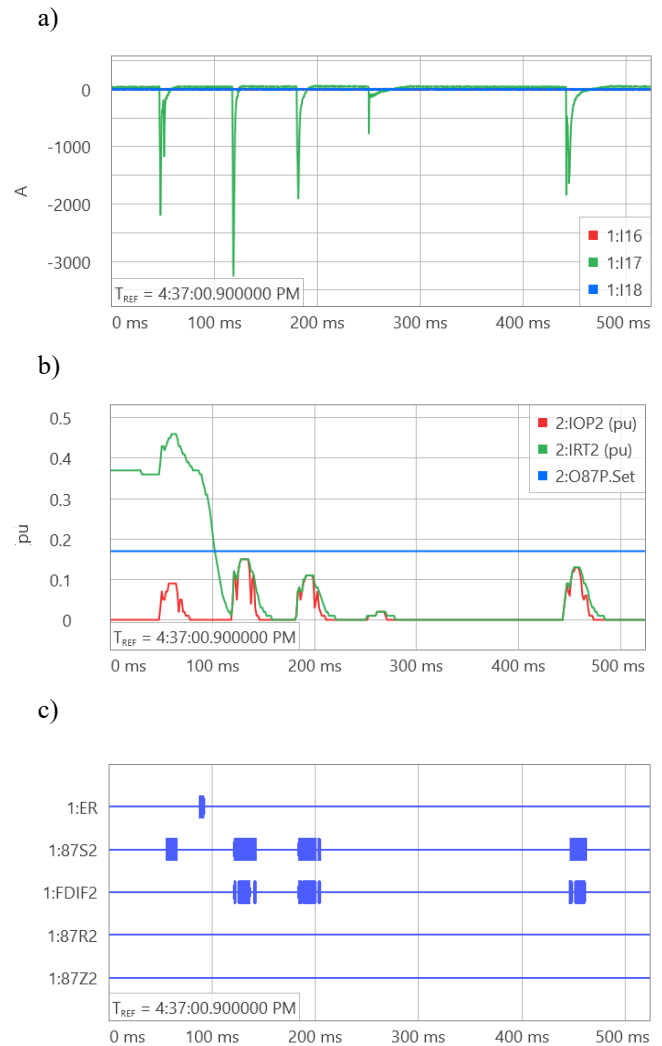
Fig. 11. High-frequency current transients in the 87B2 currents.

The protection engineers proceeded with the event analysis by looking at the 87B2 relay's COMTRADE event. An initial look at the currents and voltages in the 87B2 event showed the voltage at nominal voltage and the current at normal load current values with no sign of a bus fault. A more detailed look revealed that although the currents through Bkr 3 were zero at the beginning of the event, which started after Bkr 3 had opened, the B-phase current had several large, high-frequency transients. These transients were due to lightning strikes on the line, as shown in Fig. 11a. Somehow, Bkr 3 was open but current still flowed through the CT. Current is not supposed to flow through open breakers. This was the first indication that the breaker was damaged, which will be discussed more later.

It is evident from Fig. 11c that the 87S2 binary output, which is the sensitive differential element for the second B-phase zone in the 87B2 relay, picked up and dropped out when lightning struck the line and flashed over in the breaker. The time-delayed output of the sensitive differential element, 87ST2, is mainly used for alarming in the 87B2 for long-time standing imbalances from CT circuit failure. The pickup setting for the 87S2 binary output, S87P, was set to 0.07 per unit (pu) and the pickup delay setting, 87STPU, was set to 300 cycles. Since the operate current for B-phase, IOP2, went above the S87P setting, the sensitive differential element asserted momentarily, but it did not assert the alarm because the operate current was not above the pickup setting for 300 cycles.

Since the magnitude of the operate current due to the first lightning strike was at almost 0.1 pu and the load current caused the restraint current magnitude to be about 0.35 pu, the 87B2 relay did not operate, as shown in Fig. 11b and Fig. 11c. After the 87B1 relay tripped the bus and the load current went to zero, the subsequent lightning strikes caused the operate and restraint current to have about the same magnitude. The FDIF2 binary output asserted for these subsequent lightning strikes because the operate and restraint current percentage was greater than the slope setting. But the 87R2 binary output did not assert for the subsequent lightning strikes because the operate current did not exceed the minimum magnitude check of the O87P setting, which was set to 0.17 pu. The operate and restraint current rose up to 0.15 pu but never reached the 0.17 per-unit setting. Therefore, the 87R2 and 87Z2 binary output did not assert and the 87B2 relay did not trip.

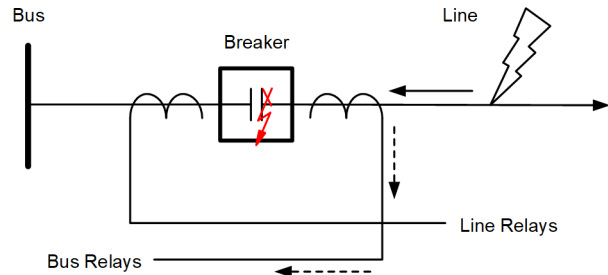
Fig. 13. Internally faulted breaker.

The CTs for the bus relays are on the line side of the breaker, and the CTs for the line relays are on the bus side of the breaker because the zones of protection for the bus and the line overlap at the breaker. The only way the bus relays' line-side CTs could see high-frequency current transients without the line relays' bus-side CTs seeing any current flow is if the current flowed from the line through the primary of the line-side CTs into the breaker and flashed over to ground through the tank of the breaker, as shown in Fig. 13.
