# A Bus Cleared and a Hidden Breaker Insulation Failure Revealed

Robert Roman and Kevin Damron  
*Avista Utilities*

Emma Clawson  
*Schweitzer Engineering Laboratories, Inc.*

Presented at the  
78th Annual Georgia Tech Protective Relaying Conference  
Atlanta, Georgia  
May 7–9, 2025

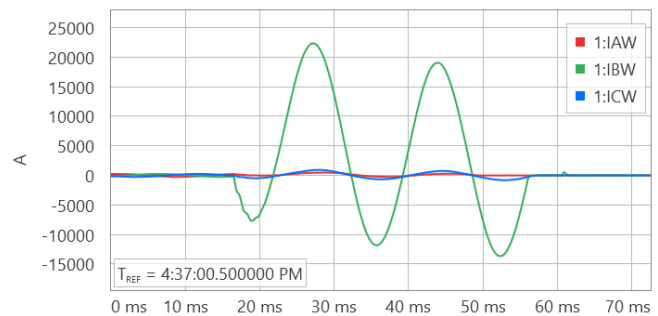
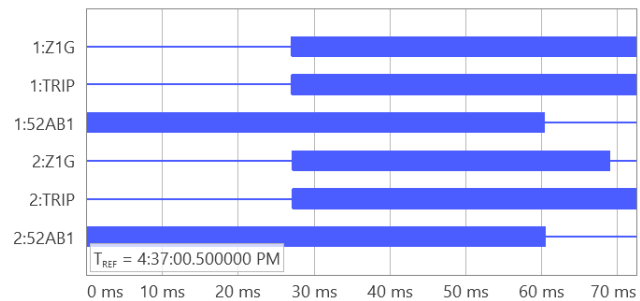
At 16:37:00 a B-phase-to-ground fault occurred on the Sub A–Sub B transmission line. Both modern line relays at Sub A detected the fault and tripped on their Zone 1 distance element, Z1G. Bkr 3 opened within about two and a quarter cycles, opening the line from the Sub A end. Both relays showed the 52A contact from the breaker deasserting, which also indicated that the breaker opened. Fig. 9 shows the current and binary values from the modern line relays for the fault. The currents for both relays are nearly identical so only one set of currents is shown. The relay estimated the fault location to be 0.73 miles from the substation. This is very close to Sub A since the total line length was approximately 70 miles. The other end of the line at Sub B also tripped quickly due to the permissive overreaching transfer trip scheme and opened the remote breaker.

Fig. 9. Initial fault detected by the modern line relays protecting the Sub A–Sub B line.

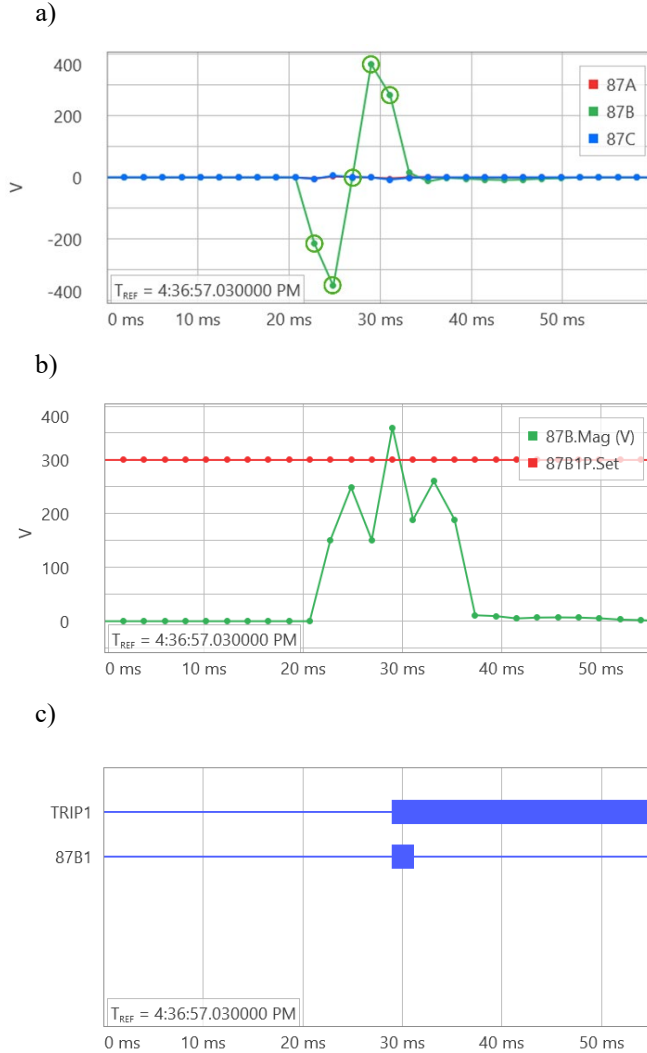
Digging deeper into the 87B1 relay's filtered compressed event report files, the engineers observed the voltage signal shown in Fig. 10a. This signal looks similar to an impulse response of the 87B1 half-cycle cosine filter. The impulse

response of a half-cycle cosine filter at eight samples per cycle should be four samples long. However, the signal shown in Fig. 10a has five samples. The reason for this signal in the 87B1 relay is discussed later in this section, after the signals shown by the 87B2 relay's COMTRADE files are discussed. The magnitude of this signal rose above the 87B1P setting in the 87B1 relay for one processing interval, causing it to trip, as shown in Fig. 10b and Fig. 10c.

Fig. 10. 87B1 relay tripped the Sub A bus.

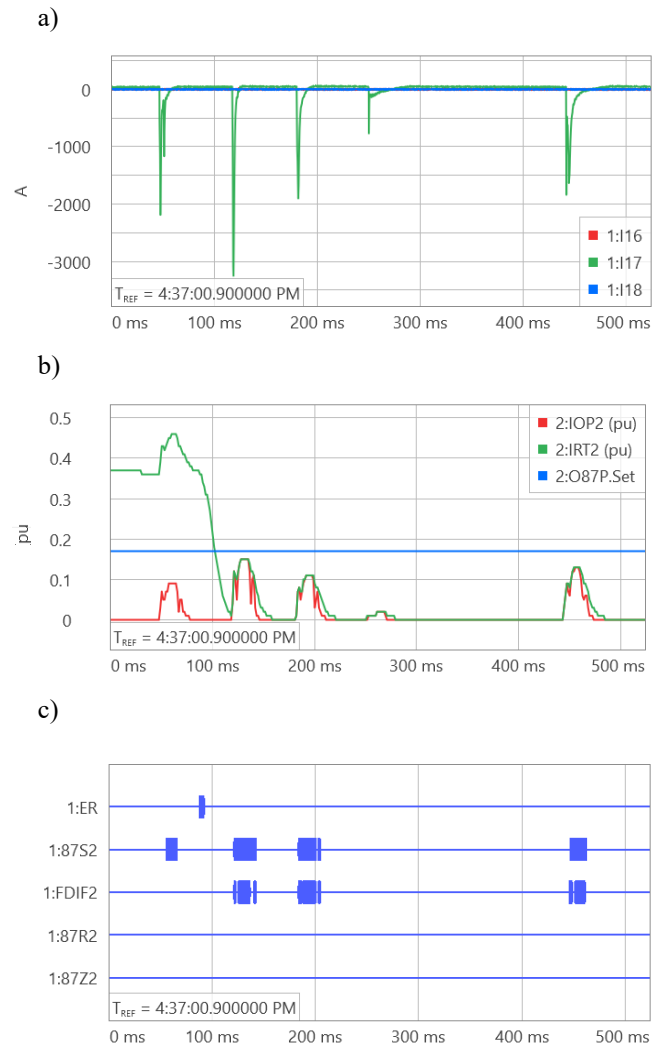
The protection engineers proceeded with the event analysis by looking at the 87B2 relay's COMTRADE event. An initial look at the currents and voltages in the 87B2 event showed the voltage at nominal voltage and the current at normal load current values with no sign of a bus fault. A more detailed look revealed that although the currents through Bkr 3 were zero at the beginning of the event, which started after Bkr 3 had opened, the B-phase current had several large, high-frequency transients. These transients were due to lightning strikes on the line, as shown in Fig. 11a. Somehow, Bkr 3 was open but current still flowed through the CT. Current is not supposed to flow through open breakers. This was the first indication that the breaker was damaged, which will be discussed more later.

Fig. 11. High-frequency current transients in the 87B2 currents.

It is evident from Fig. 11c that the 87S2 binary output, which is the sensitive differential element for the second B-phase zone in the 87B2 relay, picked up and dropped out when lightning struck the line and flashed over in the breaker. The time-delayed output of the sensitive differential element, 87ST2, is mainly used for alarming in the 87B2 for long-time standing imbalances from CT circuit failure. The pickup setting for the 87S2 binary output, S87P, was set to 0.07 per unit (pu) and the pickup delay setting, 87STPU, was set to 300 cycles. Since the operate current for B-phase, IOP2, went above the S87P setting, the sensitive differential element asserted momentarily, but it did not assert the alarm because the operate current was not above the pickup setting for 300 cycles.

Since the magnitude of the operate current due to the first lightning strike was at almost 0.1 pu and the load current caused the restraint current magnitude to be about 0.35 pu, the 87B2 relay did not operate, as shown in Fig. 11b and Fig. 11c. After the 87B1 relay tripped the bus and the load current went to zero, the subsequent lightning strikes caused the operate and restraint current to have about the same magnitude. The FDIF2 binary output asserted for these subsequent lightning strikes because the operate and restraint current percentage was greater than the slope setting. But the 87R2 binary output did not assert for the subsequent lightning strikes because the operate current did not exceed the minimum magnitude check of the O87P setting, which was set to 0.17 pu. The operate and restraint current rose up to 0.15 pu but never reached the 0.17 per-unit setting. Therefore, the 87R2 and 87Z2 binary output did not assert and the 87B2 relay did not trip.

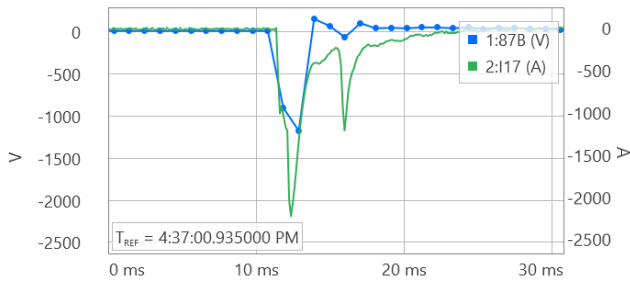
Before continuing to analyze the 87B2 relay's response to these high-frequency lightning strikes, recall the signal observed in the 87B1 relay's event report. Fig. 12 shows the first lightning strike from the 87B1 relay's unfiltered voltage, 1:87B, and the 87B2 relay's unfiltered current, 2:I17. The 87B1 relay's event record is a 16-samples-per-cycle (960 Hz when the nominal frequency is 60 Hz) unfiltered event record, and the 87B2 relay's event record is an 8 kHz COMTRADE event record. The 87B1 relay's lower 16-samples-per-cycle sampling rate caught only two data points that had a high value in the unfiltered event report. When these two points passed through the half-cycle cosine filter of the 87B1 relay and were downsampled to eight samples per cycle, the result was the five-point signal shown in Fig. 10a. The 87B1 relay samples data at 16 samples per cycle, but the filtered event reports it records are 8 samples per cycle. This analysis of the relay's filtering explains the nontypical signal seen in the 87B1 relay's event report.

The 87B1 relay only saw the initial lightning flashover in the breaker and not the subsequent ones because as soon as the 87B1 output to the LOR asserted the LOR shorted the inputs to the 87B1 to protect the internal MOV of the relay from thermal damage, as previously discussed.

Fig. 12. First lightning strike seen by 87B1 and 87B2 relays.

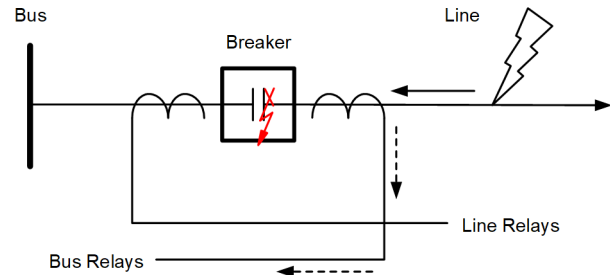
The CTs for the bus relays are on the line side of the breaker, and the CTs for the line relays are on the bus side of the breaker because the zones of protection for the bus and the line overlap at the breaker. The only way the bus relays' line-side CTs could see high-frequency current transients without the line relays' bus-side CTs seeing any current flow is if the current flowed from the line through the primary of the line-side CTs into the breaker and flashed over to ground through the tank of the breaker, as shown in Fig. 13.

Fig. 13. Internally faulted breaker.

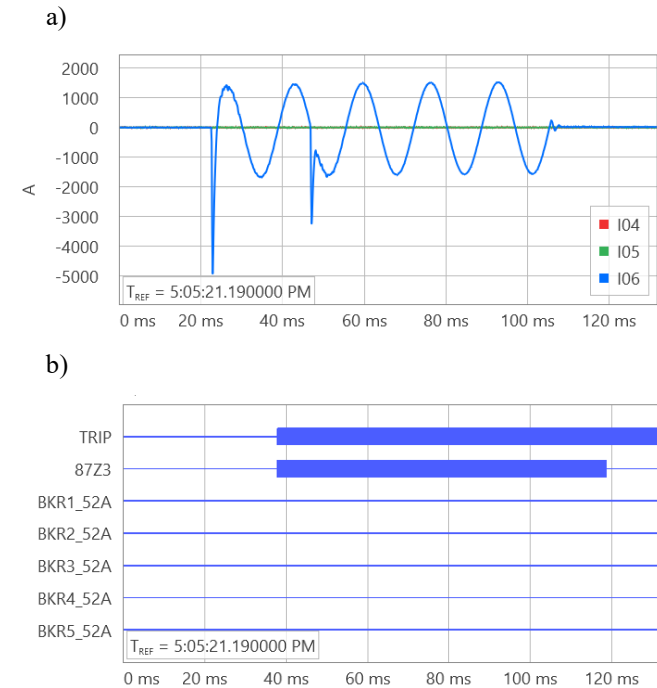
At 17:05:21 lightning struck the Sub A–Sub C line on C-phase, which was open at the Sub A end of the line and closed from the Sub C end of the line, as shown in Fig. 14. The lightning surge caused Bkr 2 to flash over. The 87B2 relay detected the internal fault and attempted to trip the Sub A bus even though the bus was already open. The fault was cleared after five cycles when the remote end of the line opened the breaker at Sub C.

The initial high-frequency current transient shown in Fig. 14a was due to a lightning strike on the line that flashed

over in the breaker. After the lightning surge initiated the flashover in the breaker, the remote end of the line continued feeding the fault in the breaker until the remote end of the line opened. Fig. 14b demonstrates that the 52A contacts of every breaker on the bus were open at the time of the fault in Bkr 2, showing that the bus was open at this time. The 87B1 relay did not see this second fault because it was still shorted by the 86B LOR, which was still rolled. At 17:05:22, Bkr 6 at Sub C successfully reclosed.

Fig. 14. Second fault while the Sub A Bus was open.

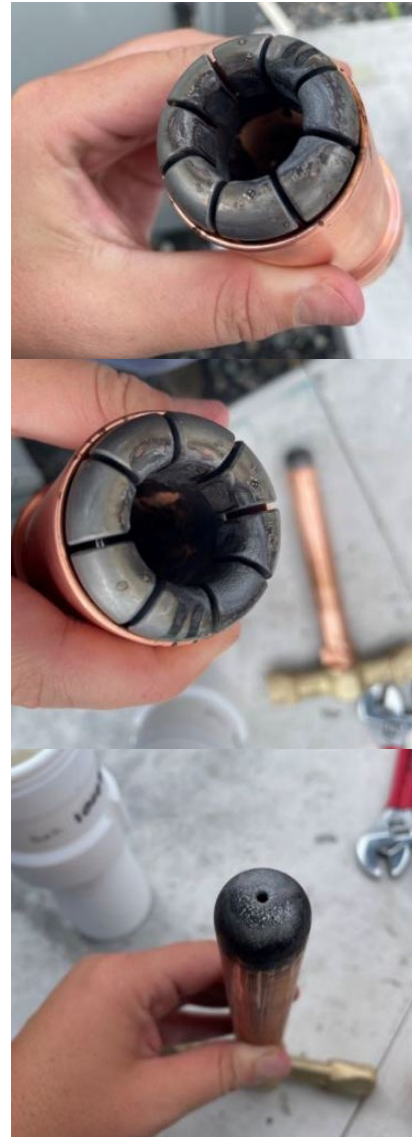
The basic insulation level (BIL) rating of the transmission line insulation connecting to Sub A is 1,105 kV. The BIL rating for Bkr 2 and Bkr 3 was only 900 kV, with no surge arresters on any of the transmission lines at Sub A. This arrangement made the circuit breakers the weakest link. Additionally, being in the open position following the initial 16:37:00 fault caused the lightning impulses to double when they reflected at the dead end formed by the open circuit breaker.

When Bkr 2 was removed from service and inspected, visible burn marks were observed on the breaker's C-phase contact, as shown in Fig. 15. The gas sample taken from this SF6 breaker indicated that the breaker was damaged. Unlike Bkr 3, Bkr 2 sustained not only the high-frequency current transients from the lightning strikes, but also five cycles of fundamental frequency fault current. This caused much more damage to Bkr 2 than the high-frequency current transients alone did to Bkr 3.

Fig. 15. Bkr 2 damage caused by lightning.

The breaker manufacturer was involved in the breaker failure analysis and recommended neither breaker be returned to service. Bkr 3 only experienced lightning flashover with no 60 Hz current reinforcing the breakdown to cause further damage to the breaker. Bkr 2 suffered lightning strikes as well as the internal fault for five cycles.

Prior to the event, the utility's standard practice was to not install lightning arresters on transmission lines due to the historically low total lightning density in their service territory. Based on this event, and the increasing lightning risk to the utility's 230 kV transmission system, a program was developed to install lightning arresters on breakers and to install shield wires on transmission lines.
