# Lessons Learned Through Commissioning, Livening, and Operating Switchgear: Part 3

Presented at the  
2024 PCIC Middle East Conference,  
Al Khobar, Saudi Arabia  
November 12–13, 2024

Copyright Material PCIC Middle East  
Paper No. PCIC ME24\_04

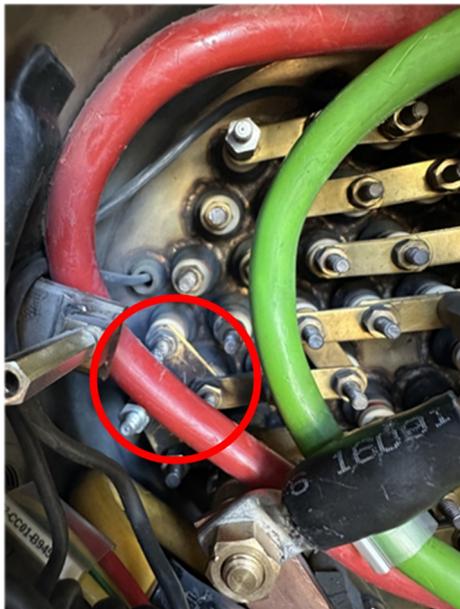
Fig. 3 Fault location at heater terminal box element.

The phase-to-phase fault occurred between the link connecting elements R1 and R13, which was supplied from Phase A, and the second rod conductor of Element R13, which was supplied from Phase B, as shown in Fig. 2. The clearance at this point was approximately 2 mm.

A lesson learned from this event is that after the final connection of the cabling and links, pre-energization final IR tests shall be performed on the complete circuit with the star point disconnected to ensure that there are no phase-to-phase or phase-to-ground short circuits present.

In this particular event, the cabling and elements were tested individually while disconnected and confirmed to be acceptable. After connection and disturbing the cabling and links, the feeder was then energized without a final IR test being performed, which would have identified short circuits on Phases A and B.

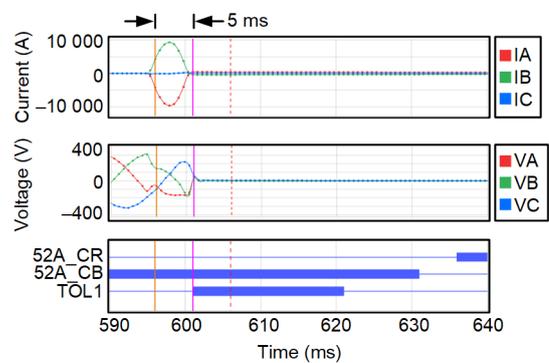
Fig. 4 shows the event recorded by the feeder protective relay during this arc-flash fault. It shows the incident started with a Phase-A-to-Phase-B short-circuit fault when the contactor was energized (52A\_CR) and closed on to the fault. It shows the through-fault current that the feeder MCCB interrupted peaked at 9.6 kA on Phase A and 9.3 kA on Phase B, and the fault was cleared in less than half a cycle, 5 ms.

Fig. 4 Event record from feeder protective relay.

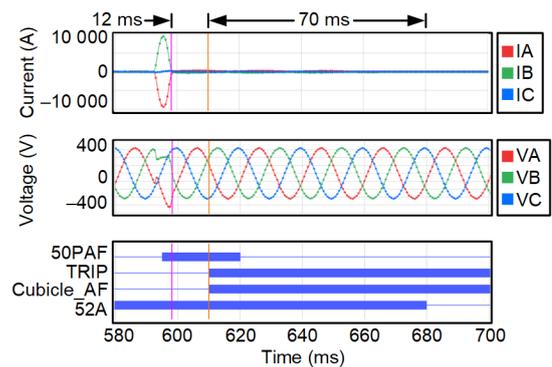
Fig. 5 shows the event recorded by the incomer protective relay during this arc-flash incident. The through-fault current that the low-voltage air circuit breaker (ACB) experienced at peak reached 9.4 kA on Phases A and B.

Fig. 5 Event record from incomer protective relay.

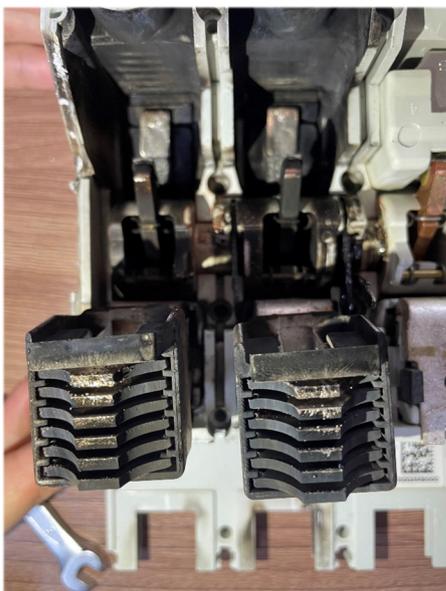
During the event, the MCCB could not successfully interrupt the fault current and was severely damaged, as shown in Fig. 7 and Fig. 8. The MCCB, according to the manufacturer's specifications, has a rated capacity of 70 kA. However, it suffered irreparable damage clearing the short-circuit fault.

Fig. 7 Failed MCCB.

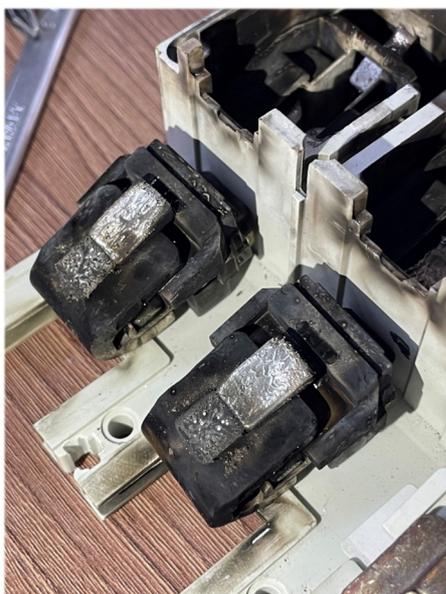
Fig. 8 Failed MCCB contact tips.

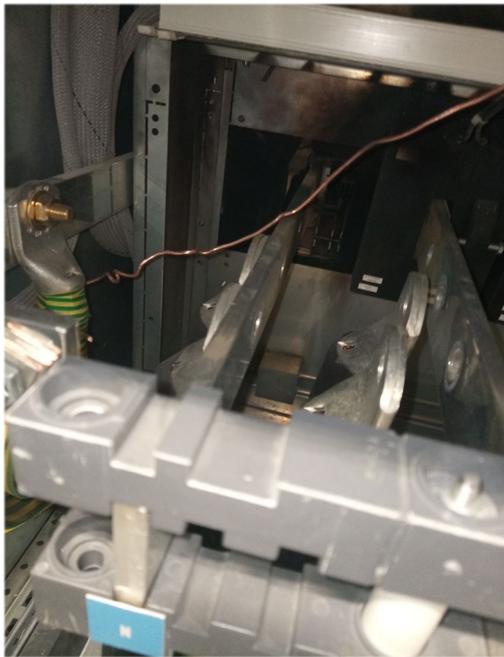
During the preparation for the IR test, a worker was installing a bare copper wire to verify continuity. The wire was connected to the grounding cable plug, as shown in Fig. 10. During this process, the opposite end of the wire inadvertently passed through a small aperture in the separation plate between the cable and bus compartments, contacting one phase of the live busbars, initiating an arc-flash fault. The arc rapidly propagated to adjacent phases. According to the event record captured by the incomer relay, the arc was extinguished within 50 ms by the incomer relay AFD system per design. There were no injuries to the technician involved but some minor damage to the equipment, involving replacement of a burnt arc-flash fiber loop.

Fig. 10 Fault path created by copper wire for IR test.

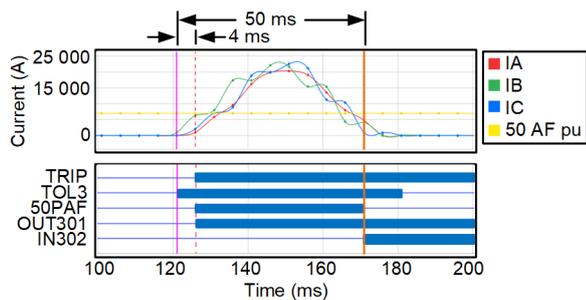
Fig. 12 shows the event recorded by the incomer relay during this arc-flash episode. It shows that the incident started with a Phase-B-to-ground fault, when the technician accidentally made contact with the energized bus bar using the ground cable. The fault rapidly propagated to Phases A and C, creating the three-phase-to-ground fault. As shown in Fig. 12, the relay detected the arc flash (TOL3 refers to time-over-light pickup on the relay) and took 4 ms to declare the arc-flash event and issue the TRIP command to clear the fault (OUT301 refers to the high-speed output contact wired from the incomer relay to the incomer breaker). And it took a total of 50 ms to completely isolate the fault by opening the incomer breaker (IN302 refers to the incomer breaker open status). This high-speed clearance of the arc-flash fault by the protective relay saved a life and limited the equipment damage to the very minimal. We can highlight two very important aspects from this incident: first, human error was the cause of the arc-flash incident and second, arc-flash protection schemes are vitally important for personal safety, equipment protection, system reliability, and economical operation.

Fig. 12 Incomer relay fault currents, AFD, trip command timing, and total fault clearing time.

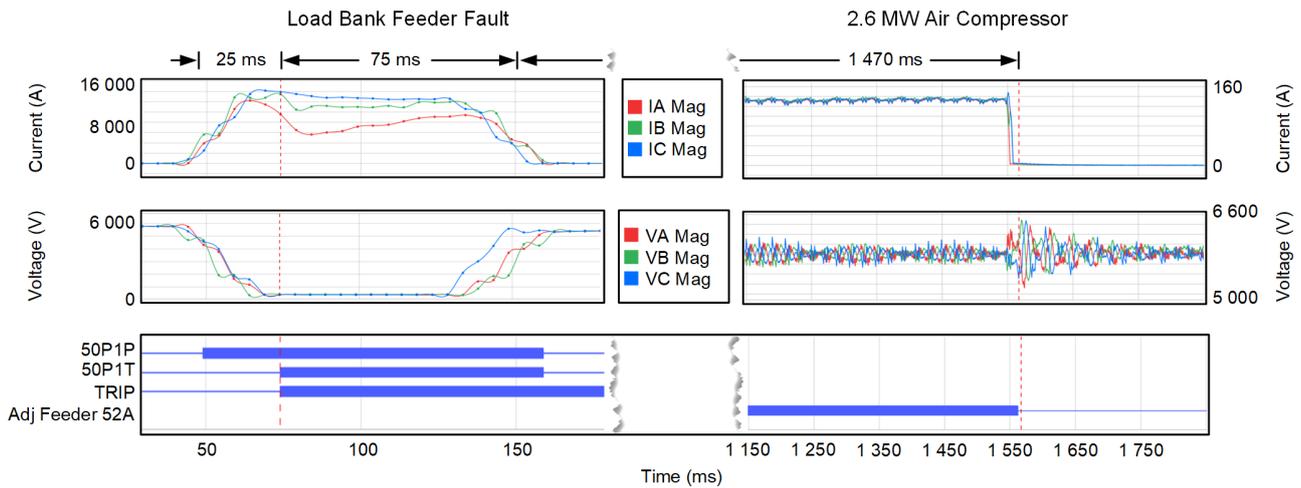
IEDs on the load bank feeder recorded an event showing a three-phase fault, albeit the operator never reported it. Further investigation of the Sequential Events Recorder (SER) of the protective relay confirmed that the operator closed the earthing switch (ES) on the load bank side (refer to Fig. 13) while the feeder breaker was closed. Closing the ES created a three-phase-to-ground fault (around 14 kA) and the feeder was tripped immediately on instantaneous (50P) protection. As per Fig. 14, the fault current was cleared within 100 ms. The feeder relay is wired with bus voltage, and it is evident from the event record that the bus

Fig. 14 Impact on the voltage and current during short circuit and the timeline of the events at load bank feeder and compressor feeder.

voltage was impacted significantly as it fell below 1 kV (line to ground) during the fault from its nominal 5.7 kV. Although the voltage was below 1 kV for approximately 55 ms, the bus voltage recovered within 125 ms. The motor feeders are set to trip for undervoltage events (less than 80 percent) with a 200 ms time delay to protect the motor feeder. However, in this instance, the voltage recovered well before the delayed time. This significant voltage dip was not expected. However, further investigation confirmed that the power system was in a weak state due to the ongoing routine maintenance taking place on the brownfield GTGs.

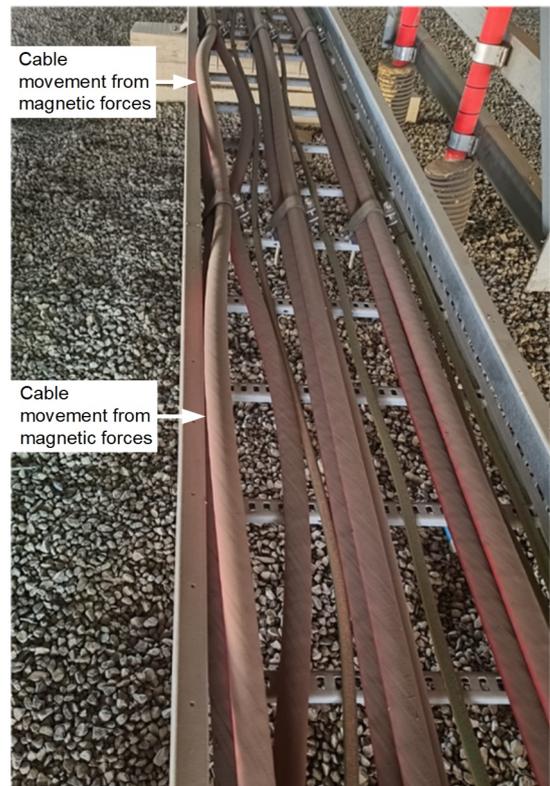
Fig. 15 shows the physical movement of the cables caused by the magnetic forces generated due to the three-phase fault. Engineers tested the feeder breaker, cables, and apparatus at the load bank to confirm their integrity and that no damage occurred due to the event. These high magnetic forces that displaced and deformed these cables serve as a good reminder to construction

crews of the importance of taking the time to install proper cable cleats and avoiding faster installation approaches, like the use of cable ties. As part of the root cause analysis, the operators were trained. The trainings emphasized good communication, highlighted the key items to be discussed at safety toolbox talks, and stressed the importance of following procedures to avoid complacency. In conclusion, even in temporary electrical arrangements, it is important to include bidirectional interlocks between the source and the feeder, in addition to following procedures meant to create and maintain a safe working environment [8].

Fig. 15 300 mm<sup>2</sup> temporary feeder cables affected by short circuit.

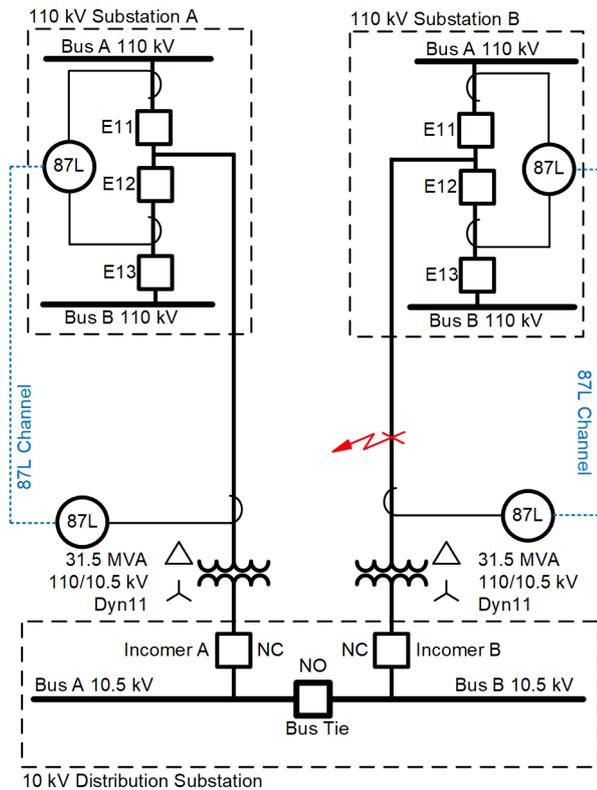
A Phase-C-to-ground fault occurred on a 110 kV transmission line energizing a 110 kV to 10.5 kV step-down transformer. In turn, the low-voltage side of the transformer energizes the 10.5 kV Incomer B into an MDB. Fig. 16 shows a simplified single-line diagram. The root cause analysis on this event provided interesting insight from two perspectives. First, the event highlights the operating difference in primary and backup relay performance in the 10.5 kV distribution substation in lieu of enabled disturbance detection logic. Second, the 10.5 kV switchboard's ATS did not operate. The logic of the ATS can be improved to include operation for an external line fault.

Fig. 16 Internal fault single-line diagram.

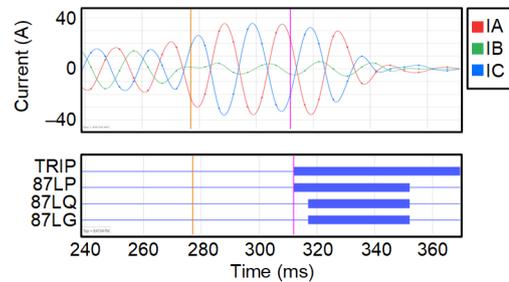
The 10.5 kV distribution substation terminal primary and backup relays are shown in Fig. 18 and Fig. 19, respectively. The fault current magnitude is several orders of magnitude less than that of the 110 kV side and appears phase-to-phase because of the delta-wye transformer due to the weak infeed contribution from the 10.5 kV substation.

Fig. 18 10.5 kV substation primary 87L relay.

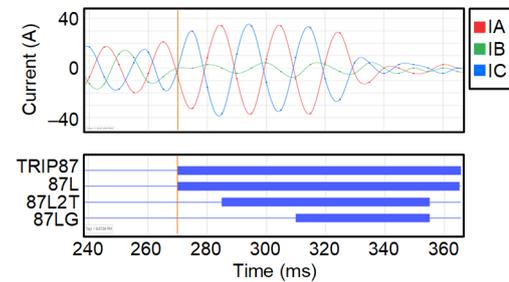
Fig. 19 10 kV substation backup 87L relay.

Both the primary and backup relays contain a disturbance detector designed to qualify 87L communications channel events from actual power system faults. The backup relay has the disturbance detection logic disabled. As shown in Fig. 18, the trip was delayed in the primary relay by 40 ms. Fig. 19 shows that the backup relay did not delay the trip.

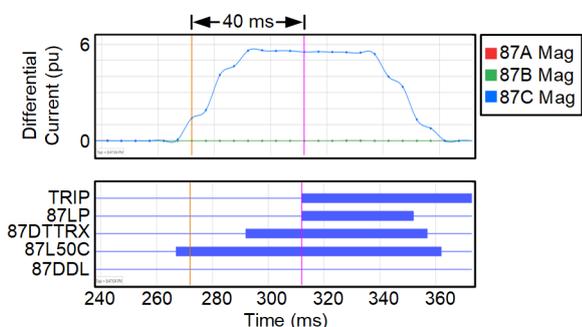
Fig. 21 highlights the primary relay's performance of the disturbance detection logic. The differential phase currents are shown where Phase C is elevated for the line-to-ground fault. Two cycles later (40 ms) as the differential current went above the pickup, the relay issued a trip. 87L50C is supervising the overcurrent element of the Phase C differential element while 87DTTRX is the 87 direct transfer trip received status from the remote end relay.

Fig. 21 10.5 kV substation primary differential relay operation.

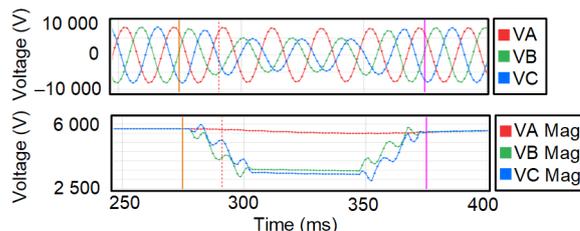
Fig. 24 is taken from the Bus A power quality meter set to capture an event report anytime bus voltage falls below 0.9 pu. For this power quality meter, voltage measurements are on the 10.5 kV side of the transformer in which a transformer primary side Phase-C-to-ground line fault results in a depressed B- and C-phase voltage on the bus.

Fig. 24 Bus A voltage.
