Fault Contributions From Inverter-Based Resources: Field Insights and Protection Challenges

Mukesh Nagpal
Burns & McDonnell

Ajmal Saeed, Ricardo Rangel, and Daniel Zhang
Pacific Gas & Electric Company

Presented at the
52nd Annual Western Protective Relay Conference
Spokane, Washington
October 28–30, 2025

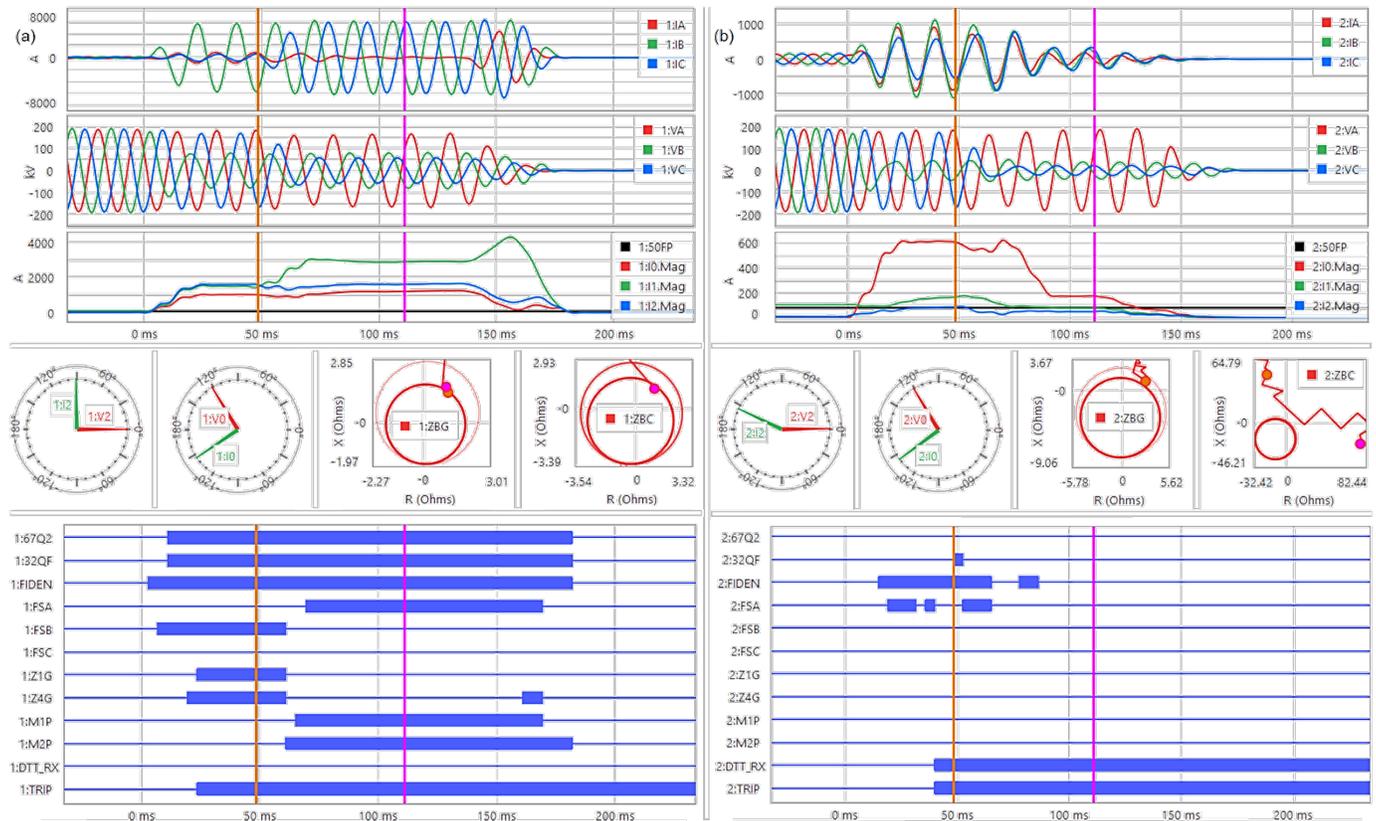
Fig. 10. Evolving BG to BCG fault records from line relays at the a) grid terminal and b) Type III wind generation terminal

At the wind generation terminal, the phase distance element did not operate at all, even though the measured impedance entered the ground mho characteristic. This is because the supervising directional element failed to assert. In addition, the relay misidentified the fault as a Phase-A-to-ground fault (FSA asserted) instead of a Phase-B-to-ground fault (FSB did not assert). The terminal eventually tripped after receiving the DTT from the grid terminal.

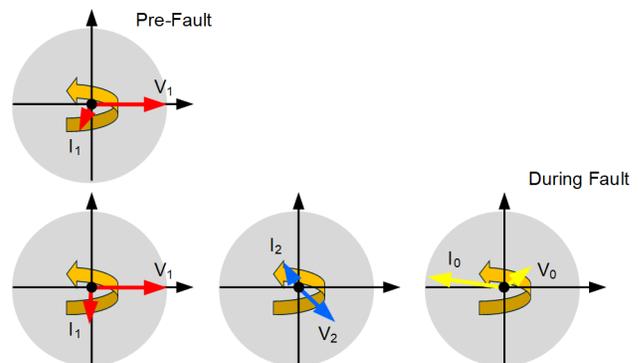
Before the fault, I_1 lagged the positive-sequence voltage (V_1) by approximately 98 degrees, indicating that the wind generation facilities were supplying predominantly reactive power, while local loads consumed active power. The grid supplemented the active power demand. During the Phase-B-to-ground fault, I_1 magnitude increased from approximately 100 A to 170 A, and its phase angle shifted slightly to about 93 degrees, mimicking a synchronous machine's angular response under fault conditions. However, the I_1 magnitude was significantly lower than that anticipated from a synchronous generation facility with a similar rating.

The phasor diagram also illustrates the I_0 behavior; its magnitude increased significantly, and it led V_0 by approximately 90 degrees. This response was like the one observed by the grid relay. The consistency in zero-sequence behavior stems from the wye-grounded-delta (YNd) transformer configuration commonly used to connect IBRs to the transmission system (with the wye-grounded winding connected to the high-voltage transmission network). This winding configuration presents an effective zero-sequence path during ground faults, independent of the type of generation connected downstream of the transformer.

Fig. 11. Phasor diagrams based on data captured by the line protection system at the wind generation terminal during the BG fault

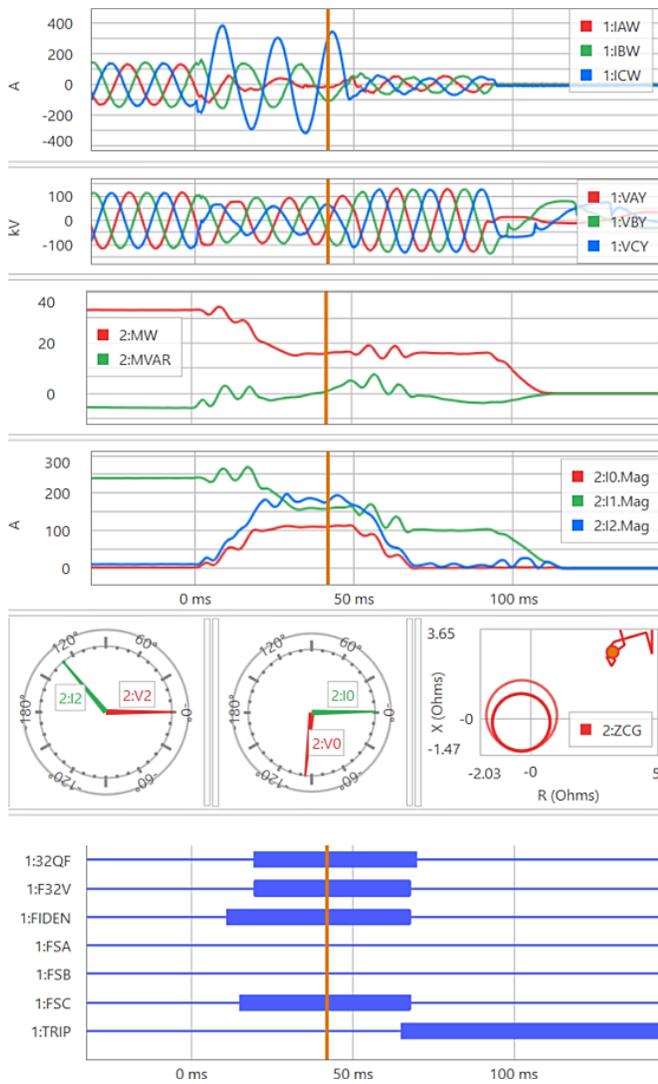
During the fault, I_1 decreased from 240 A to 158 A, which was exactly the opposite of the anticipated increase in I_1 from synchronous generation. The I_2 increased from near zero to about 180 A—greater than I_1 , which is not typical. Note that the phase angle of I_2 led V_2 by approximately 130 degrees, once again significantly greater than the 90 degrees anticipated from synchronous generation.

Fig. 13. Line relay recordings from a Type III wind generation facility for an external CG fault

Fig. 13 further illustrates the behavior of the ground mho element under these conditions. The mho characteristic exhibited a dynamic expansion in the reverse direction, based on V_{1MEM} polarization, a response similar to what we anticipate from synchronous generators. This observation suggests that the ground distance element would have operated correctly if the fault was within the protection zone.

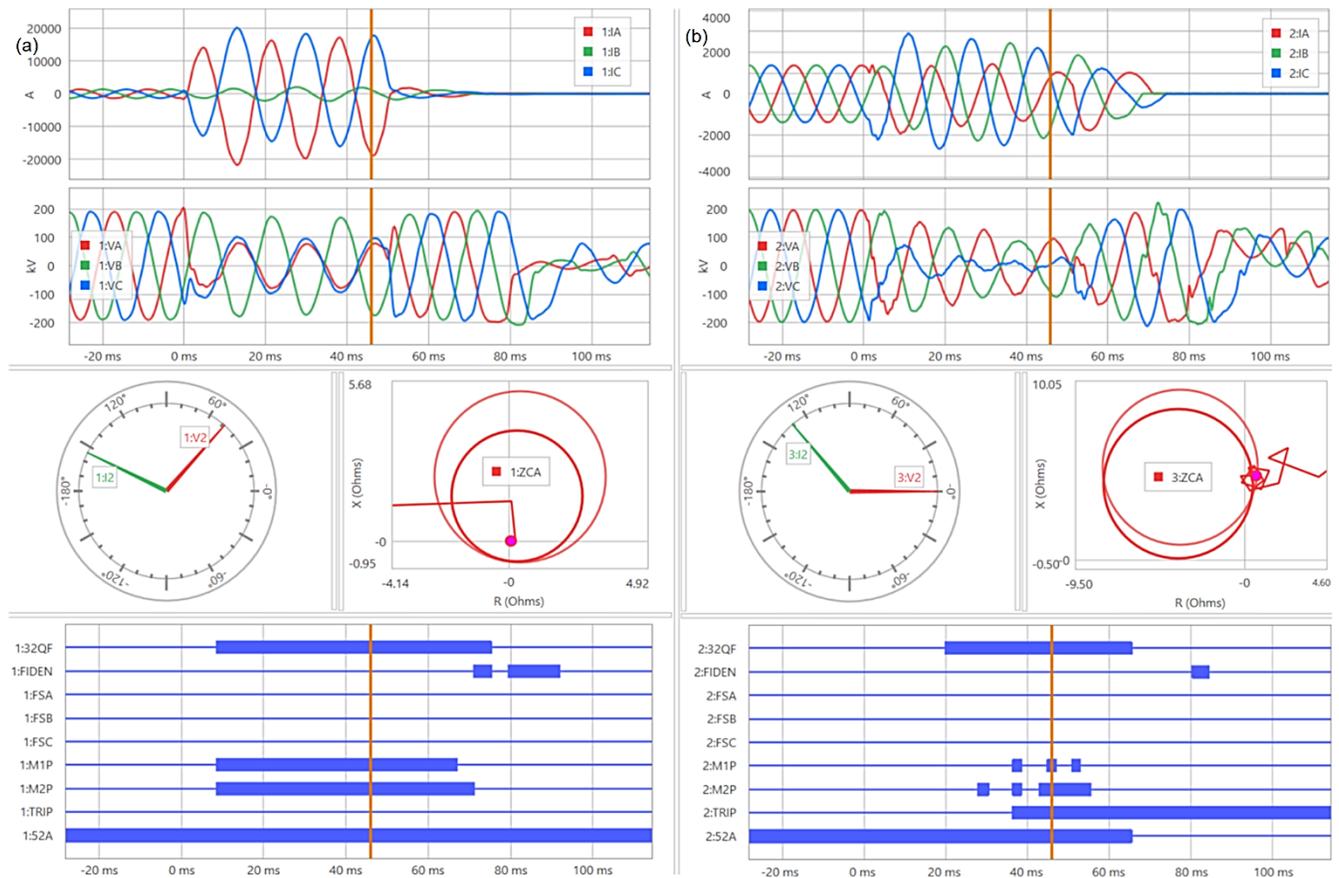
Referring to the fault loop apparent impedance (Z_{CA}), we notice significant oscillations. Additionally, the large angular difference between V_{1MEM} and V_1 caused an expansion and shift of the mho characteristics toward the second quadrant. These two behaviors caused M1P to overreach transiently. In contrast, the grid relay calculated a stable Z_{CA} . Its mho expansion was toward the third quadrant, as is typical in an inductive system with synchronous generators.

We conclude that the control response of IBRs during phase faults (without ground involvement) can cause phase distance elements to exhibit significant transient overreach. The fault voltages may also exhibit unusual behavior—the unfaulted phase (and loop) voltages may be lower than the faulted phase (and loop) voltage.

Fig. 15. Phase-C-to-A fault records from line relays: a) grid relay and b) IBR relay

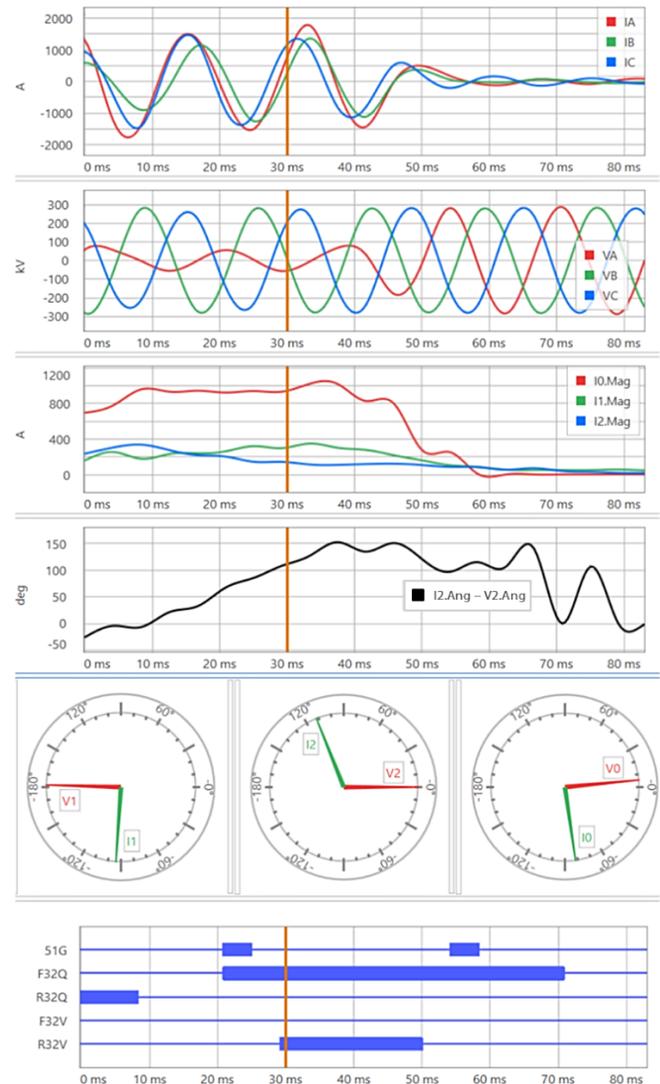
The root cause of this angular variation lies in the grid-following behavior of the inverter. While the system voltage—and therefore the V_2 phasor—remained relatively stable due to the grid's strong inertia, the inverter's output current did not maintain a stable frequency. Because the inverter lacked significant inertia, it exhibited transient oscillations under fault conditions, causing the I_2 phasor to drift relative to the voltage phasor, leading to directional misinterpretation.

Further examination of the phasor diagram shows that I_2 led V_2 by 110 degrees, incorrectly suggesting a forward fault. I_0 lagged V_0 by 90 degrees, correctly indicating a reverse fault because of the zero-sequence path presented by the YNynd transformer.

Fig. 17. Relay records from the station line protective relay for the reverse Phase-A-to-ground fault

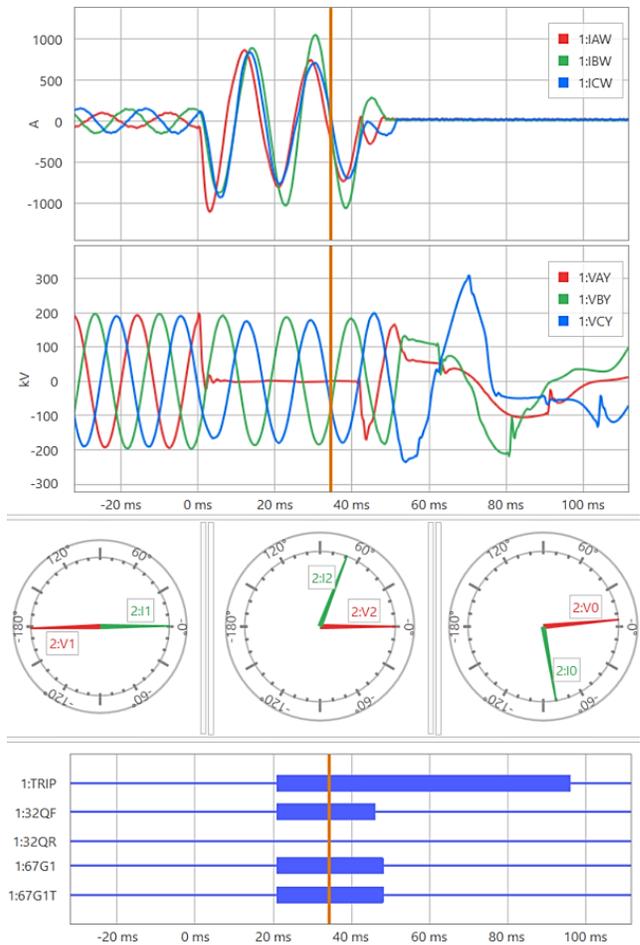
Fig. 19. The fault record captured by one of the station relays misoperating on the reverse fault

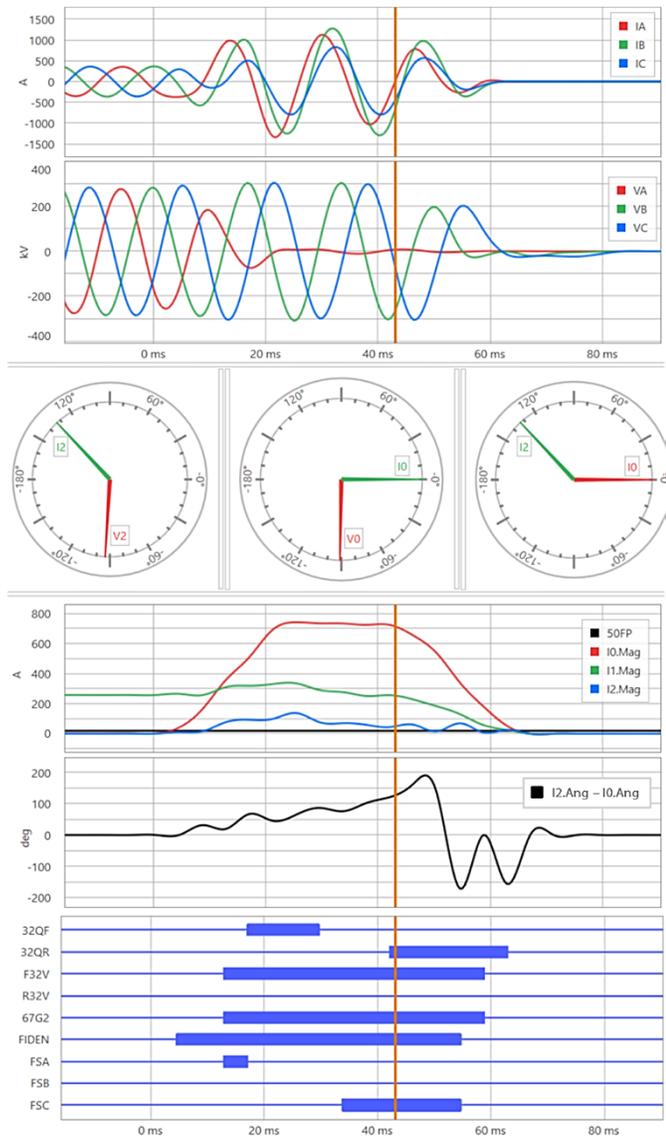
A phase-to-ground fault occurred on the transmission line connecting the wind facility to the grid. Fig. 21 shows the bus voltages and fault current recorded by the transmission line protective relay facing toward the fault. The complete collapse of Phase A voltage unambiguously indicates a Phase-A-to-ground fault.

Fig. 21. Type IV wind generator response during a Phase-A-to-ground fault

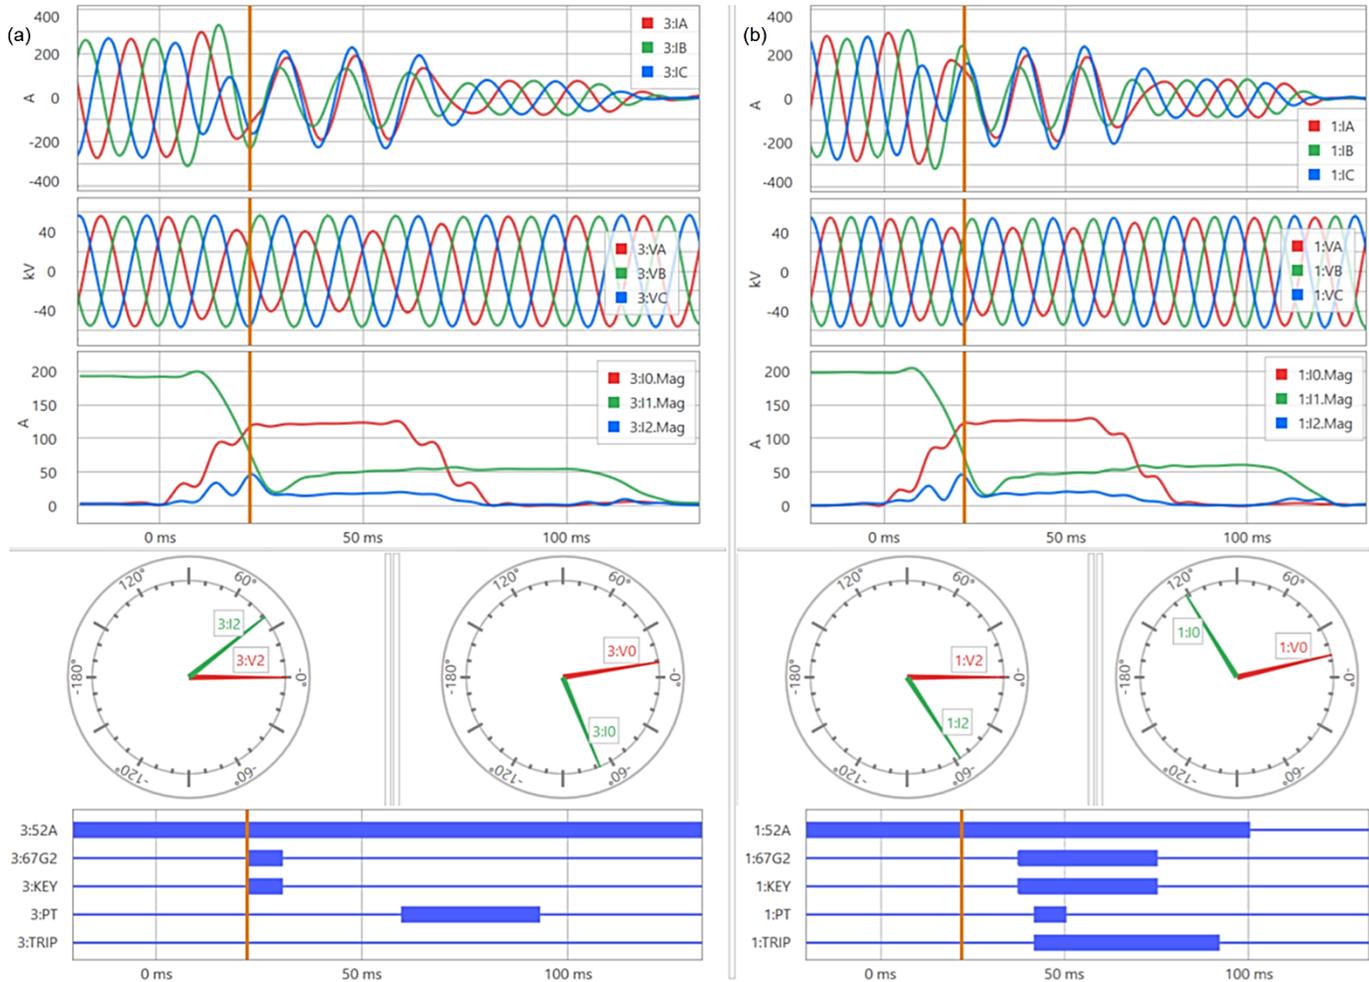
Both relays see the same current (ignoring polarity) and similar voltages (very short line). Because I_2 keeps rotating with respect to V_2 , the fault initially appears to be toward the IBR. The grid relay declares a forward fault incorrectly and sends a permissive signal to the IBR relay. I_2 continues to rotate with respect to V_2 and by the time the permissive signal arrives at the IBR relay, the fault appears to be toward the grid (correctly). The changing nature of the I_2 contribution from the IBR, in conjunction with the channel delay, caused the misoperation. Because external ground faults are quite common, this event illustrates one of the most common types of line relay misoperations near IBRs.

Another observation from this event is that the fault current contribution from the IBR is quite small. Removing I_0 from the phase currents, the IBR phase currents were about one-third of the pre-fault load current.

Fig. 23. Misoperation of a permissive scheme for an external ground fault as shown by a) the grid relay and b) the IBR relay

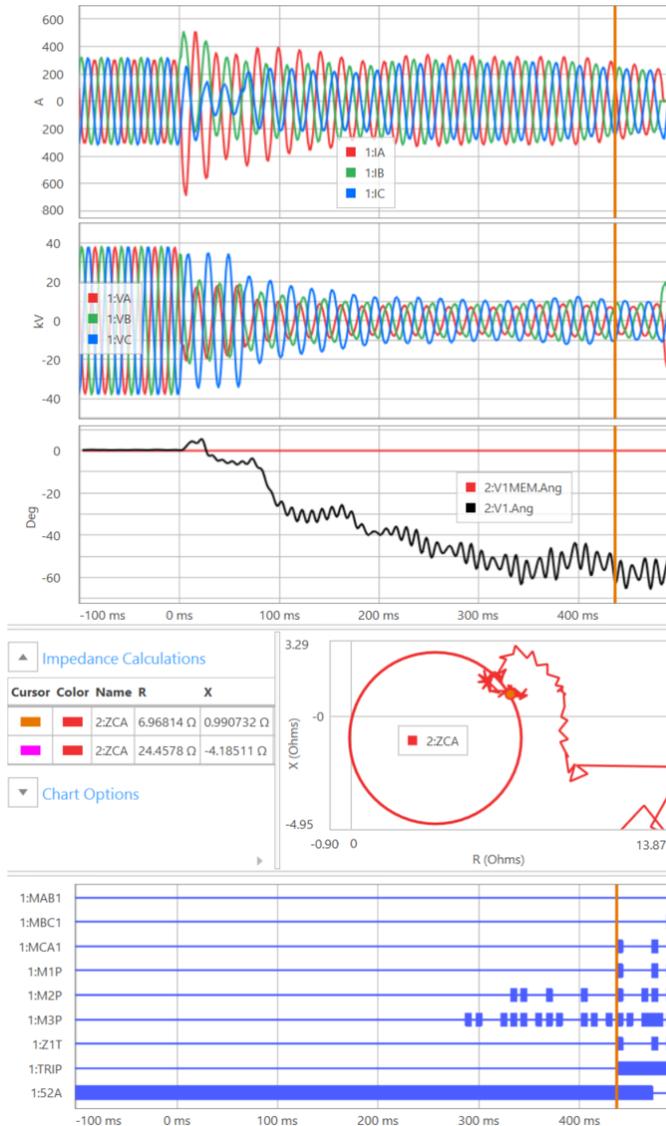
Fig. 25. Type III wind generation response for an external evolving phase fault

The fault was uncleared for a significant duration, which caused corruption of the positive-sequence memory voltage used by the distance relay. Initially, the phase angles of the real-time V_1 and memory V_1 (V_{1MEM}) were aligned. However, immediately after fault inception, the two began to diverge (V_1 slowed down), reaching a 60-degree phase angle difference at 436 ms when Zone 1 misoperated. This divergence significantly impacted the relay's operation:

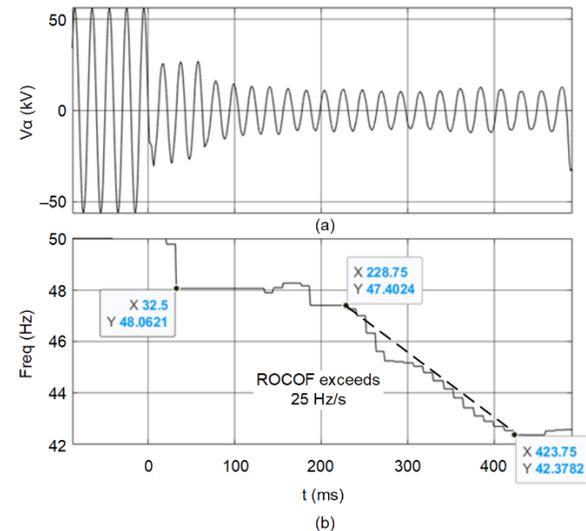
To investigate further, the waveform data were exported to MATLAB, and the frequency was calculated using zero-crossing analysis of the voltage waveform. The alpha voltage ($V_\alpha = V_A - 0.5 \cdot V_B - 0.5 \cdot V_C$) was used to remove any common-mode zero components in the voltages. The alpha voltage and its corresponding frequency are shown in Fig. 26. During the fault, the system frequency dropped from 50 Hz to below 42.5 Hz, a deviation greater than 7.5 Hz. The ROCOF exceeded 25 Hz/s during the marked interval. Notably, this occurred even though the WTG was online, although there was a three-phase fault between the WTG and the grid. This event demonstrates how IBRs can induce fast frequency decline, impairing memory-polarized distance relays.

Fig. 26. a) Alpha voltage and b) frequency calculated using its zero-crossings

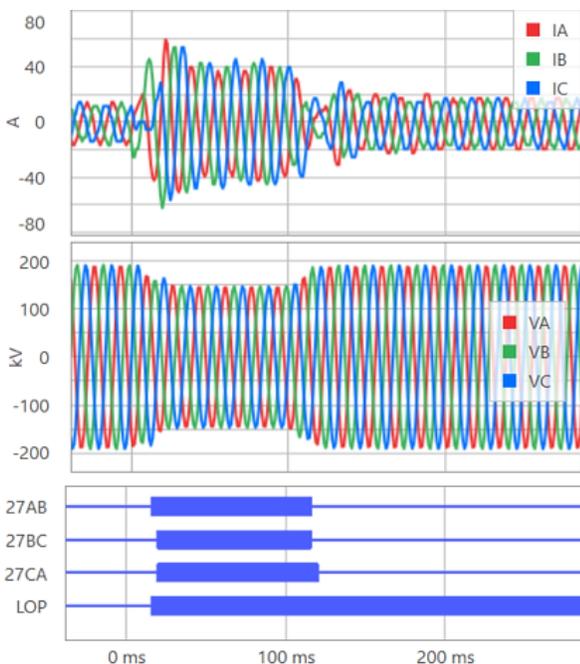
Even after the fault was cleared and voltages recovered above 85 percent of nominal, the LOP condition remained asserted for 500 ms. The LOP signal falsely stayed latched even though system conditions had returned to normal, undermining dependability of the voltage-dependent elements (e.g., distance, directional overcurrent, and undervoltage elements).

Fig. 28. Extended LOP assertion during an external three-phase fault due to low fault currents

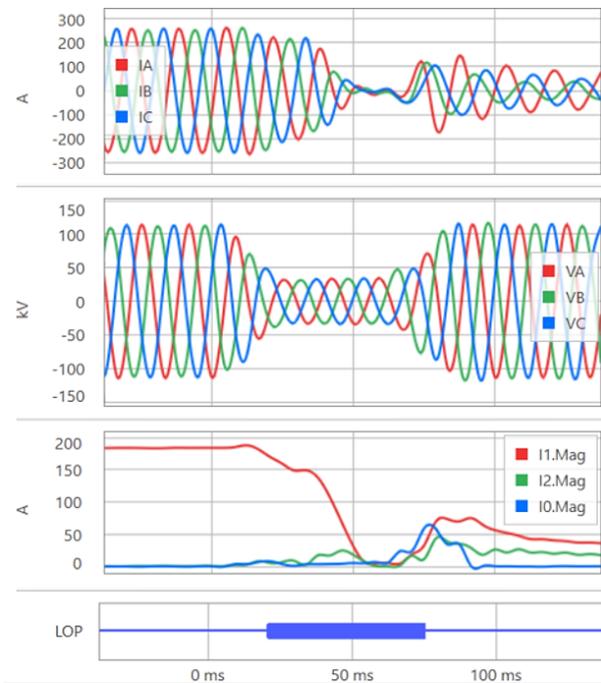
During the fault, the IBR maintained a nearly constant output current, despite a significant voltage depression at the terminals. This lack of appreciable current change, combined with the sharp voltage drop, caused the relay's LOP element to assert.

Before the fault was cleared, the IBR entered a momentary current cessation mode, suspending its output entirely. This behavior, where the inverter inhibits current output under abnormal voltage conditions, is discussed in detail in Section V. Once the fault was cleared and the system voltage recovered, the IBR also resumed its output. The resulting increase in voltage magnitude was sufficient to satisfy the LOP reset criteria, and the relay deasserted the LOP condition.

Fig. 29. LOP assertion during an external three-phase fault due to the IBR's controlled response

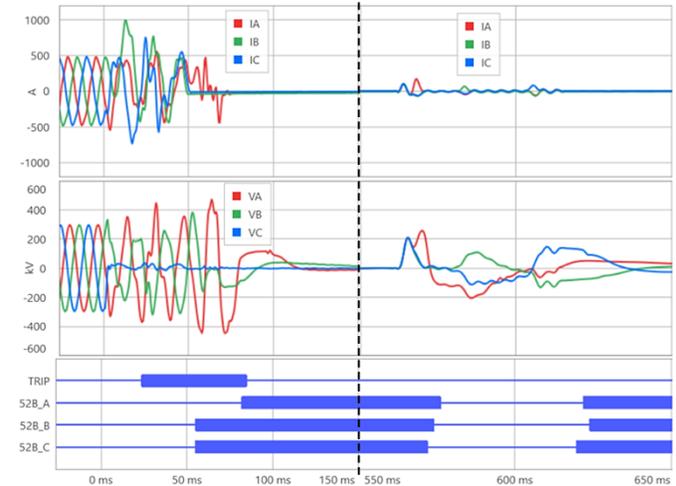
When the breaker closes on the de-energized line, transients in the currents and voltages can be seen, indicating that the WTG facility was still energized.

Fig. 31. Reclosing following a Phase-C-to-ground fault in July 2000

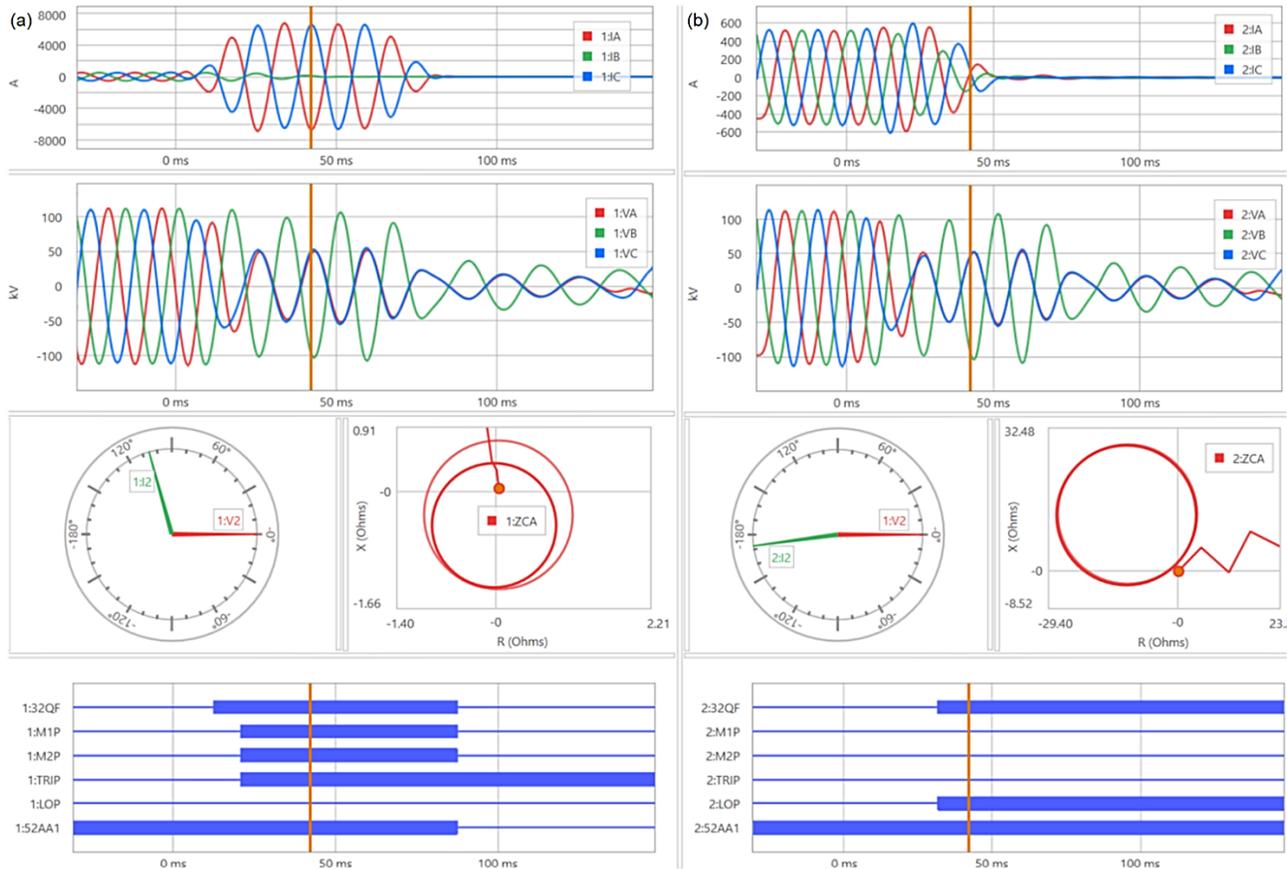
The protection element on the IBR side either failed or incorrectly asserted, compromising protection reliability due to extended cease mode operation:

Fig. 33. Line protective relay recordings from a) the grid b) the IBR

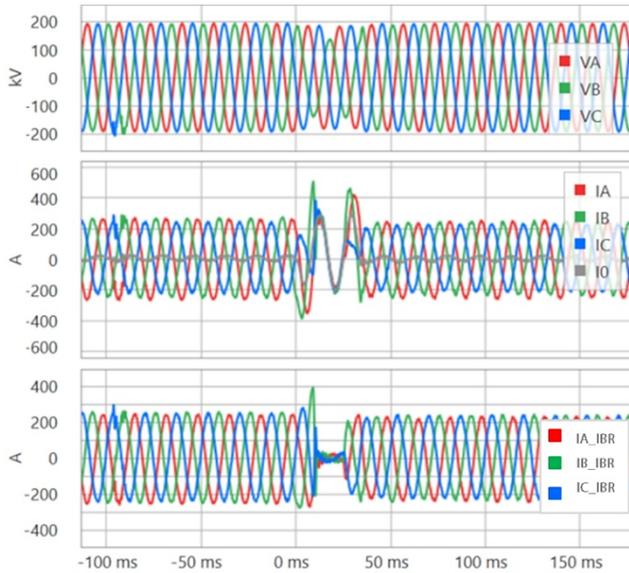
Fig. 37. Zero-sequence current from the transformer camouflaging the cease mode

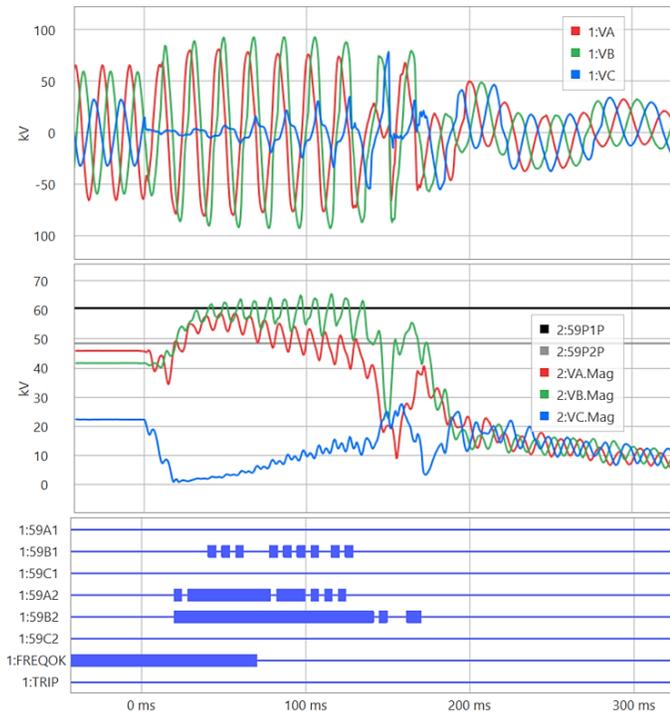
Fig. 42. Three-phase voltages at the 70 kV tapped bus during a Phase-C-to-ground fault with an ungrounded IBR connected but isolated from the grid

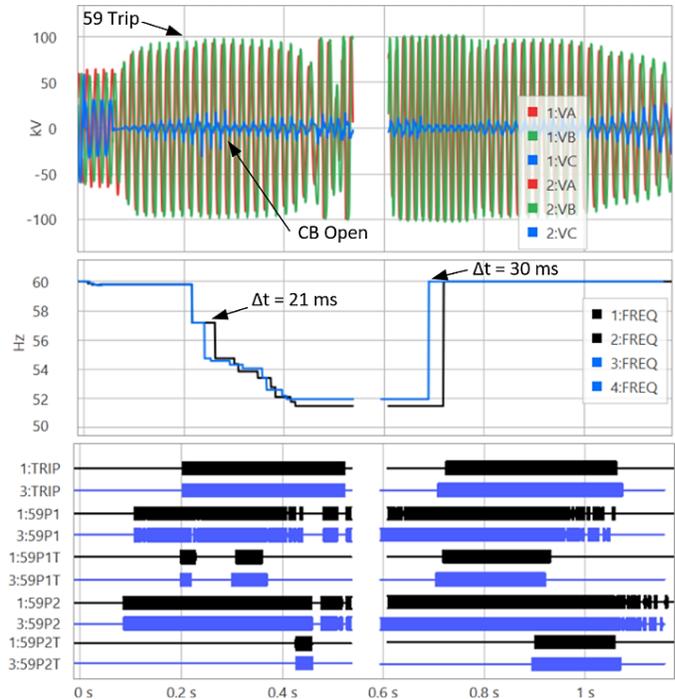
Fig. 46. Overvoltages recorded at Substation 2

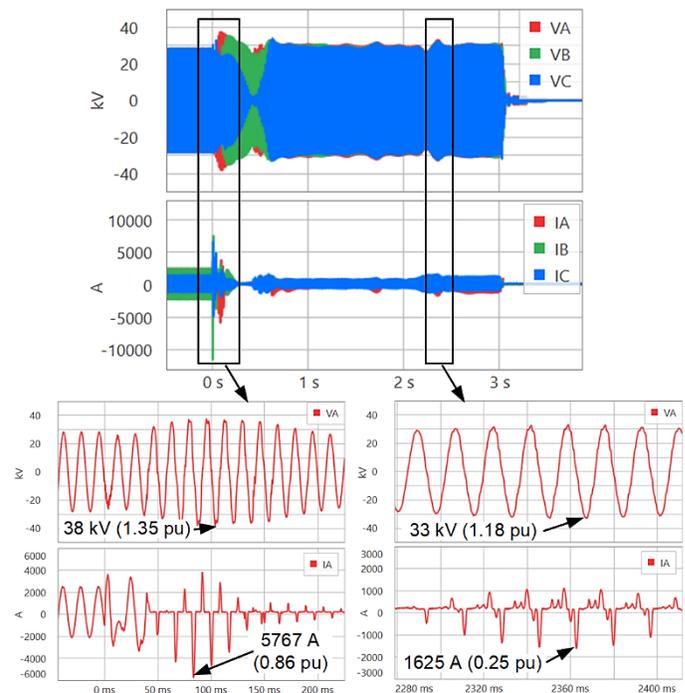
Fig. 48. Overexcitation oscillography following islanding.

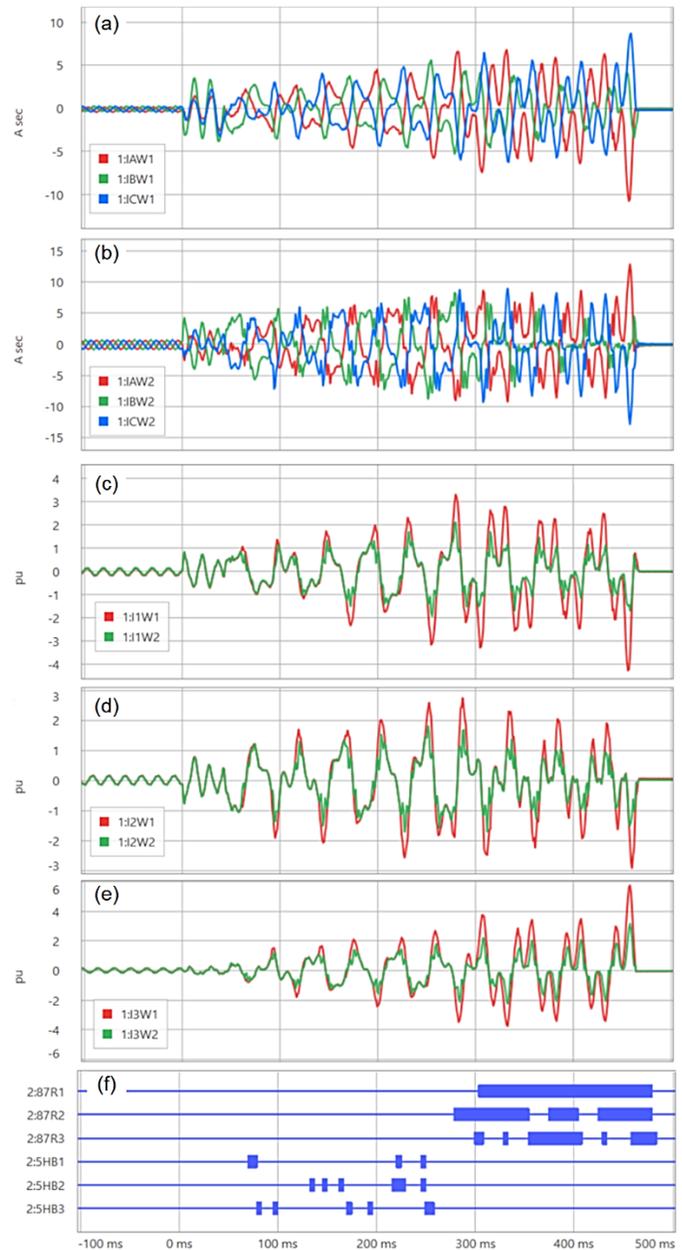
Fig. 50. Subharmonic overexcitation captured by a transformer differential relay: a) 354 kV Winding 1 phase currents, b) 34.5 kV Winding 2 phase currents, c) Compensated Current 1, d) Compensated Current 2, e) Compensated Current 3, and f) the transformer differential element response

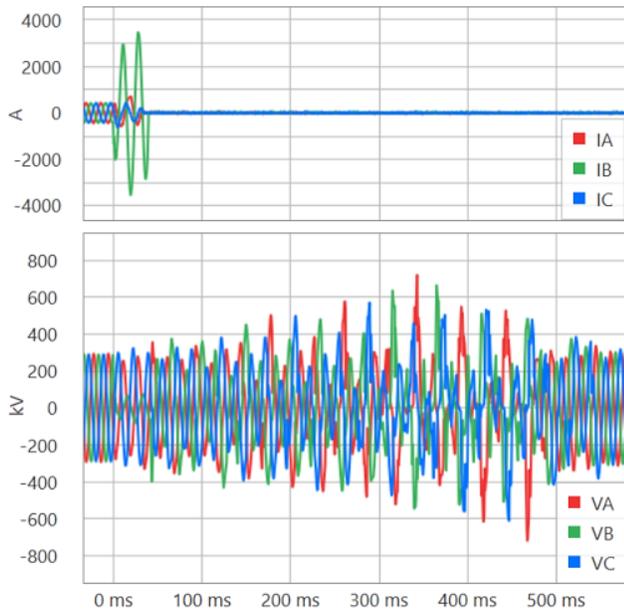
Fig. 51. Subharmonic 2.45 pu overvoltage on a 345 kV line due to SSO

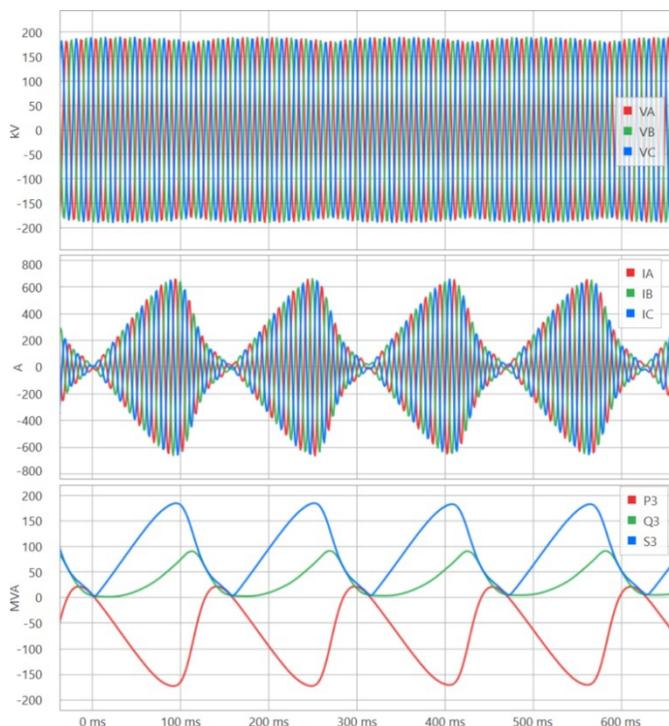
Fig. 52. Forced SSO introduced by the IBR controller in a new installation

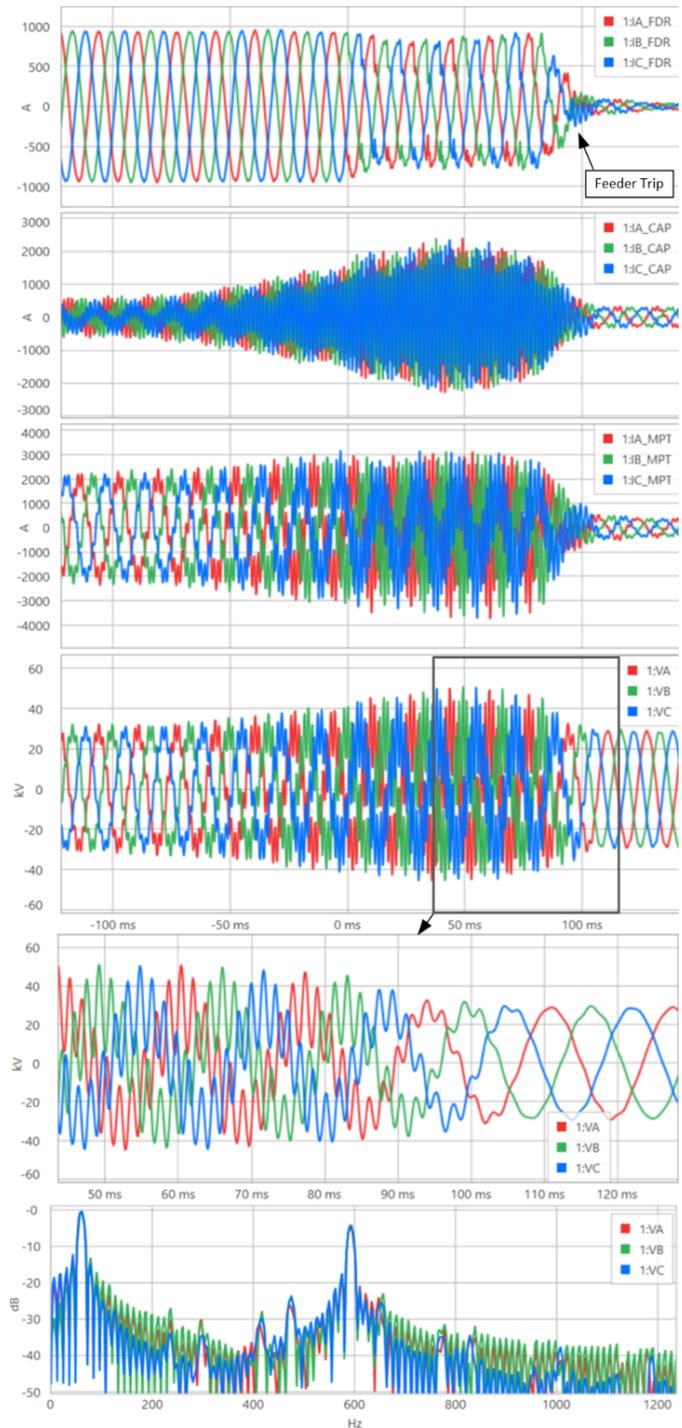
Fig. 54. Resonant harmonic overvoltage causes the inverter to trip

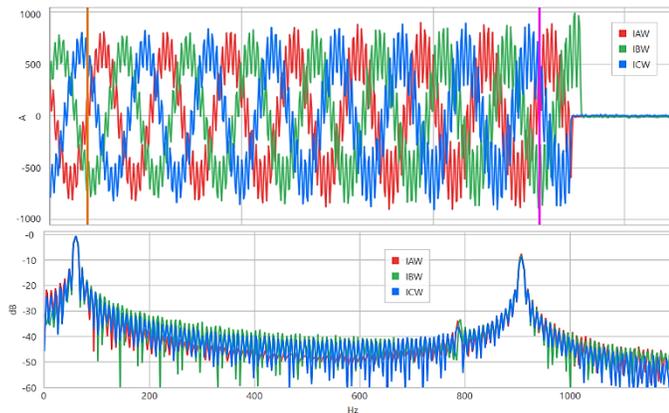
Fig. 55. Excessive current harmonics measured by a 138 kV line relay during normal operation

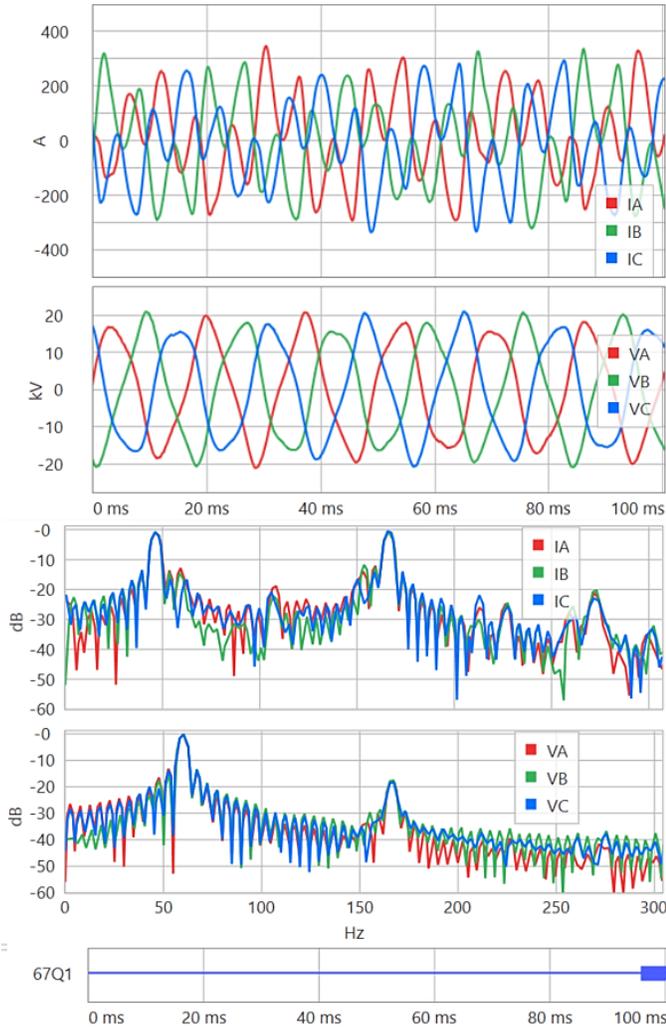
Fig. 57. Steady-state harmonic distortion recorded at the 21.6 kV bus of the BESS facility

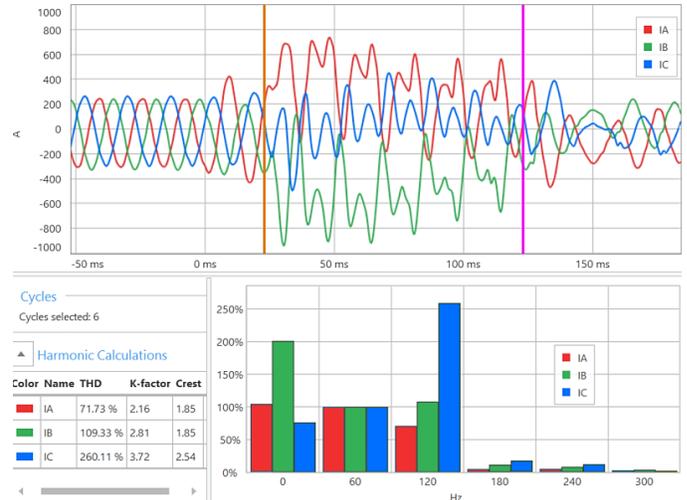
Fig. 58. Excessive dc and harmonics in fault currents for a remote Phase-A-to-B fault recorded on a 230 kV line

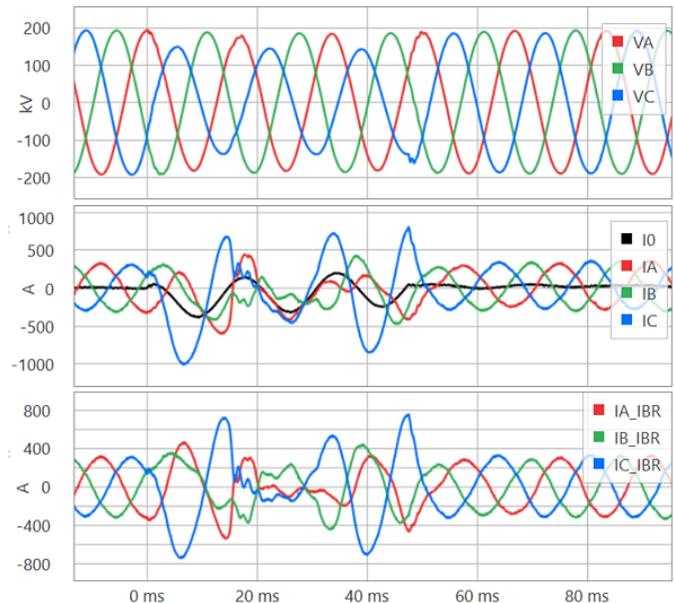
Fig. 62. Excessive harmonic content in currents from IBRs during a ground fault

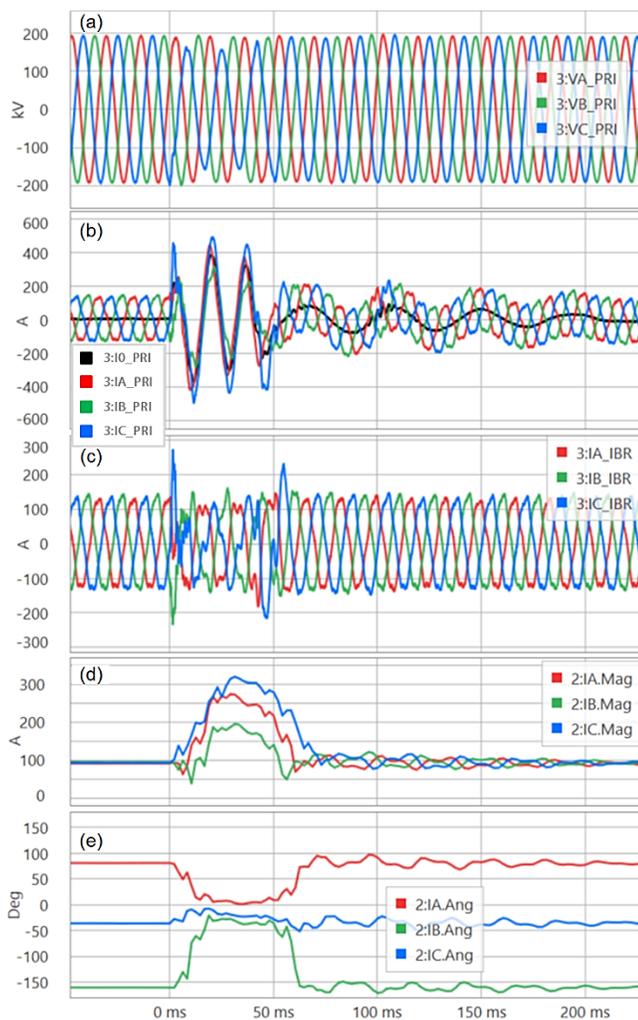
Fig. 63. Subsynchronous current oscillations after fault clearing

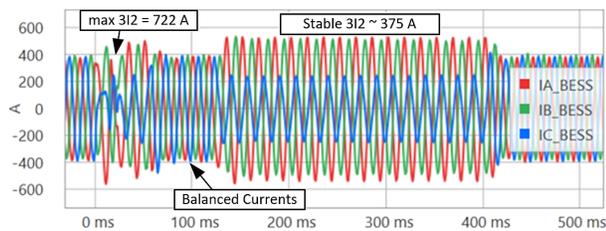
Fig. 66. 115 kV phase current after zero-sequence current removal showing significant IBR current changes without apparent cause

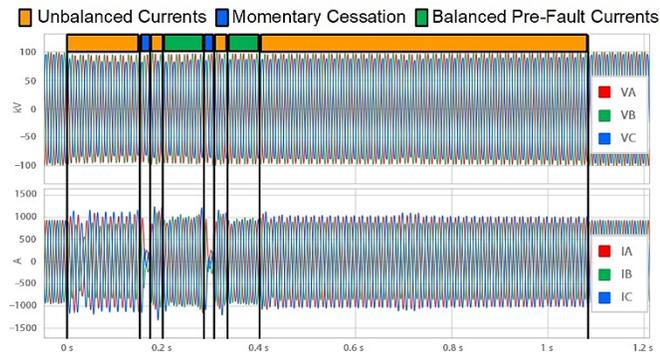
Fig. 68. Momentary cessation due to controller issue, providing inconsistent response during fault
