# Resolving Digital Line Current Differential Relay Security and Dependability Problems: A Case History

Debra Carroll and John Dorfner  
*Tacoma Power*

Tony Lee and Ken Fodero  
*Schweitzer Engineering Laboratories, Inc.*

Originally presented at the  
29th Annual Western Protective Relay Conference, October 2002

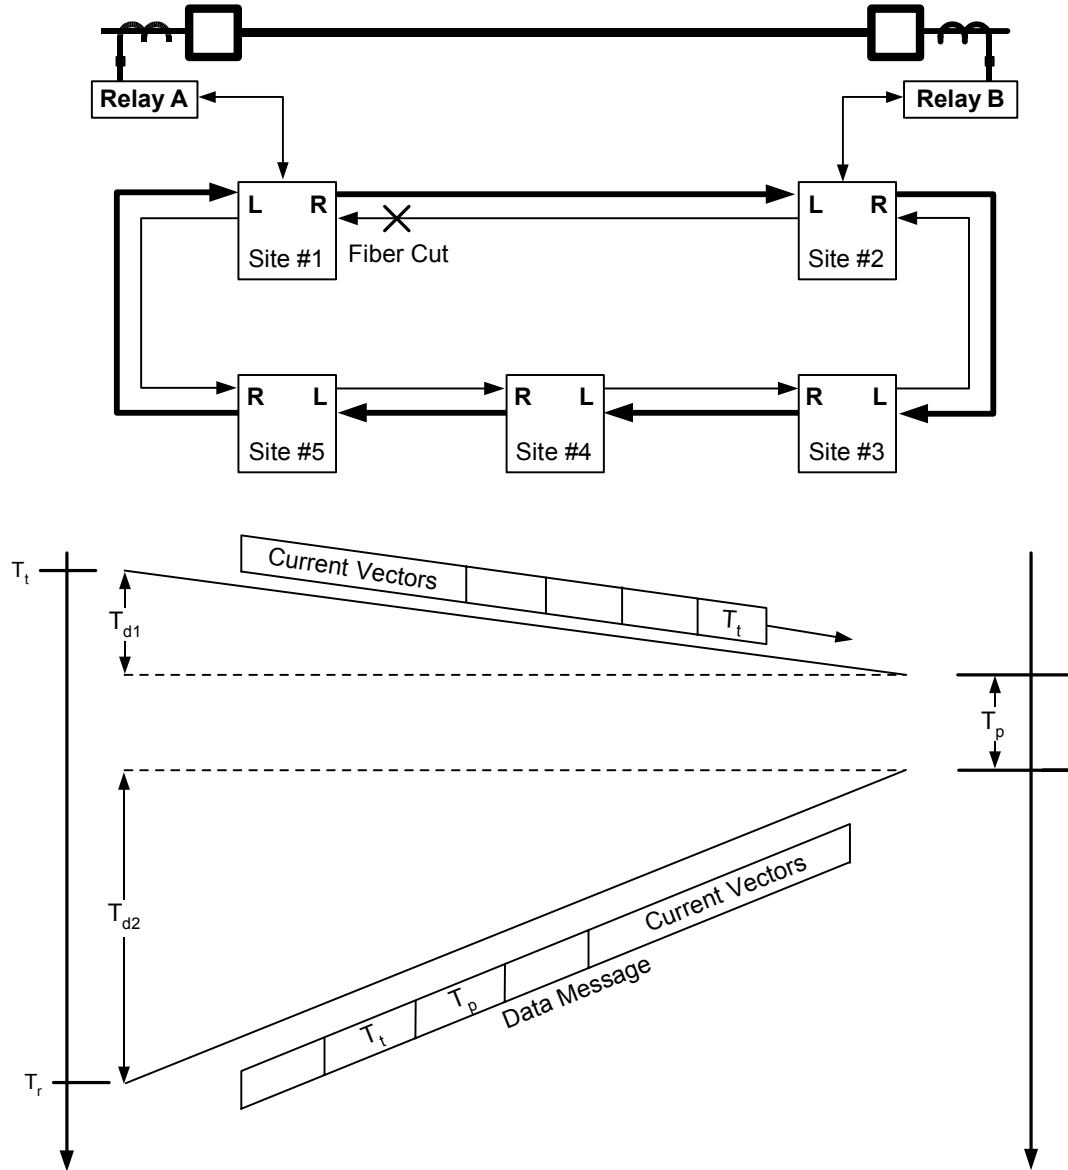
**Figure 3** Fiber Cut Forces Larger Delay from Relay B to Relay A

In Figure 3, the fiber carrying data from Site #2 to Site #1 is cut. The SONET node at Site #1 quickly detects the cut and reconfigures to route data received on the L port to Relay A. Data from Relay B to Relay A now flows the long way around the ring, passing through all five SONET nodes. Data from Relay A to Relay B still passes through only two SONET nodes. This causes the transmission delay from Relay A to Relay B to be shorter than the transmission delay from Relay B to Relay A, as shown in the bottom of Figure 3. Now  $T_{d2}$  is larger than  $T_{d1}$ , so  $T_{d1} \neq T_{d2} \neq T_d$  by Equation 3. The  $T_d$  calculated by each relay is not equal to either  $T_{d1}$  or  $T_{d2}$ . Each relay uses  $T_d$  to time align the received current samples with the local samples, but  $T_d$  is in error. Under steady state conditions (i.e., load current) the error causes an apparent phase shift between the local and remote currents in each relay. The phase shift operates on the load current to produce a false difference current, which can cause some current differential relays to misoperate.

To quantify the effect, assume the fiber cut causes the delay from Relay A to Relay B to increase from 1 ms to 4 ms. Substituting  $T_{d1} = 1$  ms and  $T_{d2} = 4$  ms into Equation 3 gives

$T_d$  is larger than  $T_{d1}$  by 1.5 ms, and smaller than  $T_{d2}$  by 1.5 ms. Relay A will process the local and remote currents assuming they are misaligned by 2.5 ms, when in fact they are misaligned by 4 ms. Likewise, Relay B will process the local and remote currents assuming they are misaligned by 2.5 ms, when in fact they are misaligned by 1 ms. Both relays will experience a 1.5 ms current misalignment, which will cause the following phase shift at 60 Hz:

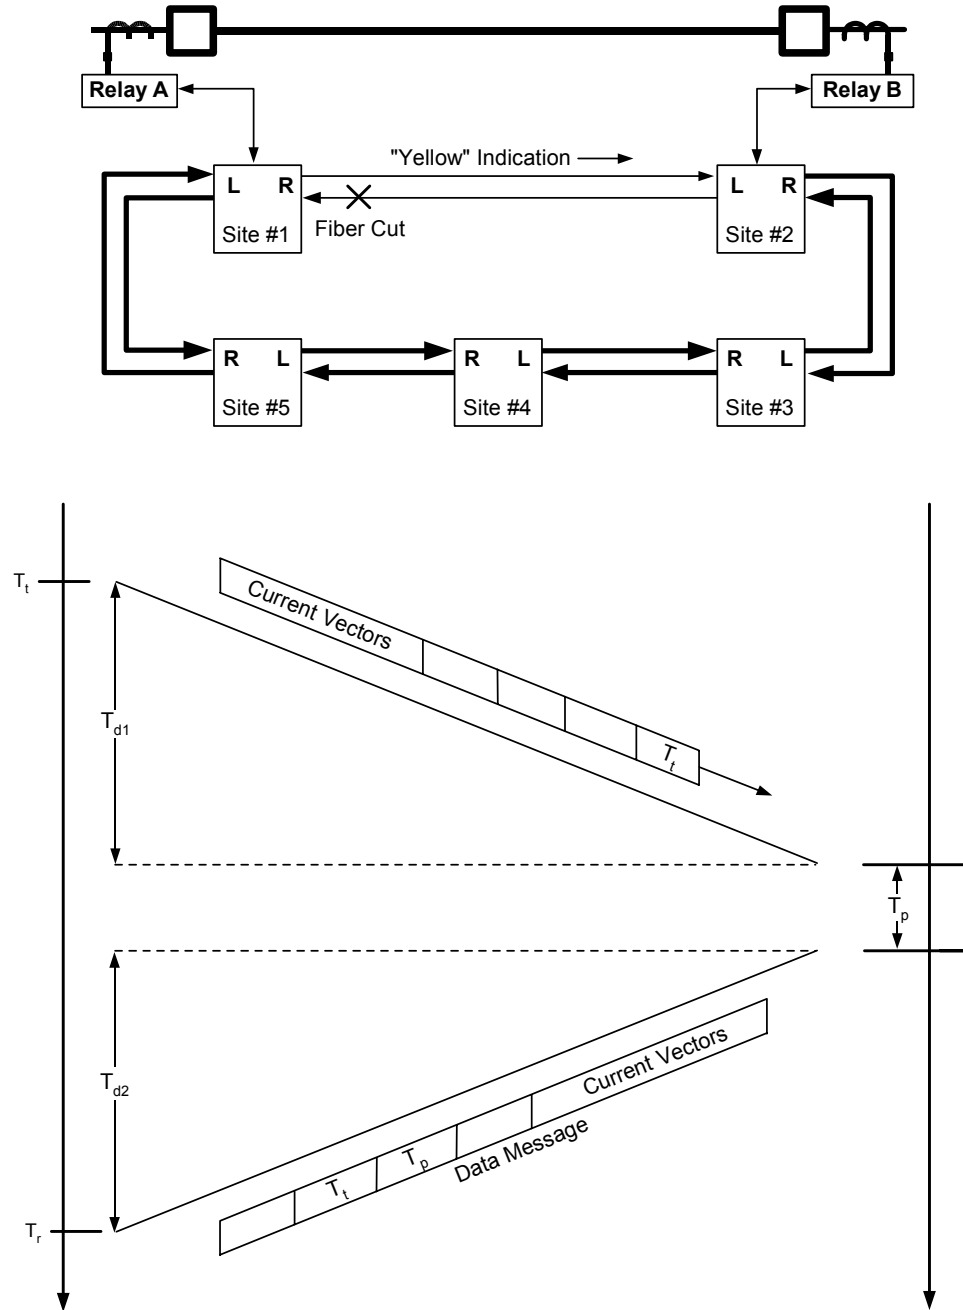
**Figure 4** Switch on Yellow Equalizes Transmit and Receive Delays After a Fiber Cut

In the spring of 2001, the communications links used by the current differential relays on the Tacoma Power SONET system were configured to “switch on yellow.” In the example system shown in Figure 4, the fiber cut is detected by the SONET node at Site #1, which causes it to send a “yellow” indication back to Site #2. If the SONET node at Site #2 is configured to switch on yellow, receipt of the yellow bit from the node at Site #1 causes the node at Site #2 to reconfigure so data received from the R connection are routed to Relay B. Notice that the data sent from Relay A to Relay B and from Relay B to Relay A now go through the same equipment. The delay from Relay A to Relay B is once again the same as the delay from Relay B to Relay A. This eliminates the apparent phase shift and difference current after the SONET system finishes reconfiguring.

Even when the SONET system is configured for “switch on yellow,” an apparent current phase shift and consequential difference current still exist temporarily during and immediately following a SONET system switch. When the SONET system is not configured to “switch on yellow,” the errors can exist permanently. According to the relay manufacturer, this temporary apparent difference current caused the misoperations experienced by Tacoma Power.

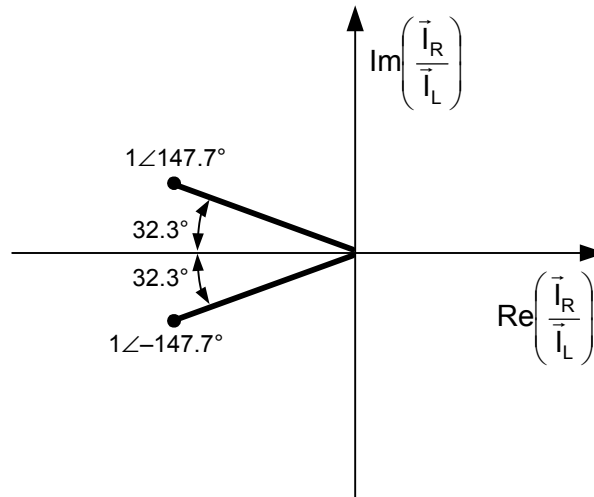
**Figure 8** Load Current Phase Shifted by 1.5 ms Current Alignment Error

As mentioned earlier, a difference between transmit and receive delays causes an apparent time shift and phase shift of the remote current. For example, a 3-ms difference between transmit and receive delays causes a 1.5 ms current misalignment, which introduces an apparent phase shift of  $32.3^\circ$ .

If the ratio normally plots at  $1\angle 180^\circ$ , this phase shift rotates the complex ratio around the origin on the alpha plane to  $1\angle \pm 147.7^\circ$ , as shown in Figure 8. The sign on the angle depends on which delay (transmit or receive) is larger.

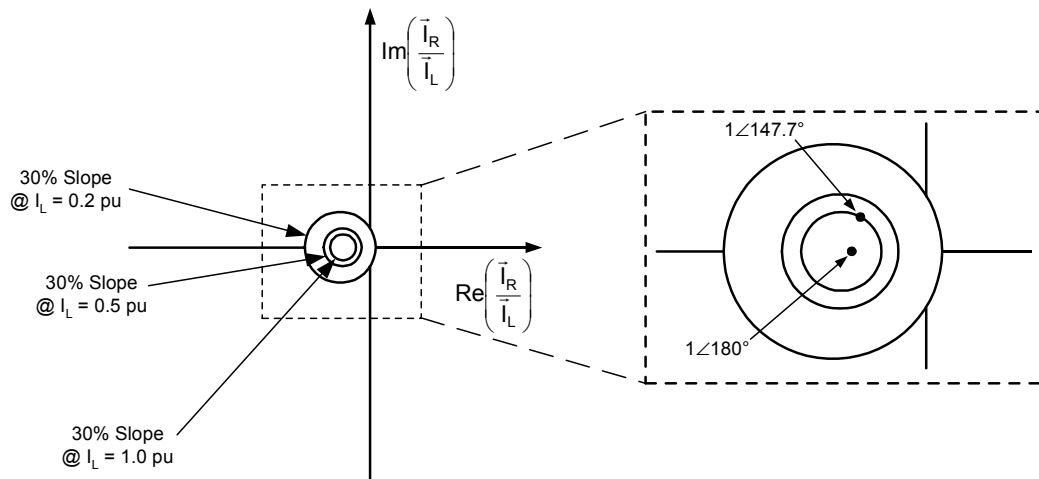
**Figure 10** Operate Characteristic of Figure 9 Represented on the Alpha Plane

As the local current increases from 0.2 per unit to 1.0 per unit of nominal current, the restraint region shrinks, decreasing the relay tolerance to differences in transmit and receive delay. At a load current of 1.0 per unit nominal, the restraint region no longer surrounds the point  $1\angle \pm 147.7^\circ$ .

The relay is expected to trip on 1.0 per unit load current given a transmit to receive delay difference of 3 ms, even if no other errors exists.

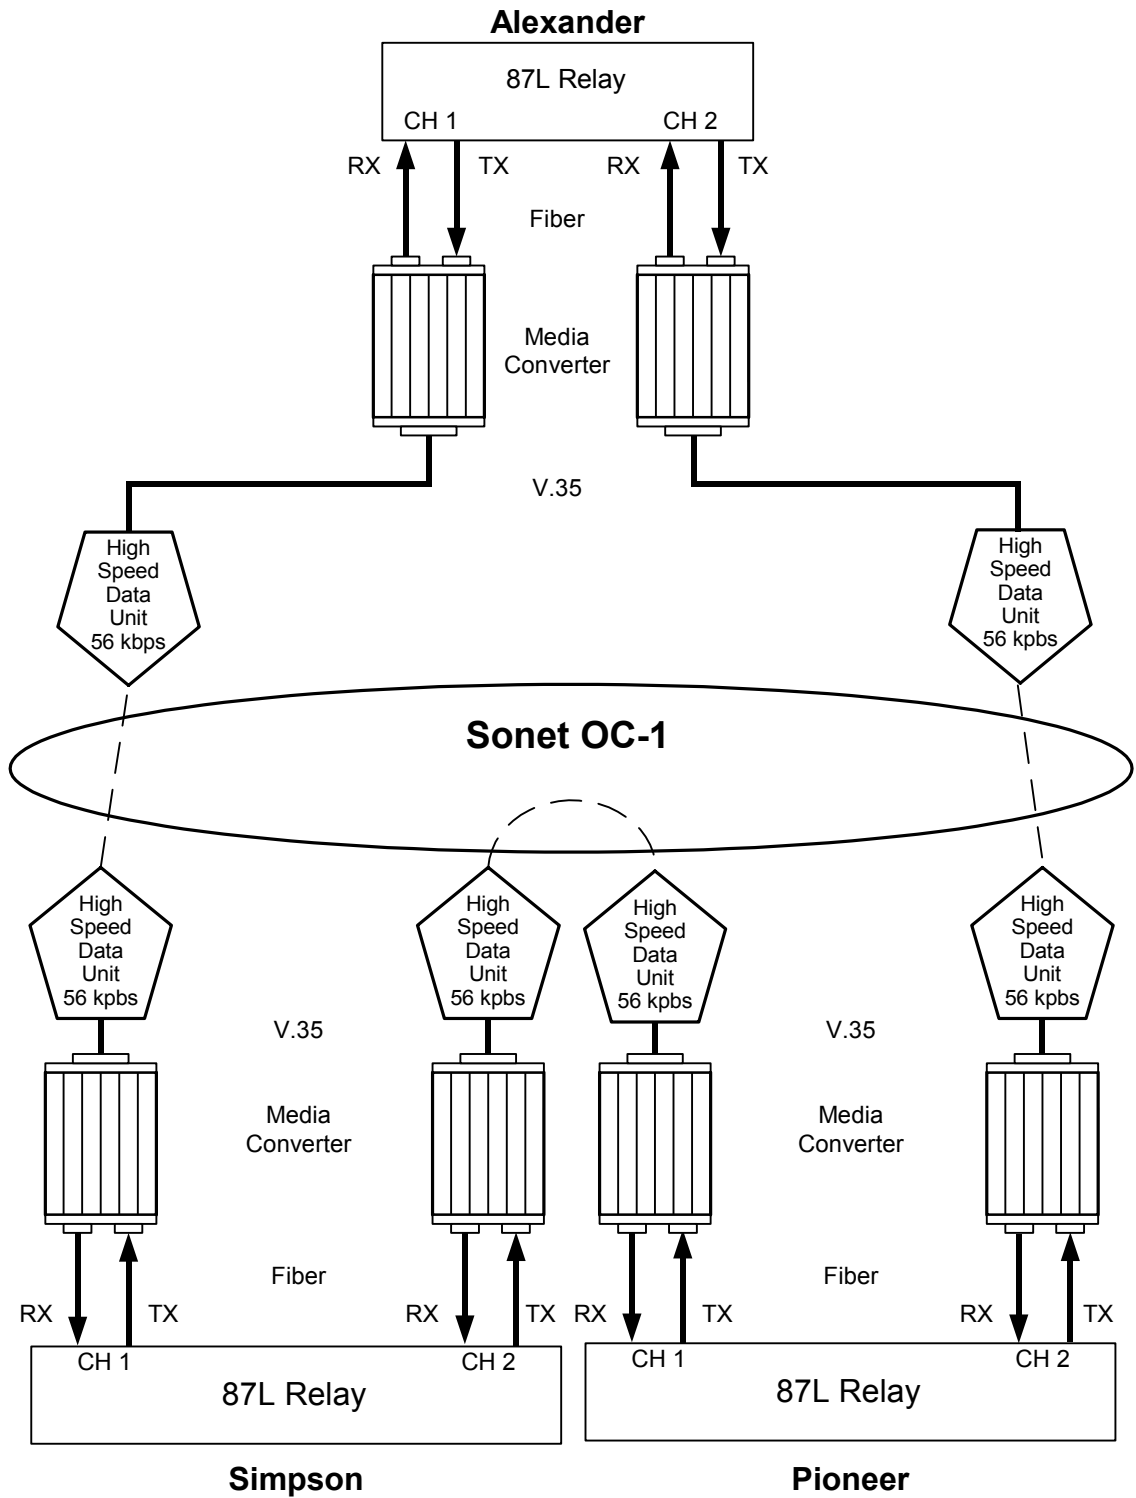
**Figure 13** Original Communications Connections Employing Media Converters

Figure 13 shows the entire three-terminal communications arrangement in place in the spring of 2001. The relay was supplied with a multimode fiber optic interface. The SONET manufacturer did not offer a channel card that would directly connect to this proprietary relay interface. A media converter on each channel converted from the proprietary relay fiber interface to the standard V.35 electrical interface supported by the 56 kbps high speed data card in the SONET channel bank.

Immediately after installation, multiple communication alarms occurred. A thorough examination of the transmit and receive timing on the SONET channel card revealed an incompatibility with the relay and the media converter. Figure 14 shows the interface in more detail.

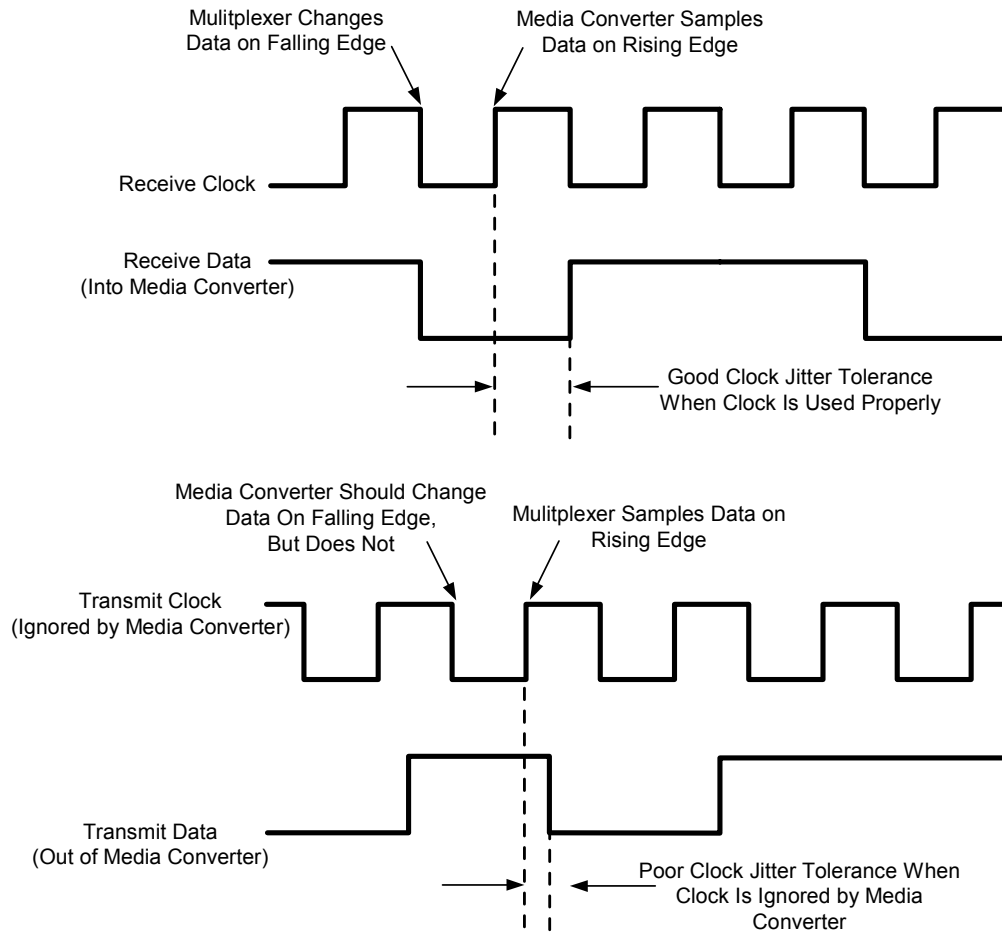
**Figure 15** Media Converter Did Not Properly Use the Transmit Clock, Causing Poor Clock Jitter Tolerance

In this case, the media converter does not properly use the supplied transmit clock as shown in Figure 15. This causes the SONET channel card to sometimes sample the transmit data at almost the same instant the data changed. Even a small amount of jitter on the transmit clock or transmit data causes data errors.

The SONET channel card supplies two clocks because the phase relationship between transmit data and receive data on the SONET system is arbitrary and changes after each network disturbance. The interface performance changed after each SONET system switch because the media converter ignored the transmit clock. Successful communications were hit and miss.
