Lessons Learned From Generator Destructive Testing

Calvin Howard, Beth Andrews, and Douglas Taylor
Avista Utilities

Normann Fischer, Dale Finney, and Matchyaraju Alla
Schweitzer Engineering Laboratories, Inc.

Presented at the
74th Annual Georgia Tech Protective Relaying Conference
Virtual Format
April 28–30, 2021

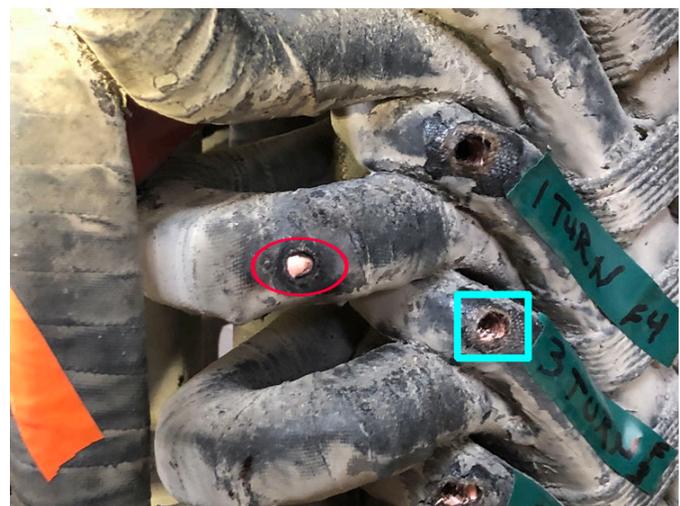
the B-phase winding) was located only two slots above Fault Points F8 and F2. When the fault evolved into a phase-to-phase fault, current flowed in the A- and B-phase CTs located at the neutral side of the generator. The generator differential relay (an electromechanical relay) tripped and cleared the fault in 250 ms. The damage caused by this evolving fault is shown in Fig. 21.

Fig. 19. Photograph showing the tapped fault point in the stator winding (blue rectangle) and the remainder of a sheared-off bolt (red oval).

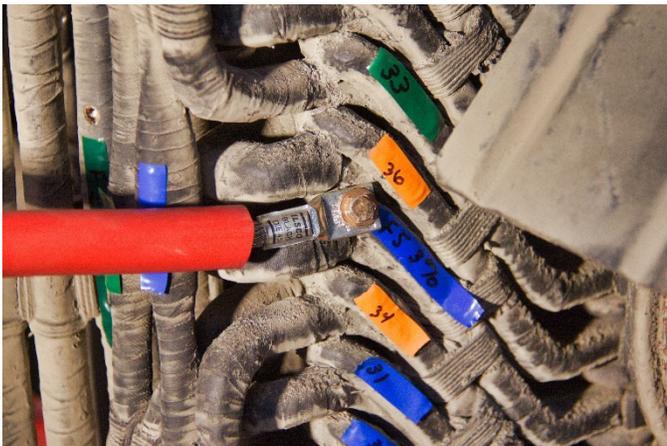
Fig. 20. Photograph showing the fly lead used to connect the fault point to the fault switch and the copper bolt used to secure the fly lead to the fault point.

The second major lesson we learned is to not leave an unused fault point exposed because, if for some reason a fly lead breaks loose or a piece of metal breaks loose and vaporizes, that vapor can become a plasma which can then result in an unanticipated fault condition. During the inter-branch fault, we did not anticipate that a sheared-off copper bolt could vaporize and create a plasma that would change the inter-branch fault into a phase-to-phase fault. This omission in our planning resulted in a premature end to the destructive testing.

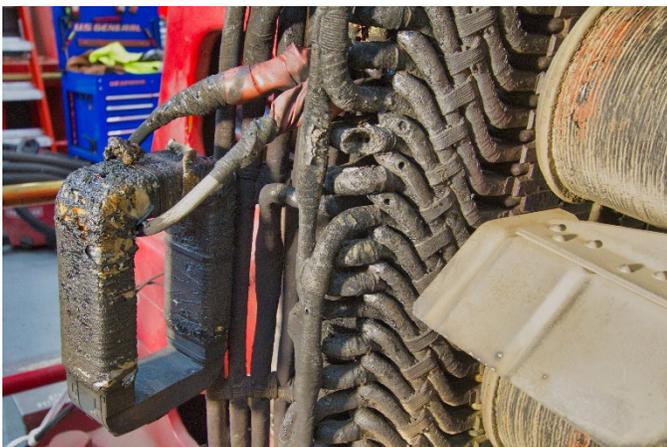
The damage to the generator stator winding was so extensive that we could not resume testing at this point, thus prematurely ending the destructive testing. We still intended to perform an open branch test, where we would have open-circuited one of the phase branches to observe how such a fault would manifest itself and how such a fault could be identified. The safety precautions implemented ensured no injuries or unexpected damage was caused beyond the generator stator winding.

Fig. 21. Photograph showing the damage to the stator windings and one of the branch CTs after a branch fault evolved into a phase-to-phase fault.
