Root-Cause Analysis of Simultaneous Faults on an Offshore FPSO Vessel

ROOT-CAUSE ANALYSIS OF SIMULTANEOUS FAULTS ON AN OFFSHORE FPSO VESSEL

Abstract—The paper “Simultaneous Faults on the 11 kV System of an Offshore FPSO Vessel” by Derrick Haas, Frederick D. Painter II, and Malcolm Wilkinson provides a case study of simultaneous faults that occurred December 5, 2009, on the 11 kV power system of a floating production, storage, and offloading vessel located in the Norwegian sector of the North Sea. The event resulted in severe damage to a 12,000-horsepower compressor motor, damage to the transformer feeding an adjustable speed drive, and interruption of many loads on the ship.

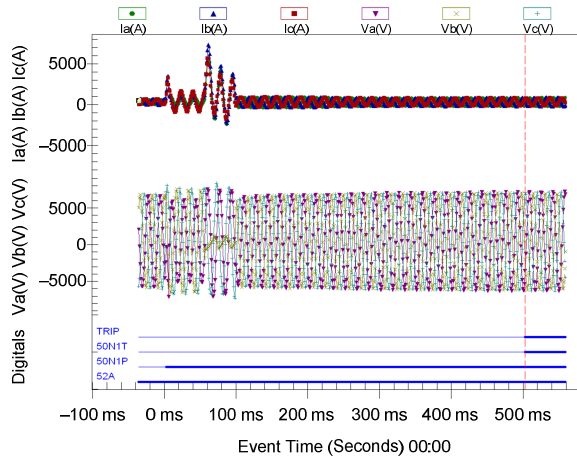
Fig. 4 Event Profile From E200 Protective Relay

Early engineering observations were crucial to further understanding. First, the ground fault current recorded by the E200 protective relay was over 17,000 A, which is well in excess of the system design maximum of 112 ground fault amperes. Hence, it was quickly concluded that this was not an incident involving a single zero-sequence current source. Second, high fault current had flowed through the FCL, causing it to activate on Phases A and B. This supported a conjecture that a second zero-sequence current source had existed on the port side of the power system (i.e., on the opposite side of the FCL from the E200 motor). Event profiles from the E100 and E200 protective relays can be seen in Fig. 3 and Fig. 4, respectively. Note that the currents and voltages displayed in these figures are divided by a factor of $\sqrt{2}$.

We begin by looking at the protective relay for the E200 motor. It did trip on a neutral time-overcurrent element with a definite-time delay, as indicated in Fig. 4. The pickup setting for the neutral time-overcurrent element (50N1P) is 2 A primary. The measured current exceeded this value. In addition, the definite-time-delay setting (50N1D) is set to 0.5 seconds. As was pointed out previously and shown in Fig. 5, the fault current cleared well before 0.5 seconds. However, the neutral current did not go to zero immediately but exhibited a unipolar decay, or subsidence current, as described earlier. It is this decay that allowed the neutral overcurrent element to time out and trip the breaker. Had the current dropped instantly to zero when the fault was cleared by operation of the FCL, the motor relay would not have operated. The relay operated as it was set and was consistent with the published literature. Was it a correct operation of the protection system?

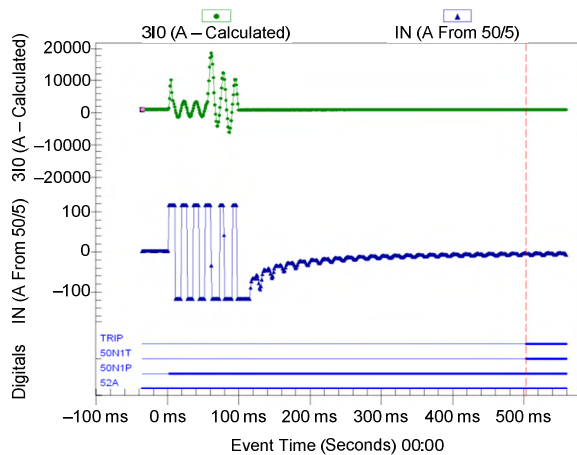
Fig. 5 Event Profile From E200 Protective Relay Showing Neutral and Ground Current

Another puzzling early observation was seen in the current profile associated with the E200 event record. While the ground fault current exceeded 17,000 A for a few cycles, the measured current from the 50:1 core-balance current transformer appeared to indicate that the fault had cleared itself and the E200 motor was returning to normal operation. In fact, ground fault current as detected at the protective relay was returning to near zero, and the relay barely timed out, causing the motor trip, as shown in Fig. 5. The motor nearly rode through this event, yet it tested with a solid ground fault on one phase.

One interesting note from the E200 motor event is that, looking at the phase currents shown in Fig. 5, Phases A, B, and C are all nearly in phase.

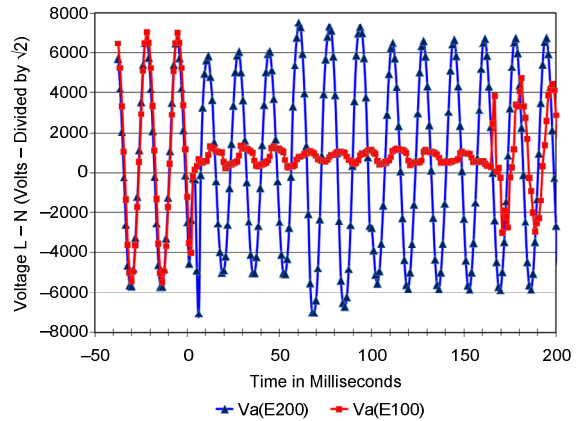
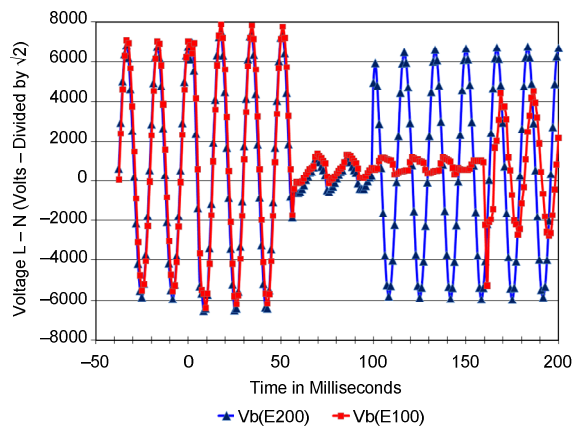
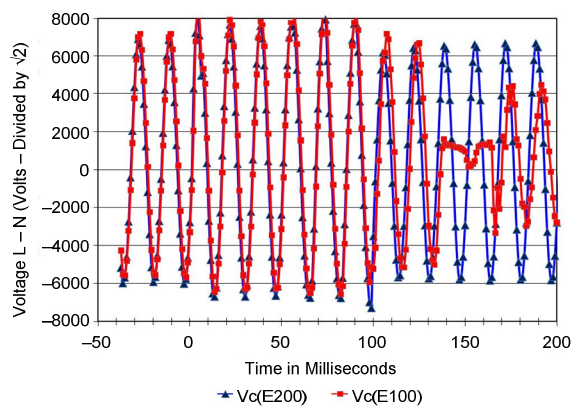
From the plots in Fig. 6, Fig. 7, and Fig. 8, the following points are clear:

- The Phase A element of the FCL cleared first at $t = 5$ milliseconds.
- After the Phase A element opened, Phase A voltage collapsed on the port side of the power system until $t = 165$ milliseconds, when voltage restoration began and the fault cleared.

- The Phase B element of the FCL cleared second at $t = 95$ milliseconds.
- Phase B voltage collapsed system-wide at $t = 55$ milliseconds. When the FCL opened Phase B at $t = 95$ milliseconds, voltage was instantly restored on the starboard power system. After the Phase B element opened, Phase B voltage collapsed on the port side of the power system until $t = 165$ milliseconds, when voltage restoration began.

- Phase C appears to have separated between the port and starboard power systems at $t = 135$ milliseconds and was the last phase to separate. Once Phase C was the only connection between the port and starboard power systems, it appears that a torque angle was developing between the two power systems. The torque angle is evident in the slight separation between the Phase C voltage on the port side and the Phase C voltage on the starboard side between 95 milliseconds and 135 milliseconds. Because FCL controls are interlocked so that FCL activation opens circuit breaker H37, it is asserted that this Phase C separation was due to the three-pole opening of breaker H37.

- After Phase C opened, Phase C voltage collapsed on the port side of the power system until $t = 165$ milliseconds, when voltage restoration began and the fault cleared.

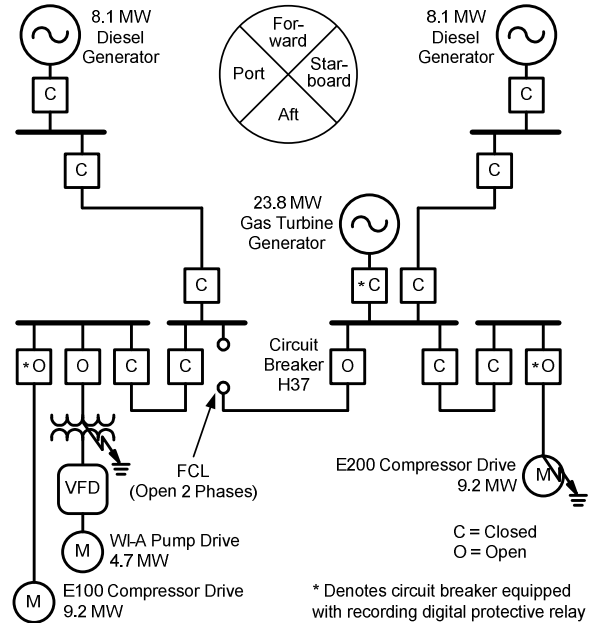
Fig. 9 Simplified Configuration Following Incident With Fault Sites Identified

Approximately three days following the original incident and after partial production had been restored, electrical integrity testing efforts discovered damage at Water Injection Pump A (WI-A). Offshore electrical technicians discovered that the complex 11 kV phase-shifting dry-type transformer that serves as the input to the VFD for WI-A was damaged. Upon disassembly and physical inspection, several signs of failure and flashover were observed.

Fault sites are labeled on the post-incident simplified diagram in Fig. 9.

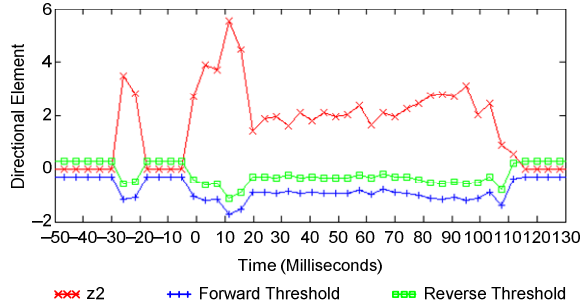
Fig. 13 Plot of z_2 and Thresholds Versus Time for Simulation of Negative-Sequence Voltage-Polarized Directional Element

It is clear from Fig. 13 that the calculated z_2 is above the reverse threshold, indicative of a reverse fault.

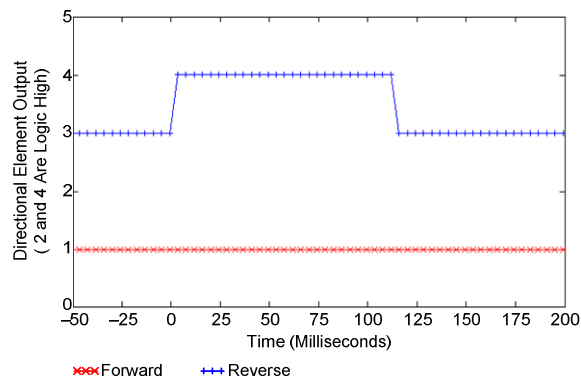
Fig. 14 Response of the Zero-Sequence Voltage-Polarized Directional Element

The simulation was performed again for the zero-sequence voltage-polarized directional element. For the sake of brevity, only the results are given in Fig. 14. The zero-sequence voltage-polarized directional element also determined a reverse direction.

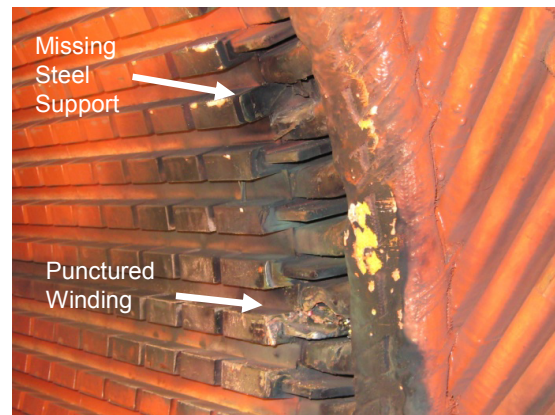
Fig. 15 Photo of E200 Stator Point of Failure

- A clear burn mark was observed inside the stator once the rotor was removed. At the center of the burned area, a stator winding was found to be mechanically punctured, as shown in Fig. 15.

- Detailed examination of stator winding connections confirmed that the winding puncture described in Fig. 15 was electrically in the first turn nearest the star point.

- One of the steel supports for the stator core pack was missing, and there were signs of a fatigue failure at the point of separation. Dimensions of this missing component were approximately 6 mm x 30 mm x 147 mm. This missing steel support was situated just a few degrees rotationally ahead of the burn mark (see Fig. 15).

Some time before the moment of the large fault event on December 5, 2009, a steel component inside the E200 electric motor became dislodged, wedged between the stator and rotor, punctured a stator winding, and shorted the winding to ground. By coincidence, the puncture occurred on the first turn nearest the star point of the Phase B winding. This failure created a low-impedance ground fault near the star point, which was undetectable by the electrical protection equipment in place. Ground fault current was approximately 0.2 A, which was well under the protection pickup setting of 2.0 A. Unknown to system operators, this failure effectively shunted the power system neutral grounding impedance, which was designed to limit ground fault current should a fault occur. The power system apparently operated with this point of low-impedance grounding at the E200 motor neutral for an unknown period of time.

With regard to the failed E200 induction motor, the design was augmented in a way to best ensure that harmonic resonance could not excite the steel supports exhibiting cracking or breakage. Once the E200 compressor was returned to service, the twin E100 induction motor was proactively removed from service to receive the same upgrade. During teardown, a developing crack was

discovered at the base of one of the steel supports. In this case, the defect was detected prior to failure and an unplanned failure was avoided. It is believed the augmented stator design will prevent further occurrence of this failure.

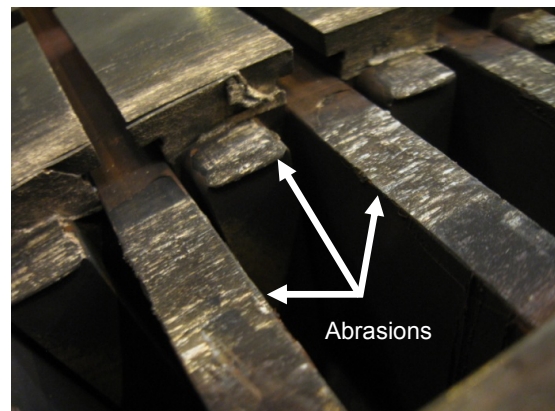
Fig. 16 Photo of E200 Rotor Opposite Stator Damage

- Clear mechanical abrasions were observed on the rotor opposite the burned area on the stator, as shown in Fig. 16.
- Several small hardened droplets of what was previously molten steel were found on the inside of the stator rotationally following the fault site.

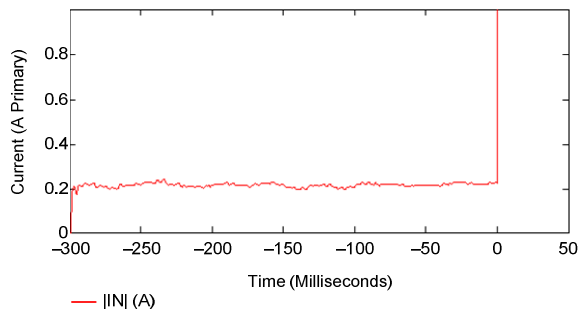
Fig. 17 Neutral Current Magnitude at E200 Motor Relay

If we assume that the best theory of what happened is correct and there was an existing fault on or very near the neutral of the motor that went unnoticed for some time before a second ground fault occurred, the ideal operation would have been to detect that fault and alarm or trip the machine before a second ground fault occurred. A fault exactly at the neutral point of an ungrounded motor in an impedance-grounded system would draw very little, if any, measurable current during normal operating conditions. Because the digital event records contain prefault data, we can look at what the measured neutral current was prior to the fault. In Fig. 17, we see approximately 0.2 A primary of neutral current measured by the relay before the event. This could certainly be indicative of a fault at or near the neutral.

A very sensitive time-delayed neutral overcurrent element could have been enabled to detect this. The minimum pickup setting for the neutral overcurrent element in this particular digital relay is 0.01 A primary. Protection is a balance between different principles and, in this particular case, a balance between sensitivity and security. Saturation and false residual currents are generally not a problem when using a ground fault current transformer; however, setting a neutral overcurrent element derived from a ground current transformer too low could present a security concern. It is also important to note that even the most sensitive neutral overcurrent setting will not detect a fault exactly at the neutral point.
