Making My Paper Mill Safer: An Arc-Flash Energy Reduction Story

Haley Newton
Schweitzer Engineering Laboratories, Inc.

Jordan McCrory
Formerly With Verso Corporation

This paper was presented at the IEEE Pulp, Paper and Forest Industries Technical Conference, Jacksonville, Florida, June 23–28, 2019.

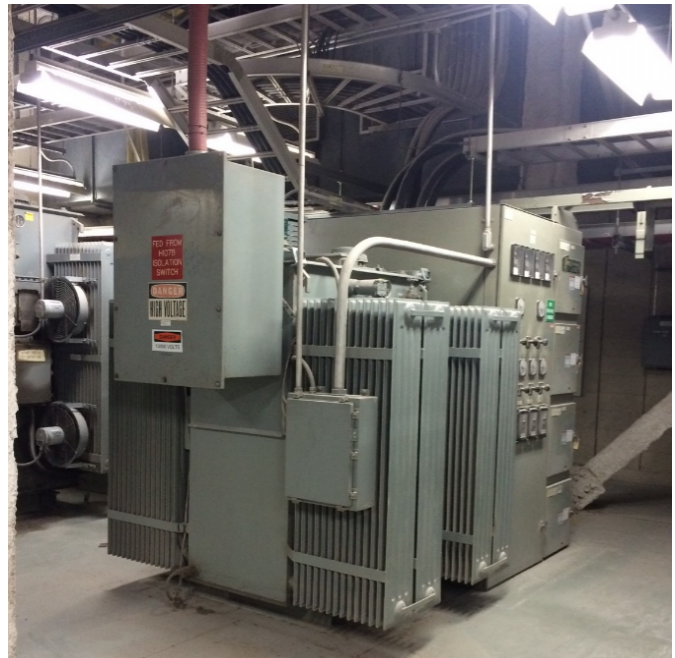
The low-voltage unit substations are fed with a primary load interrupter switch with fuses to protect the transformer. The transformer is close-coupled with the switchgear (see Fig. 1). Four to six 480 V feeder circuit breakers, selected based on the needs of the operating area, are installed in the switchgear (see Fig. 2). On the 480 V secondary side there is no main circuit breaker. With this design, the area of concern encompasses the 480 V feeder circuit breakers and all the 480 V switchgear compartments.

Fig. 1 Close-Coupled Transformer and Switchgear

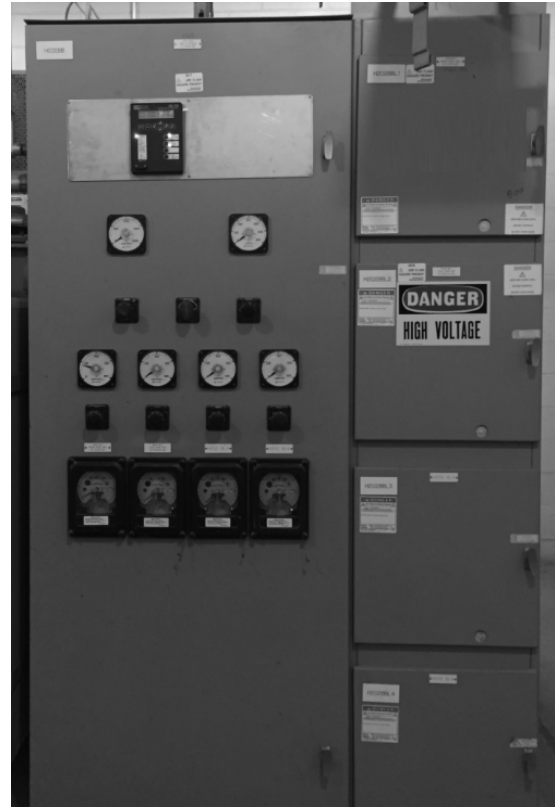
Fig. 3 Manufacturer A Switchgear

Manufacturer A equipment consists of two rear bus compartments and five feeder breaker compartments. All breaker compartments in Manufacturer A equipment are fully equipped with bus connections regardless of whether they have a breaker installed.

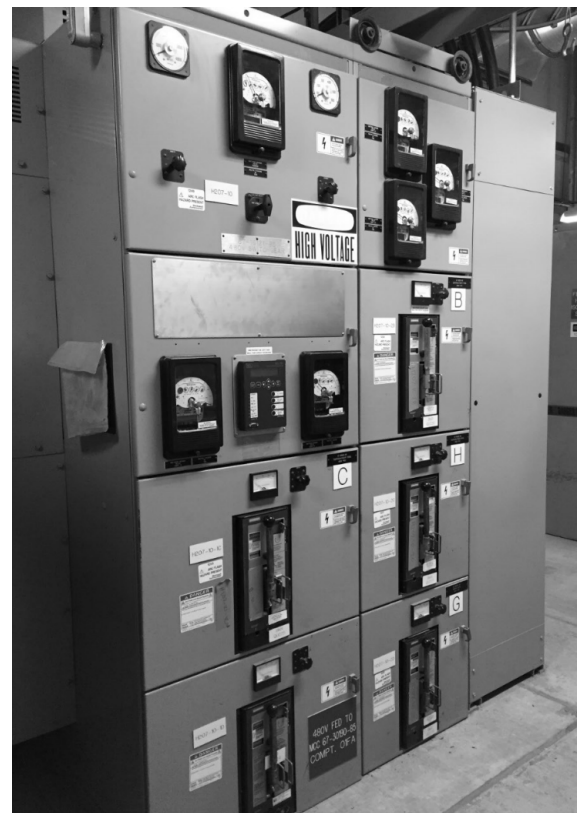
Fig. 4 Manufacturer B Switchgear

Manufacturer B equipment consists of two rear bus compartments, one transformer bus linkage compartment, and five breaker compartments, where one to five are equipped based on the number of feeder breakers installed.

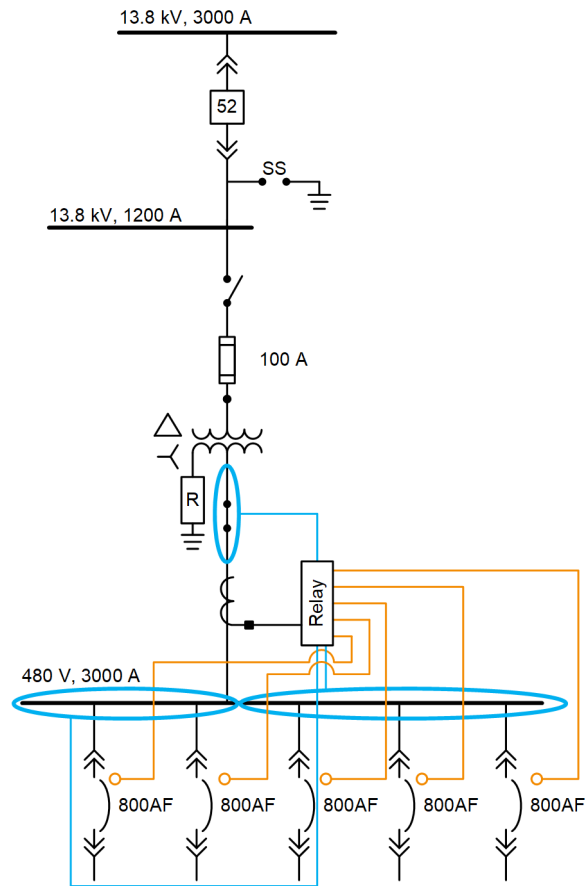
Fig. 5 Light Sensor Locations

Selecting the proper microprocessor-based relay for the replacement required consideration of the required protective functions, form factor, and arc-flash sensor installation. Each switchgear installation required one microprocessor-based relay for all its associated 480 V circuit breakers. It was decided that a feeder protective relay would suit the needs, as the protective functions are basic and require only inverse-time overcurrent elements. A relay would need a form factor like that of the existing electromechanical relays so that the relay could fit into the door with only minor modifications. Finally, the relay needed to support up to eight arc-flash light sensors for the worst-case Manufacturer B equipment. This equipment contains five breakers and three bus compartments; each breaker and each bus compartment requires its own sensor (see Fig. 5).

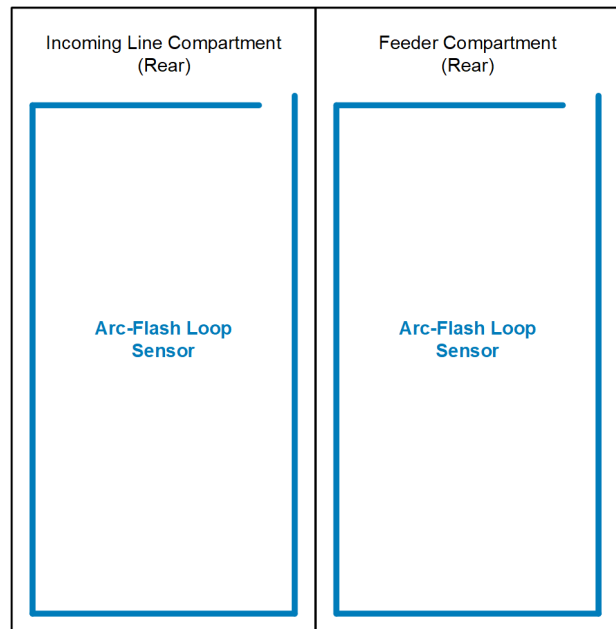
Fig. 6 Loop Sensor Routing Detail

Correct mounting for the arc-flash sensors was critical to ensuring that the arc-flash mitigation functions properly. The bus sections and transformer link section on each manufacturer’s equipment were designated for bare-fiber loop sensors. For the bare fiber to detect light, it needs to be located no more than 2 meters from the light source and must have no less than half a meter of fiber exposed to the light. To accomplish this, the fiber was looped through the compartment, with all the bare fiber in the protected compartment (see Fig. 6).

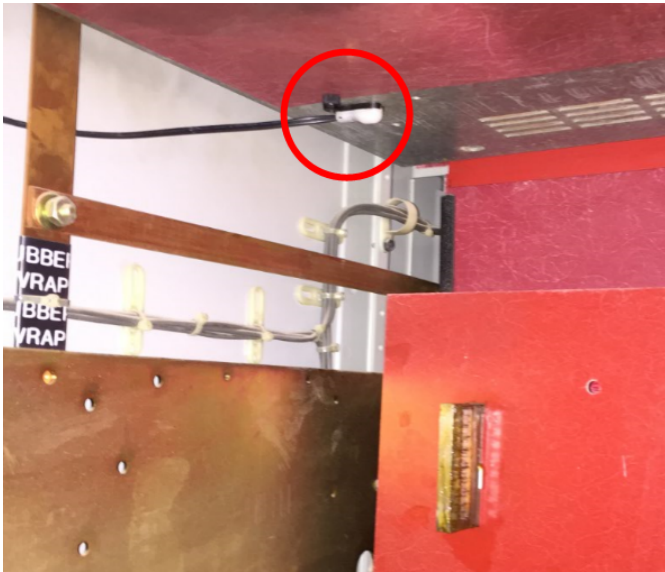
Fig. 7 Point Sensor Mounting Detail

The circuit breaker compartments are equipped with point sensors to better protect the enclosed breaker space. They were mounted on the ceiling of each compartment directly over the breaker stabs to detect arc-flash events as quickly as possible (see Fig. 7).

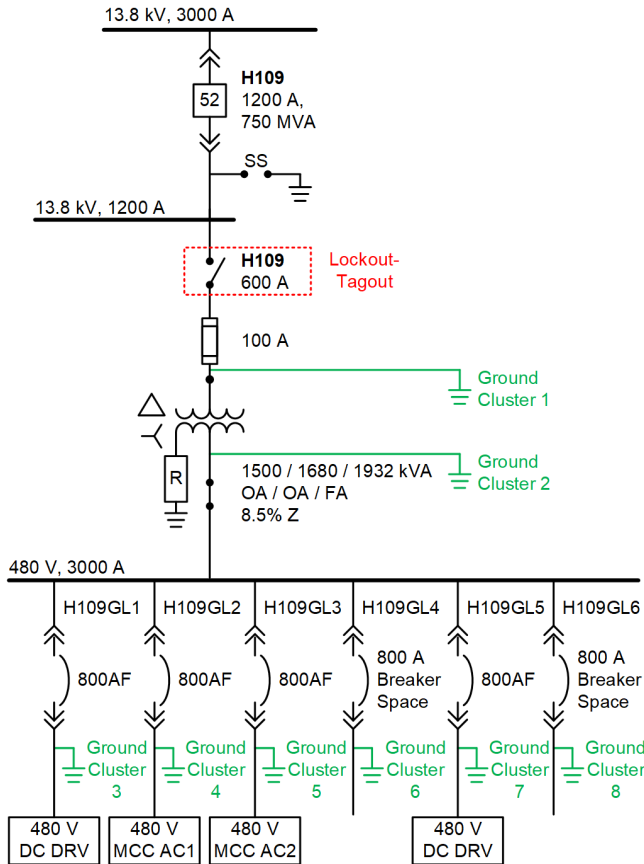
Fig. 9 Isolation and Lockout Detail
