# Finding Common Ground: A Case Study of Phantom Currents and Ground Loops

Matthew Boecker and Genardo Corpuz Lower Colorado River Authority

Jared Candelaria and Ariana Hargrave Schweitzer Engineering Laboratories, Inc.

Presented at the 74th Annual Georgia Tech Protective Relaying Conference Virtual Format April 28–30, 2021

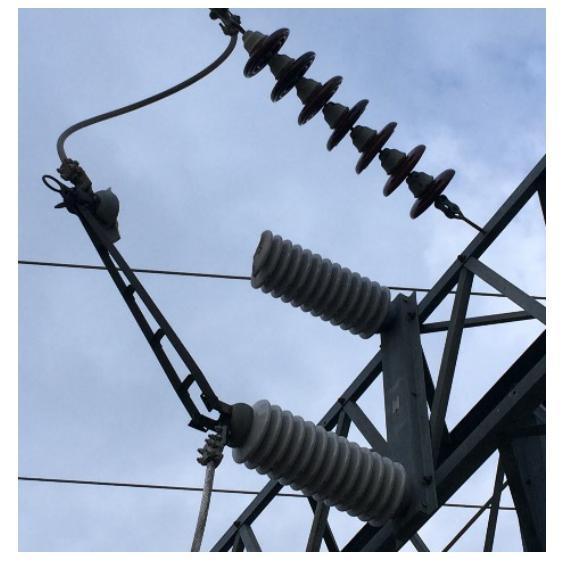
The first fault occurred on February 14 at 3:34 a.m. It was an AG fault on Switch S11 on the line side of the open circuit breaker, CB5. Fig. 5 shows the switch, where a flashover to the structure caused the switch to break away from the insulator. The location on the system is shown as Fault Location 1 in Fig. 4. Even though this fault was clearly not in the transformer relay's zone of protection, the relay tripped on the C-phase percentage-restrained differential element. The 138 kV circuit breakers (CB2 and CB3) and the 69 kV circuit breaker (CB4) opened in response.

Fig. 5. First fault on A-phase of Switch S11.

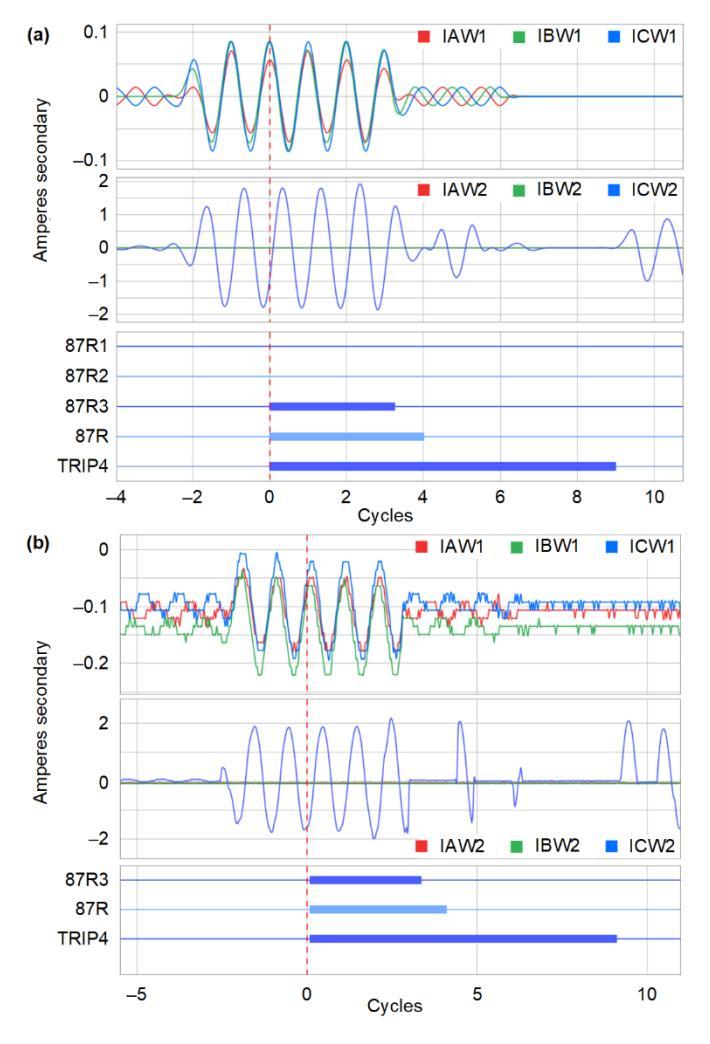
Fig. 6a shows the filtered event report and Fig. 6b shows the raw event report retrieved from the transformer differential relay after the fault. Winding 1 (W1) currents are from the 138 kV side and Winding 2 (W2) currents are from the 69 kV side.

Analyzing the events, what immediately stands out is that the W1 currents are all approximately equal, low in magnitude, and in phase with each other. This is characteristic of zerosequence ground current. This current is expected, since there is a long path that connects the Substation A 138 kV side to another 138/69 kV grounded autotransformer at another substation and to the 69 kV system. This provides an alternate path for ground current to flow to the fault. The ground current will go up through the ground on the 138 kV side of the transformer at Substation A and feed the fault via this long path. This ground current will flow through the W1 CTs and be detected by the relay.

Fig. 6. Filtered (a) and raw (b) event reports from transformer relay after first fault.

The second thing of note is that W2 measured current on the C-phase. This was not expected. With the 69 kV side of the transformer isolated, as shown in Fig. 4, no current should flow on W2. The events also show that the current on C-phase W2 is arcing. This arcing continued even after the transformer tripped. The length of this arcing time was due to the remote electromechanical ground time-overcurrent relay taking 34 cycles to clear the fault.

Based on the explanation in Section II of how current differential protection works and how IOP and IRT are calculated, we can conclude that the transformer relay tripped due to the relay detecting current on W2 and very low (effectively zero) current on W1. Since current into the zone of protection did not equal current leaving the zone of protection, an operate current was present and caused the relay to trip. The relay operated correctly based on the currents it was measuring, but the question remained: Why was it measuring these currents in the first place?

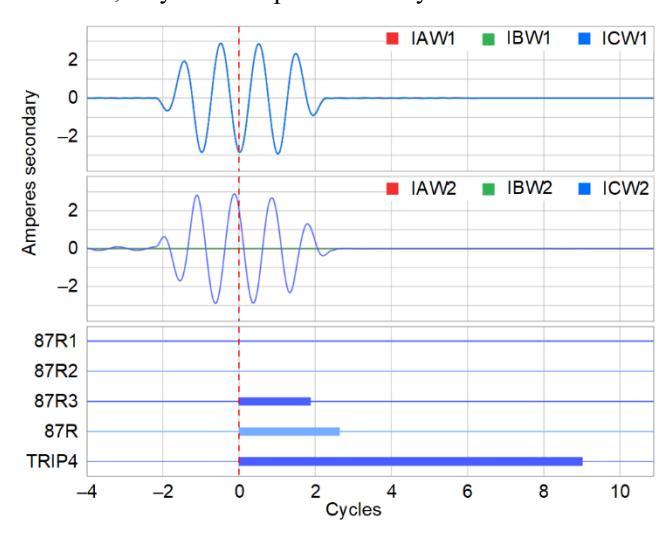
Fig. 7 shows the filtered event report from the transformer relay. The raw event looks similar.

Immediately evident is that the W1 currents are all exactly equal and in phase with each other, again indicating pure zerosequence ground current. The magnitude is higher this time, since the transformer is serving as a ground source to a fault on a nearby line. W2 is again detecting current on the C-phase with the 69 kV side open. The magnitude is higher this time, as well, and there is no arcing on the W2 currents.

Fig. 7. Filtered event report from transformer relay after second fault.

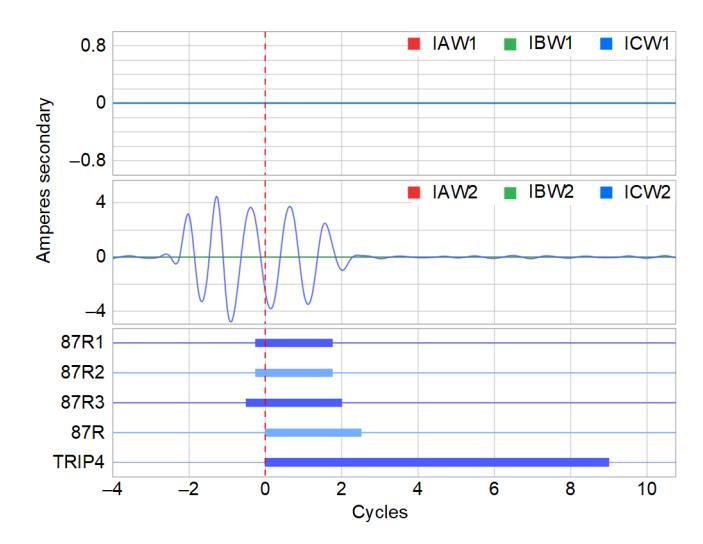
Fig. 8 shows the filtered event report retrieved from the transformer relay after the fault. Since the transformer was completely isolated from the system, there should not be any currents on either of the windings. However, there is still current detected on C-phase W2.

The assertion of all three-phase differential elements was correct based on the transformer compensation settings, which were set at 12 for both W1 and W2. For further information about transformer differential compensation, see [2]. For this fault, the relay again operated correctly based on the currents that it measured. But the question remained: Why did the relay measure those currents?

Fig. 8. Filtered event report from transformer relay after fourth fault.

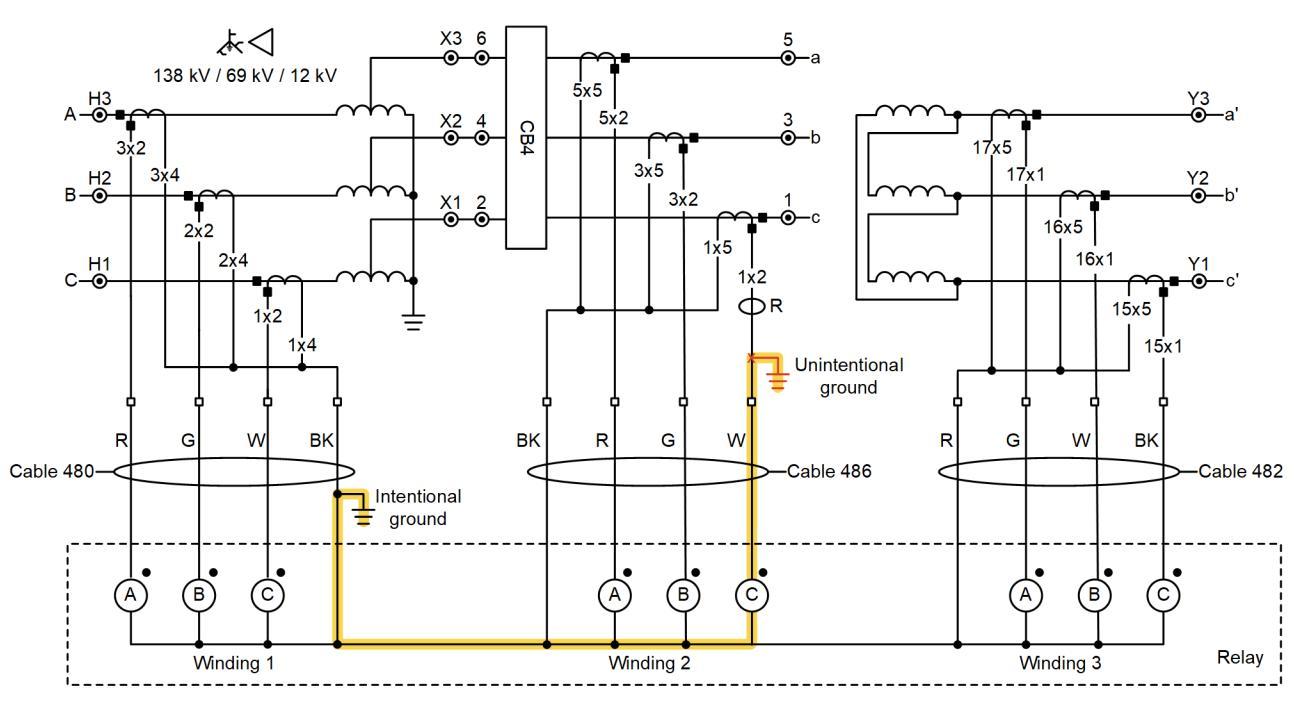
We now knew where the intentional ground was located, and we also knew that current flowed through the C-phase current input (IC) on W2 of the relay. Since the primary circuit on the 69 kV side was open at the time of the faults, that open circuit would reflect on the secondary side of the CT, causing the secondary CT winding (1x2 to 1x5) to appear as an open circuit as well. Keeping this in mind, the only way for current to flow from the intentional ground through the IC input of the relay was through the highlighted path shown in Fig. 10. The unintentional ground would have to be located on the polarity side of the C-phase W2 input of the relay, as shown in Fig. 10.

Fig. 10. Simplified three-line diagram of differential circuit.

An unintentional connection to ground may also occur when the integrity of the insulation on the CT secondary leads has been compromised. Due to the arcing, we hypothesized that insulation breakdown was causing the unintentional ground and was the reason for the misoperations. We asked the technicians to look for an unintentional ground between the polarity side of the C-phase CT and the polarity side of the C-phase W2 input of the relay.

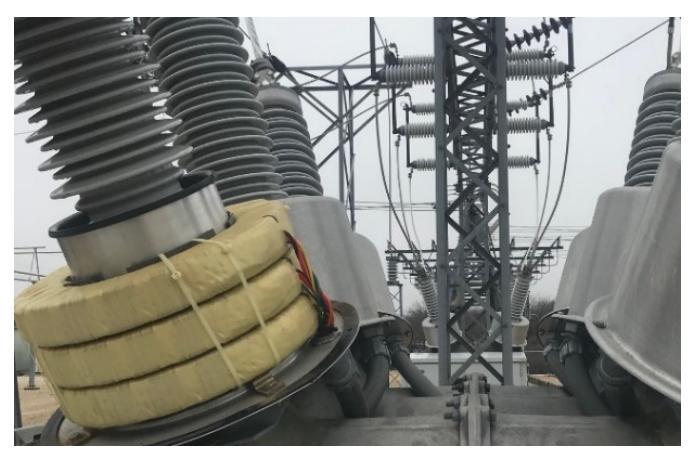
Next, the utility removed the CT cover from Pole 1 (C-phase) on the 69 kV side of the transformer to inspect the CT wires. This is shown in Fig. 11.

Fig. 11. Cover of Pole 1 removed.

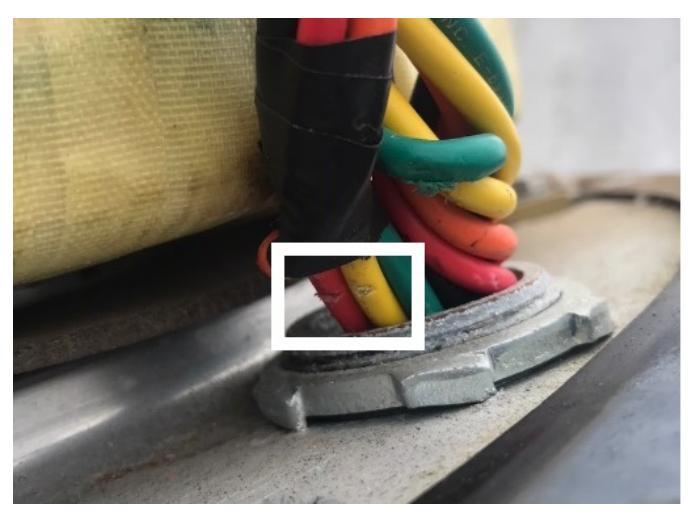
Fig. 12 shows a close-up view of the CT wires. The differently colored wires correspond to the different CT taps of the multi-ratio CT. The wires from the CT are run in flex conduit to the breaker control cabinet, where each wire is terminated. Cable 486 is then connected from the chosen tap points at the breaker control cabinet and routed back to the relay at the control house. Fig. 12 shows that two of the wires (red and yellow) had nicks in them. The wires were rubbing against the side of the flex conduit coupler.

The red wire in Fig. 12 is connected to 1x2, and the yellow wire is connected to 1x4. Fig. 10 shows that 1x2 is brought back to the relay via the white wire in Cable 486. This wire hits the polarity side of the C-phase W2 input on the relay, which is exactly where the phantom current in the event reports was measured.

Fig. 12. Nicked CT wires (red and yellow).

One may initially think that the nicks on the yellow wire (1x4) could not cause an issue since that wire corresponds to an unused tap on the multi-ratio CT. The yellow wire is terminated at the breaker control cabinet and not brought back to the relay. Fig. 13, however, shows how the unintentional ground on the yellow wire could have also caused a problem if the 69 kV side of the transformer had not been open. If 1x4 and 1x5 are both grounded, it effectively creates a short circuit on the secondary side of the CT between 1x4 and 1x5 (highlighted path). This short will cause all the current on the secondary side of the CT to circulate in this highlighted path, instead of forcing the desired ratio current to flow between 1x2 and 1x5. A similar issue could have occurred due to the unintentional ground on the red wire, with current circulating in the short circuit between 1x2 and 1x5, and not being sent to the relay. A misoperation could have easily occurred for either of these cases since the relay would not be measuring correct ratio current.

When the technicians discovered the nicks in the CT wires, they moved the wires to prevent them from contacting the conduit coupler. Before the wires could move again, they quickly performed another insulation resistance test, which passed. Because they were able to turn the problem on and off, root cause was confirmed.

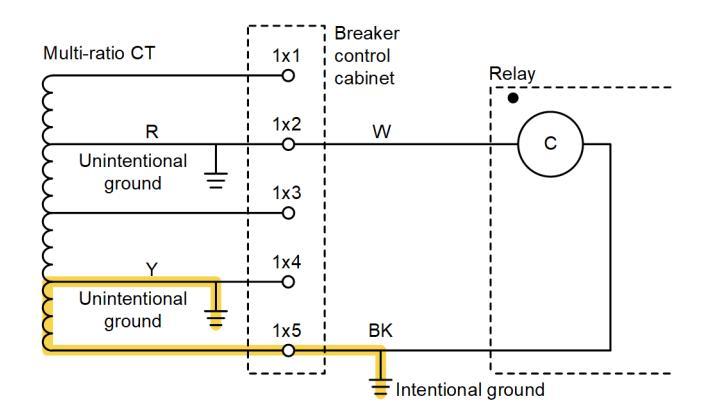
Fig. 13. Ground current path due to unintentional ground on yellow wire.

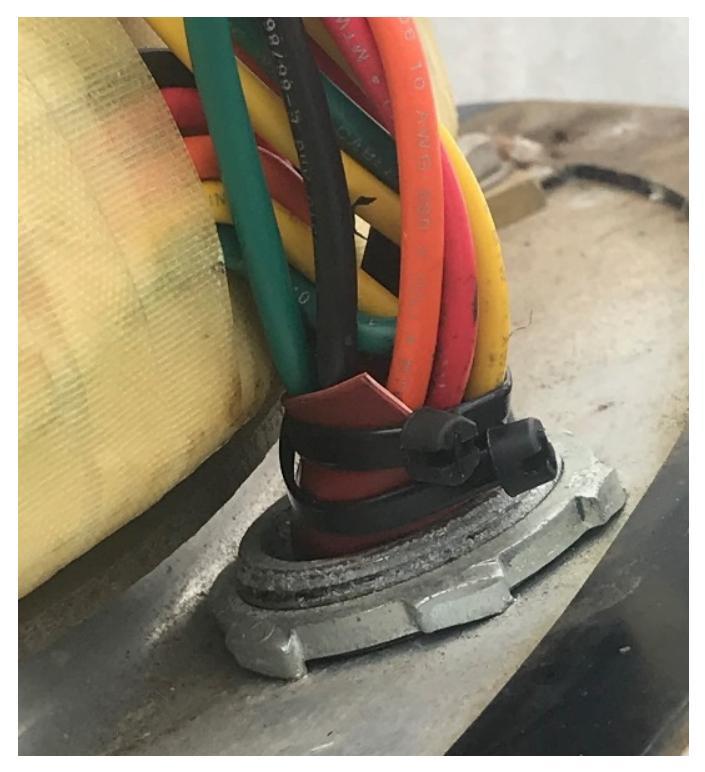
Fig. 14. Corrective action.

To repair the issue permanently, the technicians first applied electrical tape to the individual conductors, to cover and insulate any exposed wiring. They then bundled the conductors and secured them together. Cork was then inserted into the flex coupler to prevent the cables from contacting and wearing against the side of the coupler. This final solution is shown in Fig. 14. The technicians performed a final insulation resistance test on the CTs and Cable 486 and everything passed.
