A Bus Cleared and a Hidden Breaker Insulation Failure Revealed

Robert Roman and Kevin Damron Avista Utilities

Emma Clawson Schweitzer Engineering Laboratories, Inc.

Presented at the Protection, Automation, and Control World Americas Conference Raleigh, North Carolina August 11–14, 2025

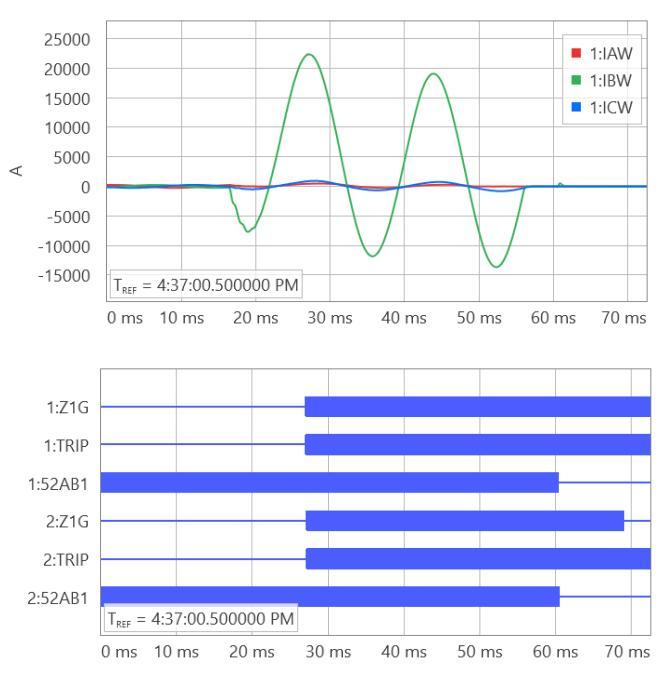
Fig. 9. Initial fault detected by the modern line relays protecting the Sub A–Sub B line.

At 16:37:00 a B-phase-to-ground fault occurred on the Sub A–Sub B transmission line. Both modern line relays at Sub A detected the fault and tripped on their Zone 1 distance element, Z1G. Bkr 3 opened within about two and a quarter cycles, opening the line from the Sub A end. Both relays showed the 52A contact from the breaker deasserting, which also indicated that the breaker opened. Fig. 9 shows the current and binary values from the modern line relays for the fault. The currents for both relays are nearly identical so only one set of currents is shown. The relay estimated the fault location to be 0.73 miles from the substation. This is very close to Sub A since the total line length was approximately 70 miles. The other end of the line at Sub B also tripped quickly due to the permissive overreaching transfer trip scheme and opened the remote breaker.

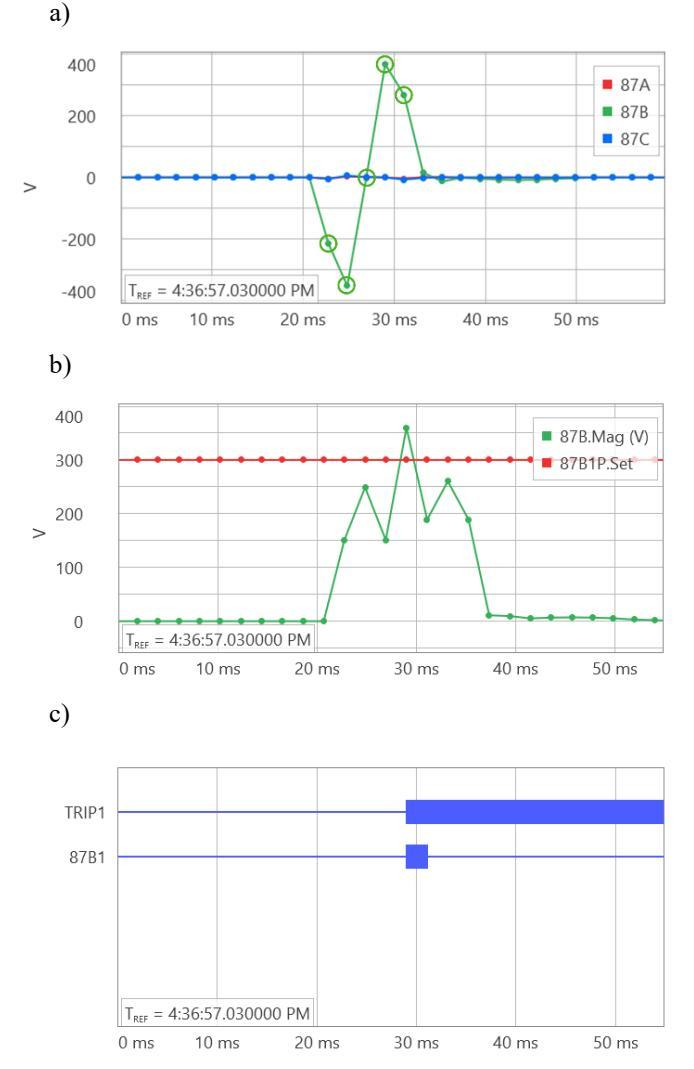
Fig. 10. 87B1 relay tripped the Sub A bus.

Digging deeper into the 87B1 relay's filtered compressed event report files, the engineers observed the voltage signal shown in Fig. 10a. This signal looks similar to an impulse response of the 87B1 half-cycle cosine filter. The impulse response of a half-cycle cosine filter at eight samples per cycle should be four samples long. However, the signal shown in Fig. 10a has five samples. The reason for this signal in the 87B1 relay is discussed later in this section, after the signals shown by the 87B2 relay's COMTRADE files are discussed. The magnitude of this signal rose above the 87B1P setting in the 87B1 relay for one processing interval, causing it to trip, as shown in Fig. 10b and Fig. 10c.

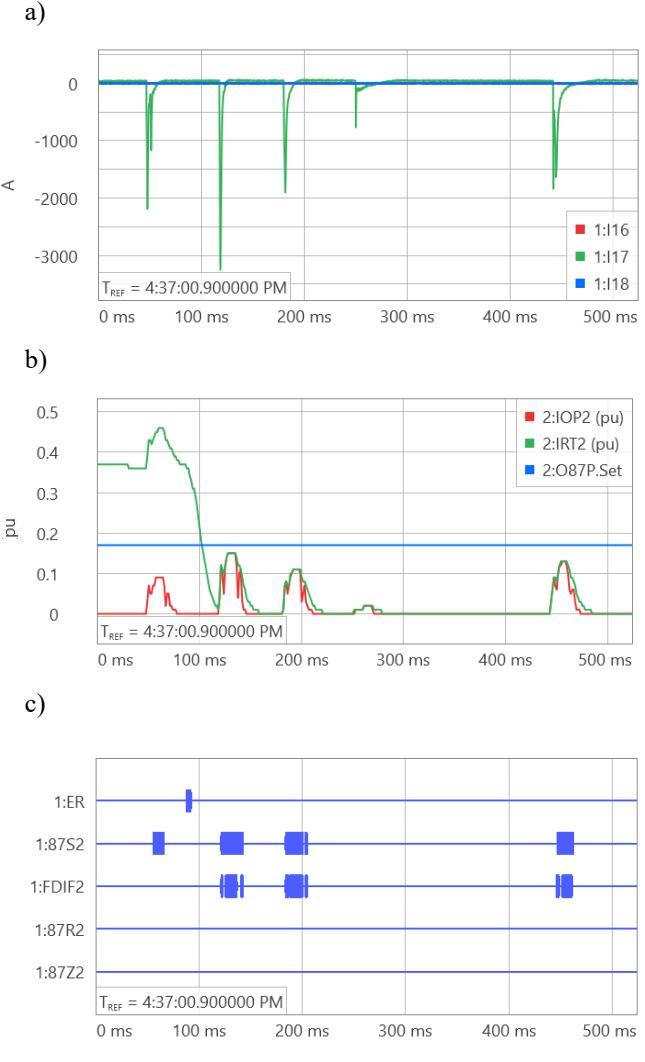
Fig. 11. High-frequency current transients in the 87B2 currents.

The protection engineers proceeded with the event analysis by looking at the 87B2 relay's COMTRADE event. An initial look at the currents and voltages in the 87B2 event showed the voltage at nominal voltage and the current at normal load current values with no sign of a bus fault. A more detailed look revealed that although the currents through Bkr 3 were zero at the beginning of the event, which started after Bkr 3 had opened, the B-phase current had several large, high-frequency transients. These transients were due to lightning strikes on the line, as shown in Fig. 11a. Somehow, Bkr 3 was open but current still flowed through the CT. Current is not supposed to flow through open breakers. This was the first indication that the breaker was damaged, which will be discussed more later.

It is evident from Fig. 11c that the 87S2 binary output, which is the sensitive differential element for the second B-phase zone in the 87B2 relay, picked up and dropped out when lightning struck the line and flashed over in the breaker. The timedelayed output of the sensitive differential element, 87ST2, is mainly used for alarming in the 87B2 for long-time standing imbalances from CT circuit failure. The pickup setting for the 87S2 binary output, S87P, was set to 0.07 per unit (pu) and the pickup delay setting, 87STPU, was set to 300 cycles. Since the operate current for B-phase, IOP2, went above the S87P setting, the sensitive differential element asserted momentarily, but it did not assert the alarm because the operate current was not above the pickup setting for 300 cycles.

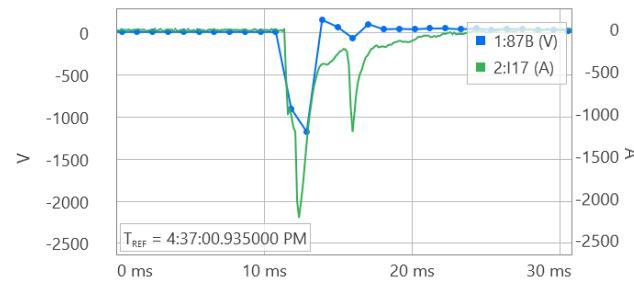
Fig. 12. First lightning strike seen by 87B1 and 87B2 relays.

Before continuing to analyze the 87B2 relay's response to these high-frequency lightning strikes, recall the signal observed in the 87B1 relay's event report. Fig. 12 shows the first lightning strike from the 87B1 relay's unfiltered voltage, 1:87B, and the 87B2 relay's unfiltered current, 2:117. The 87B1 relay's event record is a 16-samples-per-cycle (960 Hz when the nominal frequency is 60 Hz) unfiltered event record, and the 87B2 relay's event record is an 8 kHz COMTRADE event record. The 87B1 relay's lower 16-samples-per-cycle sampling rate caught only two data points that had a high value in the unfiltered event report. When these two points passed through the half-cycle cosine filter of the 87B1 relay and were downsampled to eight samples per cycle, the result was the five-point signal shown in Fig. 10a. The 87B1 relay samples data at 16 samples per cycle, but the filtered event reports it records are 8 samples per cycle. This analysis of the relay's filtering explains the nontypical signal seen in the 87B1 relay's event report.

The 87B1 relay only saw the initial lightning flashover in the breaker and not the subsequent ones because as soon as the 87B1 output to the LOR asserted the LOR shorted the inputs to the 87B1 to protect the internal MOV of the relay from thermal damage, as previously discussed.

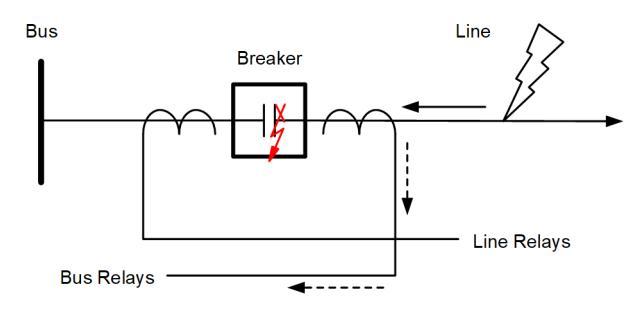
Fig. 13. Internally faulted breaker.

The CTs for the bus relays are on the line side of the breaker, and the CTs for the line relays are on the bus side of the breaker because the zones of protection for the bus and the line overlap at the breaker. The only way the bus relays' line-side CTs could see high-frequency current transients without the line relays' bus-side CTs seeing any current flow is if the current flowed from the line through the primary of the line-side CTs into the breaker and flashed over to ground through the tank of the breaker, as shown in Fig. 13.

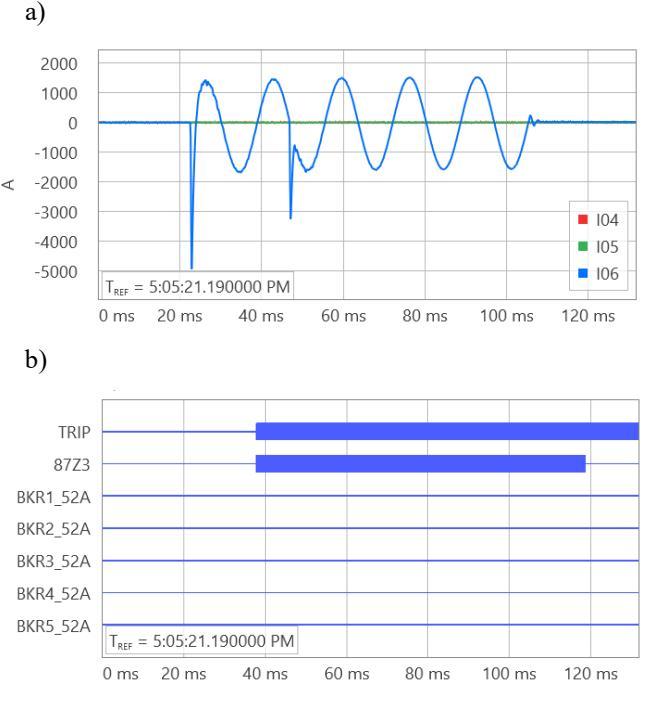
Fig. 14. Second fault while the Sub A Bus was open.

At 17:05:21 lightning struck the Sub A–Sub C line on Cphase, which was open at the Sub A end of the line and closed from the Sub C end of the line, as shown in Fig. 14. The lightning surge caused Bkr 2 to flash over. The 87B2 relay detected the internal fault and attempted to trip the Sub A bus even though the bus was already open. The fault was cleared after five cycles when the remote end of the line opened the breaker at Sub C.

The initial high-frequency current transient shown in Fig. 14a was due to a lightning strike on the line that flashed

over in the breaker. After the lightning surge initiated the flashover in the breaker, the remote end of the line continued feeding the fault in the breaker until the remote end of the line opened. Fig. 14b demonstrates that the 52A contacts of every breaker on the bus were open at the time of the fault in Bkr 2, showing that the bus was open at this time. The 87B1 relay did not see this second fault because it was still shorted by the 86B LOR, which was still rolled. At 17:05:22, Bkr 6 at Sub C successfully reclosed.

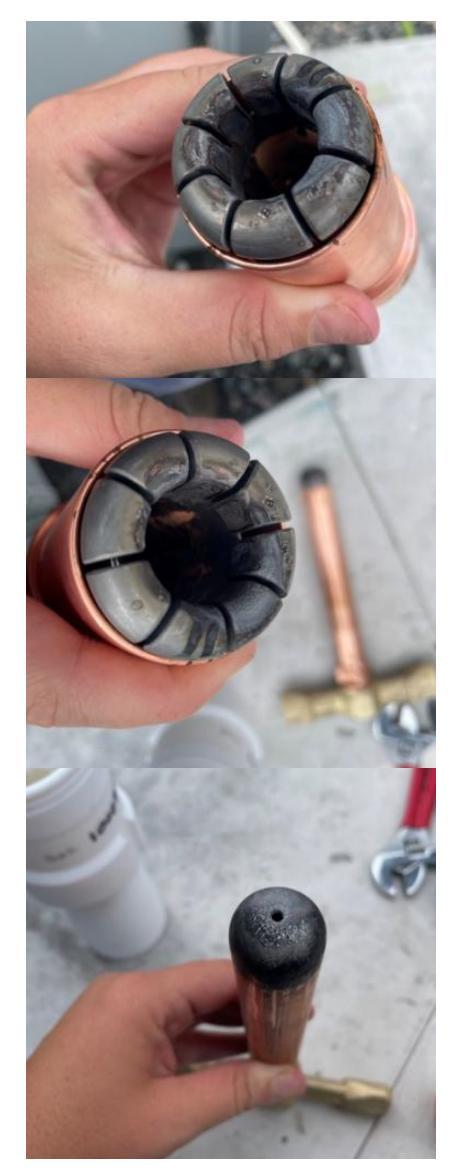
Fig. 15. Bkr 2 damage caused by lightning.

The basic insulation level (BIL) rating of the transmission line insulation connecting to Sub A is 1,105 kV. The BIL rating for Bkr 2 and Bkr 3 was only 900 kV, with no surge arresters on any of the transmission lines at Sub A. This arrangement made the circuit breakers the weakest link. Additionally, being in the open position following the initial 16:37:00 fault caused the lightning impulses to double when they reflected at the dead end formed by the open circuit breaker.

When Bkr 2 was removed from service and inspected, visible burn marks were observed on the breaker's C-phase contact, as shown in Fig. 15. The gas sample taken from this SF6 breaker indicated that the breaker was damaged. Unlike Bkr 3, Bkr 2 sustained not only the high-frequency current transients from the lightning strikes, but also five cycles of fundamental frequency fault current. This caused much more damage to Bkr 2 than the high-frequency current transients alone did to Bkr 3.

The breaker manufacturer was involved in the breaker failure analysis and recommended neither breaker be returned to service. Bkr 3 only experienced lightning flashover with no 60 Hz current reinforcing the breakdown to cause further damage to the breaker. Bkr 2 suffered lightning strikes as well as the internal fault for five cycles.

Prior to the event, the utility's standard practice was to not install lightning arresters on transmission lines due to the historically low total lightning density in their service territory. Based on this event, and the increasing lightning risk to the utility's 230 kV transmission system, a program was developed to install lightning arresters on breakers and to install shield wires on transmission lines.
