# Schweitzer Engineering Laboratories SEL-8317 LINAM® UGFI Faulted Circuit Indicator

IEEE Std 495-2007, Clause 4.4.7 and 4.4.8 and Client  
Specifications

## REPORT OF PERFORMANCE

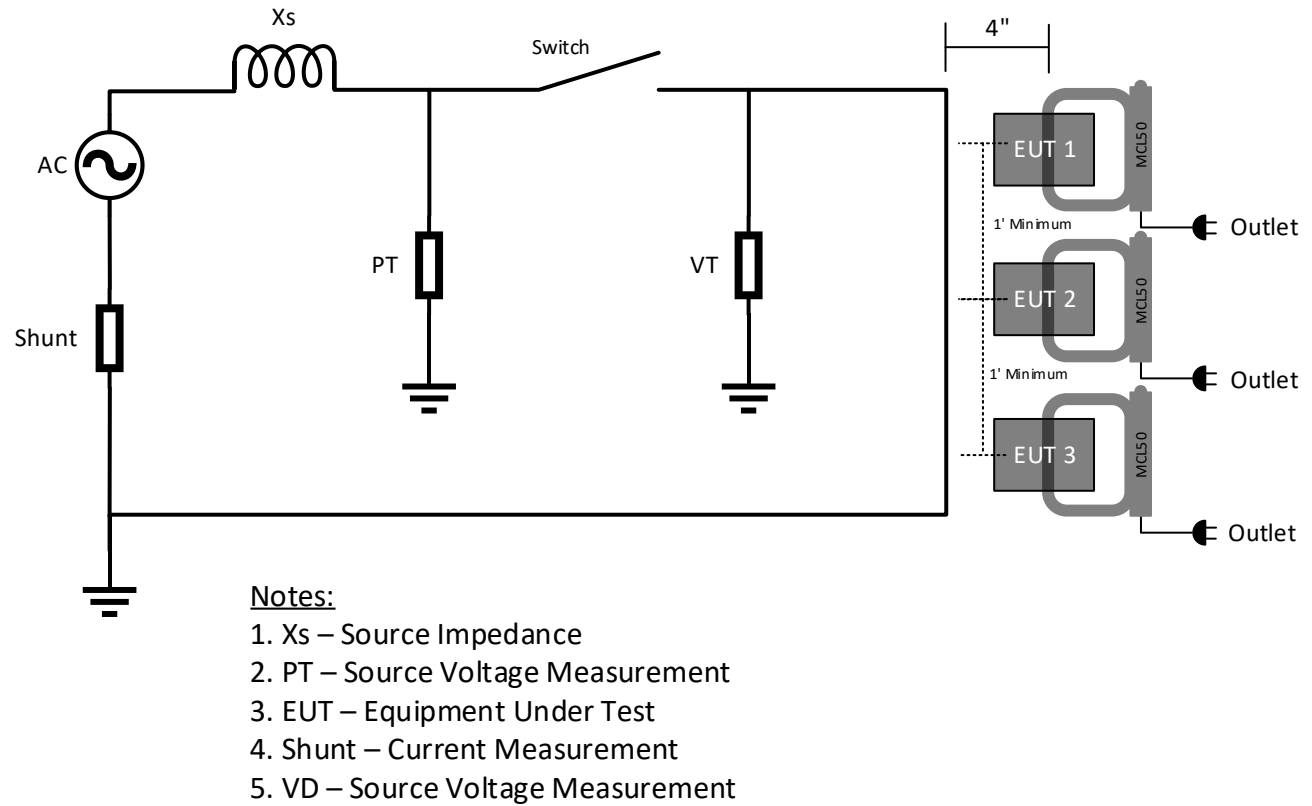
**Figure A-1: Setup Diagram for Effect of Current from Adjacent Conductors Test.**

With each orientation, the test current was applied twice on the adjacent conductor. All tests were performed at 60 Hz in the circuit shown in Figure A-1. The test current parameters were summarized as below:

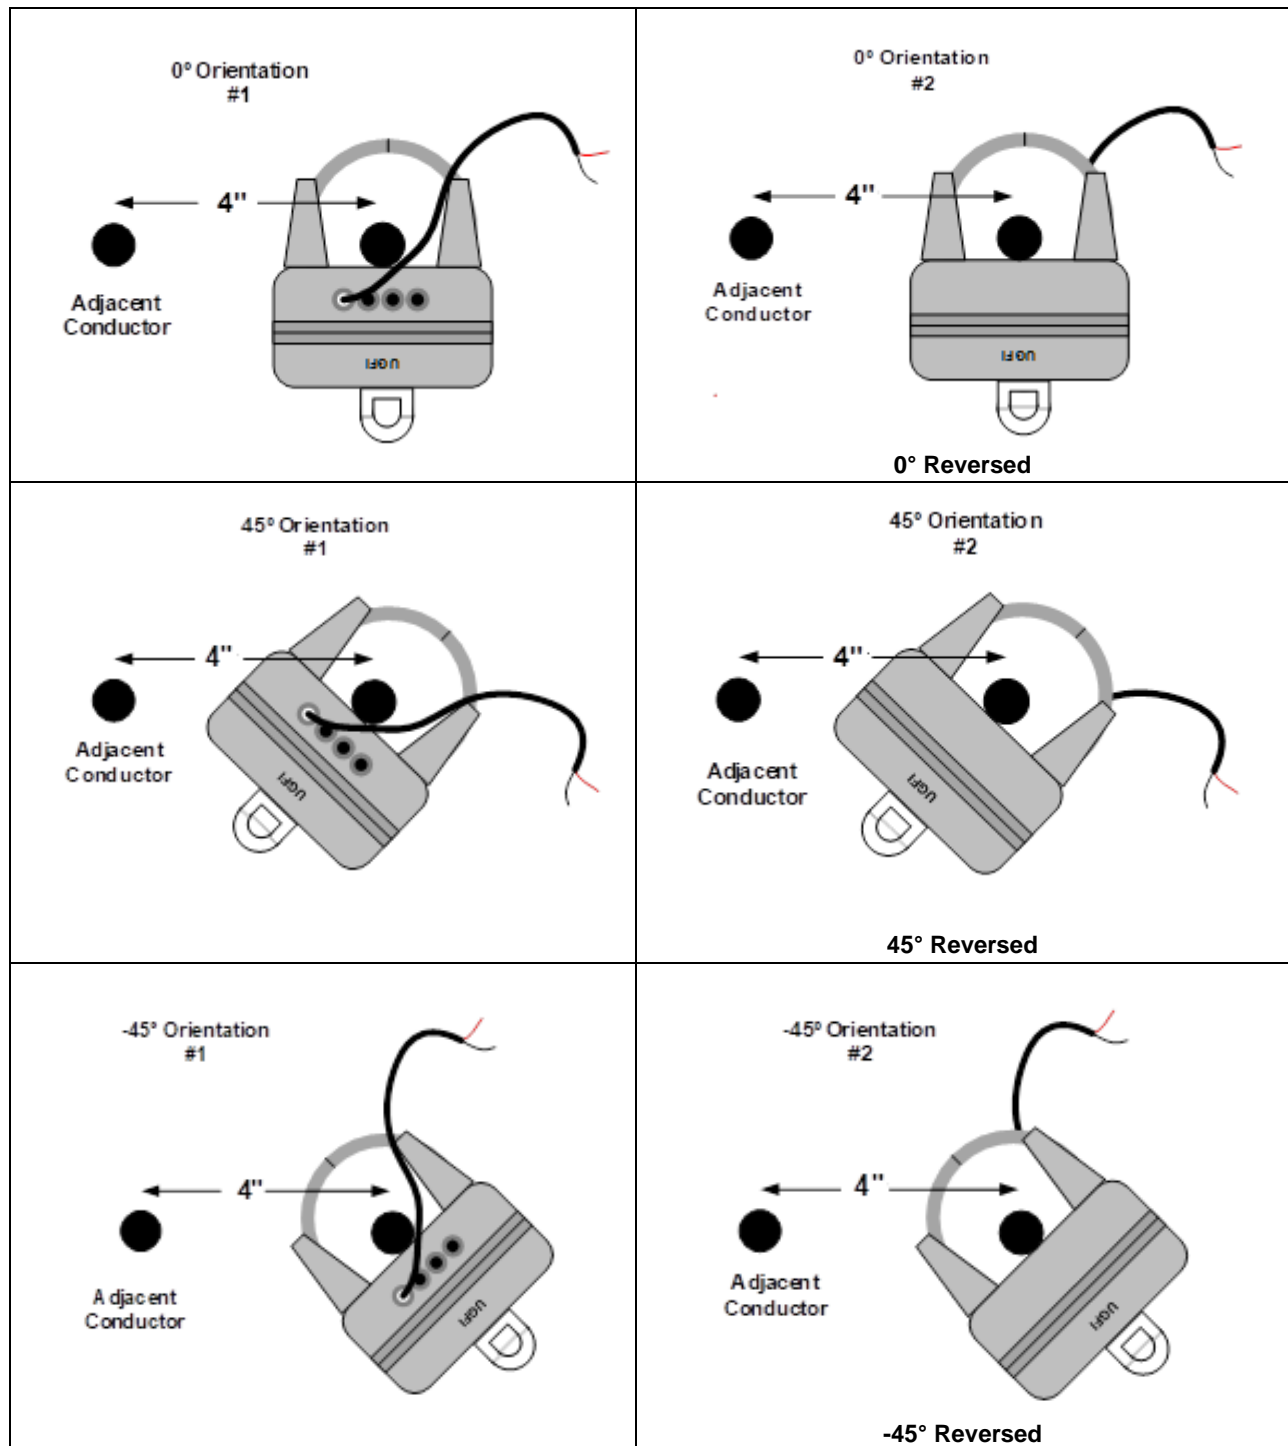
**Figure A-2: Six Orientations of the FCIs for Effect of Current from Adjacent Conductors Test**

In each test shot, the three UGFI units were set at the same orientation on their mini-current loops. After every two test shots, the orientation of the UGFI units was changed per client specifications. In total six different orientations were configured, as shown in Figure A-2.

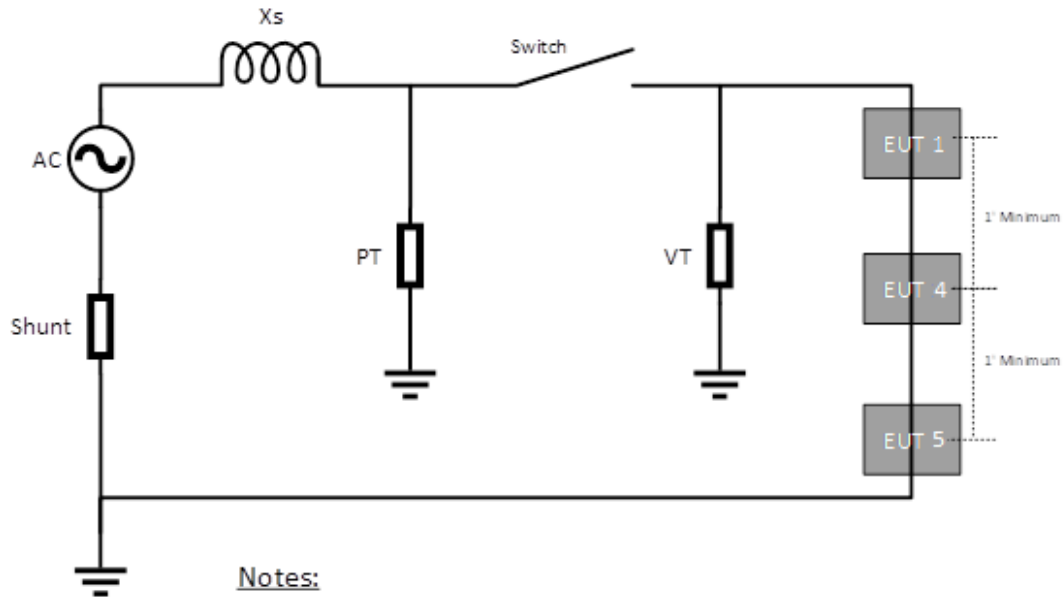
1. Xs – Source Impedance
2. PT – Source Voltage Measurement
3. EUT – Equipment Under Test
4. Shunt – Current Measurement
5. VD – Source Voltage Measurement

**Figure B-1: Setup Diagram for Short-time Current Test**

The bus, mounted with FCIs, was subjected to two short-time current shots at a level of 25 kA. All tests were performed at 60 Hz in the circuit shown in Figure B-1. The test current parameters were summarized as below.

The bus, mounted with UGFI units, was subjected to two short-time current shots at a level of 40 kA. All tests were performed at 60 Hz in the circuit shown in Figure B-1. The test current parameters were summarized as below.

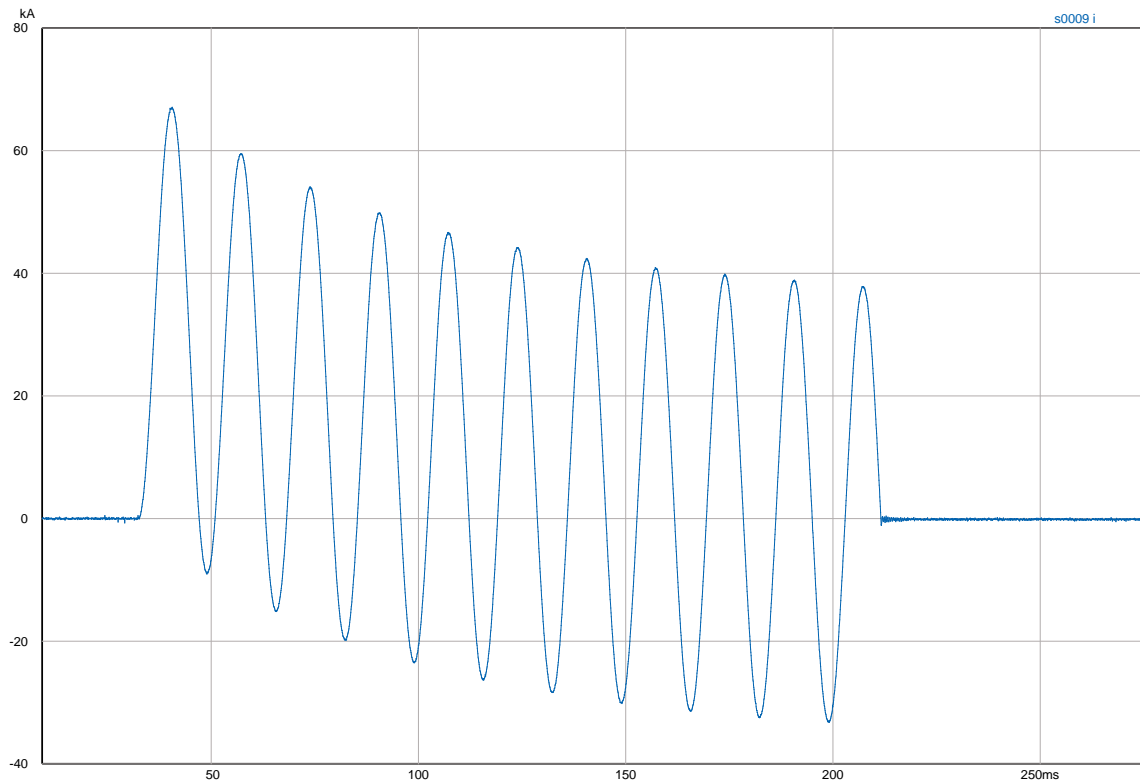
**Figure C-1: Typical current waveforms at 25 kA.**

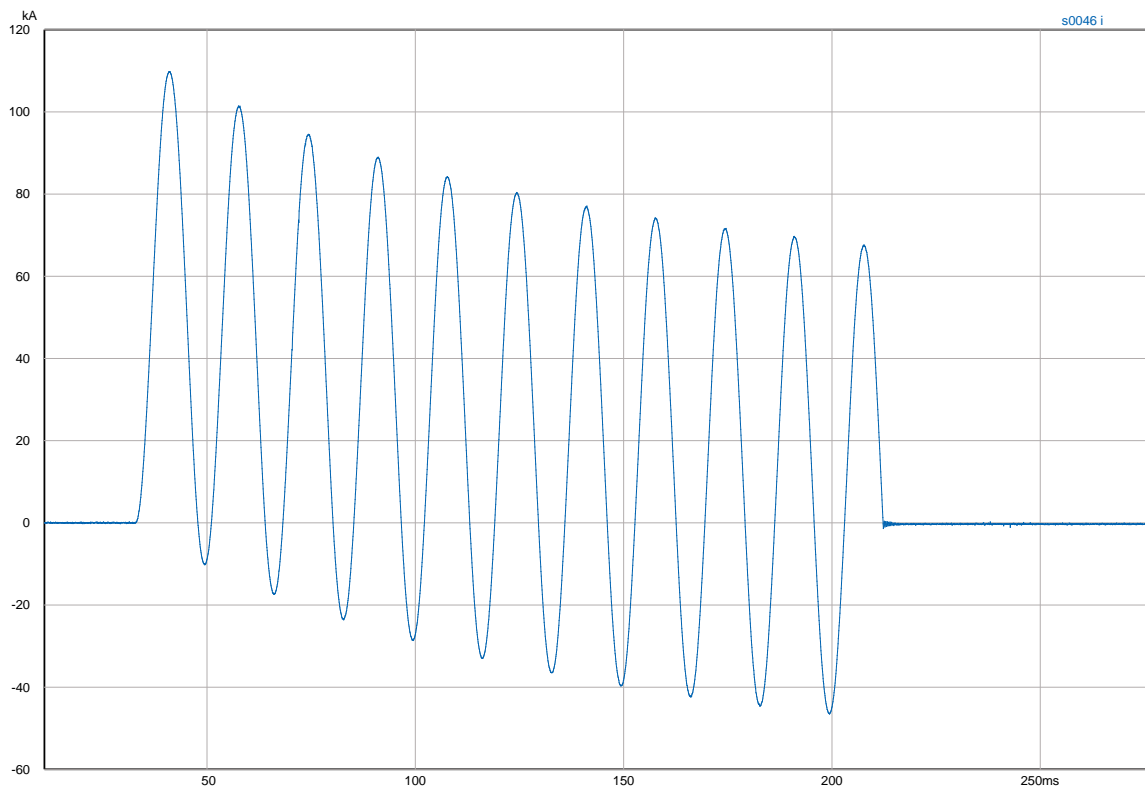
**Figure C-2: Typical current waveforms at 40 kA.**

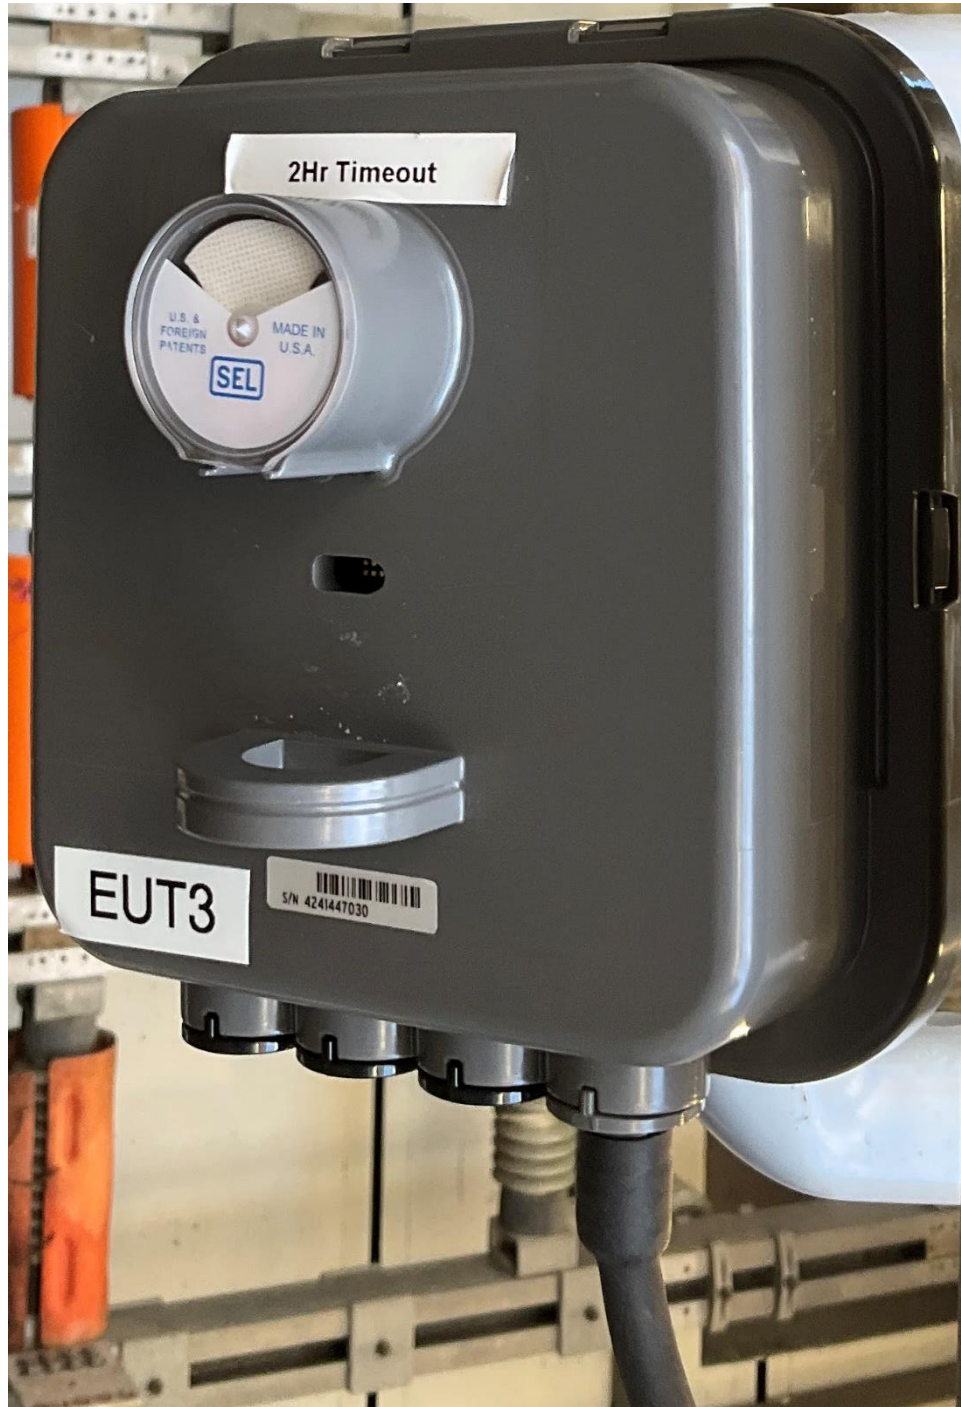
*Figure C-3: Tested SEL-8317 LINAM® UGFI FCI unit.*

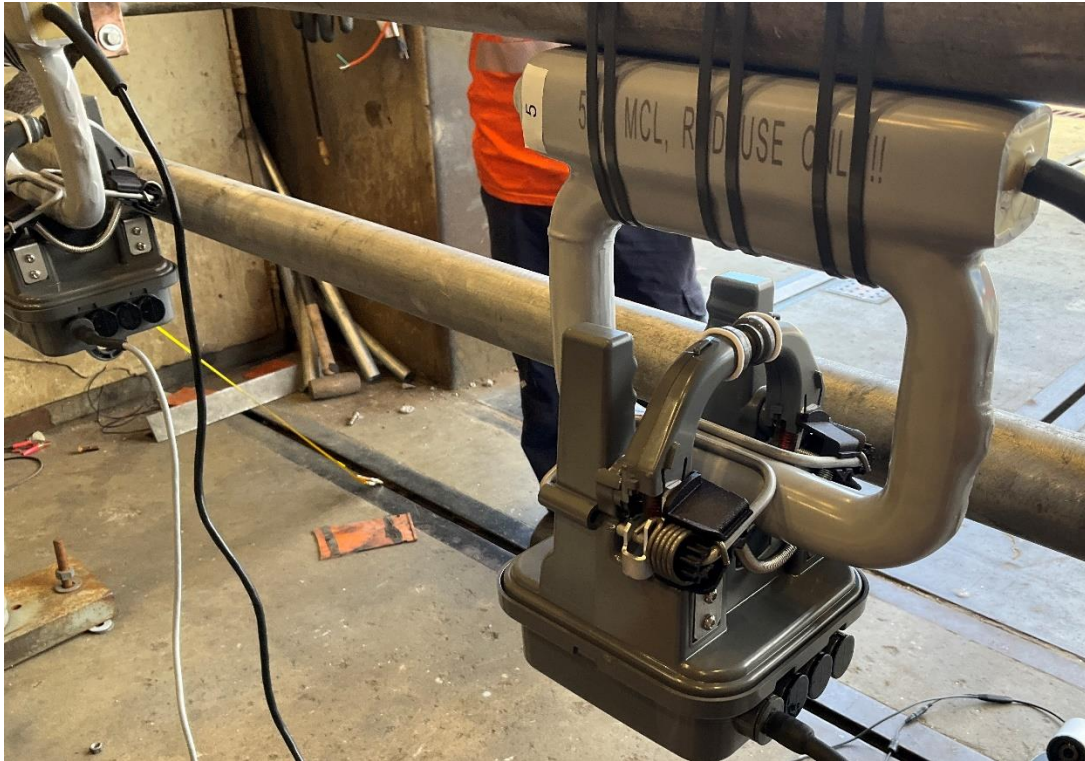
**Figure C-4: Tested SEL-8317 LINAM® UGFI unit with mini-current loop.**

Three SEL-8317 LINAM® UGFI units were tested simultaneously. Each unit was installed on a mini-current loop. The mini-current loops were powered by 110 V AC supply to simulate a conductor energized to the requirements necessary for FCIs to function. Three UGFI units, together with their mini-current loops were attached to a  $\Phi 2''$  round bus with minimum one foot apart from each other, and 4'' from the adjacent conductor, as shown in Figure C-5.

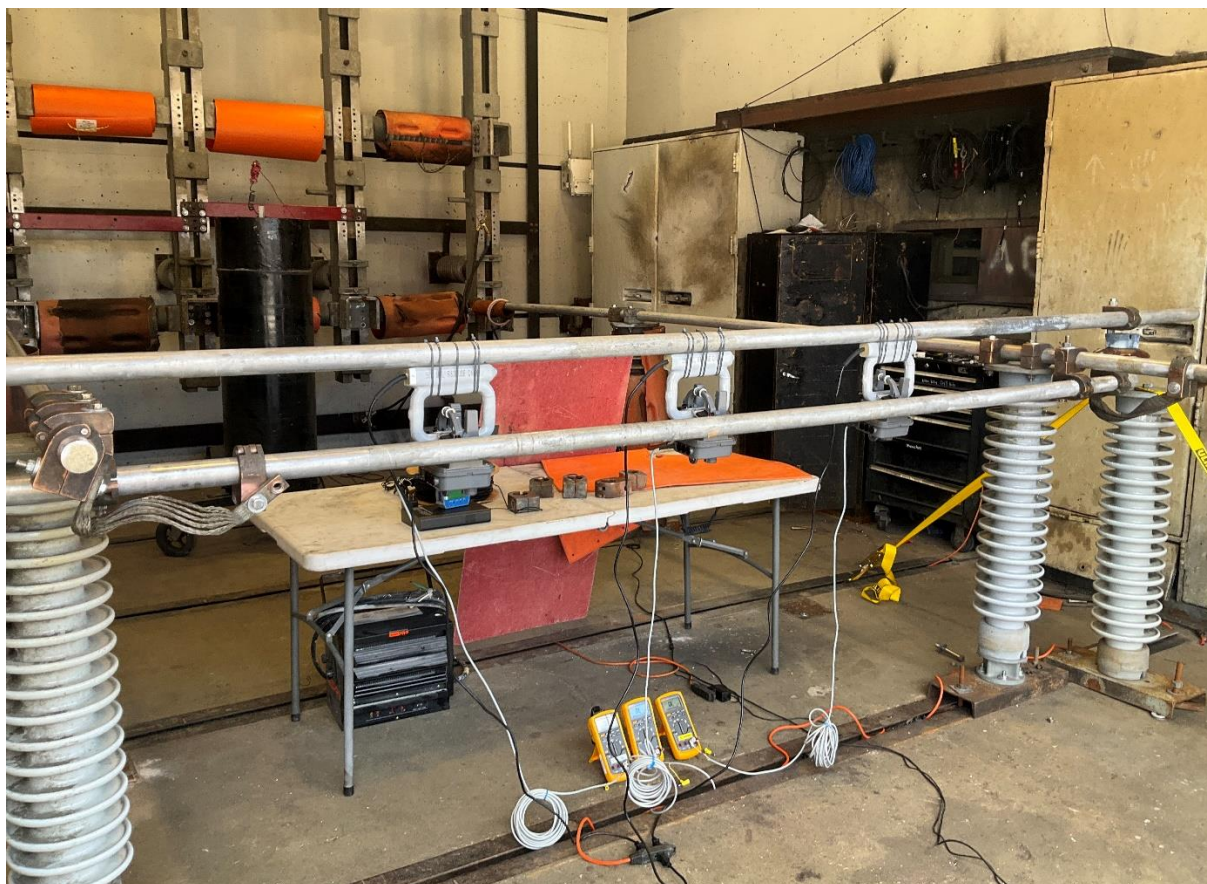
**Figure C-5: Test setup for effect of current from adjacent conductor tests.**

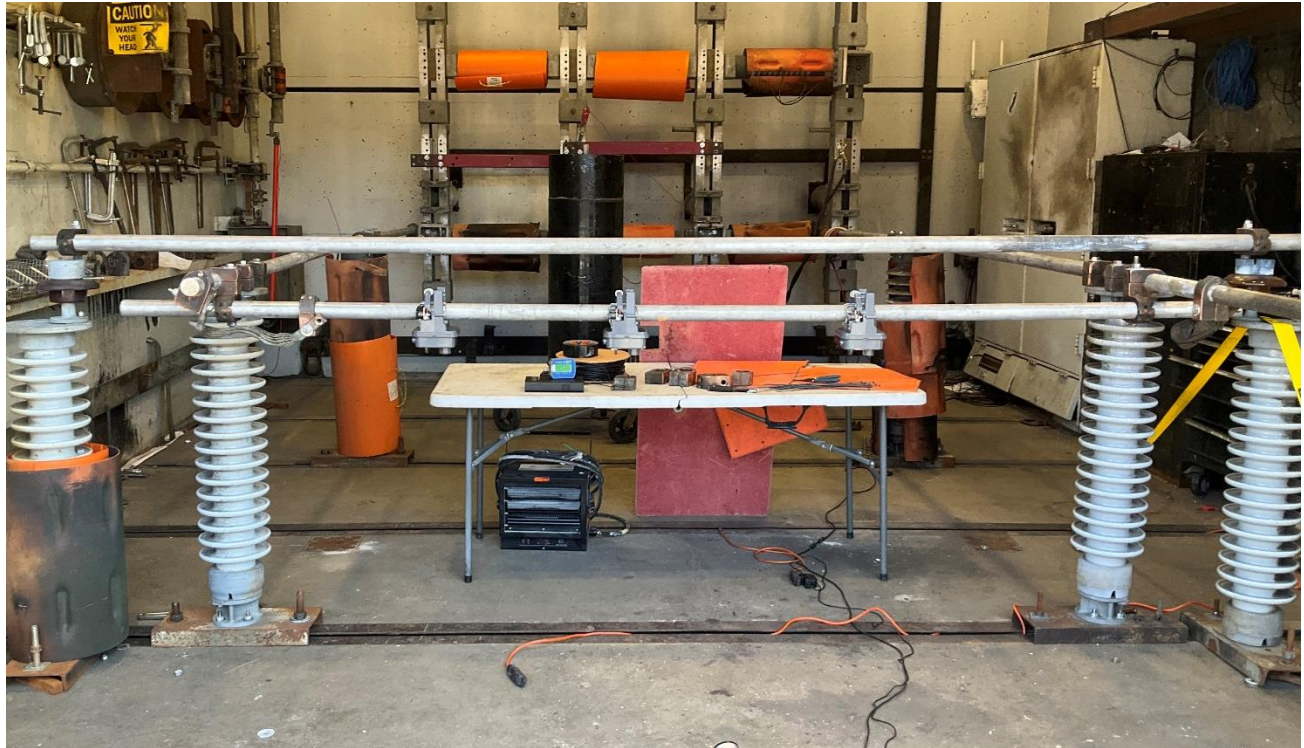
**Figure C-6: Test setup for the short-time current tests.**

Three SEL-8317 LINAM® UGFI units were tested simultaneously. The units were installed on a  $\Phi 2''$  round aluminum bus conductor with minimum one foot apart from each other, as shown in Figure C-6.

Three SEL-8317 LINAM® UGFI units were tested simultaneously. The units were installed on a Φ2" round aluminum bus conductor with minimum one foot apart from each other, as shown in Figures C-6.

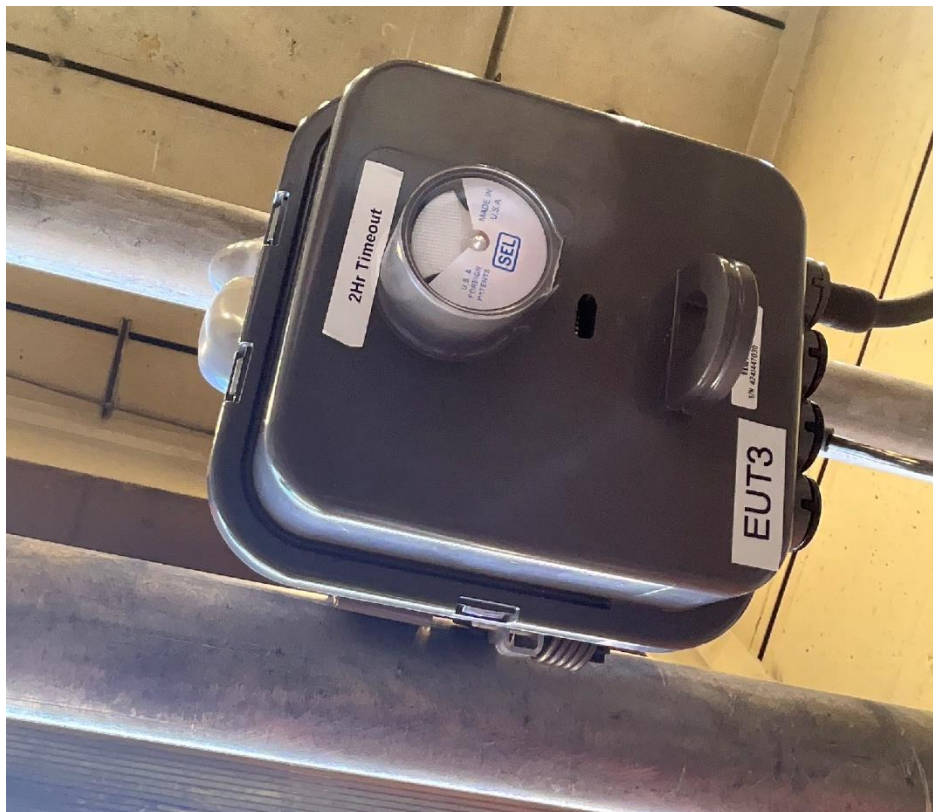
**Figure C-7: Sample in normal state after all 25 kA effect of current from adjacent conductor tests**

All three units continue to indicate NORMAL (untripped) after each short-time current test shot on the adjacent conductor.

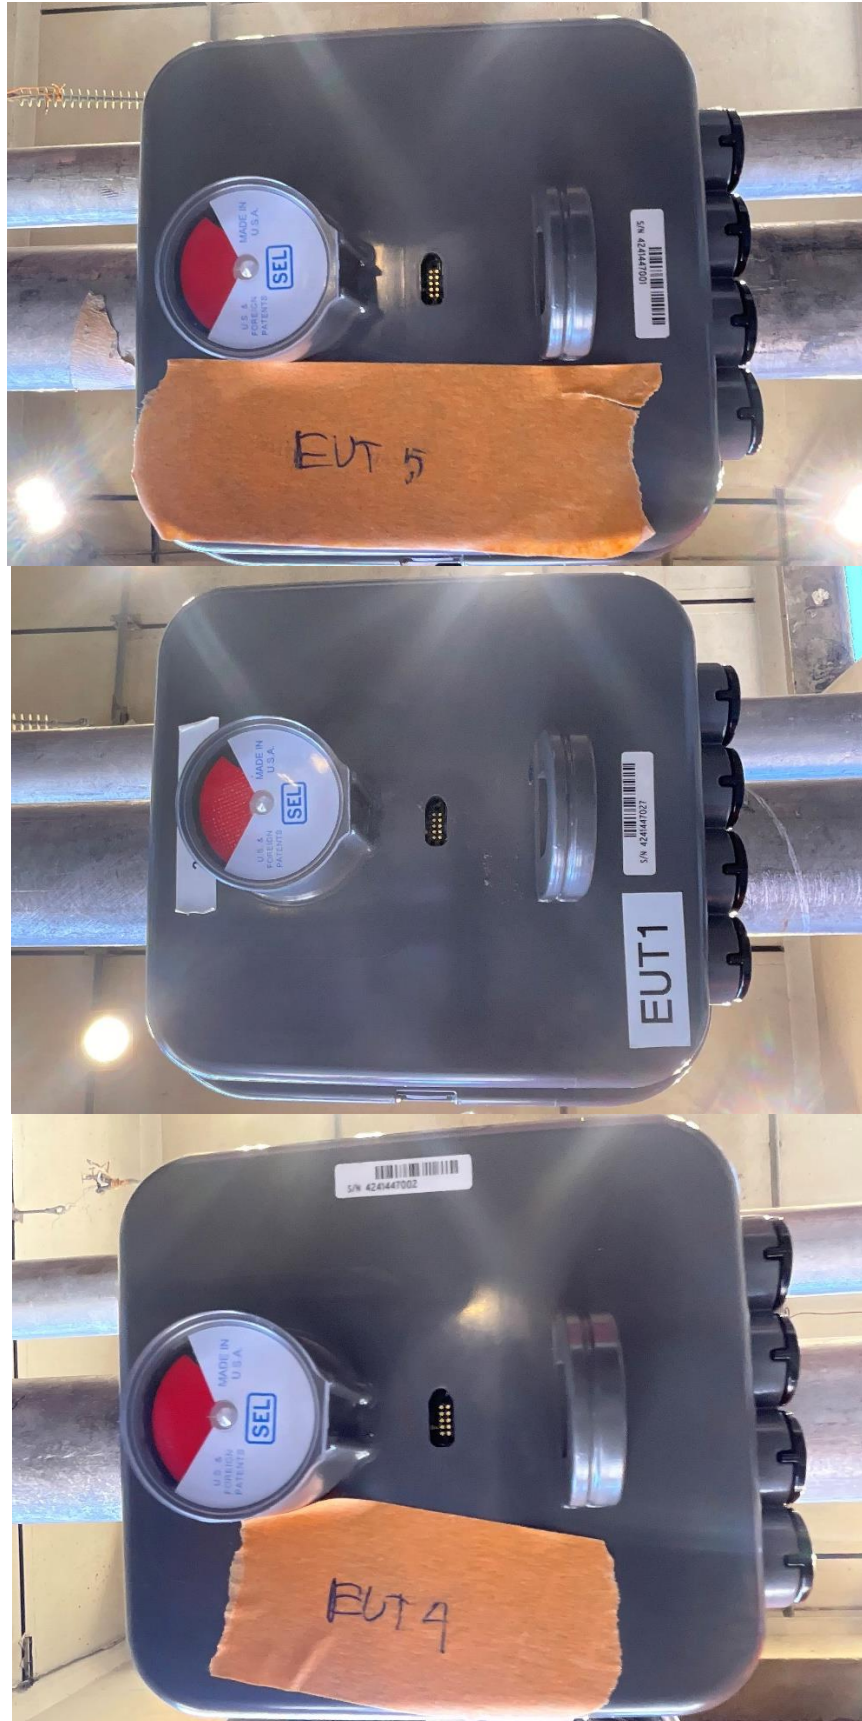
**Figure C-8: Samples in trip state after all 25 kA short-time current tests**

All three units turned into trip state after each test, as shown in Figure C-8. No visual damage was observed on the tested units after tests. The three units were able to be reset to normal state after the tests.

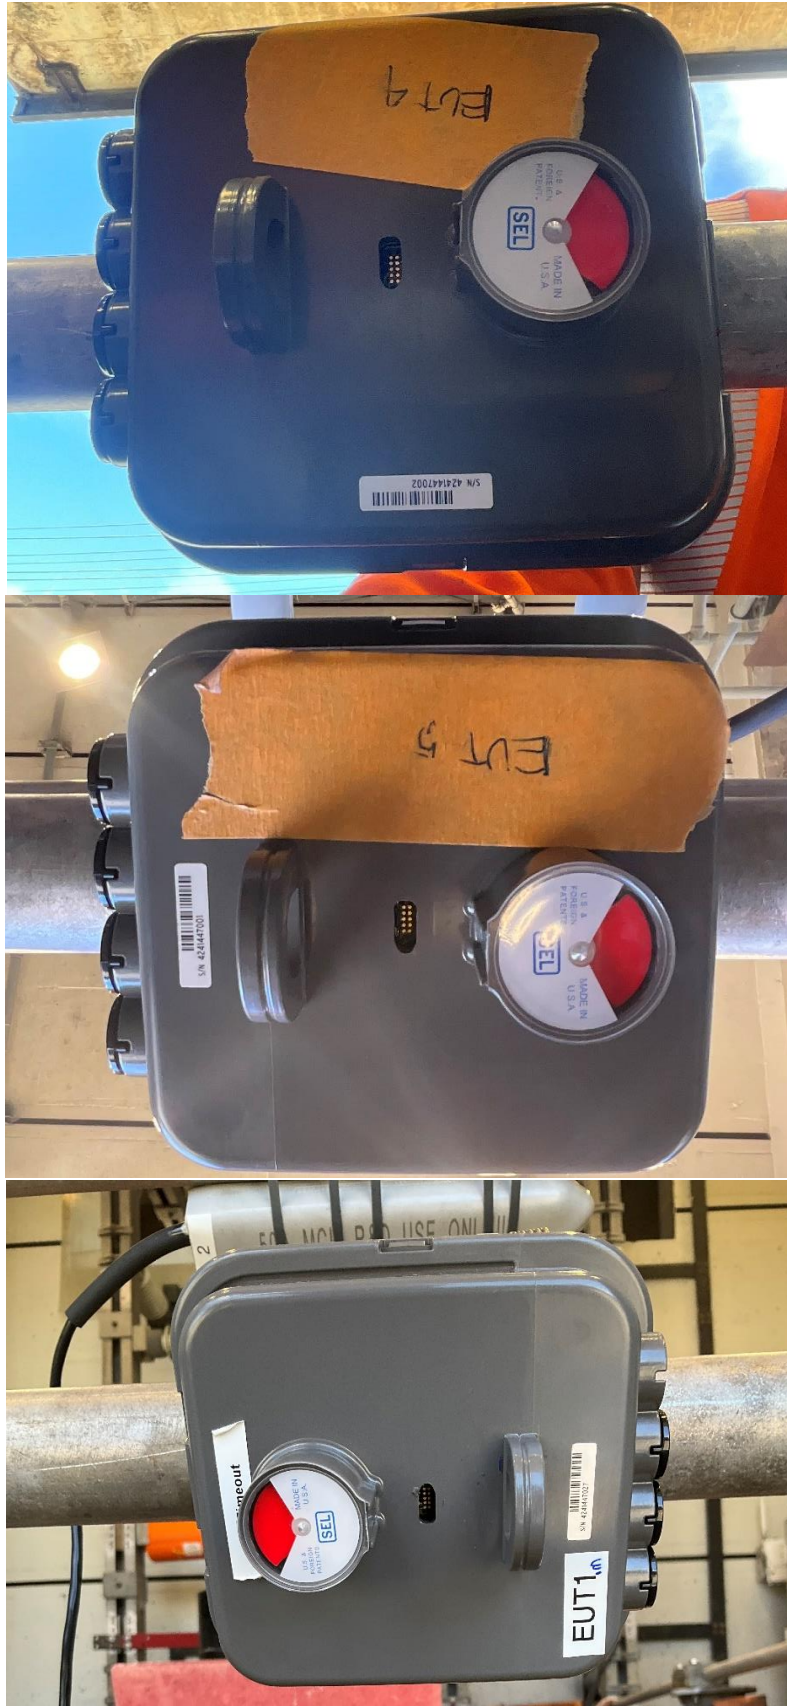
**Figure C-9: Samples in trip state after the first 40 kA short-time current test**

All three units turned into trip state after the first test, as shown in Figure C-9. And they were able to be reset to normal state.

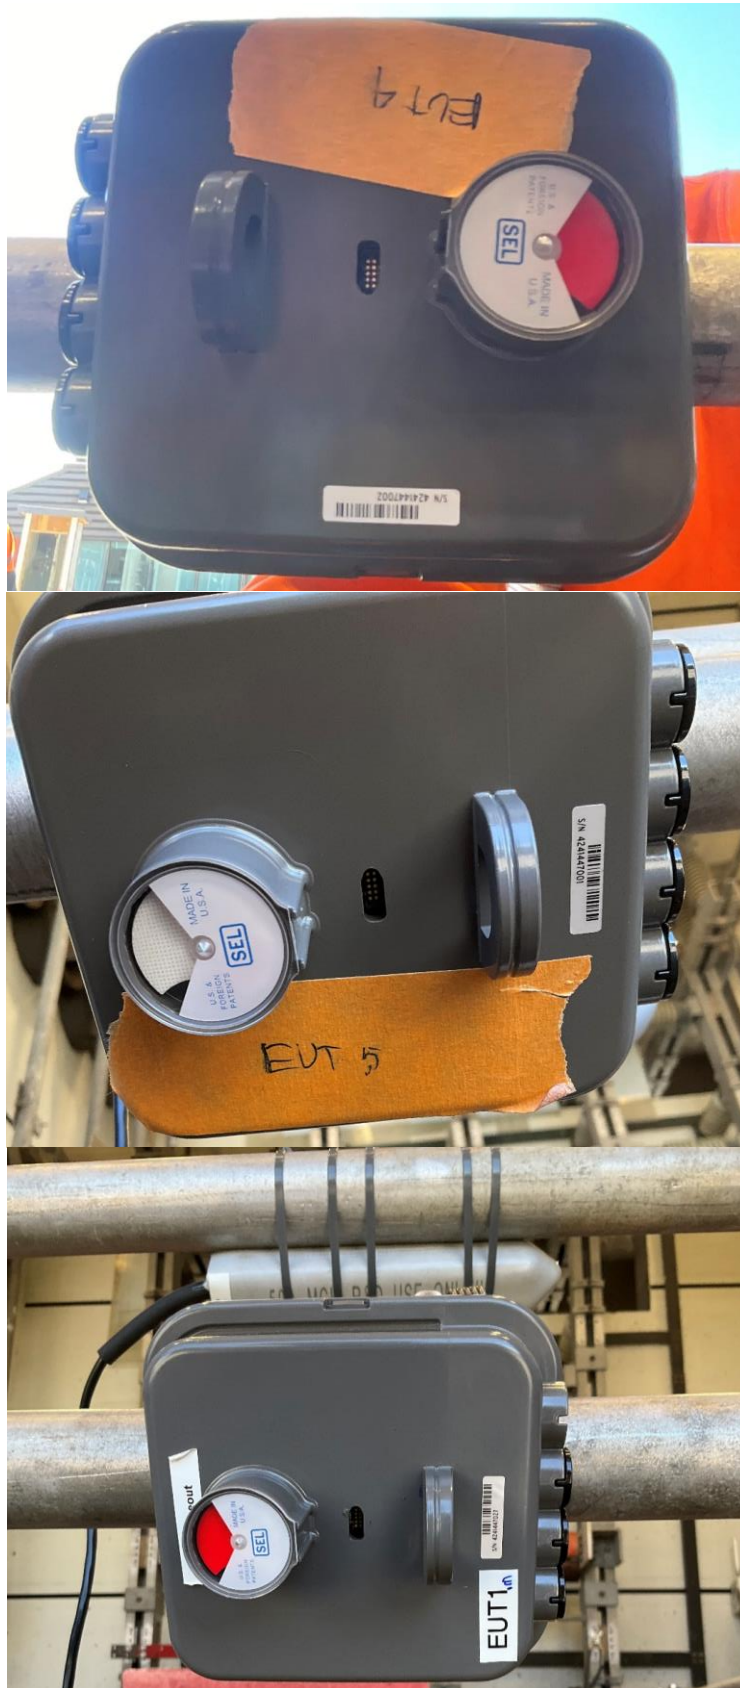
**Figure C-10: Sample #5 in normal state after the second 40 kA short-time current test**

EUT #5 maintained normal state after the second test shot, as shown in Figure C-10. It turned to trip state after being pull off from the conductor.
