# Utility Experience With an Ultra-High-Speed Line Protection Relay on a 230 kV Transmission Line

Ram Viswanathan, Andrew Jenkins, Monir Hossain, and Tu Nguyen  
*Entergy Corporation*

Presented at the  
53rd Annual Western Protective Relay Conference  
Spokane, Washington  
October 27–29, 2026

**Abstract**—As part of a pilot effort to learn more about time-domain relaying, fault locating, and ultra-high-speed protection, Entergy installed ultra-high-speed (UHS) line protection relays at both ends of a critical 230 kV transmission line that traverses a marshy area with limited access. While the pilot installation only monitored the transmission line and did not trip breakers, the fault records captured by the relays were analyzed and compared to fault records from in-service phasor-based relays. The comparative analysis focused on these key areas:

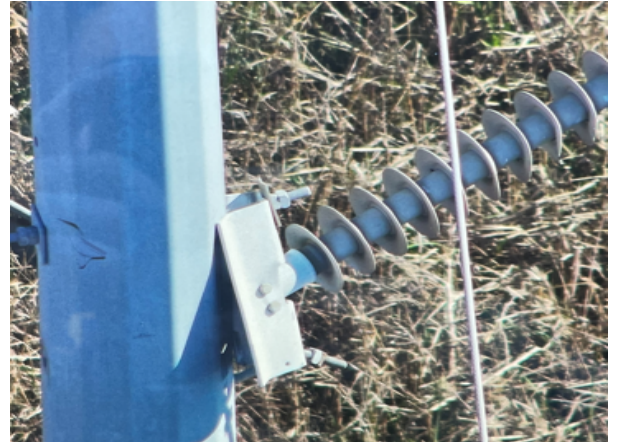
Fig. 4. Picture of Failed Insulator Support

The double-ended impedance-based distance to fault from the traditional relay was estimated to be 2.02 mi from Side B, which would be between Structures 23 and 24 on the transmission line. The traveling-wave fault-locating method of the UHS relay gave a distance-to-fault value of 2.405 mi from Side B, which would be between Structures 25 and 26. The line was inspected, and on Structure 25, an insulator supporting the faulted phase was found loosely attached to the pole due to a bolt failure, allowing the faulted phase to move freely. Evidence of contact was not found, but the calculated 2.405 mi point on the line was 834 ft from Structure 25 and 361 ft from Structure 26.

With this physical evidence (Fig. 4), it is clear that all relays operated correctly. More importantly, it shows that the UHS relay gave a more accurate fault location than the impedance-based estimate from the phasor-based relay. It was within 900 ft of the actual fault, which is within one transmission line span.

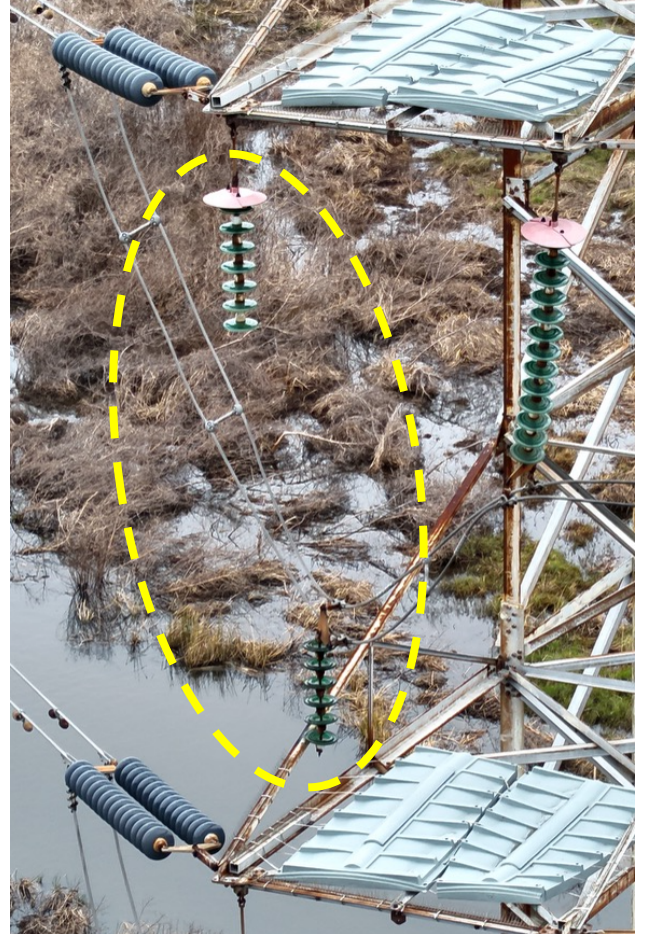
Fig. 10. Suspension Insulator Broken in Half

Transmission line inspection revealed a damaged suspension insulator 31.25 mi from Side A that appears to have allowed a conductor contact with the tower. A picture of the damaged insulator can be seen in Fig. 10. This event demonstrates the dependability offered in a UHS relay that also employs phasor-based elements, but it also underscores the importance of presenting the relay with the most complete power system information available by connecting a breaker
