# Applying Digital Current Differential Systems Over Leased Digital Service

Ken Fodero  
*Schweitzer Engineering Laboratories, Inc.*

Girolamo Rosselli  
*San Diego Gas & Electric*

Presented at the  
58th Annual Conference for Protective Relay Engineers  
College Station, Texas  
April 5–7, 2005

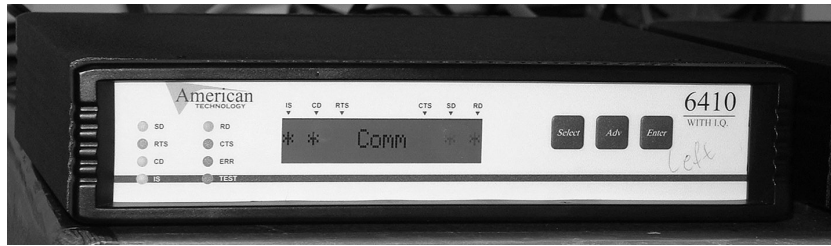
Starting in 2004 a new digital current differential relay using the principle of vector ratio of the remote-to-local current was tested for compatibility over a similar digital circuit. The first issue we encountered was that the CSU/DSU was designed for a V.35 communications circuit and the relay was only available with an EIA-422 interface. After an exhaustive search it was determined that there currently was no CSU/DSU device on the market that supported EIA-422 synchronous communications.

The relay manufacturer did an evaluation of the standards and determined that the electrical signal requirements between the two standards made the devices incompatible.

**Figure 6** CSU/DSU

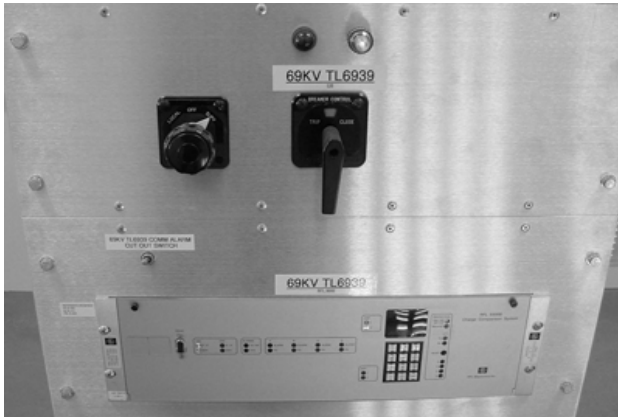
One such application is shown in Figure 17, Figure 18, and Figure 19.

**Figure 17** SDG&E Differential Relay 1

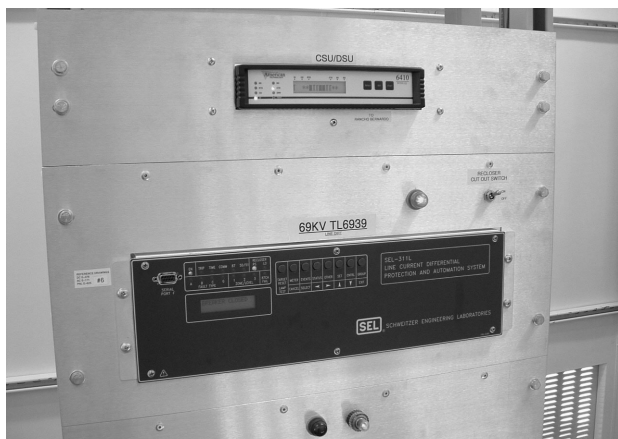
**Figure 18** SDG&E Differential Relay 2 Front View
