# Very High-Resistance Fault on a 525 kV Transmission Line – Case Study

**Abstract**—This paper analyzes a 300 ohm primary ground fault, which is an unusually high value for a 525 kV transmission line in southeastern Brazil. This case study emphasizes the techniques used by the analysts.

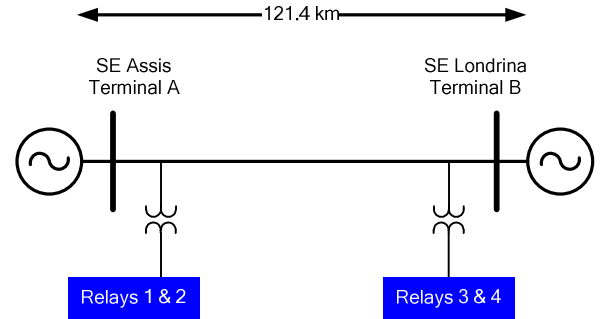
Fig. 1. 525 kV transmission line from SE Assis Terminal A to SE Londrina Terminal B, located in southeastern Brazil

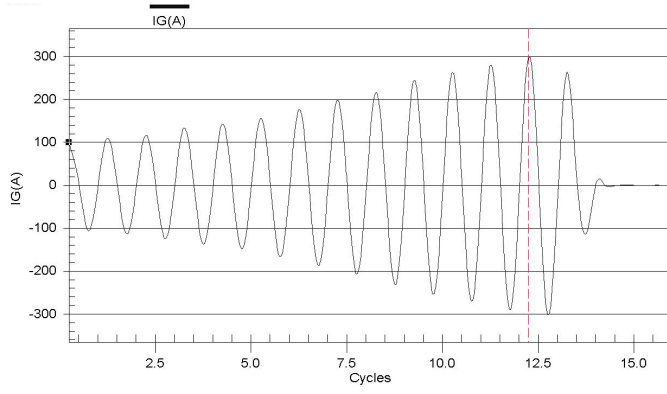
The first fault was characterized as a high-impedance fault with gradually rising ground current. Several cycles after the start of the fault, the current reached the minimum protection threshold. Fig. 2 displays the ground fault current as seen from Terminal A.

Fig. 2. Ground current at Terminal A

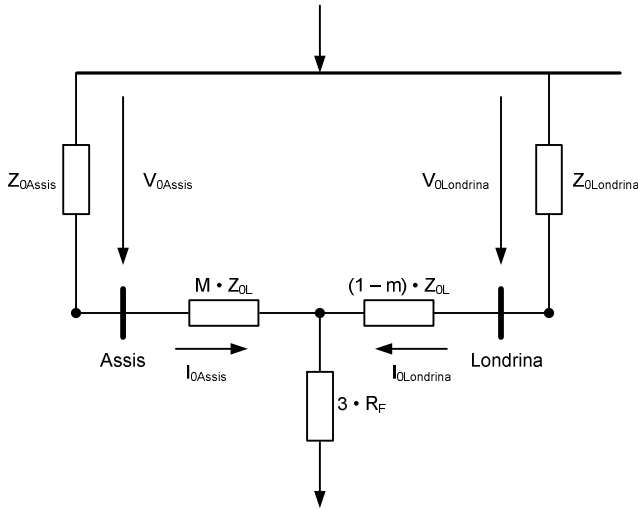
The engineers used the zero-sequence network for fault location calculation because it is not influenced by load conditions at the fault instant like the positive-sequence network is. Fig. 5 shows the zero-sequence network, and Table X shows the validation results.

Fig. 5. Zero-sequence network

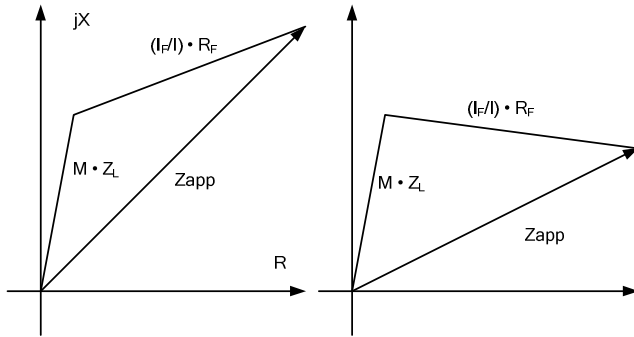
The effect of  $R_F$  in a looped line can be seen at [1] and is illustrated in Fig. 6.

Fig. 6. Fault impedance effect

The  $I_F/I$  ratio can cause an increase in the measured  $R_F$  as well as a displacement of the measured resistance angle so that the apparent phase-to-ground impedance can assume high values.

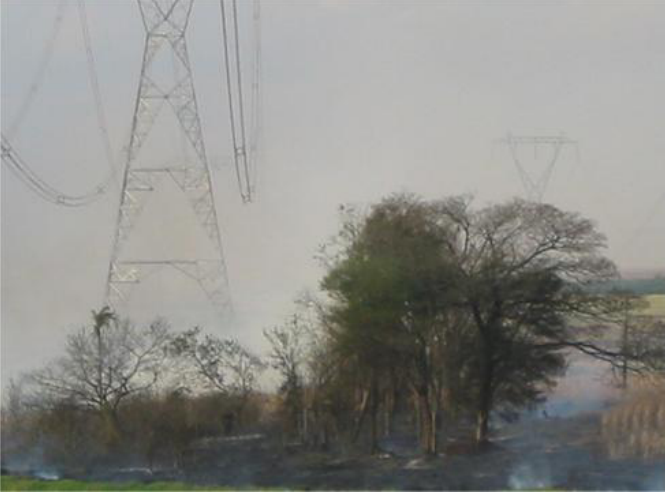
On August 16, 2006, two faults were recorded (at 2:00 p.m. and 2:04 p.m.), with the transmission line opening and reclosing in both cases. At the time, a line maintenance team observed the flashover from the transmission line and the vegetation close to the Paranapanema River, as shown in Fig. 7.

Fig. 7. Fire damage visible at fault location

Fig. 7 and the fault locations shown before prove that there was a phase-to-ground fault involving a tree, and the analysts concluded that the July 2006 faults were caused by the same tree. Fault resistances between 528 ohms (first fault of July) and 34 ohms (last fault in August) were observed.

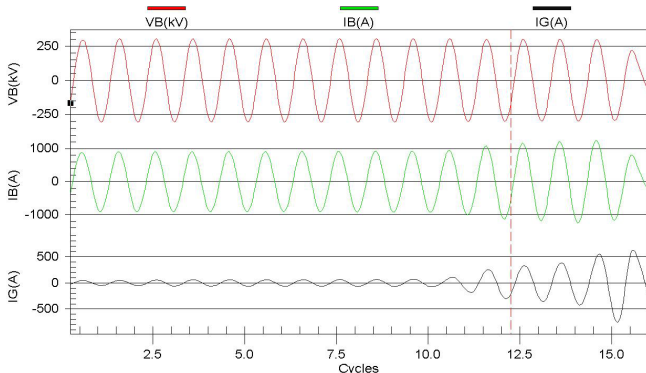
This fault involved a tree and was characterized by very high resistance. The faulted phase voltage and current and the residual current are displayed in Fig. 8.

Fig. 8. VB, IB, and IG waveforms
