Advanced Event Analysis Tutorial

Part 2: Answer Key

Karl Zimmerman, *Schweitzer Engineering Laboratories, Inc.*

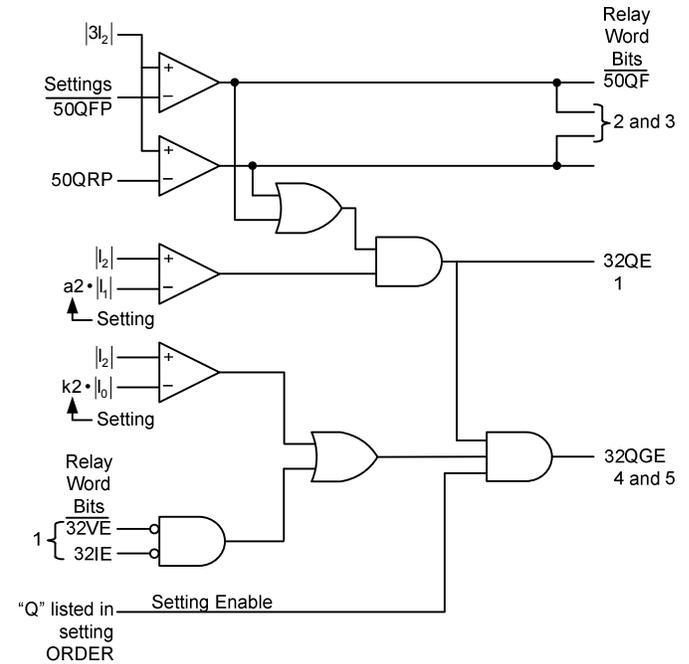
The 32 element ORDER setting (QV) is set to use the negative sequence (Q) and then switch to zero sequence (V) if the operating quantities dictate, indicated by element 32QGE dropping out. The following figure displays a logic diagram from the SEL-311C Instruction Manual (Figure 4.8) that shows the internal enables used in ORDER switching logic.

There were about 40 A of I2 and 200 A of I0. The settings 50QFP and 50QRP are based on $3 \cdot I_2$, and 50GFP and 50GRP are based on $3 \cdot I_0$. Thus, there were $120/400 = 0.3$ A of $3 \cdot I_2$, greater than 50QRP. But the k2 ratio, I_2/I_0 , is slightly less than the 0.2 setting. Thus, the relay switched from Q to V, as indicated by the 32QGE bit dropping out.

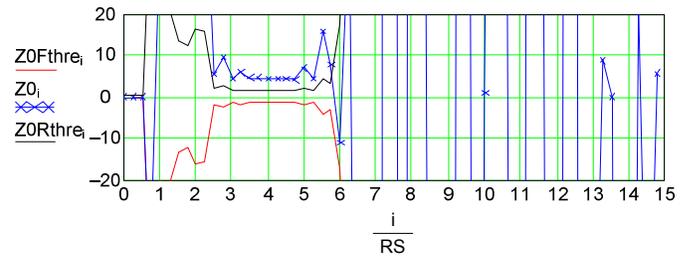
The root cause of the problem is that the Z0F and Z0R settings are biased too far in the forward direction.

In the following figure, the Z0 element simulation correctly declared reverse after the Z0F and Z0R settings have been changed to -0.3 and +0.3, respectively. As we can see, Z0_i plots above the Z0F and Z0R thresholds.

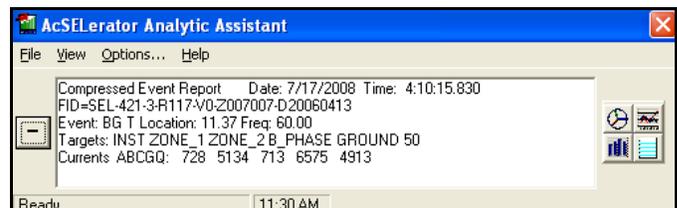
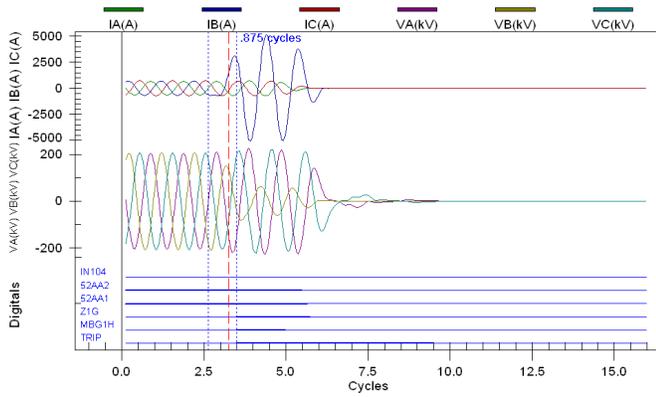
This was a BG fault. The following screen captures of a local filtered event show a high-speed Zone 1 trip.

Element Z1G produced the TRIP condition. From the initial change in current to TRIP was 0.875 cycles. From the initial change in current to both breakers opening was 3.0 cycles.

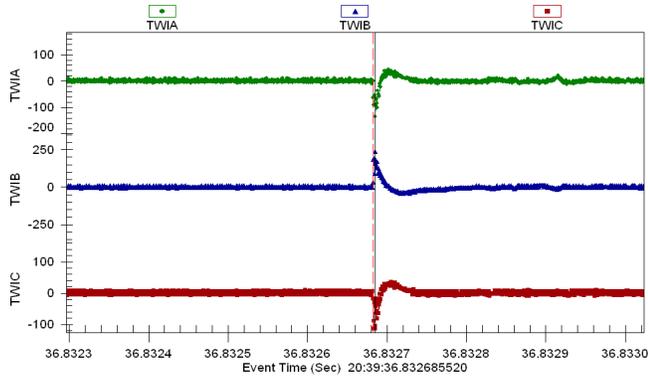
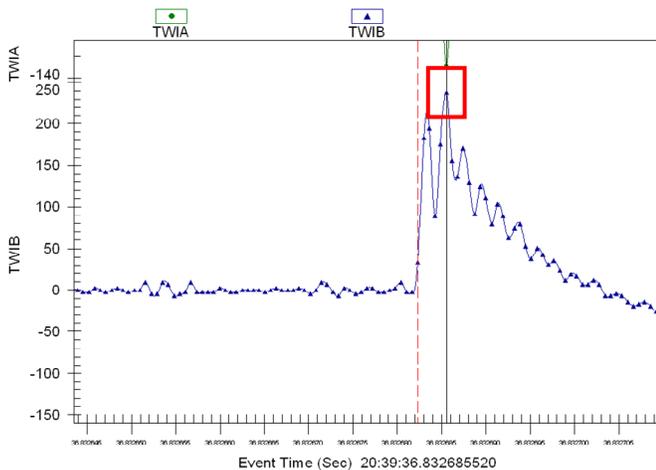
For the local event, the time stamp is 20:39:36.832685520. The following screen capture of the local TW COMTRADE event gives accurate time stamps for TW fault location.

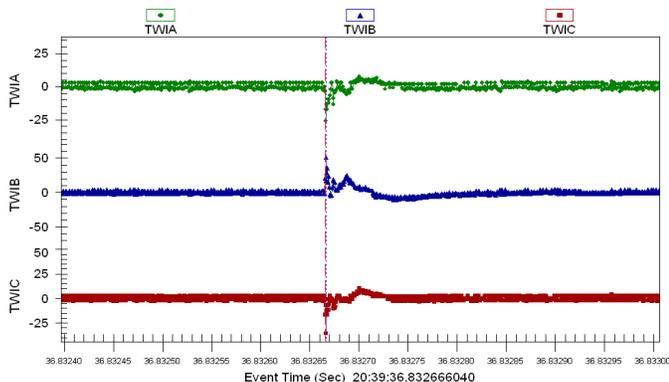
For the remote event, the time stamp is 20:39:36.832666040. The following is a screen capture of the remote TW COMTRADE event.

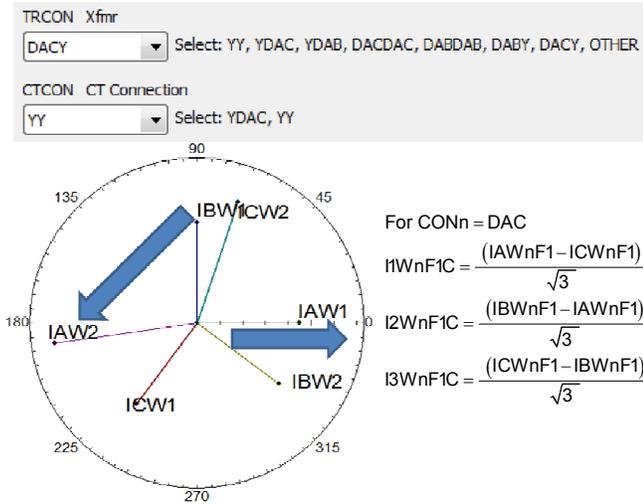
The following screen capture shows the settings based on incorrect information.

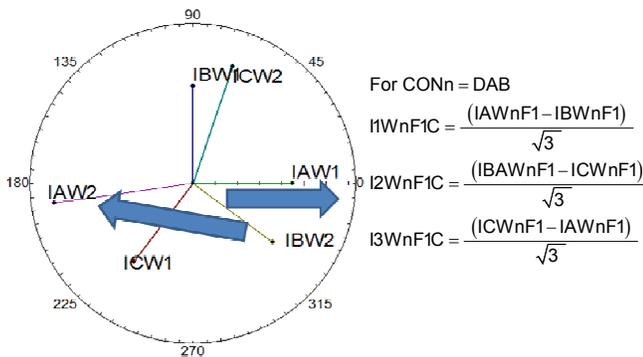
Can we correct the 87T setting by changing to DABY? The following screen capture shows current phasors with the TRCON = DABY setting.

The answer is yes, but the system phases and phase rotation will not match the relay. The solution is to fix the wiring.

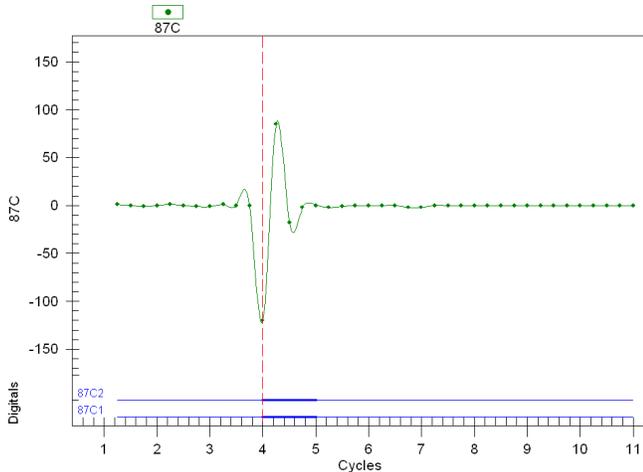
This was a trip by the 87C1 element. The pickup was set for 75 V. The following screen capture of the local filtered event shows a high-speed Zone 1 trip.

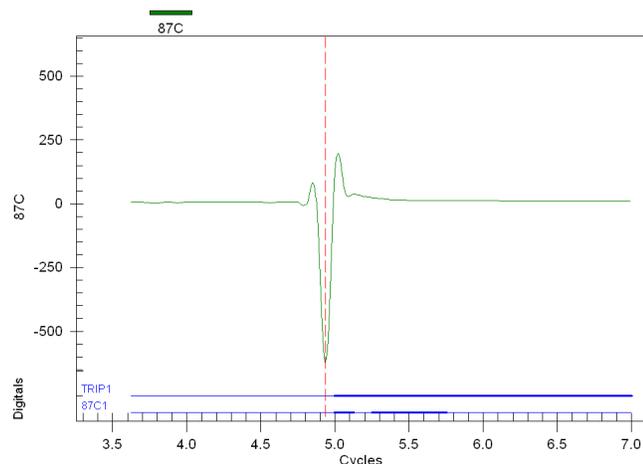
The following screen capture of the local unfiltered event shows a high-speed Zone 1 trip.

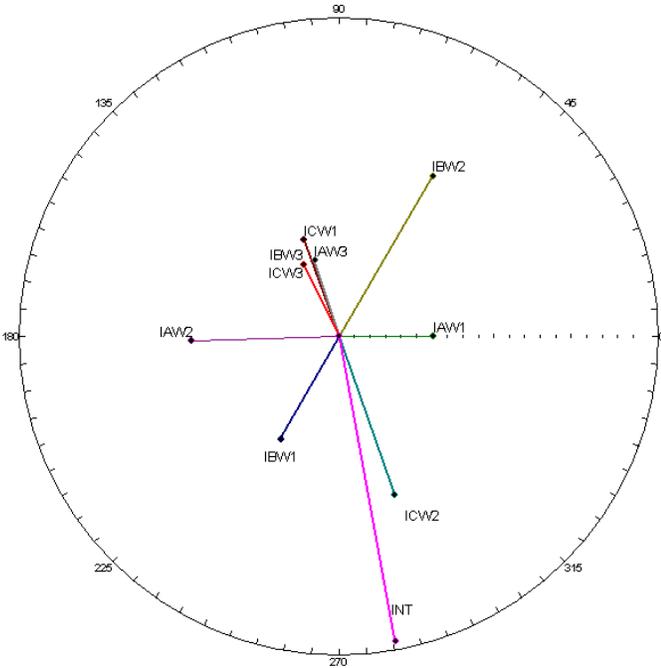
A review of the event data reveals only slightly unbalanced phase currents, but unusually high neutral current (INT).

We can see that the secondary phase currents on Winding 2 were about 1.5 times the Winding 1 currents. This matches the expected currents for a given load. All of the winding currents were relatively low, indicating there was no fault condition. Thus, we suspect the wiring in the CT neutral circuit.

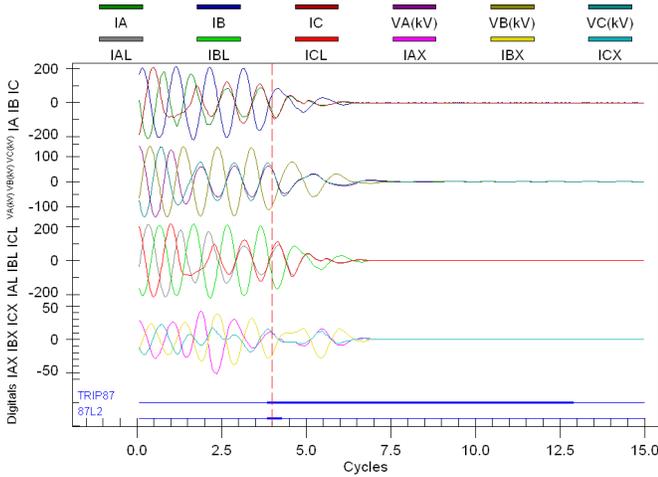
The following screen capture shows 87L2 operate.

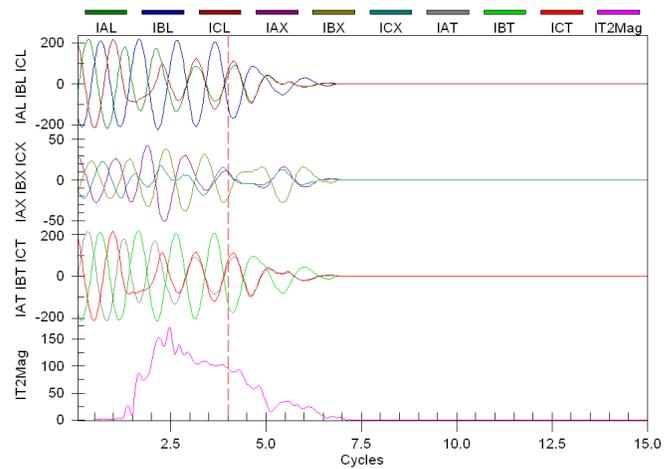
We can see significant differential current in the pre-fault. One of the prominent characteristics of high-voltage cables is the presence of line charging current caused by the electrical shunt capacitance. Even on short lines, this can be an issue.

If we focus on the total I2 magnitude (IT2Mag), we see an increase during the external fault, as shown in the next screen capture.

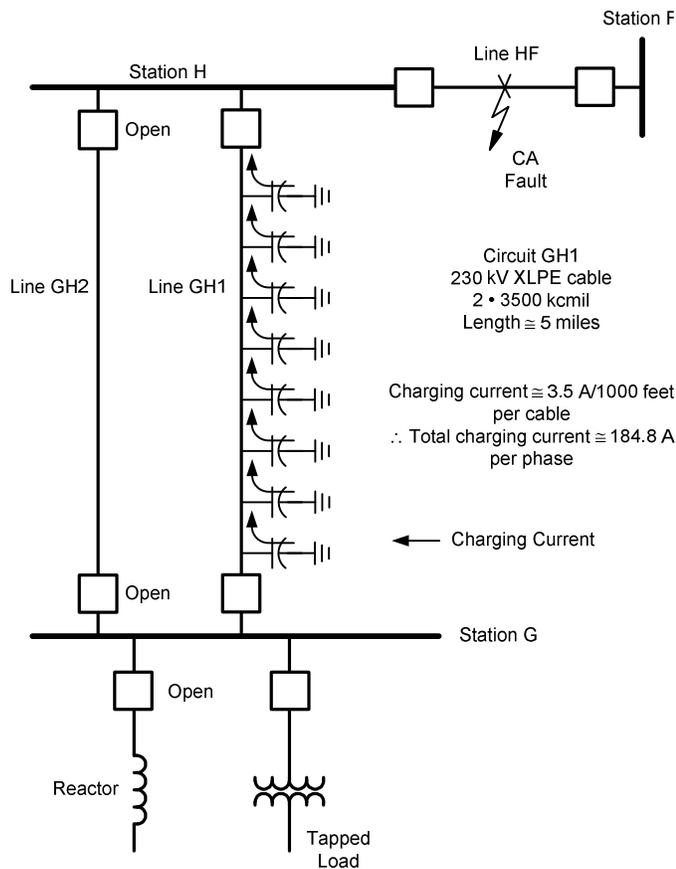
The following one-line diagram shows the shunt capacitance source.
