Open-Circuited CT Misoperation and Investigation

David Costello

Schweitzer Engineering Laboratories, Inc.

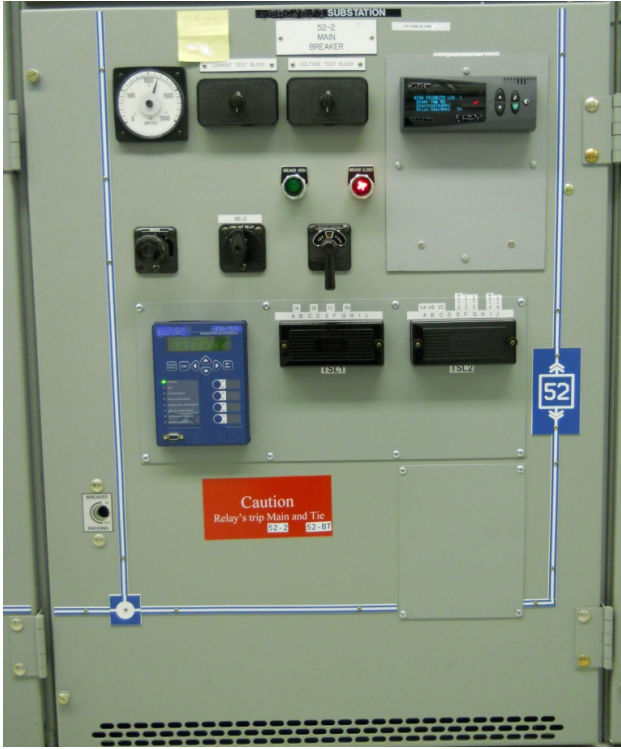
Fig. 9. Switchgear Breaker, Relay, and Controls

The application under study in this paper is a microprocessor-based overcurrent relay installed in switchgear in an industrial plant (see Fig. 9). CTs from the main and bus tie breakers are paralleled and wired to the relay. One breaker is normally closed while the other breaker is normally open.

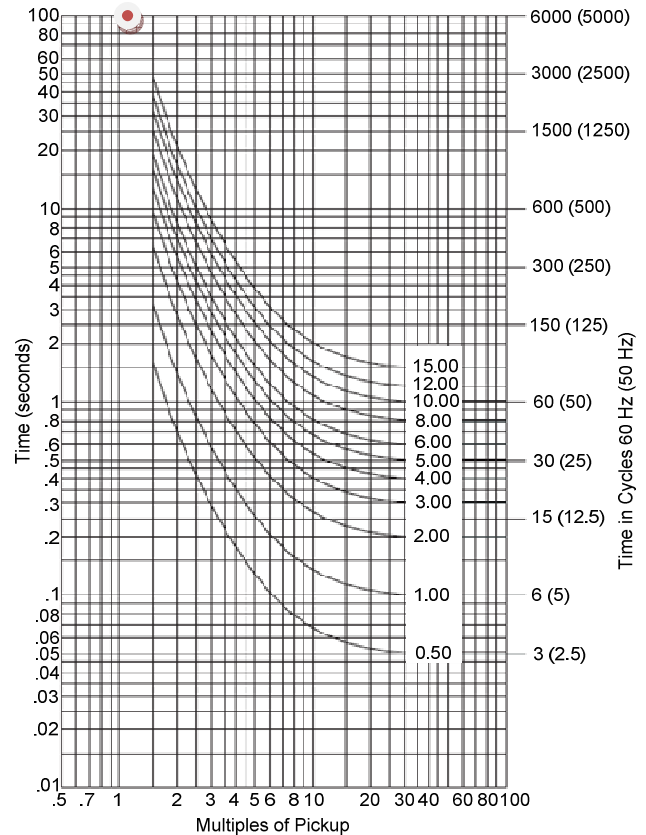
Fig. 15. IEEE Very Inverse Curve

When 51NIP finally asserted continuously, IN was equal to 817 A primary, just above pickup. At this current level and with an IEEE very inverse curve and a time dial setting of 5, the 51N element would take over 7.5 minutes to trip (see Fig. 15). Load current continued to increase, however, and IN increased in magnitude to over 900 A primary at the time of the trip. This sped up the trip time.

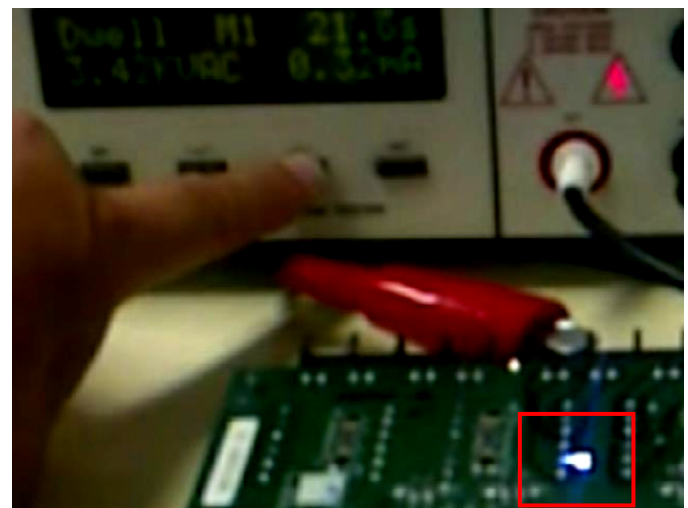
Fig. 22. Video From Dielectric Strength Test

To prove this theory in the laboratory, the relay manufacturer conducted a dielectric strength test on a circuit board from a like make and model relay. A video recording was made of this test. The relay specifications state that its analog inputs will withstand up to 2,500 Vac. This exceeds the IEEE standard minimum by 1,000 V. Voltage was applied between the polarity of IC (terminal Z05) and the relay ground. At approximately 3.4 kV, the relay failed the dielectric test. The test was repeated, and in the second test, we can observe a visible flash (see Fig. 22). No permanent damage was observed on the relay under test, primarily because the dielectric test equipment automatically shuts down the high voltage for safety when measured leakage current exceeds a threshold of about 300 mA.

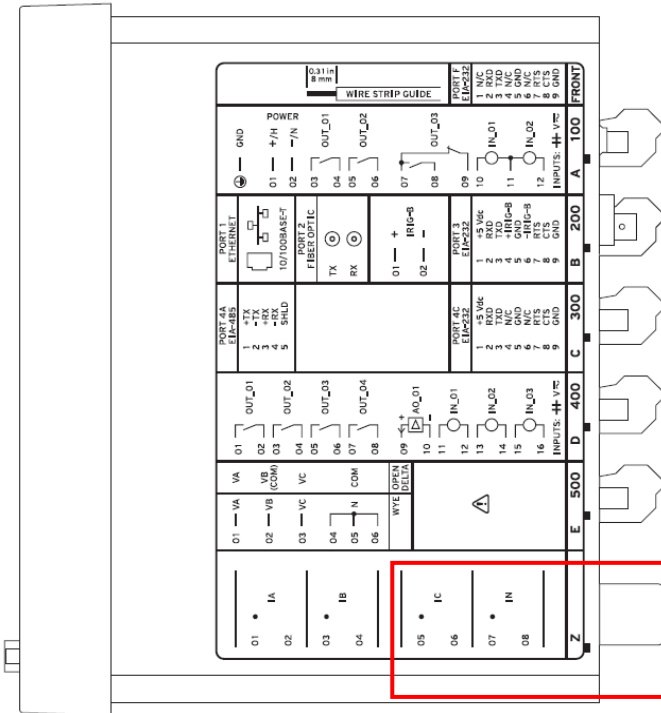
Fig. 23. Profile of Relay Hardware

The relay current terminals are shown in more detail in the next few figures. Fig. 23 is a profile view of the relay hardware. The bottom terminal block is for the current connections. The diagram or sticker on the side of the relay simply explains the connections and terminal numbering. Terminal Z05 is C-phase polarity. Terminal Z06 is C-phase nonpolarity. Recall in this application that Z06 is the terminal that was open-circuited.

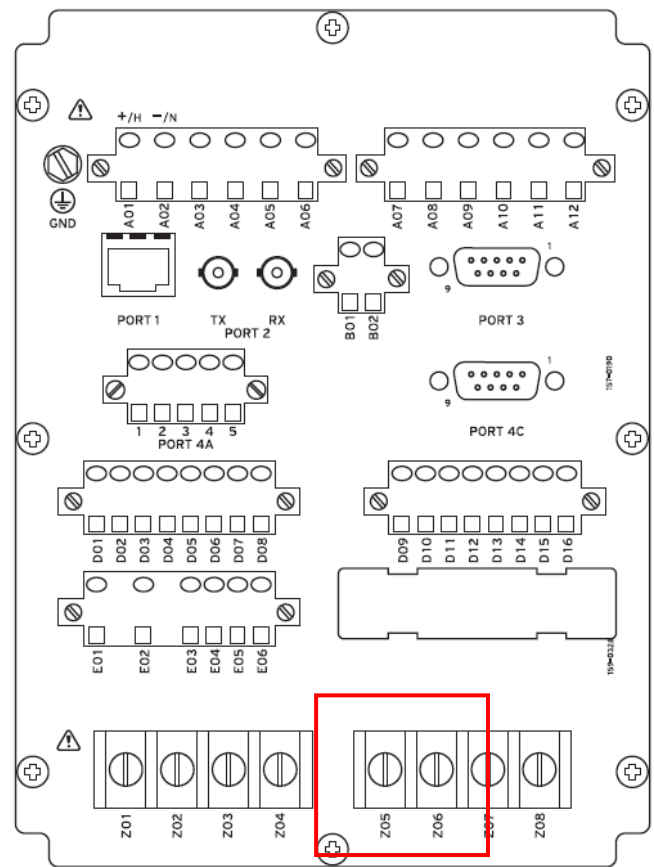
Fig. 24. Rear-Panel Layout of Relay Hardware

Fig. 24 is a view of the relay rear-panel layout. The CT connections are made to the Z terminal block on the bottom. Terminal Z05 is the fourth screw from the right, and terminal Z06 is the third screw from the right.

With a theory and a dielectric test on a like make and model relay in hand, the industrial plant was advised that they had a damaged relay in service that needed to be removed from service and repaired immediately. After switching loads to an alternate source, the breaker and relay were removed from service for thorough inspection.
