Simultaneous Faults on the 11 kV System of an Offshore FPSO Vessel

Presented at the
PCIC Europe Conference
Rome, Italy
June 7–9, 2011

Abstract—This paper provides a case study of simultaneous faults that occurred December 5, 2009, within the 11 kV power system of a floating production, storage, and offloading vessel located in the Norwegian sector of the North Sea. The event resulted in severe damage to a 9.2 MW compressor drive motor, damage to the transformer feeding an adjustable speed drive, and interruption of many loads on the ship. Background regarding the power system on the vessel and the state of the system at the time of the event is provided in Section I and Section II. This paper shares an exhaustive analysis of the event, including initial responses and findings of the offshore technicians, event reports from two microprocessor-based motor protection relays, subsequent analytical work, and forensic work performed on the failed equipment.

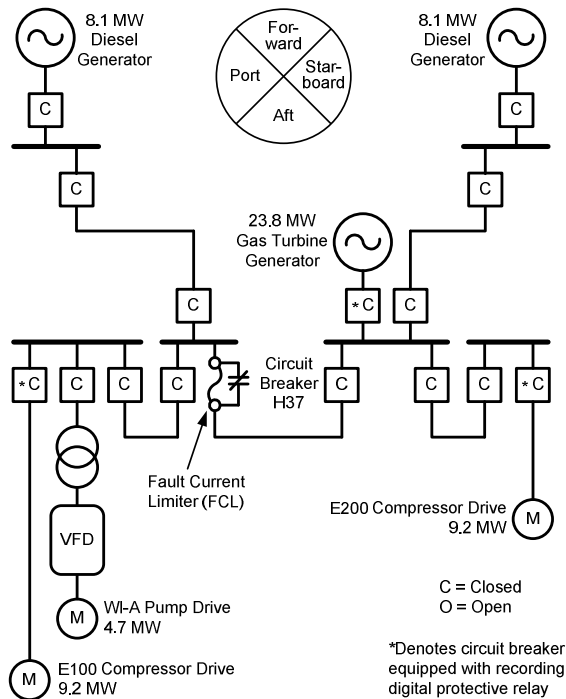
Fig. 1 Simplified Configuration Prior to Incident

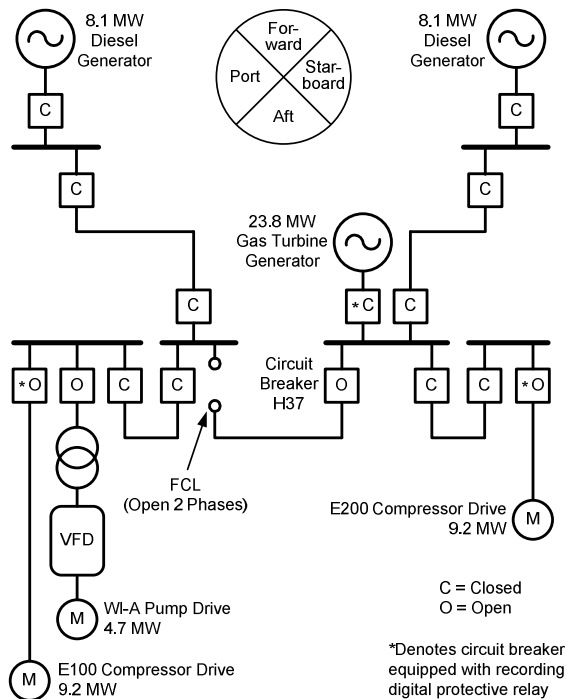
Fig. 2 Simplified Configuration Following Incident

With circuit breaker H37 open, the power system had separated into two independent islands (i.e., port and starboard island separation). Within a short time, offshore operating and maintenance staff determined that two poles in the FCL had activated (opened) and the E200 export

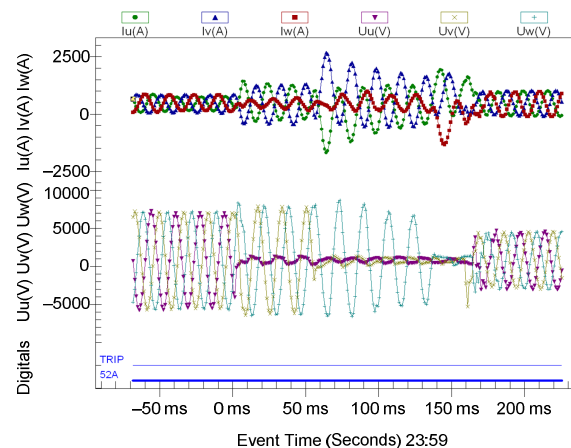
Early engineering observations were crucial to further understanding. First, the earth fault current recorded by the E200 protective relay was over 17,000 A, which is well in excess of the system design maximum of 112 earth fault amperes. Hence, it was quickly concluded that this was not an incident involving a single zero-sequence current source. Second, high fault current had flowed through the FCL, causing it to activate on Phases U and V. This supported a conjecture that a second zero-sequence current source had existed on the port side of the power system (i.e., on the opposite side of the FCL from the E200 motor). Offshore efforts were then focused on searching for this phantom second earth connection. In particular, the search was focused on confirming that neutral earthing systems and associated connections were properly configured and functional. One possible theory was that this second earth connection had unknowingly existed for some time and its existence was highlighted when the E200 motor fault occurred. Event profiles from the E100 and E200 protective relays can be seen in Fig. 3 and Fig. 4, respectively. Note that the currents and voltages displayed in these figures are divided by a factor of $\sqrt{2}$.

Fig. 3 Event Profile From E100 Protective Relay

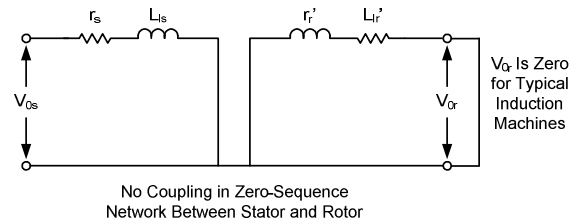
We can recall that for a motor whose windings are connected in star with the neutral point ungrounded, no zero-sequence current can flow in the windings. However, if for some reason the machine became a grounded machine, then the zero-sequence equivalent circuit for the motor would be as shown in Fig. 12 [3].

Fig. 12 Zero-Sequence Network for an Induction Machine Whose Windings Are Connected in a Grounded Star Configuration

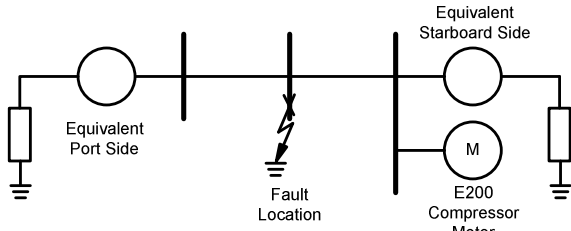
Because the machine is intended to be an ungrounded motor, one possible explanation of this is Theory IV (outlined in Section V): that a fault occurred at or near the neutral point of the machine. To help illustrate how a grounded induction machine can supply zero-sequence current to a second fault elsewhere in the power system, consider the simplified one-line diagram shown in Fig. 13.

Fig. 13 Simplified One-Line Diagram With Thévenin Equivalent Circuits for Port- and Starboard-Side Power Systems

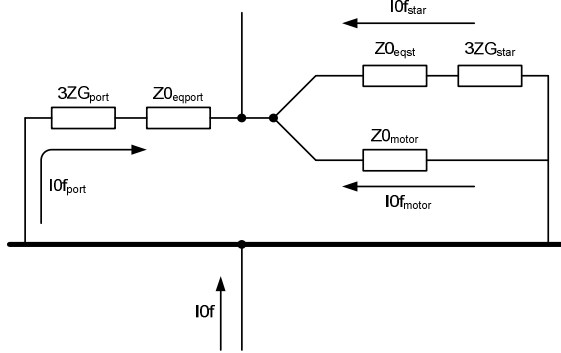
If we consider only the zero-sequence network, use Thévenin equivalent circuits for the port- and starboard-side power systems, and include the equivalent circuit for the induction machine shown in Fig. 12, we arrive at the zero-sequence network shown in Fig. 14. Because the motor impedance $Z_{0\text{motor}}$ is much less than the port or the starboard equivalent impedances (because of the grounding resistors), the motor provides a low-impedance path for the zero-sequence current to flow. Again, this path is only present when the machine is either a grounded star machine or, as Theory IV asserts, there is a ground fault near or at the neutral point of the machine.

Fig. 14 Equivalent Zero-Sequence Network
