A Current Story – When Primary Met Secondary

Genardo Corpuz
Lower Colorado River Authority

Swagata Das and Ariana Hargrave
Schweitzer Engineering Laboratories, Inc.

Abstract—Protective relays require accurate voltage and current measurements from potential transformers (PTs) and current transformers (CTs) to reliably protect the power system. In this paper, we describe a unique event in which the secondary wiring of two CTs, one going to a bus differential relay and the other to a transformer differential relay, made contact with the primary system and caused a fault. This subjected both relays to primary-level currents, causing them to measure false differential current and operate. The paper discusses the outage that occurred and the investigation the utility performed, followed by how relay event reports were used to substantiate the utility’s findings and gain additional insight into the fault. The paper also discusses the damage that can occur to a relay when CT secondary wiring comes in contact with the primary system.

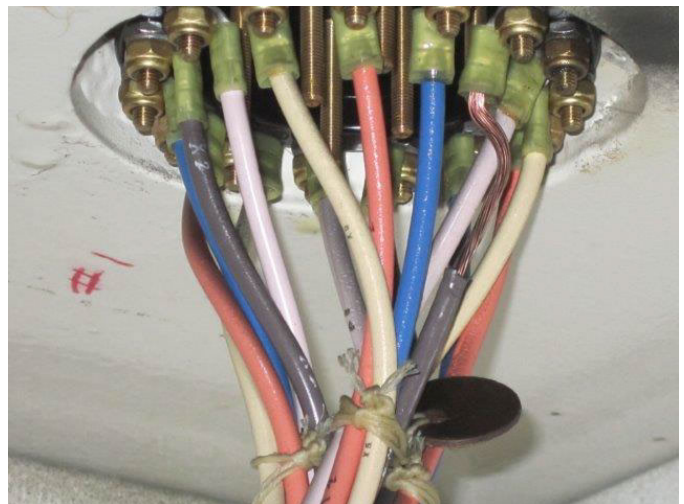
Fig. 4. CT secondary wiring inside the tank connected to the underside of a junction box

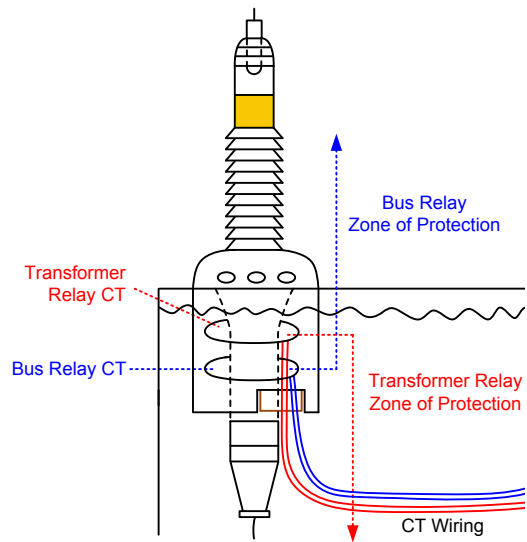
Fig. 17. CT placement and zones of protection

Although the point where the CT wiring made contact with the bottom of the bushing was physically outside of the bus relay zone of protection (per Fig. 17), this is not a bus relay misoperation. During the first part of the event, the bus relay saw the transformer relay CT wiring make contact with the bottom of the bushing and properly restrained for this external fault. When the bus relay CT wiring became physically involved in the fault, the bus relay was no longer receiving reliable signals from its CT. This made it impossible for the relay to determine whether the fault was inside or outside of its zone of protection, and the relay operated.

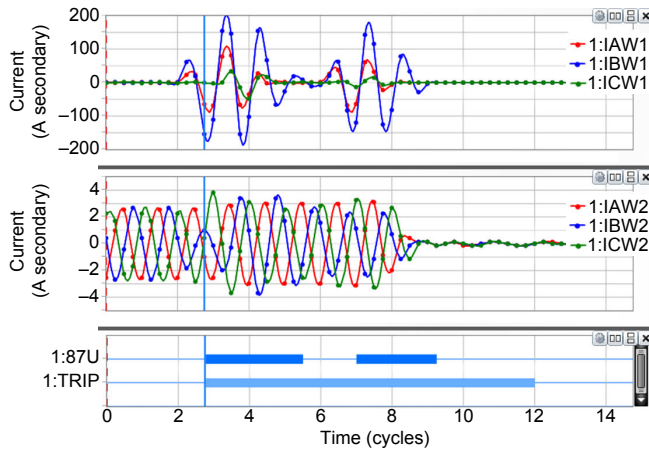
Fig. 18 shows the filtered event report from the transformer differential relay (Relay Y) protecting Transformer T1. The blue vertical line shows when the relay issued a trip on the unrestrained differential element (87U). The event shows that fault current is very high on the high side of the transformer (IAW1, IBW1, and ICW1), with not much change to the currents on the low side (IAW2, IBW2, and ICW2). Because fault current did not pass through the low-side CTs, it can be concluded that the fault was upstream of those CTs.

Fig. 18. Filtered currents on high and low side reported by transformer relay

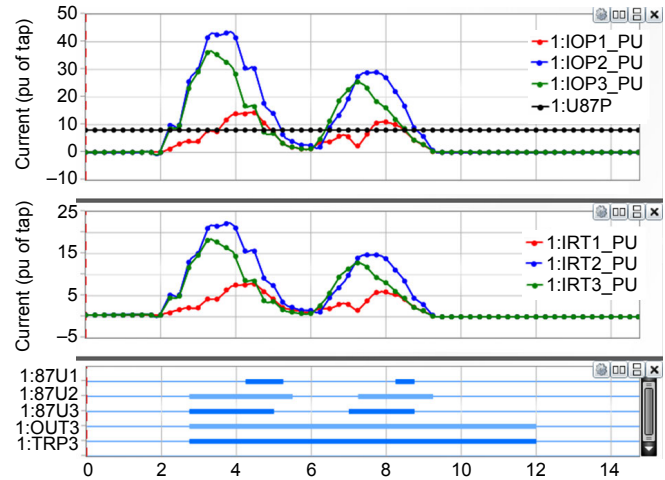
Fig. 19 shows the operate and restraint currents recorded by the transformer relay in per unit (pu) of tap. IOP1_PU and IRT1_PU correspond to the A-phase operate and restraint currents that the relay calculates after it has compensated IAW1 and IAW2 (in Fig. 18) by magnitude and phase angle, as described in Section I. Similarly, IOP2_PU and IRT2_PU correspond to the B-phase and IOP3_PU and IRT3_PU correspond to the C-phase operate and restraint currents. Note that when the fault starts to occur at Cycle 2, both the operate and restraint currents increase. The B-phase and C-phase operate currents soon become higher than the unrestrained element pickup value (U87P) of 8 pu. Unrestrained elements 87U2 and 87U3 assert, and the relay operates. The transformer relay tripped correctly for the increase in operate current that it saw from the fault.

Fig. 19. Operate and restraint quantities from the transformer relay

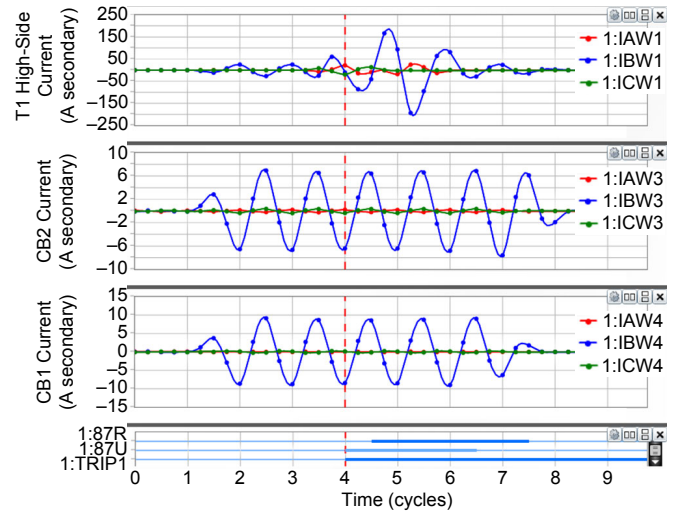
Fig. 21 shows the filtered event report from the low-impedance bus differential relay (Relay X). The dashed red vertical line shows when the relay issued a trip on the unrestrained differential element (87U). The W2 input on the bus relay (corresponding to the high side of Transformer T2) is not shown because it was not a source of fault current throughout the event.

Fault current begins to flow at Cycle 1 of the event. Between Cycle 1 and Cycle 3, B-phase fault current was seen on the W3 and W4 inputs of the relay (corresponding to the incoming transmission lines) as well as the W1 input (corresponding to the high side of Transformer T1). For a true external fault, the currents coming into the zone of protection

Fig. 21. Filtered currents reported by the bus relay

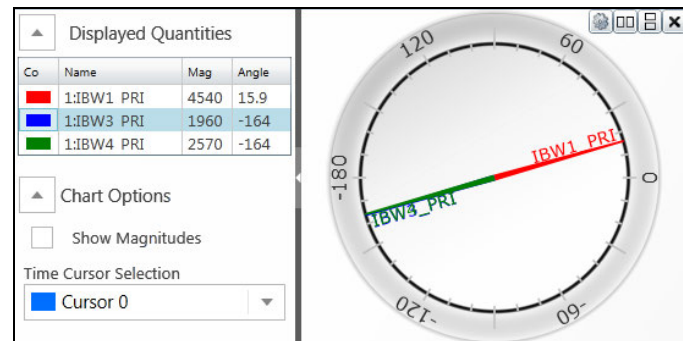
should equal the currents leaving the zone of protection. Fig. 22 shows the B-phase current phasors in primary amperes for W1, W3, and W4 at Cycle 3 of the event. The phasors show that the two incoming feeds (W3 and W4) have the same phase angle, and their sum is equal to and 180 degrees out of phase with the outgoing feed (W1). This is what is expected for an external fault.

Fig. 22. B-phase current phasors in amperes primary reported by the bus relay at Cycle 3

This part of the event can be related to what was going on physically inside of the transformer at the time. This external fault corresponds to the transformer relay CT secondary wiring making initial contact with the primary system. The bus differential relay correctly identified the fault to be outside of its zone of protection and remained secure during these first 3 cycles.

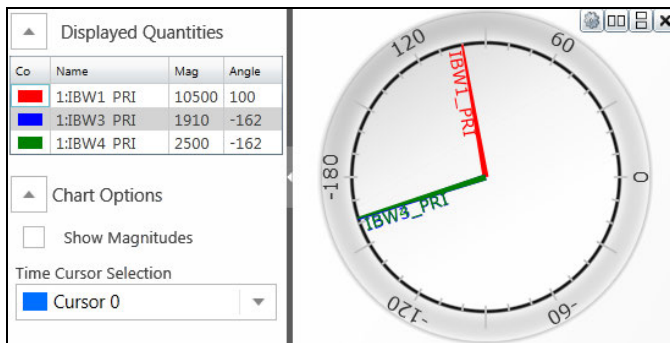
At Cycle 4, the bus relay operated on unrestrained differential. Fig. 20 shows that between Cycles 3 and 4, there is a change in B-phase current on the W1 input (corresponding to the high side of Transformer T1). Fig. 23 shows the B-phase current phasors at Cycle 4 of the event. Note that W3 and W4 still have the same magnitude and phase angle, but because the W1 input changed, their sum is no longer equal to and 180 degrees out of phase with W1. Note also the dramatic increase in W1 current. Because the system is radial, the magnitude of W1 can never be greater than the summation of the W3 and W4 currents for a fault on the system. The fact that this occurred leads us to conclude that the relay could not have been receiving reliable signals, and the CT secondary wiring of the bus relay W1 CT also became involved in the fault.

Fig. 23. B-phase current phasors in amperes primary reported by the bus relay at Cycle 4

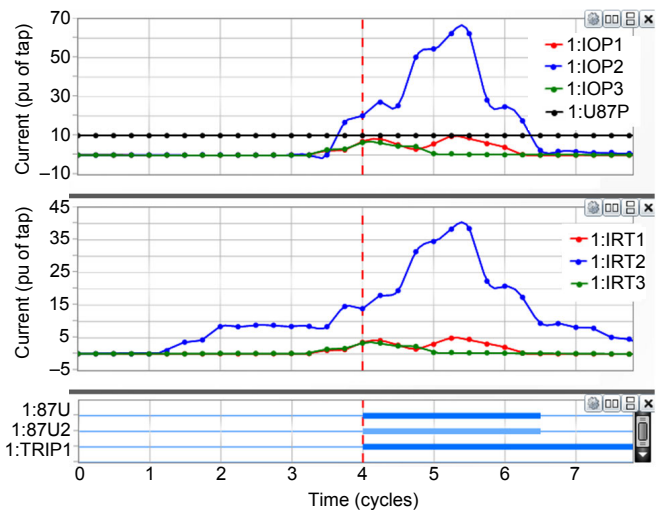
Fig. 25 shows the operate and restraint currents during the event in pu of tap. Note that when the fault starts to occur at Cycle 1, the B-phase restraint current (IRT2) increases, but there is no increase in the B-phase operate current (IOP2). This keeps the relay secure for the external fault. At Cycle 3.5, the fault starts to evolve and the operate current increases dramatically. At Cycle 4, the operate current becomes higher than the unrestrained element pickup value (U87P) of 10 pu, and the relay operates.

Fig. 25. Operate and restraint quantities from the bus relay

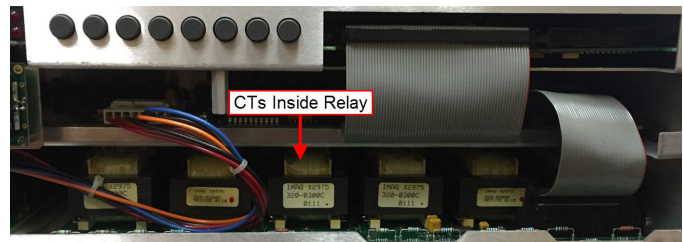
Fig. 27. CTs inside a bus differential relay

Thermal stress can manifest itself in two forms. First, the transformer windings can short together, causing the relay to measure and report an undesired current value proportional to a reduced turns ratio. Second, the leads that connect the internal CTs to the terminal block on the back of the relay can melt. A complete melting of the leads would result in the relay reading no current value on that input. It is possible to detect melted leads with a visual inspection, but knowledge about how to take the relay apart and what to look for is required. An alternative method of verifying the integrity of the internal relay CT circuitry is to perform a metering test. This test validates that the relay is metering within specifications and confirms that no significant thermal damage to the windings or leads has occurred.
