# Finding Common Ground: A Case Study of Phantom Currents and Ground Loops

Matthew Boecker and Genardo Corpuz Lower Colorado River Authority

Jared Candelaria and Ariana Hargrave Schweitzer Engineering Laboratories, Inc.

Presented at the 74th Annual Georgia Tech Protective Relaying Conference Virtual Format April 28–30, 2021

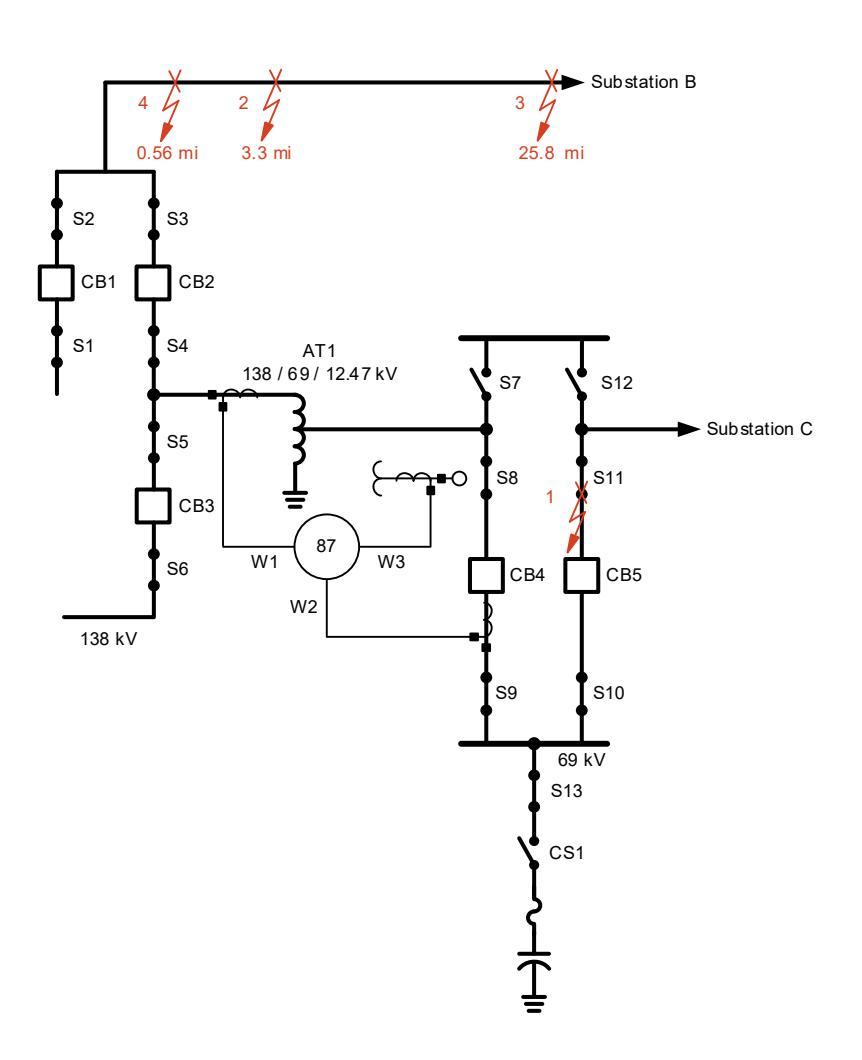
Fig. 4. One-line diagram of Substation A.

The one-line diagram of Substation A and the system configuration at the time of the event are shown in Fig. 4. The transformer shown is a 138 kV/69 kV/12.47 kV wye-wye-delta (YYD) grounded autotransformer, with the delta tertiary used for station service. Circuit Breaker CB5, Circuit Switcher CS1, and Switches S7 and S12 were all open, effectively opencircuiting the load side of the transformer. A microprocessorbased current differential relay was protecting the transformer.

The second thing of note is that W2 measured current on the C-phase. This was not expected. With the 69 kV side of the transformer isolated, as shown in Fig. 4, no current should flow on W2. The events also show that the current on C-phase W2 is arcing. This arcing continued even after the transformer tripped. The length of this arcing time was due to the remote electromechanical ground time-overcurrent relay taking 34 cycles to clear the fault.

Before any testing could be performed, the power system delivered another surprise. The next day, on February 21 at 9:56 a.m., a CG fault occurred on the 138 kV transmission line going to Substation B, 25.8 miles from Substation A. This is shown as Fault Location 3 in Fig. 4. This time, the transformer was completely isolated from the system with Breakers CB2, CB3, CB4, and CB5 all open. Operations again attributed the fault to lightning in the area, since no physical evidence of a fault was found. Although the line relay operated for this fault, the transformer relay did not trip.

Later that same day, at 12:58 p.m., a CAG fault occurred on the 138 kV transmission line going to Substation B, 0.56 miles from Substation A. This fault was also attributed to lightning in the area and is shown as Fault Location 4 in Fig. 4. The A-, B-, and C-phase differential elements all asserted and caused the transformer relay to trip.

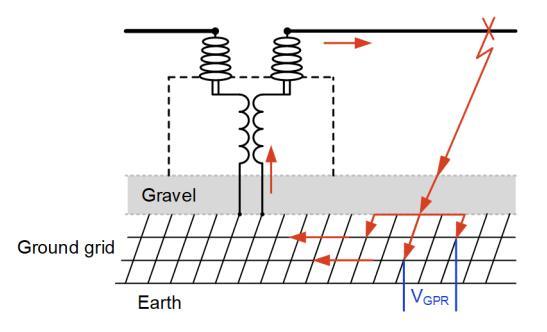
Fig. 9. Ground current flow during a ground fault causes GPR at a substation.

When ground faults occur, the zero-sequence current returns to the source through the earth, as well as through other paths such as neutral conductors, overhead ground wires, and cable shields. The total zero-sequence current splits between the earth and these alternate paths [3] [4]. When a fault occurs near a substation, a large amount of current flows through the station ground grid. Because the ground grid has some impedance, the zero-sequence current flowing through it causes a voltage to develop across the grid. This is known as ground potential rise (GPR) and is illustrated in Fig. 9. IEEE 80 defines GPR as:

The GPR voltage only defines the maximum voltage possible. The voltage will drop across the substation ground grid, resulting in a gradient of different voltages at different points on the grid, as illustrated in Fig. 9.
