# Event Investigation of 69 kV Double-Circuit Faults

Ahsan Mirza, Christopher Bolton, Girolamo Rosselli, and Sergio Flores  
*San Diego Gas & Electric<sup>®</sup>*

Presented at the  
23rd Annual Georgia Tech Fault and Disturbance Analysis Conference  
Virtual Format  
April 26–27, 2021

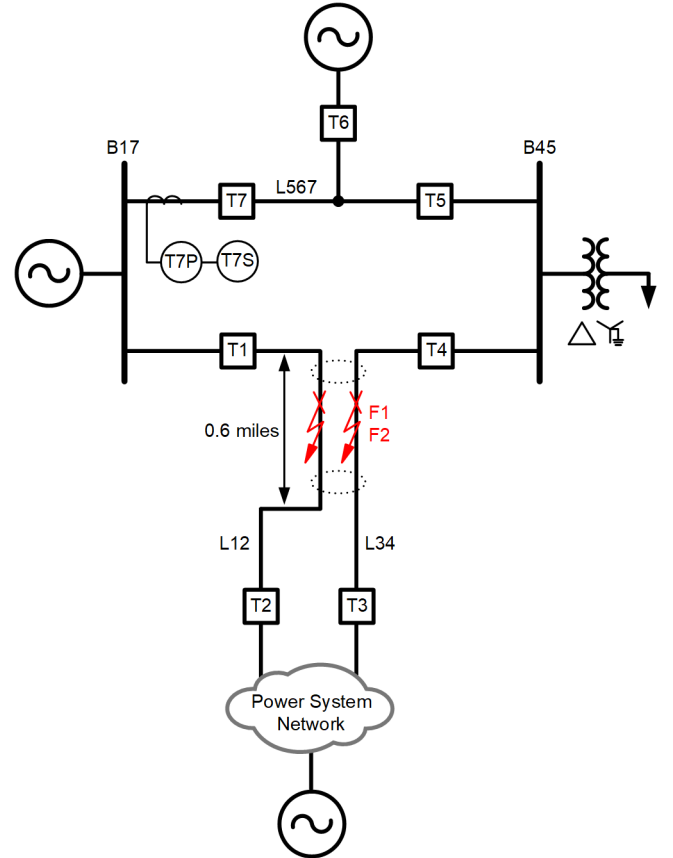
Fig. 1. SDG&E 69 kV System

In September 2018, two faults occurred within hours of each other, and multiple breakers tripped on SDG&E’s 69 kV system (Fig. 1). Because the system’s close proximity to the coast exposes conductors and insulators to the salty atmosphere, some of the insulators on the system lines are rated for 88 kV. As a result, faults are rare on these lines (L12, L34, and L567).

All of the system lines shown in Fig. 1 are overhead conductors. Line L12 is 8.52 miles long and connects Terminals T1 and T2. Similarly, Line L34 connects Terminals T3 and T4 and is 4.6 miles long. Terminals T2 and T3 do not terminate in

the same substation, but are instead connected through the rest of SDG&E’s 69 kV grid comprising multiple other lines. Line L567 makes up the three-terminal line interconnecting Terminals T5, T6, and T7. The length of Line L567 from T5 to T7 is 1.89 miles. Terminal T6 is tapped at 0.5 miles from T5. In addition, Terminal T6 is itself 0.9 miles long measuring from the tapped point.

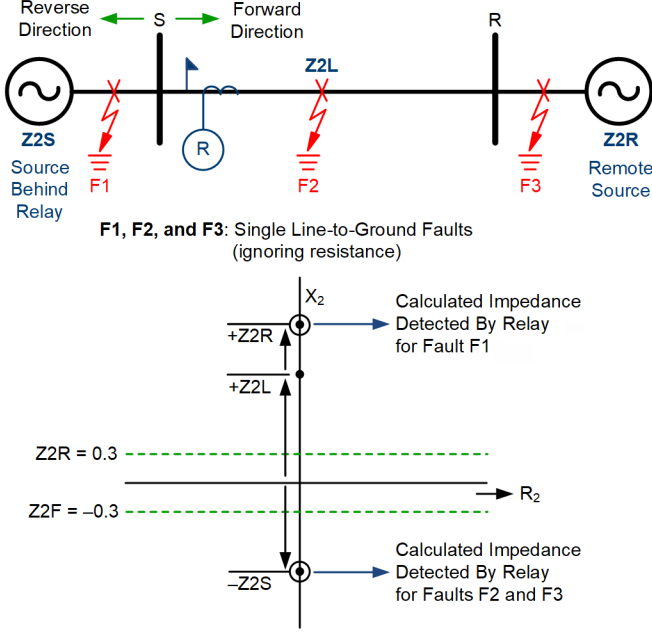
Fig. 4. Negative-Sequence Impedance Plot for a Forward and Reverse Single-Line-to-Ground Fault

Fig. 4 illustrates this concept. The calculated point of  $Z2L+Z2R$  is fixed regardless of the distance between the reverse fault and the relay. Given the separation between the  $-Z2S$  and  $Z2L+Z2R$  points in Fig. 4, the relay uses two blinders placed between these points to distinguish whether a fault is forward or reverse. The blinder at the bottom is the forward negative-sequence threshold ( $Z2F$ ). Similarly, we have threshold  $Z2R$  as the top blinder for the reverse fault detection. If the calculated negative-sequence impedance seen by the relay for a fault falls under the  $Z2F$  forward blinder threshold, the fault is forward. If the calculated impedance is above the  $Z2R$  reverse blinder threshold, the fault is reverse.

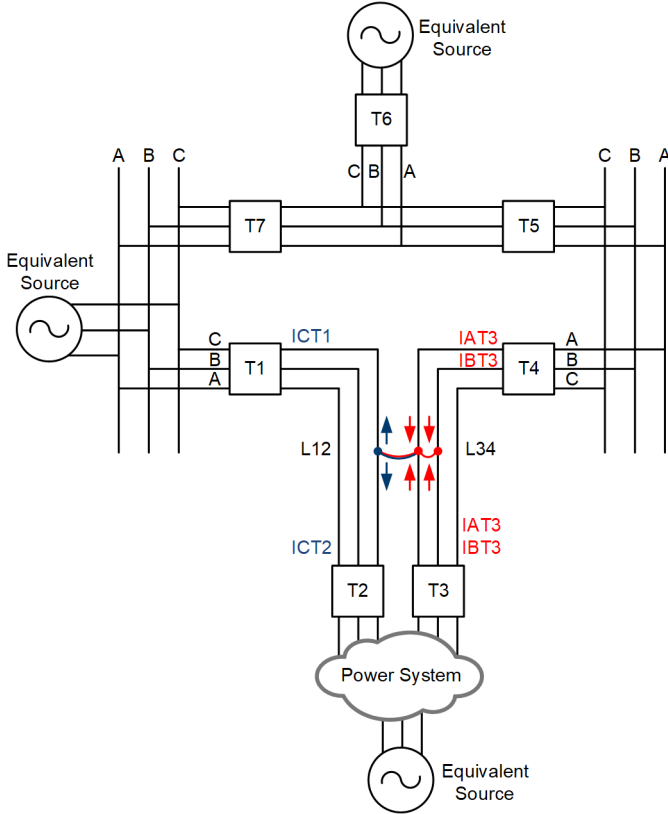
Fig. 9. Intercircuit Fault Illustration

To start, we transform the one-line diagram of Fig. 1 into its three-phase view and place a short between C-phase of L12 and A-phase and B-phase of L34, as shown in Fig. 9.

To find out if this is an intercircuit fault, we take the Kirchhoff's Current Law (KCL) approach. If it is indeed a case of an intercircuit fault with no ground involved, then adding all the current flows into the fault point should give us a value of zero in accordance with KCL. If the currents add up to a significant non-zero value, then that non-zero value represents the ground current, and it is instead a case of a double-circuit fault involving ground.

The currents to add up are C-phase currents at T1 and T2 (shown as ICT1 and ICT2 in Fig. 9), and IA and IB pairs at T3 and T4 (shown as IAT3, IBT3, IAT4, and IBT4, respectively, in Fig. 9). To add the currents, we simply combine the event reports from the T1, T2, T3, and T4 relays and perform custom calculations in the event viewer software to obtain the KCL summation in (1).

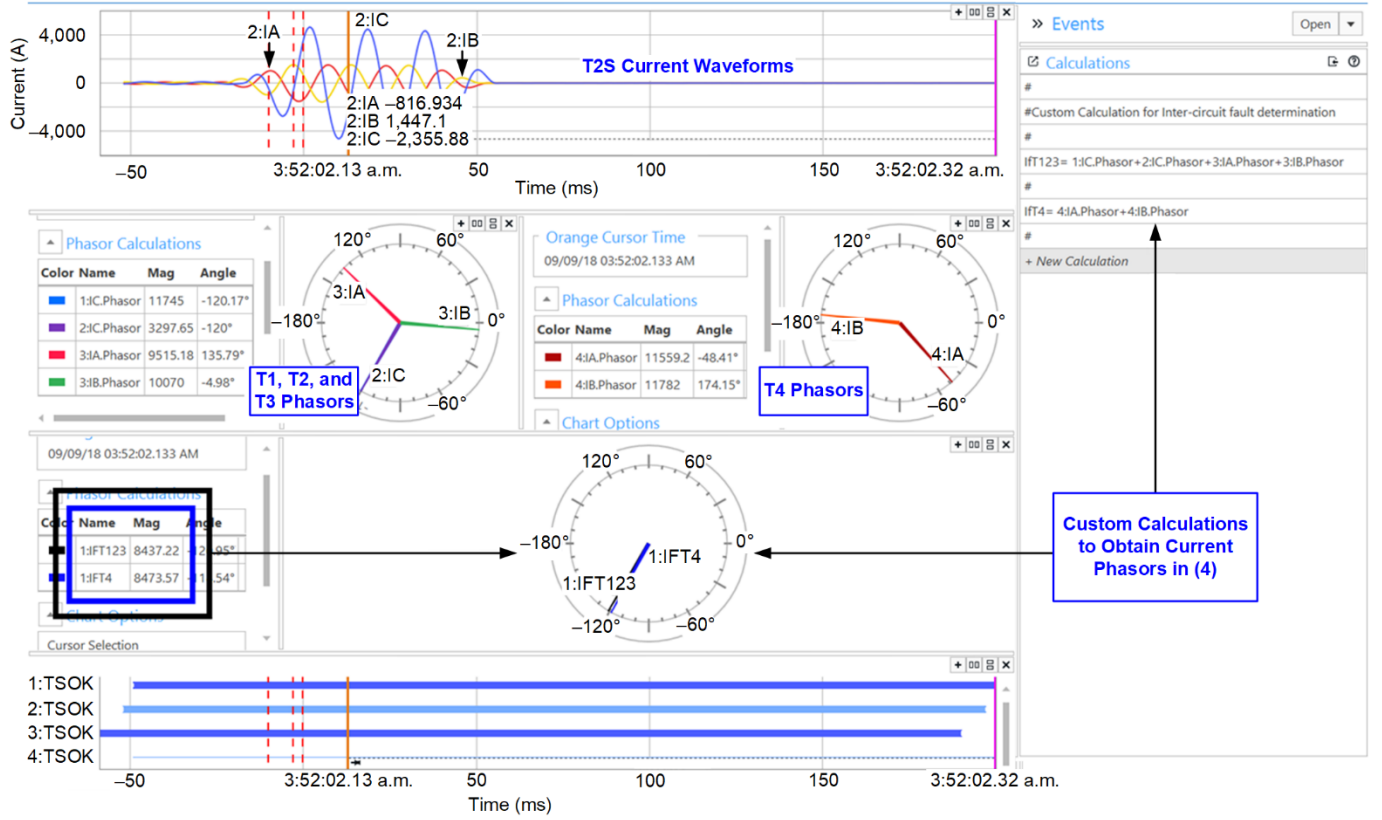
Fig. 11. Combined Event Reports to Form (4)

We proceed further and combine all four event reports from T1S, T2S, T3S, and T4S in the event viewer software and perform custom calculations to form (4). Fig. 11 shows the result of the two phasors ( $I_{FT123}$  and  $I_{FT4}$ ). The two current magnitudes are quite close to each other at 8,437 A for  $I_{FT123}$  and 8,473 A for  $I_{FT4}$ . Such close magnitudes indicate that ground was possibly not involved, and the fault was instead a phase-only intercircuit fault between C-phase of L12 and A-phase and B-phase of L34.

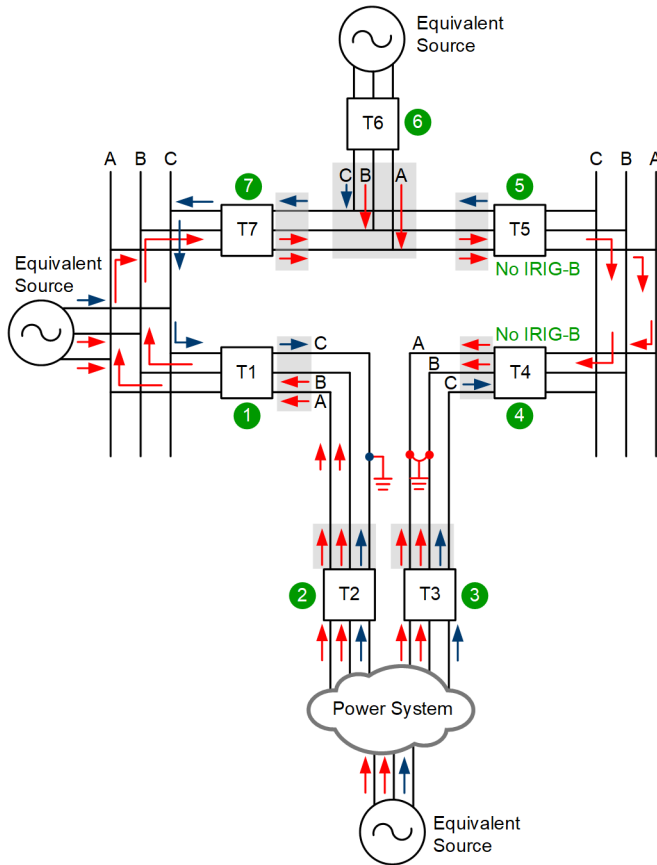
Fig. 12. Hypothetical Three-Phase Current Flow for Simultaneous Double-Circuit Ground Faults

We start by drawing the three-phase current flow distribution that would best represent the simultaneous double-circuit faults. Fig. 12 captures this hypothetical per-phase current flow.

Since the fault on Line L34 only involves A-phase and B-phase, the C-phase is unscathed, as is evident by magnitudes of 2,144 A seen at both terminals of T3 and T4 (see Fig. 7 and Fig. 8). The magnitudes being equal suggests current came in through one terminal and out of the other, matching the current flow distribution in Fig. 12.

- Drawing a system-wide view and analyzing on a per-phase basis (Fig. 12) helped understand the unconventional current flows captured in relay event reports for the double-circuit fault.

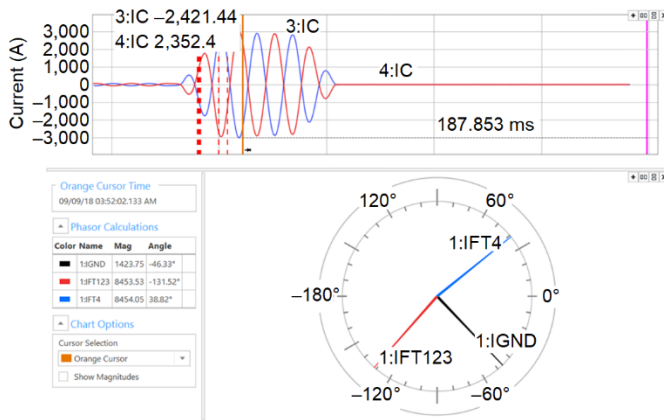
Fig. 14. Ground Current (IGND) of (5) Obtained Through Event Report Custom Calculations and Time Alignment

Fig. 14 shows the phasor value of IGND obtained through custom calculations in the event viewer software.

Not surprisingly, we still have roughly the same magnitudes of 8,453 and 8,454 A of IfT123 and IfT4, respectively, just like we saw in Fig. 11. But now we know their respective angles (now that all the event reports have been time-aligned) as well. IfT123 and IfT4 are roughly 170 degrees apart from each other. The 10-degree difference (180–170 degrees) is enough to reveal the existence of ground current of ~1,423 A.
