The Missing Link: How CT and VT Connection Errors Affect Protection

Marcel Taberer, Praveen Iyer, and Karl Zimmerman
Schweitzer Engineering Laboratories, Inc.

Presented at the
75th Annual Georgia Tech Protective Relaying Conference
Atlanta, Georgia
May 4–6, 2022

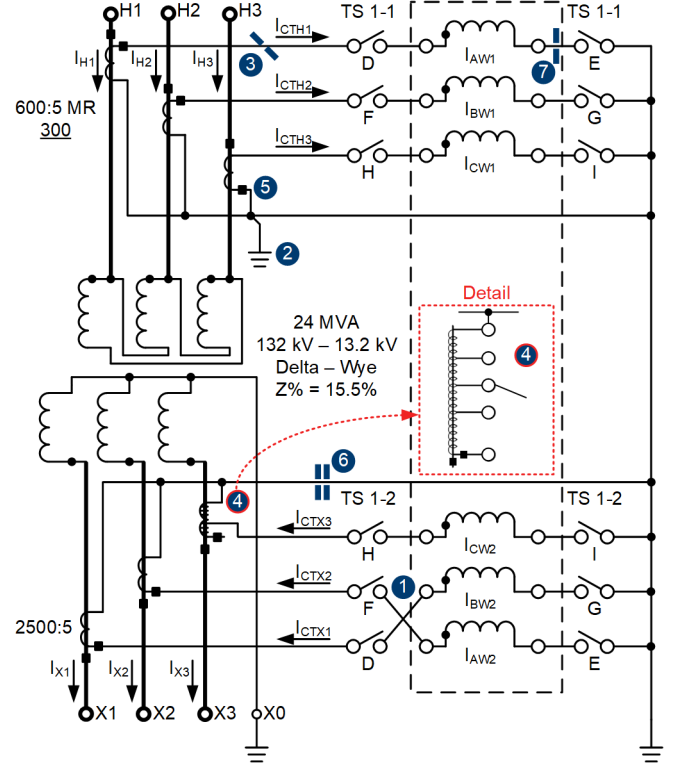
Fig. 5. Typical CT secondary wiring with seven common issues. An enlargement is provided for Point 4.

Fig. 5 illustrates some common issues that may arise on the secondary wiring of CT circuits. It shows a typical delta-wye transformer that has bushing CTs on both the high-voltage (HV) and low-voltage (LV) bushings of the transformer. It showcases a common CT arrangement where both CTs are connected in wye. The HV bushing CT secondary wiring is landing on IAW1, IBW1 and ICW1 respectively on the current channel inputs on the differential relay via test switch TS1-1. The LV CT secondary wiring is, as per design, expected to land on IAW2, IBW2 and ICW2 respectively on the current channel inputs on the differential relay via test switch TS1-2. Point numbers 1–7 reflect some of those common issues.

- **Point 1** indicates a wiring swap issue where the B-phase CT secondary wiring is going to the A-phase channel input on the relay, IAW2. Similarly, the A-phase CT secondary wiring is going to the B-phase channel input on the relay, IBW2.
- **Point 2** indicates a second ground on the HV bushing CT circuit.
- **Point 3** indicates an issue where the insulation of the secondary wiring has been cut or damaged during

installation, which could lead to unintentional grounds on the CT circuit, water intrusion, or other failures.

- **Point 4** indicates a CT tapping issue that will result in a CT ratio error.
- **Point 5** indicates the CT polarity can be rolled [3].
- **Point 6** indicates that there may be a missing neutral wire [3].
- **Point 7** indicates that there may be an open-circuit CT which can cause personnel injury and equipment damage.

Similar issues can also be easily missed on VT secondary circuit wiring. To avoid errors like those seen in Fig. 5, it is imperative to have a methodical approach when verifying the integrity of the secondary wiring interconnecting the ITs to the relevant relay.

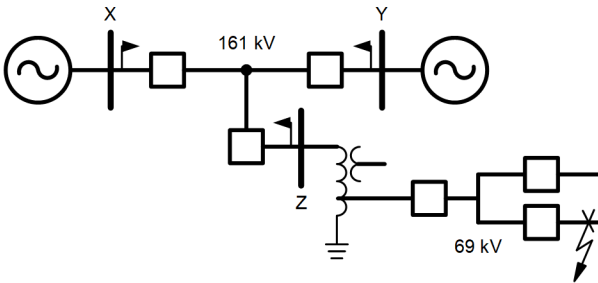
Fig. 17. 161 kV line trips for a fault on 69 kV line.

Fig. 17 shows the one-line system diagram for a three-terminal 161 kV line. The protection scheme deployed is a DCB scheme. An A-phase-to-ground fault occurred on an adjacent 69 kV line.

The ground-directional relays in the scheme use a negative-sequence impedance-based (Z2) element to declare forward or reverse [9]. For this A-phase fault, the ground-directional relay at the Z-terminal should have declared a reverse fault and sent a block signal, via a communications link, to the remote X and Y terminals. Instead, the ground-directional relay at the Z-terminal declared a forward fault, resulting in an undesired trip of the 161 kV line.

Further investigation revealed that the A-phase capacitor voltage transformer (CVT) had been replaced a few years earlier. Further, all recent undesired operations had occurred on A-phase-to-ground faults (see Table 1). Due to this information, wiring or grounding errors on the A-phase voltage input source were suspected.

Field staff found several drawing and wiring errors at the site which may have been introduced when the A-phase CVT had been replaced. Upon investigation, the field crew found only

Summary—A floating neutral point in the secondary VT circuit produced incorrect voltage supplied to the A-phase of the protective relays, which caused the ground-directional element to declare forward for a reverse fault. Wiring and drawing errors were corrected and tested and the directional relay scheme performed correctly thereafter.

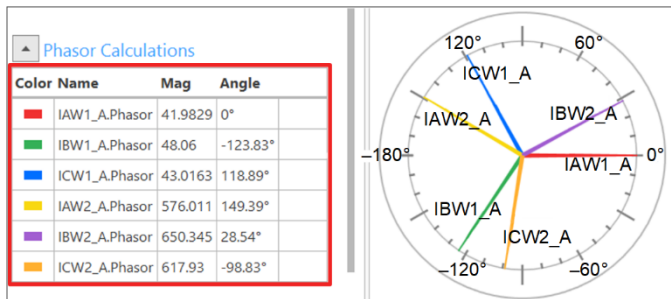
Fig. 25. Winding 1 and Winding 2 uncompensated currents at energization and after taking load.

Based on the settings, the phase relationship (IAW2_A leading IAW1_A by 150 degrees) and a phase rotation of ABC appear to be correct, as shown in Fig. 25.

Thus, the expected primary currents should be 167 A (at 13.8 kV) and 555 A (at 4.16 kV), respectively. This shows that Winding 2 currents were near the expected value, but the Winding 1 currents were about four times lower than expected (41 A vs. 167 A), as shown in Fig. 25.

Field staff suspected a wiring error. As shown in Fig. 23, there were also 5000:5 bushing CTs on the 13.8 kV Winding 1. Secondary wiring was terminated for this 5000:5 CT at the same relay panel as the 1200:5 CTs. Field staff quickly determined that they had indeed found the root cause because the currents were off by a factor of approximately four (5,000/1,200). The current inputs of the relay for Winding 1 were connected to the 5000:5 CTs instead of to the intended 1200:5 CTs.

Summary— Discrepancies between the drawings and the actual field wiring resulted in incorrect CT connections to the relay, which caused the undesired operation.

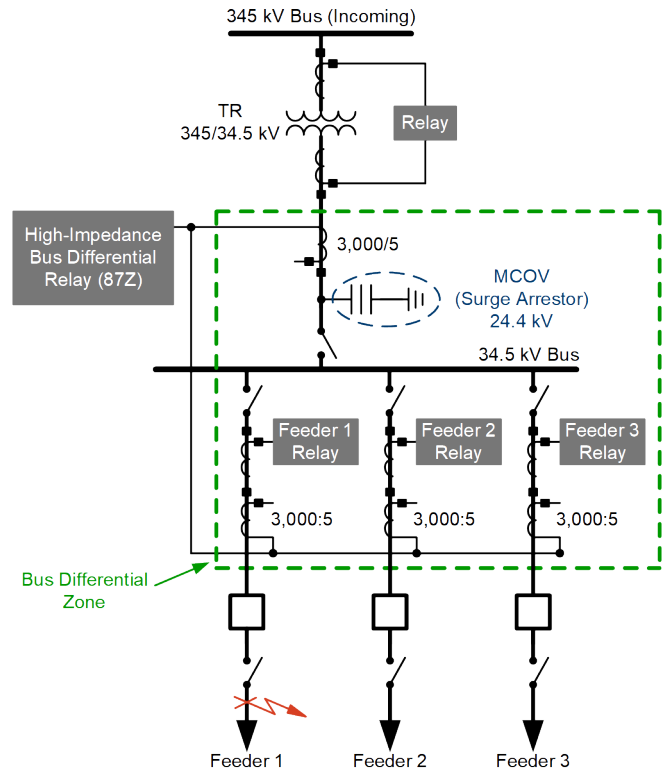
Fig. 32. Single line diagram for the case study.

Fig. 32 shows a 345 kV incoming transmission line stepped down to a 34.5 kV line that feeds a bus, which in turn feeds multiple feeders downstream. The 34.5 kV bus, highlighted in green, is protected by an 87Z relay. Thus, the relay should trip all breakers connected to the 34.5 kV bus if there is a fault detected in the defined protected zone. For any fault out of the protected zone, the relay should not detect any differential current and so should not operate. The system experienced a C-phase-to-ground fault on Feeder 1. The relay protecting Feeder 1 tripped correctly because the fault was in its zone of protection. However, the 87Z relay also tripped for this out-of-zone fault.

Since there was no conclusive evidence to prove that the 87Z relay's misoperation was due to the lightning arrester conduction, focus shifted to the next probable cause. The next step was to investigate possible wiring errors. The 87Z relay applied in this case study had a set of current coils (i.e., nondirectional overcurrent elements) in series with the voltage coils (i.e., the 87Z element). Thus, analyzing the

This led the investigation toward the suspicion that one of the sets of CTs connected to the 87Z relay may have had a missing neutral-to-ground connection.

A missing neutral-to-ground connection will cause the fault current to circulate through the non-faulted phase instead of flowing into the ground. Such a scenario is similar to what had been observed in this case. Fig. 35 depicts a C-phase-to-ground out-of-zone fault, much like in the case study. The red arrows show the flow of primary fault current, the green arrows show the flow of CT secondary fault current, the blue arrows show the differential current flowing into the 87Z relay, and the orange arrows show the secondary fault current in C-phase flowing through the non-faulted phases (A and B), which was due to a missing neutral-to-ground link. This hypothesis falls in line with the oscillography shown in Fig. 34.
