Lessons Learned Through Commissioning, Livening, and Operating Switchgear

Matthew Watkins and Kamran Heshami
Schweitzer Engineering Laboratories, Inc.

Michael T. Mendiola and Nilushan K. Mudugamuwa
Tengizchevroil

Presented at the
2022 PCIC Europe Conference,
London, England
June 2022

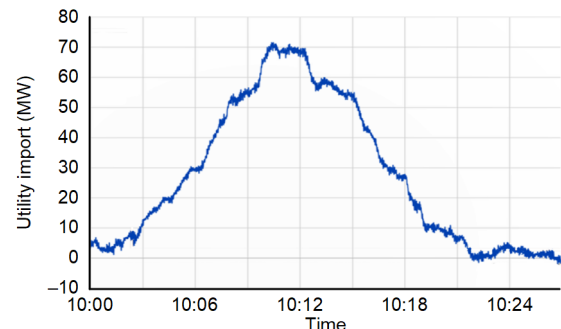
Fig. 1 Utility power import during the incident

approved procedure included the team isolating the relay trip outputs by inserting a test plug and relying on the redundant relay to protect the line. Upon isolating the in-service relay, the facility's slow-response generator control system detected an unexpected dip in utility power import from 6 MW to 0 MW due to a loss of voltage in the relay and the relay being used as the control system's source of line megawatts. This resulted in the gradual offloading of the facility generation in an attempt to increase the utility import back to the desired tie-flow set point. The slow-response generator control system drove up the utility import from 6 MW to 73 MW until the system operators could get the situation under control. Fig. 1 depicts the power import from the utility during this incident, which was measured by another relay sensing the utility currents and voltages.

To solve this problem, the team recommended sending a value of -500 , which is identified by the slow-response control system as a bad value, if Decision Gates 3 and 4 evaluate to YES. The expected action of the slow-response control system when receiving that bad value is to take no action, which addresses the concern about the loss-of-potential condition. This recommendation is currently under review.

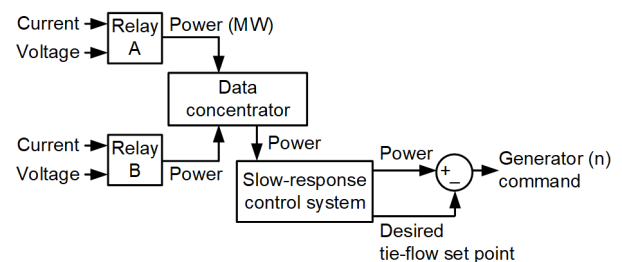
Fig. 2 Data-flow diagram

The trip output contacts and voltage transformer inputs to the primary line Relay A were wired to the relay sharing the same 14-pole test block. All 14 poles of the test block were isolated by inserting the test plug in the test block socket, resulting in a loss-of-voltage measurement by the primary relay. The desired system response to a loss-of-voltage measurement is to switch the power-flow measurement source to the redundant backup Relay B, as described in the data-flow diagram in Fig. 2.

In investigating the issue, the field engineers found that although communication between the data concentrator and Relay B appeared to be healthy to the electrical control system, the data received by the slow-response control system’s data concentrator were flagged with having bad data quality. The active IEC 61850 configuration file was retrieved from Relay B; it confirmed that the data set being polled by the slow-response control system’s data concentrator was set as a spare data set with blank data. Therefore, the Decision Gate 2 result in the process diagram was NO, and Relay A remained as the primary power-flow measurement source, which provided a reading of 0 MW to the slow-response control system. The corrective action to address the bad data quality was to update the IEC 61850 configuration, perform laboratory testing to verify correct functionality, and load the configuration file into Relay B.

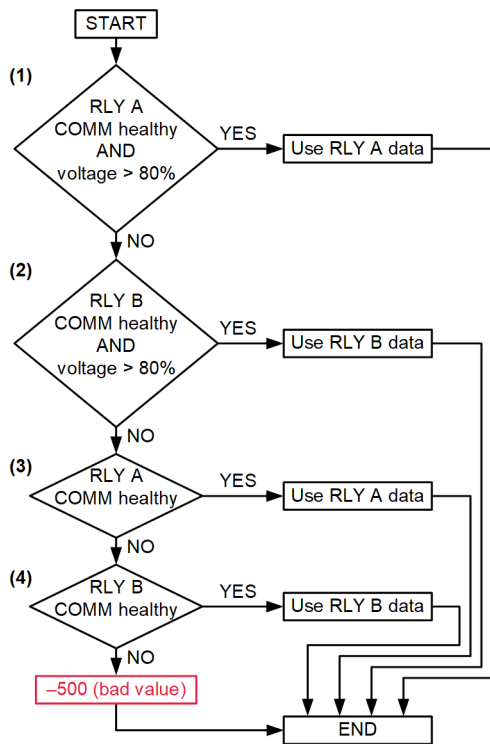
Fig. 3 Process diagram

As mentioned, the desired system response to a loss-of-voltage measurement is to switch the power-flow measurement source to the redundant relay. Decision Gate 1 in the process diagram evaluated to NO because of the loss of voltage in Relay A. Decision Gate 2 evaluated YES because Relay B communications were healthy and its voltage inputs were unaffected. Therefore, the power-flow measurement should have switched to Relay B as the source, and the slow-response generator control system should have taken no action.

frequency load-shedding to restore system stability. The process diagram also shows that even with healthy communications with both devices, the same outcome would have been expected for a simultaneous loss-of-potential condition on both relays caused by a blown voltage transformer (VT) fuse, because both relays are connected to the same VT.

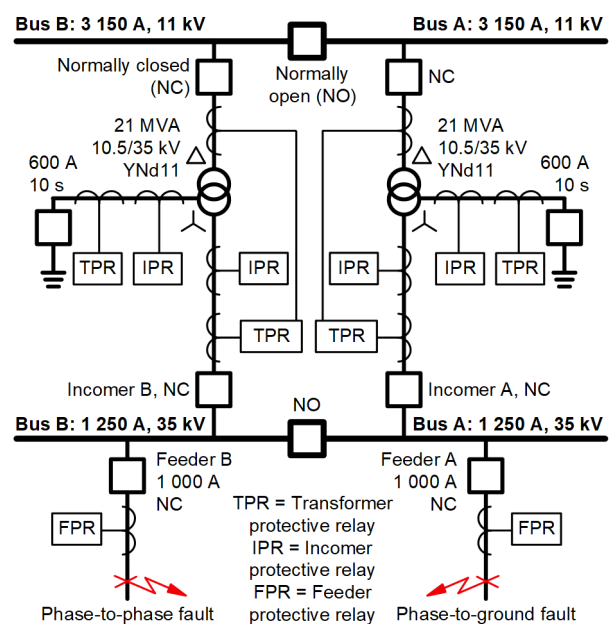
Fig. 8 System where transformer protection trip occurred

The event described in this section includes an undesired operation of the transformer differential relay for an out-of-zone fault and an incomer relay trip for a feeder fault during the liveness process. As shown in Fig. 8, the system is comprised of a step-up delta-wye transformer from a 10.5 kV brownfield feeder to a 35 kV greenfield substation. The transformer is protected with a transformer protective relay that provides differential and restricted earth fault protection. The incomer protective relay provides inverse-time overcurrent protection.

Preliminary investigation found a BC phase-to-phase fault at the 35 kV Feeder B. Although the expectation was that the feeder would be tripped, the Incomer B breaker was tripped by both the transformer protective relay, for differential protection, and the incomer protective relay, for instantaneous overcurrent protection.

Fig. 8 shows the switchgear arrangement and the possible fault location on Feeder A. Fig. 20 shows the fault current recorded at the feeder relay for the first of the two Feeder A trips. The fault current gradually declined, then increased and remained stable until the fault was cleared. The fault was cleared soon after the 600 ms time delay included for discrimination purposes.

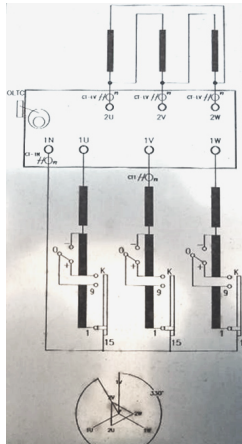
Fig. 13 Internal connection and vector arrangement taken from the transformer nameplate (21 MVA)

It is important to set the compensation settings to match the transformer nameplate (an example nameplate is shown in Fig. 13), taking into account the phase-to-

After the review, it was found that the compensation settings were set to TSCTC = 0 (Winding 1 S input, 10.5 kV) and TTCTC = 11 (Winding 2 T input, 35 kV) to compensate for a YNd11 arrangement. According to Fig. 14 and Fig. 15, the set points were incorrect [2]. The commissioning engineers concluded that the settings should have been TSCTC = 0 (S input, 10.5 kV) and TTCTC = 1 (T input, 35 kV) to correctly compensate the differential currents for the step-up transformer.

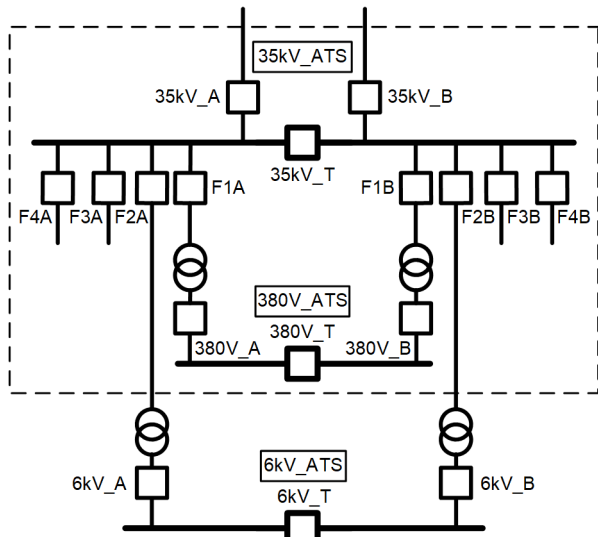
Fig. 24 Simplified single-line system diagram

switchgears are equipped with transfer controllers for automatic and manual source transfer. These controllers are labeled 35kV_ATS, 6kV_ATS, and 380V_ATS in the single-line diagram. At the time of the event, only a single 6 kV switchgear was in service; therefore, only one 6 kV switchgear is depicted in the simplified diagram in Fig. 24.

Event 2 occurred during the replacement of the relays at F3B and F4B. The construction contractor accidentally created a short circuit on the control circuit, which caused the miniature circuit breaker (MCB) supplying control voltage to all Bus B relays to trip. There were reports of switching operation at both the local downstream 380 V switchgear and the remote downstream 6 kV switchgear shortly after the MCB tripped. Interrogation of the relays and controller at both the 380 V and 6 kV switchgears showed fast transfer initiation by the 380_B Incomer B relay due to the detection of the upstream Breaker 35kV_F1B opening.
