A Tale of Two Out-of-Phase Synchronizing Events at BC Hydro

Mukesh Nagpal and Lesley Gu
BC Hydro

Presented at the
77th Annual Georgia Tech Protective Relaying Conference
Atlanta, Georgia
April 24-26, 2024

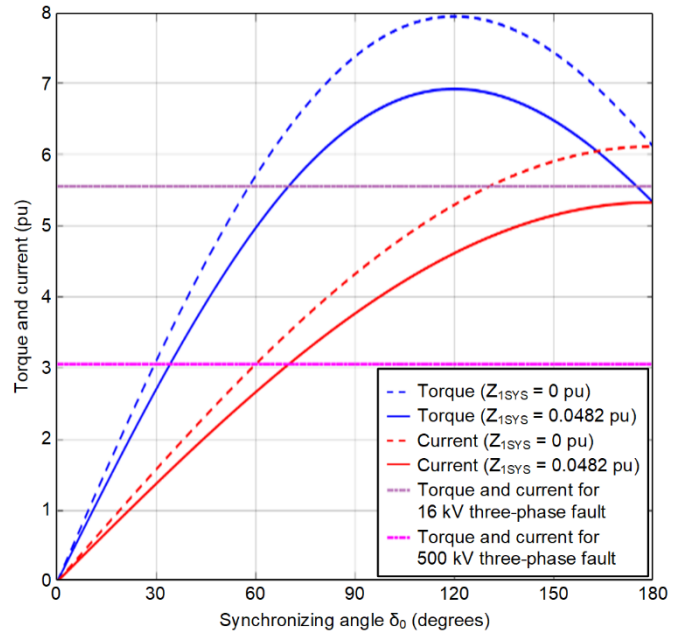
Fig. 6. Torque and current for a three-phase fault at generator terminals and for OOPS events versus synchronizing angle.

The torque and currents for the different synchronizing angles for this system and for an infinitely strong system are shown in Fig. 6. As in the system featured in this paper, power systems are usually much stronger than the impedances presented by the generator and the GSU. This makes it so that in most installations, the torque and currents for an OOPS event are primarily limited by the generator and GSU impedances. The torques and currents in Fig. 6 do not consider the unit's saliency. However, the difference is not significant enough—less than 5 percent torque difference and about 10 percent current difference for our application—to justify the added complexity that would be associated with a revision of these equations. It can also be observed from (1) and (2) and Fig. 6 that the anticipated maximum electromagnetic torque and current are experienced when the synchronizing angles are 120 degrees and 180 degrees, respectively.

A current of 1 pu in Fig. 6 corresponds to 19 kA at the LV (16 kV) level (see Table I) or 593 A at the HV (512.5 kV) level. For comparison, a three-phase fault on the 500 kV bus results in both a torque and current of 3.06 pu. In this system, an OOPS with a δ_0 of about 34 degrees and an OOPS with a δ_0 of about 70 degrees result in similar torque and current levels as a three-phase fault on the 500 kV bus, respectively.

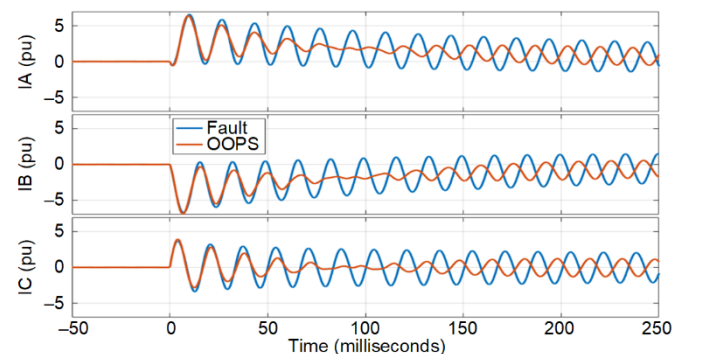
Fig. 17. Behavior of zero-crossings during three-phase fault and 60-degree OOPS simulation.

The delayed zero-crossings phenomenon for OOPS events has been discussed in previous literature [3] [4] and is much more severe than it is for external faults. This is illustrated in Fig. 17, which shows a comparison of a simulated three-phase fault at the GSU HV terminals and an equivalent 60-degree OOPS simulated event that has a similar current envelope (because they have the same voltage difference). For the three-phase fault, the ac current magnitude reduces during the event. This is because of the gradual transition from subtransient to transient reactance, which makes it nearly lose zero-crossings.

For an OOPS event like the one shown in Fig. 17, the decaying ac component associated with the transition from subtransient to transient reactance, as for an external fault, still exists. Additionally, as the rotor pulls in with the system, the voltage difference between the generator and the system decreases relatively quickly. This reduced voltage difference lowers the ac component of the fault current further, increasing the likelihood of delayed zero-crossings [4].

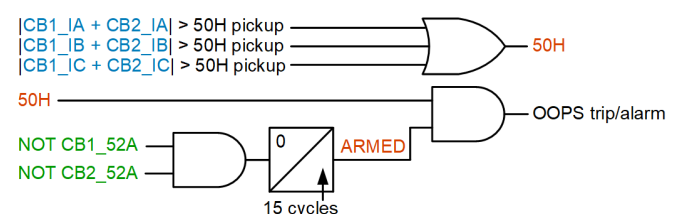
Fig. 19. OOPS element for HV synchronizing breakers in dual-breaker configuration.

One reason that the OOPS scheme of Fig. 18 was not applied to the 500 kV breaker was because of the high bus current ratings and the possibility of closing either of the ring-bus breakers, 5CB6 or 5CB7, to synchronize the generator. For example, if 5CB6 is already closed and 5CB7 is subsequently closed, a high current could flow through the breaker that closed second, thus jeopardizing the security of the OOPS protection scheme shown in Fig. 18.

An alternative to the scheme of Fig. 18 for dual-breaker configurations is shown in Fig. 19. If either breaker is closed, the scheme is disarmed and remains secure. The overcurrent element operates on the partial differential current of the two breakers. For the system shown in Fig. 1, this current corresponds to the generator current and can, therefore, be set in a similar manner as the scheme of Fig. 18 [3]. The phasor sum of the two currents can be obtained by paralleling the CTs externally, using a relay designed for two breaker applications that internally sums the current, or by using programmable math in a digital relay.

Once the scheme operates, to avoid the problem of delayed zero-crossings on the 500 kV breakers, the unit generator breakers connected to the bus can be tripped. For example, if the scheme operates on the relay measuring currents from 5CB6 and 5CB7 of Fig. 1, then G3 and G4 can be tripped. This works because the only scenario where a generator is being synchronized using the 500 kV breaker instead of the generator breaker is when the other generator is out of service. Tripping both breakers trips the closed one that is involved in the OOPS event and a breaker that is already open because the generator is not in service.

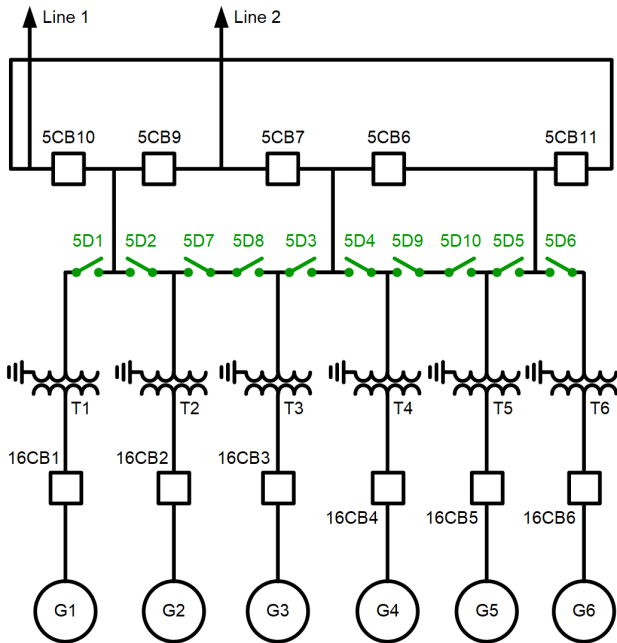
Fig. 20. One-line diagram showing switches that add plant operational flexibility.

The one-line diagram in Fig. 1 is simplified and does not show the many disconnect switches that add operational flexibility at this plant. These switches are shown in green in Fig. 20. For instance, depending on the position of the switches, 5CB6 and 5CB7 might no longer synchronize G3 and G4, but could synchronize any other generator. The presence of these switches can add significant scheme complexity, because their status requires consideration before the appropriate unit generator breaker is tripped. Furthermore, the generators might have different parameters that could impact the 50H pickup setting. For a plant with such operational flexibility, the scheme of Fig. 19 would require some additional complexity, as described in the next paragraph. However, this scheme can be an excellent choice for plants with no unit generator breaker and a dual-breaker bus configuration.

A solution for the application shown in Fig. 20 should not rely on problem-prone topology tracking of the configuration switches. One proposed solution is for the 500 kV breaker OOPS relays to send the trip to each generator relay. The generator relay would then only pass on the trip to its breaker if the generator were energized and carrying no real or reactive load before the event. This would indicate that the generator is the one unit that is being synchronized at the time that the

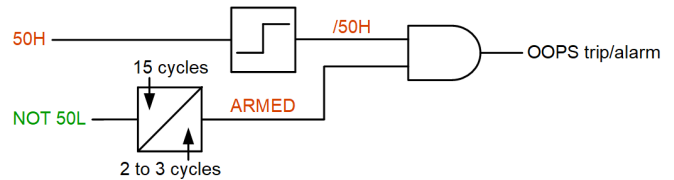
Fig. 21. OOPS scheme without reliance on breaker status.

An alternative to the OOPS scheme of Fig. 18 is shown in Fig. 21; it does not rely on breaker status. The arming path uses a 50L element that picks up for all loading scenarios but not GSU magnetizing current. The GSU magnetizing current is typically less than 1 percent of the GSU rating, but setting the 50L pickup to this value may be outside the range supported by many relays. The 50L element pickup should, therefore, be set as low as possible while being higher than the GSU magnetizing current. The 50H has an additional rising edge to the AND gate to improve security. The dropout timer of the arming path is shortened to two cycles to accommodate timing differences associated with 50H, 50L, and the rising-edge trigger. This scheme looks for a high step change in current to declare an OOPS condition.

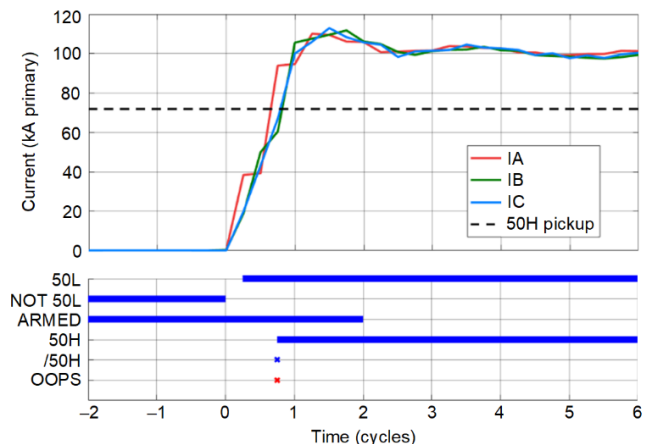
Fig. 22. Dependability of OOPS scheme for 180-degree OOPS event.

The dependability of the scheme of Fig. 21 for the second OOPS event is shown in Fig. 22. The 50L pickup is set to 2 percent of the generator rated current, the 50L arming timer dropout is selected as 2 cycles, and the 50H pickup is set to 120 percent of the generator contribution to a three-phase fault on the high-side of the GSU, which is 70 kA (equal to $1.2 \cdot 3.06 \cdot 19$ kA). It is clear that the element is dependable for the 180-degree OOPS event and, based on the analysis from Section III.A, it would remain dependable for events with a synchronizing angle greater than 80 degrees.

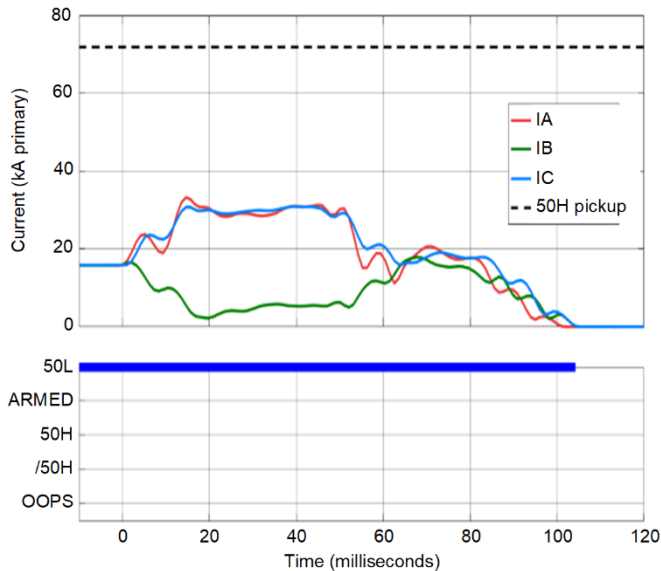
Fig. 23. Security of OOPS scheme for external multiphase fault.

The security of the scheme for the external multiphase fault of Fig. 10 is shown in Fig. 23. The element does not remain armed because of the load current asserting 50L. Even if the element were armed, the fault current is not high enough to assert 50H, which is set to remain secure for a bolted three-phase fault at the GSU 500 kV terminals. Infeed and fault resistance further reduce the fault current so that the element is at no risk of a misoperation.
