Catastrophic Breaker Failures Due to Missing Current Zero-Crossings in Highly Shunt-Compensated 500 kV Lines—Point-on-Wave, Reclosing, and Protection Considerations

Mukesh Nagpal
Burns & McDonnell

Kenan Hadzimahovic, Tyler Scott, and Tony Jiao
BC Hydro

Presented at the
50th Annual Western Protective Relay Conference
Spokane, Washington
October 10–12, 2023

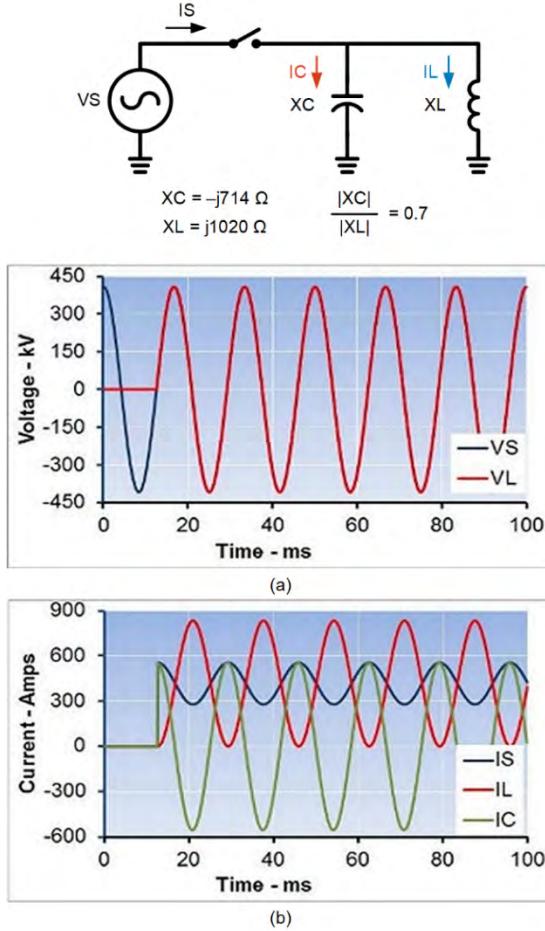
Fig. 6a demonstrates a smooth transition, without voltage transients, from a de-energized to an energized state after the 70 percent shunt-compensated line is energized at a voltage zero. Fig. 6b shows that the line current, which is the sum of the capacitive charging current and the shunt reactor current (referred to as compensated line charging current), has no zero-crossings. This lack of zero-crossings is due to a higher dc (70 percent of the line's capacitive charging current) than alternating current (ac) (30 percent). This principle applies if the shunt compensation in the line is more than 50 percent, which makes the line a highly shunt-compensated line. As a result, POW-controlled closing, designed to minimize switching overvoltage transients, unintentionally leads to missing zero-crossings in a highly shunt-compensated line current.

Fig. 6. Switching (a) voltage and (b) current in a 70 percent compensated line with target closing at voltage zero across the breaker.

It is important to note that modern SF₆ circuit breakers can fail even when interrupting low-magnitude currents [10] (as low as 10 A) with missing zero-crossings. If a protective trip is issued immediately after closing the breaker from POW control, it is likely to cause SF₆ circuit breaker failures. In summary, applying POW-controlled switching during manual energization of a highly shunt-compensated line presents competing requirements. On one hand, controlled closing at a voltage zero minimizes voltage transient but maximizes dc offset in the current, which introduces missing zero-crossings and poses a risk of breaker failure. On the other hand, the POW-controlled closing at maximum voltage minimizes dc offset in the current but maximizes voltage transient, risking line conductor flashover or even damage to the station equipment due to stressed insulation.

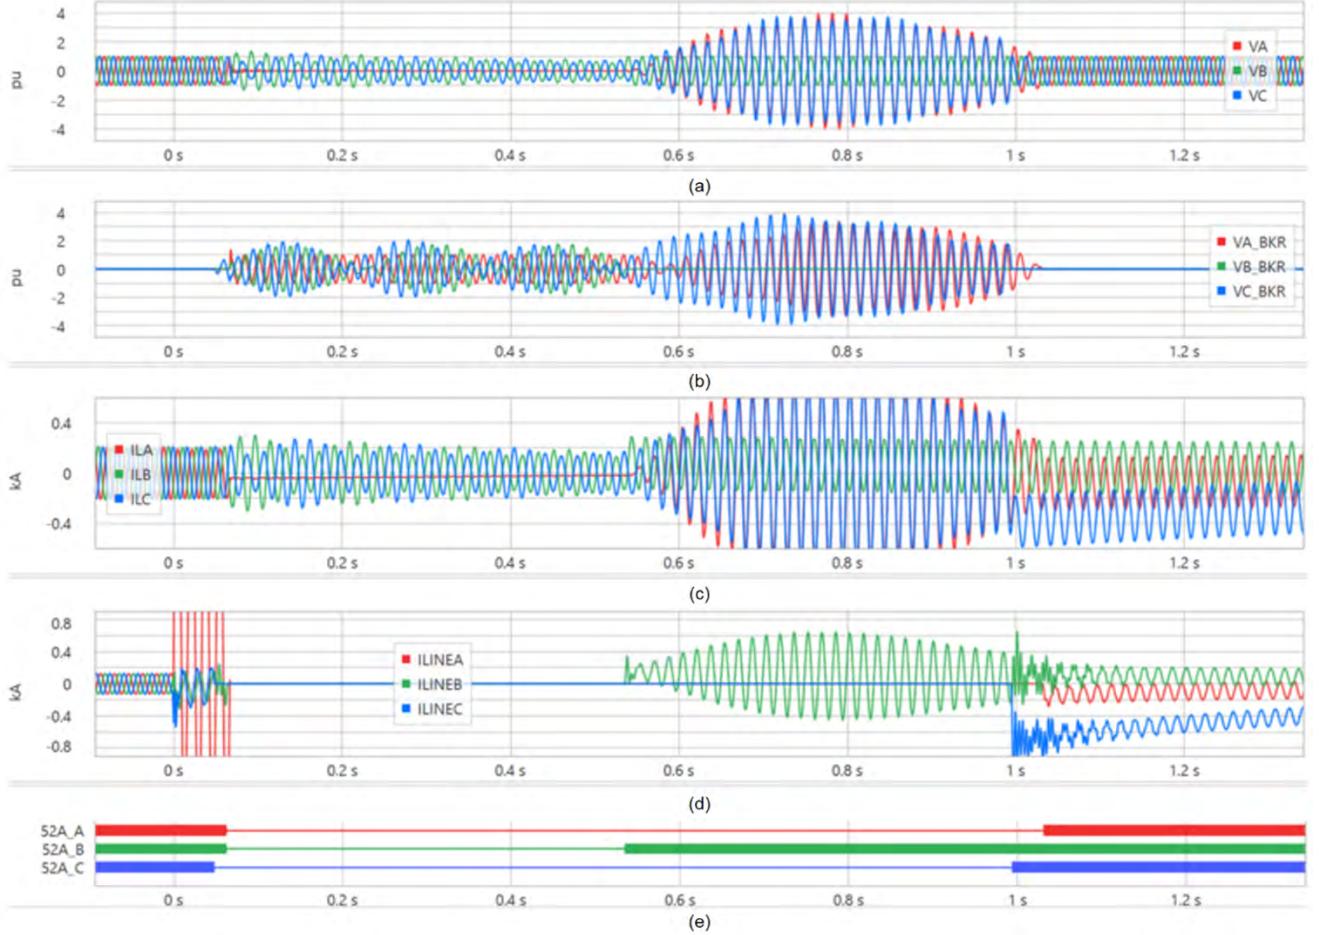
- In Fig. 8a, the faulted phase (Phase A) voltage remains zero during and after the fault, following the line breaker opening. The unfaulted phases (Phases B and C) maintain the source voltage during the fault and start to ring down with a beat period of about 155 milliseconds after the breaker opens. The ringdown voltages decay during the three-phase open

- interval due to resistive losses in the open line and connected reactors.
- After a 28-cycle (almost 500-millisecond) three-phase open interval, POW-controlled closing was simulated to attempt the closing of each phase at the beat minimum. Fig. 8b shows the voltage across the breaker for each pole. Phase B closes first at $t = 536$ milliseconds. In Fig. 8c, there is some dc offset current in the reactor even when Phase B closes at the beat minimum due to the decaying non-60 Hz ringdown voltage. In Fig. 8d, the missing zero-crossings from this small dc component disappear shortly, approximately 32 milliseconds after Phase B closes.

- Once Phase B is energized, the beat pattern on Phase C changes due to interphase coupling. A single-phase energization of a highly shunt-compensated line creates resonant overvoltages⁸ on the floating phases A and C, which are yet to be closed [11] [12]. The waveform traces show voltages reaching up to 4 pu, but in real-life scenarios, overvoltages are limited by surge arresters and magnetic saturation, which were not modeled. In a separate event reported in Section III.B, voltages of more than 1.6 pu on the two floating phases were observed under similar conditions.

- The next beat minimum occurs for Phase C at $t = 995$ milliseconds. As mentioned previously in Section II.C.2, the POW controller would have switched to the backup mode upon failing to detect the next beat minimum in approximately 100 milliseconds after closing the first phase to prevent an extended duration of line energization on fewer than three phases. In the simulation, the backup mode was not implemented to illustrate the behavior of the dc current when the second phase closes at the beat minimum. A large magnitude difference between the source and resonant line voltages introduces a high dc offset in the Phase C reactor current. The missing zero-crossings in the line current last a long time, about 1.37 seconds.

- At $t = 1,032$ milliseconds, Phase A closes at the beat minimum, introducing missing zero-crossings in the line current for approximately 130 milliseconds.

As evident from this simulation, a three-phase POW-controlled close encounters significant challenges due to the competing factors of missing current zero-crossings, resonant overvoltages, and complex beat patterns.

Fig. 8. Missing current zero-crossings, significant overvoltages, and complex beat patterns in a simulated 80 percent shunt-compensated EHV line. Analog traces from top to bottom: (a) line voltages, (b) voltages across the breaker, (c) inductor currents, and (d) line currents.

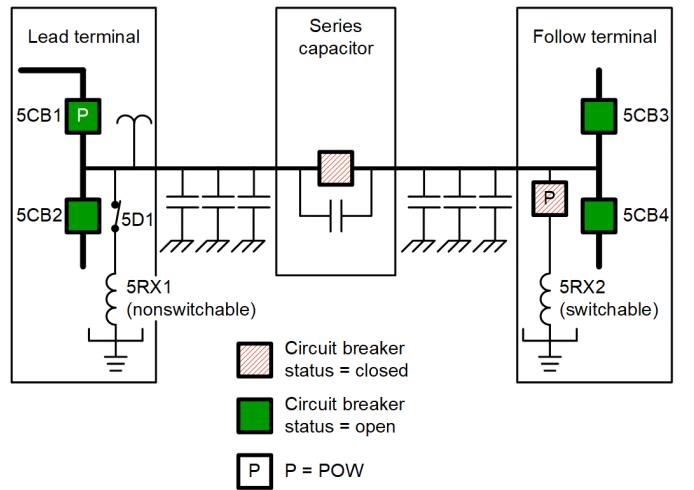
BC Hydro experienced five breaker failures, all of which were associated with highly shunt-compensated lines. These failures occurred when attempting to interrupt the line current after protection operated during manual or automatic line energization. Fig. 9 illustrates a generic one-line diagram of a 500 kV line configuration with shunt compensation. Four of the failures occurred in lines that also had a midline series capacitor (for series compensation). However, the series capacitor was irrelevant to the failures because it is bypassed on all phases after the three phases of the line open.

The line is equipped with two shunt reactors, one at each terminal. These reactors are standard-sized, rated 135 MVAR at 525 kV, commonly used by BC Hydro. Together, the reactors draw an inductive current that exceeds 50 percent of the line's capacitive charging current. During heavy line loading, one reactor can be switched out to regulate the terminal voltage. Typically, both reactors are connected to the line during energization to keep the Ferranti voltage in check at the follow terminal.

Fig. 9 Generic one-line diagram of the 500 kV lines involved in failure events. The series capacitor was bypassed and not relevant.

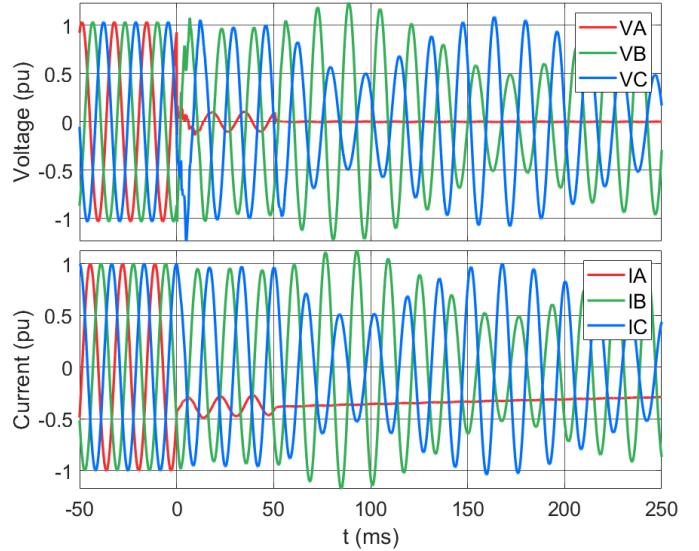
The possibility of opening the shunt reactor during autoreclose was considered but deemed unviable. This is because autoreclose is applied after line faults, which introduce missing zero-crossings in the currents of the reactor breaker throughout the three-phase open time interval [16]. Fig. 23 displays waveforms obtained from a simulation conducted using an electromagnetic transient program. In this simulation, a Phase-A-to-ground fault was applied on a highly shunt-compensated line near one of the line terminals, resulting in a significant voltage depression. The fault was applied when the Phase A voltage was at a 60 degree phase angle after the positive zero-crossing.

The reactor in the faulted phase exhibited a high offset current with a very long decay time constant, leading to the persistence of missing zero-crossings. Switching out the reactor during the three-phase open interval following a line fault would be counterproductive and would increase the risk of a reactor breaker failure.

Fig. 23. Missing zero-crossings in the reactor current after a line Phase A-to-ground fault.

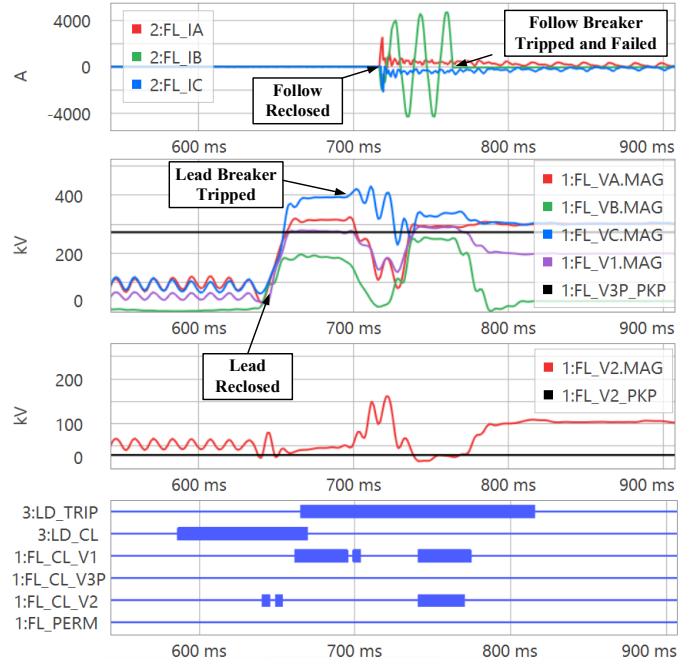
The proposed supervision logic was tested using the voltage waveforms recorded by the relay at the follow terminal during Event E. Fig. 25 compares the performances of the proposed and existing logics. In the top-middle chart, which displays the line voltage magnitudes at the follow terminal, it can be observed that the lead terminal closed on the high-impedance Phase-B-to-ground fault at about 650 milliseconds. Shortly after, the positive-sequence voltage reached the 90 percent threshold, allowing the reclose to proceed when the existing logic was used during the failure event. While the follow terminal breaker was still in the process of closing, the lead terminal tripped and opened at about 700 milliseconds because of the permanent fault. Finally, it closed only after the opening of the lead terminal and thus had uncontrolled closing, as shown in the top chart displaying the terminal line currents. In contrast, the proposed logic would have prevented autoreclose from proceeding at the follow terminal due to two reasons: (a) the faulted Phase B voltage remained below the 90 percent threshold, as shown in the top-middle chart displaying the phase voltages, and (b) the negative-sequence voltage rose above the 10 percent threshold shortly after the closing of the lead terminal, as shown in the bottom-middle chart showing the negative-sequence voltage. Consequently, the input to the 60-millisecond time delay never asserted.

Fig. 25. Secure performance of reclose supervision logic for Event E. Analog traces from top to bottom: (1) follower breaker three-phase current, (2) follower breaker line voltage measurements and threshold, and (3) follower breaker line negative-sequence voltage measurement and threshold.

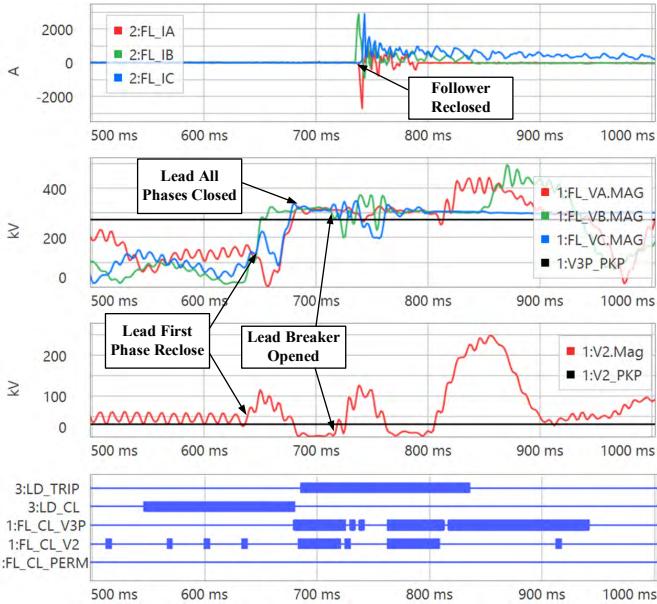
Similar tests were conducted for Event C, in which autoreclose at the lead terminal occurred on the healthy line. The proposed supervision logic correctly blocked the breaker autoreclose sequence. Fig. 26 illustrates the results. It shows that line voltage on all three phases recovered at the follow terminal, and no negative-sequence voltage was present because there was no fault. Thus, the input to the 60-millisecond timer was asserted. But the output timer was never asserted because the lead terminal tripped before the expiration of the timer, causing the voltage to drop below the threshold and preventing follow terminal autoreclose from proceeding.

Fig. 26. Secure performance of reclose supervision logic for Event C. Analog traces from top to bottom: (1) follower breaker three-phase current, (2) follower breaker line voltage measurements and threshold, and (3) follower breaker line negative-sequence voltage measurement and threshold.

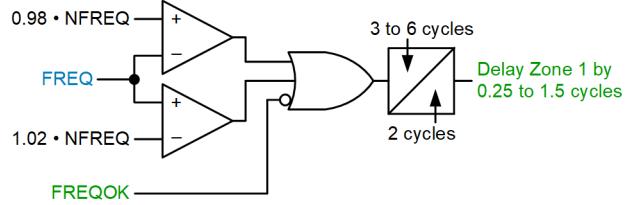
Fig. 28. Zone 1 delay using frequency supervision.

The logic of Fig. 27 slows down Zone 1 when any phase at the local terminal is open, which may be undesirable in some applications, e.g., single-phase tripping. The challenge to protection occurs when the line is being energized following a period of de-energization from both terminals. Upon line energization, the relay's polarizing voltage angle suddenly changes when the frequency suddenly changes from the ringdown frequency to 60 Hz, the power source frequency. When the line is de-energized from both terminals, the line VTs measure the ringdown voltage at an off-nominal frequency. A ringdown voltage detection logic was proposed earlier [15]. It uses frequency supervision to improve the security of sensitive and fast shunt reactor protection. A similar approach can be used to delay Zone 1; the associated logic is shown in Fig. 28. If the frequency measurement is not healthy (NOT FREQOK) or if the measured frequency (FREQ) is significantly off

nominal (e.g., a 2 percent difference from the nominal frequency, NFREQ) for a few cycles (e.g., 3 to 6 cycles), then a short delay is added to Zone 1.

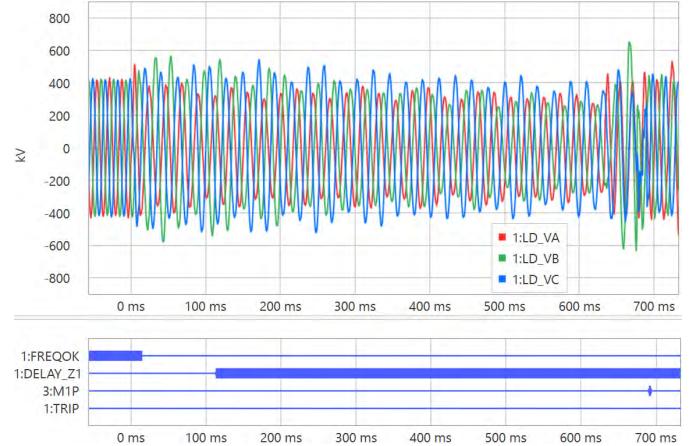
The frequency supervision logic, shown in Fig. 28, with a pickup time of 6 cycles was implemented, and Event D was played back through the relay with the results illustrated in Fig. 29. FREQOK drops out after the line is de-energized from both terminals and the relay starts measuring the ringdown voltages. After 6 cycles, the additional time delay is added to Zone 1 and the relay remains secure.

Fig. 29. Secure performance of frequency supervision for Event D.
