# Lessons Learned Through Commissioning, Livening, and Operating Switchgear: Part 2

Matthew Watkins and Kamran Heshami  
*Schweitzer Engineering Laboratories, Inc.*

Presented at the  
2024 PCIC Europe Conference,  
Rotterdam, Netherlands  
June 2024

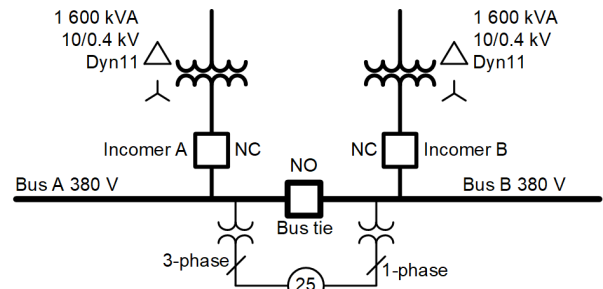
Fig. 8 Two delta-wye transformers energizing an MCC

Two 10 kV delta to 380 Vac wye transformers energize MCC incomers separated by a normally open bus tie. Both transformers were independently commissioned. During precommissioning, the 380 Vac incomer (either Bus A 380 V or Bus B 380 V in Fig. 8) was energized via a temporary generator. This permitted energizing downstream loads off the MCC to aid in commissioning activities. As the electrical commissioning neared completion for both the transformers and MCC, preparations were made for each transformer to be energized by the permanent supply. This is often done a week or two apart from the final activity of verifying the manual transfer scheme, which consists of a closed transition that is achieved by closing the bus tie and then opening the selected incomer. In the process of performing the manual transfer, the normally open bus-tie breaker cannot close. See Fig. 8.

In reviewing the installation in detail, the commissioning team found that the delta links on the 10 kV transformer winding were installed incorrectly on Incomer B. See Fig. 11 for a typical installation showing the delta link placement (photo taken during precommissioning).

After commissioning over 100 switchboards, the field commissioning team was familiar with the synchronization function in the relay and never had it block closing. This was the only transformer found with incorrect delta link placement. It was important for the field team to trust the information provided and use that information to dig deeper into the root cause. Ultimately, the delta links were reconfigured to achieve the proper desired transformer connection and permit proper synchronization.

With the incorrect delta link configuration, all three-phase voltages were 60 degrees out of phase. With both incomers energized, under normal conditions, the voltage across the open contacts is 0 percent of the phase-to-ground voltage. However, with the incomers 60 degrees out of phase, the voltage across the open contacts was 100 percent of the phase-to-ground voltage. See Equation (1) based on the actual synchronizing phasor in Fig. 9 and the expected synchronizing voltage in Fig. 10. While this voltage difference is no different than having one energized source and one de-energized source, the problem is the short-circuit current interruption. If operators attempt to close a normally open tie circuit breaker with two out-of-phase sources, there will be significant transient current between the two sources, which may exceed the capability of the circuit breaker to interrupt out-of-phase currents [4].

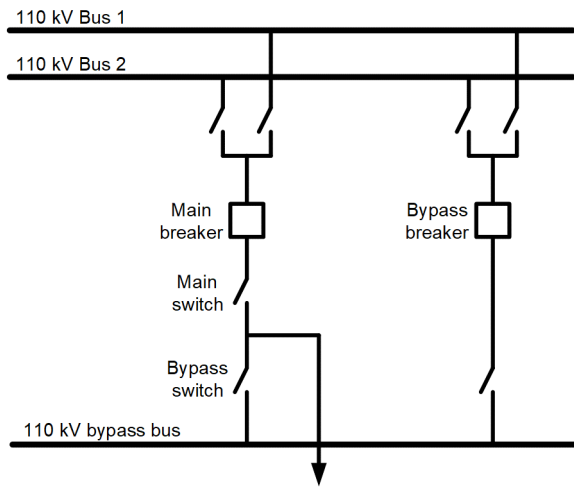
Fig. 13 Simplified utility single-line diagram

The bus configuration at the utility substation is a double-bus single breaker with an additional bypass bus, as shown in Fig. 13 with key breakers and switches labeled. In this configuration, the line can be fed from either Bus 1 or Bus 2 when both the main breaker and main switch are closed, or fed from the bypass bus when both the bypass breaker and bypass switch are closed. The main breaker, bypass breaker, and switch statuses are wired to the line protective relays on the utility side. The breaker and switch positions are then transmitted to the facility-side line protective relays through the line current differential channel and finally transmitted to the fast load-shedding system via a serial communications channel between the facility line protective relay and the fast load-shedding system. No direct communication occurs between the fast load-shedding system and any of the equipment on the utility side. Additionally, due to the limited bandwidth available on the dedicated line current differential, the status of the utility breaker was sent as a combined “both open” and “either closed” signal. The combined “both open” and “either closed” logic generated in the utility line protective relay is shown in Fig. 14.

Upon review of the relay event reports confirming presence of a legitimate power system fault, the team conducted a walkdown of the transmission line. The OPGW was found to be broken on one of the transmission poles. This OPGW carried the line current differential fiber for the redundant line differential channels of the line relays. When it broke, it caused failure and disabling of the line current differential channel. This demonstrates the importance of routing each fiber channel in two physically separated paths. Alternately, an existing communications network and multiplexing technologies, such as a synchronous optical network (SONET), can be leveraged to establish a secondary line differential channel to complement a primary dedicated line differential channel [5].

This event highlights the importance of monitoring the line current differential channels and generating alarms in case of a channel failure. A line current differential channel failure alarm would have asserted in this case and allowed the system operators to address the issue before the broken OPGW caused a line trip. Additionally, [1] describes advanced reporting functionalities that can be implemented in line current differential relays to enhance monitoring of the communications channel.

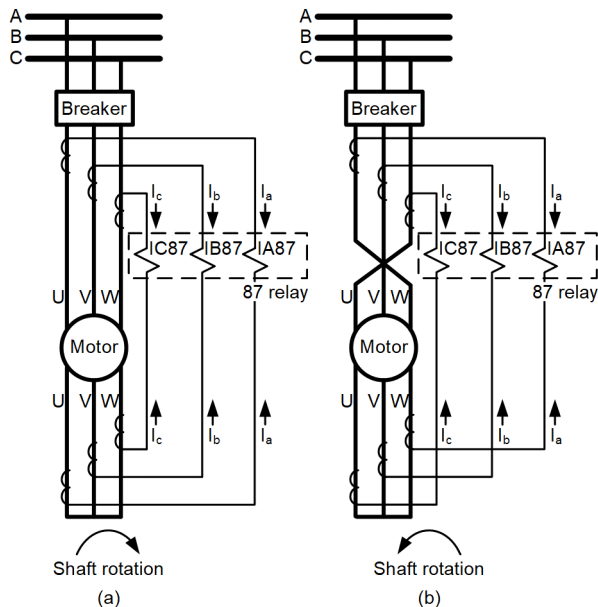
Fig. 16 (a) Clockwise and (b) counterclockwise rotation of the power system connections

During the initial bump start of an uncoupled 2.6 MW air compressor motor from a 10 kV medium-voltage switchboard, the protective relay tripped on the 87 differential element. The commissioning team identified that the motor rotated in the wrong direction. While the root cause of the incorrect rotor rotation was easy to identify, the cause for the differential trip was more complex. Differential CT connections to this relay are shown in Fig. 16. Feeder CTs from the switchboard are used by the relay for motor currents. These CTs are externally summed with the motor neutral-end CTs for the differential current connection. With opposing CT polarity, for a no-fault condition, the differential current into the relay should be zero.

In Fig. 16, the application intent was for the rotor to rotate in the counterclockwise direction. As a result, the motor terminal U connection needs to be the power system C-phase, the motor terminal V needs to be the power system B-phase, and the motor terminal W needs to be the power system A-phase. Instead, the commissioning team found the motor wired to the power system as identified in Fig. 16a and needed to reconnect the motor to the power system as identified in Fig. 16b. When multiple problems are found during commissioning, it is important to treat each one independently and to recognize that the solution may impact the other problem. In this case, when modifying the primary leads to the motor terminals, the commissioning team had to change the CT connections on the neutral end accordingly so that A-phase on the medium-voltage breaker side aligns with Terminal W on the motor's neutral end. Incorrect CT wiring was not the root cause of the differential trip.

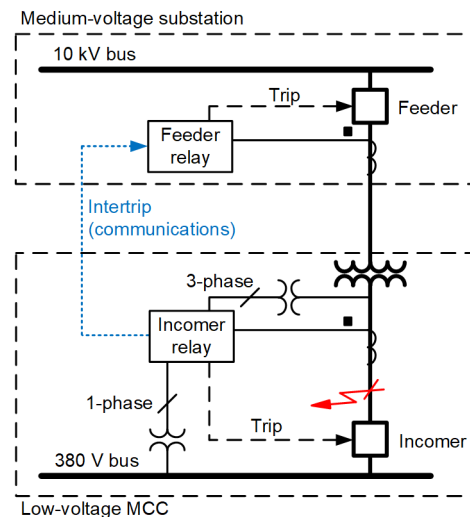
Fig. 20 380 V Incomer/Bus B simplified single-line diagram

Fig. 20 depicts the simplified single-line diagram of the system. The incomer protective relay is wired to measure phase currents from a current transformer installed upstream to the incomer circuit breaker. This relay receives three-phase voltage from the line side of the circuit breaker and single-phase (sync-check) voltage from the bus side of the circuit breaker. This figure also depicts the location of the arc-flash event based on the post-fault inspection of the MCC.

During the cutover from temporary power to permanent power, the commissioning team followed all procedures, including an appropriate switching procedure, isolation of the temporary supply, and permit to work. The prechecks completed included a 72-hour soak test of the dry-type 10/0.4 kV transformer. Busbars were previously energized under a temporary 380 V supply from a diesel generator for a much longer time. A pre-energization insulation resistance test had also shown normal insulation levels.

Upon an intrusive post-event inspection of the MCC, copper shavings, which were hardly visible during the general visual inspection, were found at the rear of the circuit breaker busbar connections. The copper shavings were suspected to be left over from a retrofit installation of a voltage transformer on the busbar, which occurred in the fabrication yard where the module was constructed. There were threaded holes drilled on the busbar to accommodate installation of the voltage transformer. Fig. 21 shows the drilling point on the copper buses for the installation of the new voltage transformer. Many copper shavings were found inside the breaker compartment. It is suspected that one of the shavings fell down on the busbar due to breaker jolt while closing and resulted in the arc-flash event.
