# A Bus Cleared and a Hidden Breaker Insulation Failure Revealed

Robert Roman and Kevin Damron  
*Avista Utilities*

Emma Clawson  
*Schweitzer Engineering Laboratories, Inc.*

Presented at the  
51st Annual Western Protective Relay Conference  
Spokane, Washington  
October 22–24, 2024

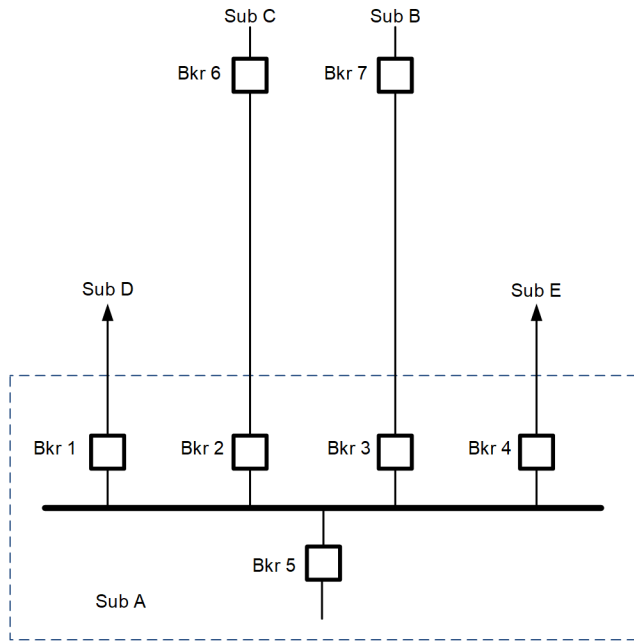
Fig. 8. Sub A configuration.

Sub A is a 230 kV substation with five 230 kV breakers, as shown in Fig. 8. The breakers relevant in the following events are Breaker (Bkr) 2 and Bkr 3. The relays protecting the Sub A–Sub B line on the Sub A end of the line were modern line relays, and the relays protecting the Sub A–Sub C line at the Sub A end of the line were legacy line relays. The Sub A bus protective relays were a modern high-impedance bus differential relay and a modern percentage-restrained bus differential relay, referred to as 87B1 and 87B2, respectively.

The initial information received from the system operators was that the Sub A–Sub B line (Bkr 3 and Bkr 7) and the Sub A bus (Bkr 1, Bkr 2, Bkr 3, Bkr 4, and Bkr 5) had tripped at the same time. The initial thought was that lightning had struck the Sub A–Sub B line and the Sub A bus at the same time. The technicians arrived at the substation, saw no visible damage
