# A Bus Cleared and a Hidden Breaker Insulation Failure Revealed

Robert Roman and Kevin Damron  
*Avista Utilities*

Emma Clawson  
*Schweitzer Engineering Laboratories, Inc.*

Presented at the  
78th Annual Conference for Protective Relay Engineers at Texas A&M  
College Station, Texas  
March 31–April 3, 2025

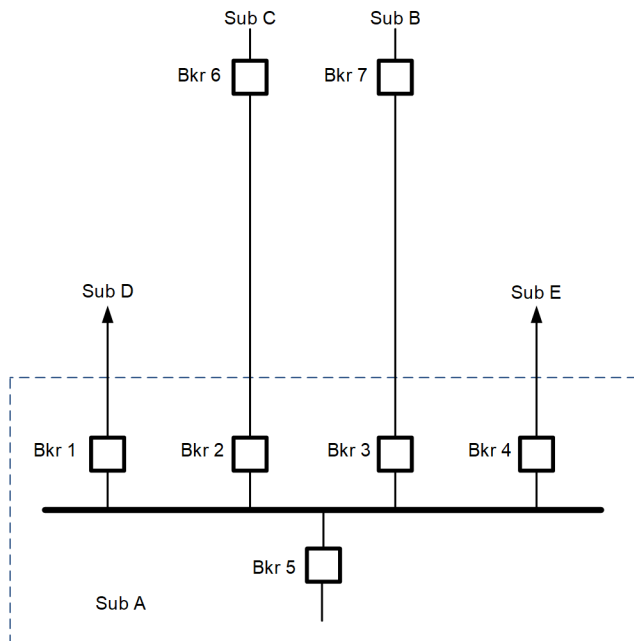
Fig. 8. Sub A configuration.

Sub A is a 230 kV substation with five 230 kV breakers, as shown in Fig. 8. The breakers relevant in the following events are Breaker (Bkr) 2 and Bkr 3. The relays protecting the Sub A–Sub B line on the Sub A end of the line were modern line relays, and the relays protecting the Sub A–Sub C line at the Sub A end of the line were legacy line relays. The Sub A bus protective relays were a modern high-impedance bus differential relay and a modern percentage-restrained bus differential relay, referred to as 87B1 and 87B2, respectively.

The initial information received from the system operators was that the Sub A–Sub B line (Bkr 3 and Bkr 7) and the Sub A bus (Bkr 1, Bkr 2, Bkr 3, Bkr 4, and Bkr 5) had tripped at the same time. The initial thought was that lightning had struck the Sub A–Sub B line and the Sub A bus at the same time. The technicians arrived at the substation, saw no visible damage

from the fault, and therefore, proceeded to re-energize the Sub A bus and the Sub A–Sub B line. There was no indication or idea that any of the breakers might have been compromised or that a second fault had occurred while the Sub A bus had been open.
