# Lessons Learned Through Commissioning, Livening, and Operating Switchgear: Part 3

Presented at the  
2024 PCIC Middle East Conference,  
Al Khobar, Saudi Arabia  
November 12–13, 2024

Copyright Material PCIC Middle East  
Paper No. PCIC ME24\_04

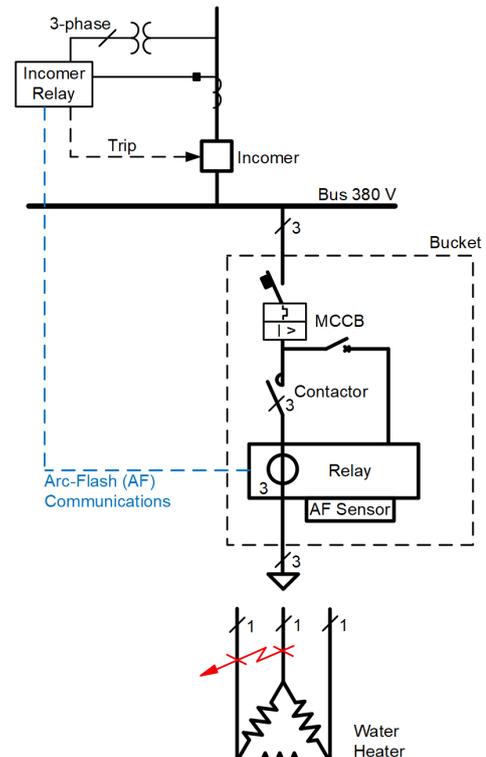
Fig. 1 Single-line diagram of a typical contactor feeder.

As part of commissioning the gas turbine generator (GTG) auxiliary systems, a three-phase, 380 V cooling water heater experienced a phase-to-phase short-circuit fault during the initial energization of the heater. The Phase-A-to-Phase-B short-circuit fault occurred in the heater terminal box when the feeder cubicle contactor was energized and closed onto the fault, as shown in Fig. 1, Fig. 2, and Fig. 3.

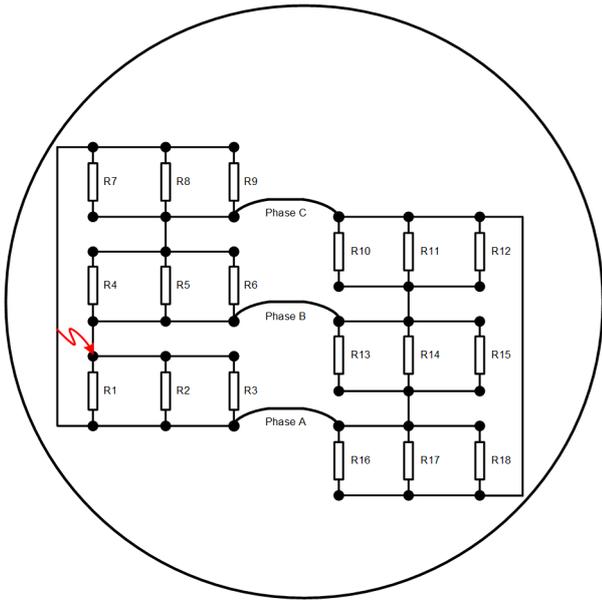
Fig. 2 Typical three-phase delta connection configuration diagram for a cooling water heater.

The phase-to-phase fault occurred between the link connecting elements R1 and R13, which was supplied from Phase A, and the second rod conductor of Element R13, which was supplied from Phase B, as shown in Fig. 2. The clearance at this point was approximately 2 mm.

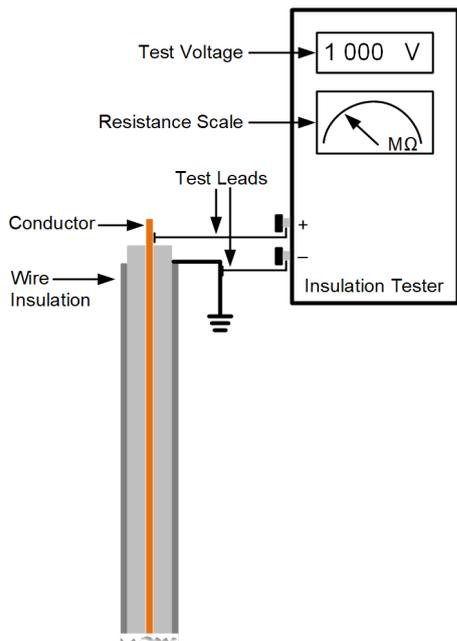
Fig. 9 Typical connections for IR test instrument.

A commissioning contractor technician was performing an IR test on the primary cable of an outgoing feeder cubicle at the MCC distribution board. The IR test of cables is performed to check the integrity of the insulation of the conductors (refer to Fig. 9).

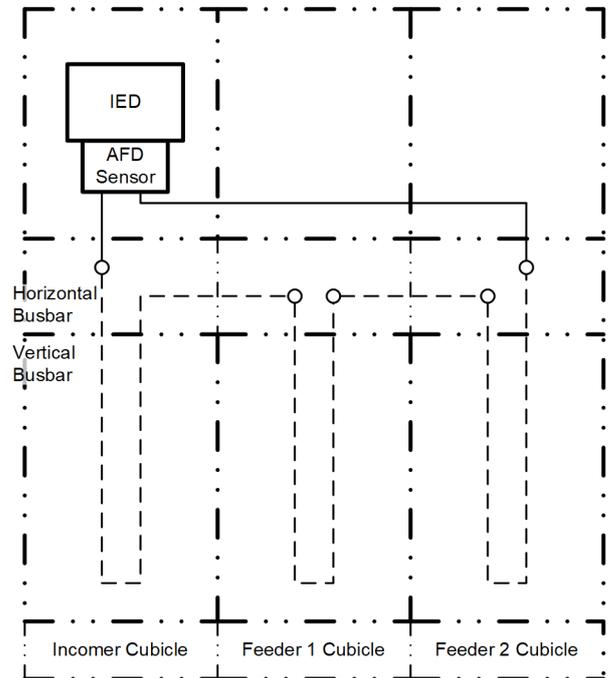
Fig. 11 Typical low-voltage MCC distribution board AFD scheme.

Fig. 11 shows the typical AFD scheme for a low-voltage MCC distribution board. The typical arc-flash zone of detection is created using arc-flash fiber loops around the horizontal and vertical busbar section to detect the arc in the busbar protection zone. The current transformers from the incomer breaker connect to the incomer relay, and the relay uses that current along with the light detected by the AFD sensor loop to declare an arc-flash event on the busbar zone and trip the incomer breaker, as shown in the following equation.

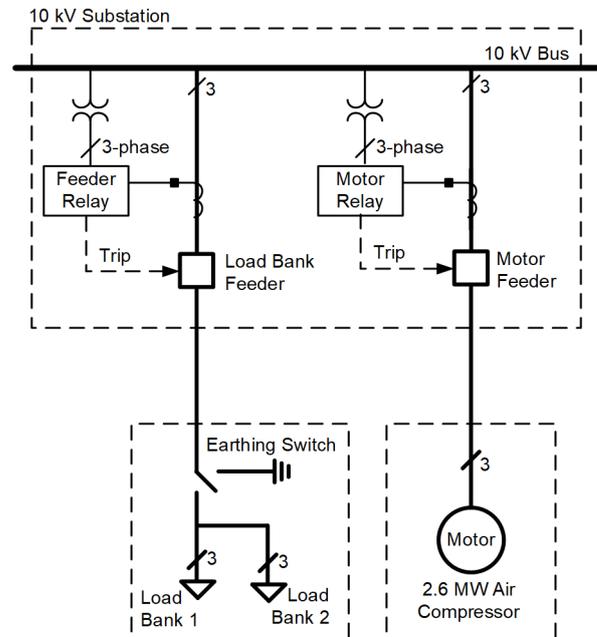
Fig. 13 Connection diagram of load bank and the transformer and RMU to the medium-voltage distribution board (MDB).

IEDs on the load bank feeder recorded an event showing a three-phase fault, albeit the operator never reported it. Further investigation of the Sequential Events Recorder (SER) of the protective relay confirmed that the operator closed the earthing switch (ES) on the load bank side (refer to Fig. 13) while the feeder breaker was closed. Closing the ES created a three-phase-to-ground fault (around 14 kA) and the feeder was tripped immediately on instantaneous (50P) protection. As per Fig. 14, the fault current was cleared within 100 ms. The feeder relay is wired with bus voltage, and it is evident from the event record that the bus

After the investigation, it was evident that the operator did not follow the correct de-energizing procedure and applied the ES on the SF<sub>6</sub>-insulated RMU of the load bank prior to switching off the feeder breaker. The impact to the voltage caused the shutdown of the air compressor. There was no physical damage observed on the ES at the SF<sub>6</sub>-insulated RMU, as it is rated for higher short-circuit currents (21 kA for 3 s). It was also evident that the operator did not notice the trip on the load bank feeder as the operator was investigating the simultaneous trip of the air compressor. The inadequate communication between the operators at both the substation and the load bank led to the short-circuit event. The operator at the load bank did not experience any shock due to the integrity of the SF<sub>6</sub>-insulated RMU and instant tripping of the upstream breaker, under 100 ms.

crews of the importance of taking the time to install proper cable cleats and avoiding faster installation approaches, like the use of cable ties. As part of the root cause analysis, the operators were trained. The trainings emphasized good communication, highlighted the key items to be discussed at safety toolbox talks, and stressed the importance of following procedures to avoid complacency. In conclusion, even in temporary electrical arrangements, it is important to include bidirectional interlocks between the source and the feeder, in addition to following procedures meant to create and maintain a safe working environment [8].

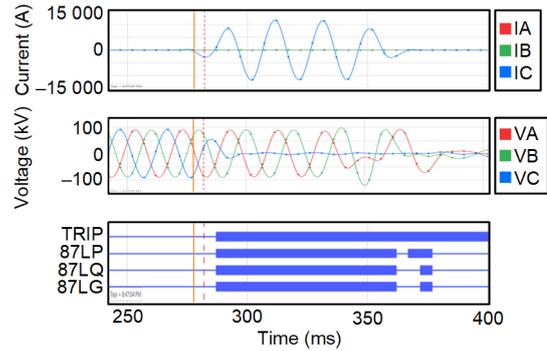
Fig. 17 Substation B primary 87L relay.

The line current differential (87L) relays shown in Substation A, Substation B, and the 10.5 kV distribution substation in Fig. 16 consist of a primary and backup relay. The relays are of the same manufacturer. However, they are different models. Prior to the fault, the 10.5 kV distribution substation had both incomers energized with the bus-tie breaker open. The 10.5 kV substation is only energized from these two incoming lines, leading to a weak infeed condition for 110 kV line faults. The event report from the Substation B primary relay is shown in Fig. 17. The performance of the backup relay matched the primary relay, and the trip occurred due to phase (87LP), negative-sequence (87LQ), and ground (87LG) differential elements asserting in both relays in 0.25 cycles.

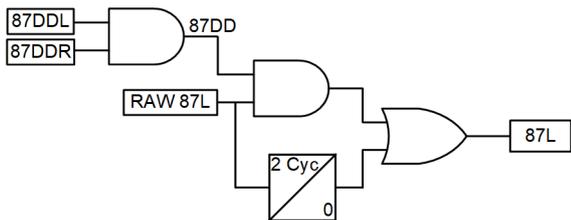
Fig. 20 Primary relay disturbance detection logic.

In the primary relay, the disturbance detector qualifies 87L differential trip events by asserting digital status 87DD. 87DD asserts when both a local (87DDL) and a remote (87DDR) disturbance is detected. In the local relay, a local disturbance is detected based on changes on either zero- and positive-sequence currents or the line-sequence voltages (zero-, negative-, and positive-sequence). 87DDR asserts on receipt of a disturbance detection bit from the remote end across the differential channel. For weak infeed conditions, the relay can base the local disturbance detection on the voltage. However, voltage inputs were not wired in this 10.5 kV distribution substation application. The trip logic also includes a 2-cycle pickup timer for instances

where an 87 differential event is detected without the associated assertion of 87DD. See Fig. 20 for the logic in the primary relay.
