Fault Contributions From Inverter-Based Resources: Field Insights and Protection Challenges

Mukesh Nagpal
Burns & McDonnell

Ajmal Saeed, Ricardo Rangel, and Daniel Zhang
Pacific Gas & Electric Company

Presented at the
52nd Annual Western Protective Relay Conference
Spokane, Washington
October 28–30, 2025

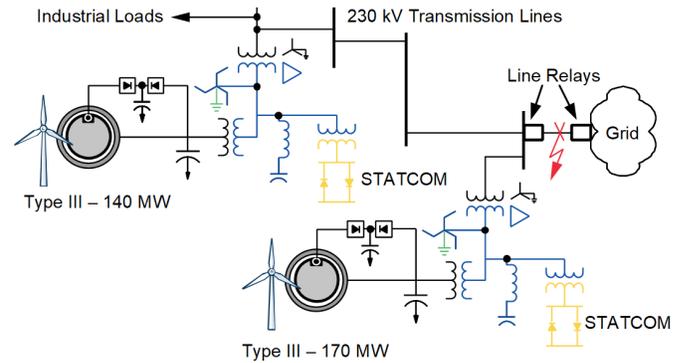
Fig. 9. A 230 kV radial transmission network integrating two Type III wind generation facilities

Fig. 9 illustrates a 230 kV radial transmission system integrating two Type III WTGs rated at 170 MW and 140 MW, respectively, into the utility grid. An evolving fault occurred on the transmission line connecting the grid to the 170 MW wind generation facility. The fault was initially a Phase-B-to-ground

short circuit and, after approximately three cycles, the arc extended to include Phase C, evolving into a phase-to-phase-to-ground short circuit.

At the wind generation terminal, the phase distance element did not operate at all, even though the measured impedance entered the ground mho characteristic. This is because the supervising directional element failed to assert. In addition, the relay misidentified the fault as a Phase-A-to-ground fault (FSA asserted) instead of a Phase-B-to-ground fault (FSB did not assert). The terminal eventually tripped after receiving the DTT from the grid terminal.

The I_2 , negligible before the fault, increased to about 90 A. Though it was also significantly less than what is anticipated from the synchronous facility, it was consistently higher than the relay's directionality threshold (50FP). Yet, 32QF only asserted transiently for this forward fault. This is because I_2 led V_2 by 155 degrees, diverging significantly from the 90 degrees lead typical of synchronous machines. This phase angle deviation prevented the 32Q element from being dependable for the forward fault. Further, the phase angle of I_2 lagged I_0 by less than 60 degrees and was within the FSA threshold illustrated by the red-shaded region (± 60 degrees) in Fig. 6. This caused the relay to incorrectly identify the fault as Phase-A-to-ground.

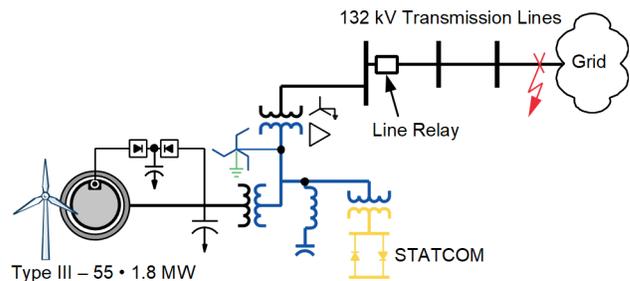
Fig. 12. A 132 kV radial transmission network integrating a Type III wind generation facility

Fig. 12 depicts a 132 kV radial transmission system integrating a Type III wind facility composed of 55 units, each rated at 1.8 MW. In this installation, the line protection utilizes distance elements supervised by the 32V element. During this event, an external single-line-to-ground fault occurred on the transmission system three lines away. Although the wind generation facility successfully rode through the external fault, the remote protection system issued a DTT signal via the anti-islanding scheme, resulting in the facility's disconnection.

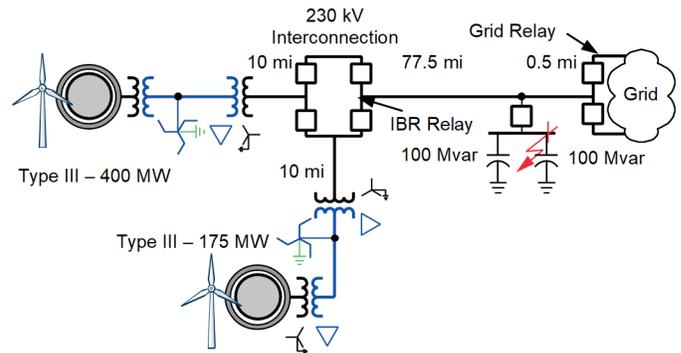
Fig. 14. A 230 kV line interconnecting 575 MW Type III wind generation

There was a Phase-C-to-A fault beside one of the capacitor banks near the grid terminal. Fig. 15 shows the unfiltered phase currents and voltages from the IBR and grid relays. When the fault occurred, about 400 MW of generation was on.

Referring to the fault loop apparent impedance (Z_{CA}), we notice significant oscillations. Additionally, the large angular difference between V_{1MEM} and V_1 caused an expansion and shift of the mho characteristics toward the second quadrant. These two behaviors caused M1P to overreach transiently. In contrast, the grid relay calculated a stable Z_{CA} . Its mho expansion was toward the third quadrant, as is typical in an inductive system with synchronous generators.

We conclude that the control response of IBRs during phase faults (without ground involvement) can cause phase distance elements to exhibit significant transient overreach. The fault voltages may also exhibit unusual behavior—the unfaulted phase (and loop) voltages may be lower than the faulted phase (and loop) voltage.

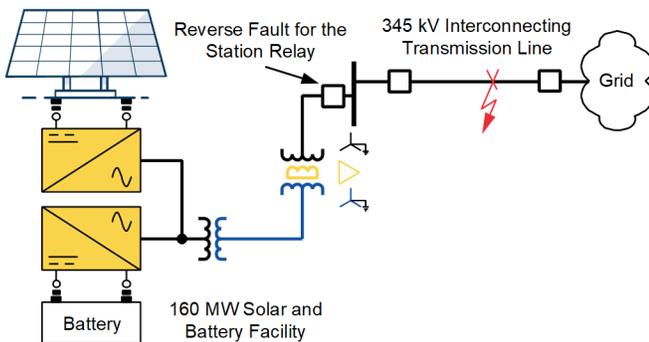
Fig. 16. 345 kV transmission line integrating 160 MW solar and battery generation to the utility grid

A Phase-A-to-ground fault occurred on the interconnecting transmission line. From the perspective of the station protective relay, which looked toward the IBR, this was a reverse fault. Fig. 17 shows the waveforms captured by this relay, detailing both the fault signatures and the behavior of protection elements.

The root cause of this angular variation lies in the grid-following behavior of the inverter. While the system voltage—and therefore the V_2 phasor—remained relatively stable due to the grid's strong inertia, the inverter's output current did not maintain a stable frequency. Because the inverter lacked significant inertia, it exhibited transient oscillations under fault conditions, causing the I_2 phasor to drift relative to the voltage phasor, leading to directional misinterpretation.

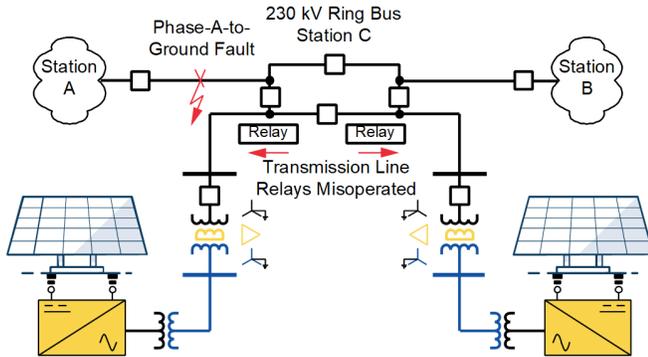
Fig. 18. A 230 kV ring bus switching station integrating two solar generation plants into the utility grid

A Phase-A-to-ground fault occurred on the 230 kV transmission segment between Stations A and C, near Station C. The line protective relays at the transmission line terminals (Stations A and C) operated correctly to isolate the fault. However, the protective relays on the two interconnection lines to the solar IBRs misoperated.

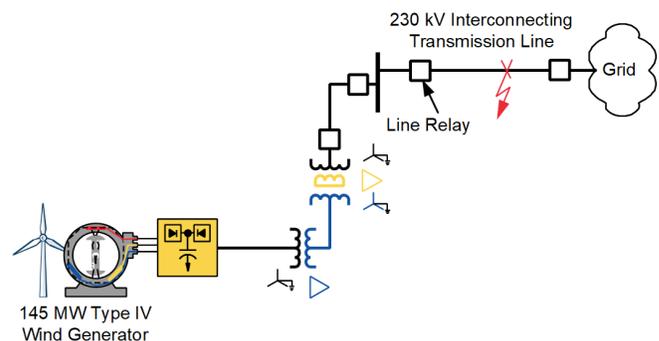
Fig. 20. Integration of 145 MW Type IV wind generation into the 230 kV transmission system

A phase-to-ground fault occurred on the transmission line connecting the wind facility to the grid. Fig. 21 shows the bus voltages and fault current recorded by the transmission line protective relay facing toward the fault. The complete collapse of Phase A voltage unambiguously indicates a Phase-A-to-ground fault.

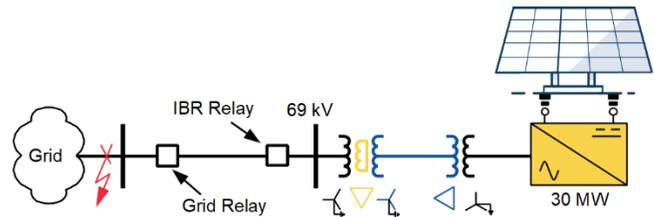
Fig. 22. External ground fault near a 30 MW solar facility

This event originated near a 30 MW solar facility, shown in Fig. 22. A line protective relay responding to the ground fault current contribution from this facility transiently asserted forward on a reverse fault and issued a permissive trip signal, causing a misoperation.

Both relays see the same current (ignoring polarity) and similar voltages (very short line). Because I_2 keeps rotating with respect to V_2 , the fault initially appears to be toward the IBR. The grid relay declares a forward fault incorrectly and sends a permissive signal to the IBR relay. I_2 continues to rotate with respect to V_2 and by the time the permissive signal arrives at the IBR relay, the fault appears to be toward the grid (correctly). The changing nature of the I_2 contribution from the IBR, in conjunction with the channel delay, caused the misoperation. Because external ground faults are quite common, this event illustrates one of the most common types of line relay misoperations near IBRs.

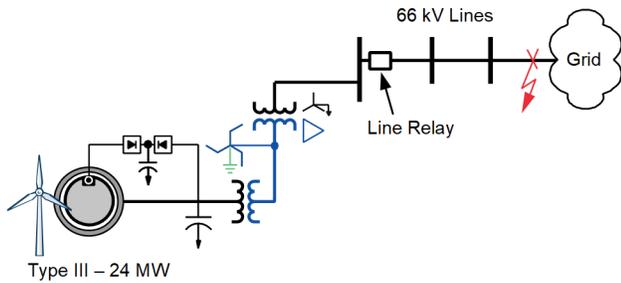
Fig. 24. Remote external phase fault in a Type III wind generation system

There were 24 MW of Type III WTG in a 50 Hz system that was connected via a 15.7 km 66 kV line, as shown in Fig. 24. The line was protected by three phase mho and three ground quadrilateral step-distance zones. Zone 1 was set to trip instantaneously, and Zones 2 and 3 were set to trip with a 20-cycle (0.4 s) and 50-cycle (1 s) delay, respectively. Fig. 25 shows the response captured by the wind facility relay for the evolving phase fault. The sequence of events is as follows:

- A Phase-A-to-B fault occurred. The fault was external to the protected line and outside Zone 3.
- After 62 ms, the fault arc extended to include Phase C and evolved to a three-phase fault, remaining uncleared for some time.
- At 436 ms, the Zone 1 phase mho element on the CA phase loop misoperated. 50 ms later, the fault was cleared from the WTG terminal.

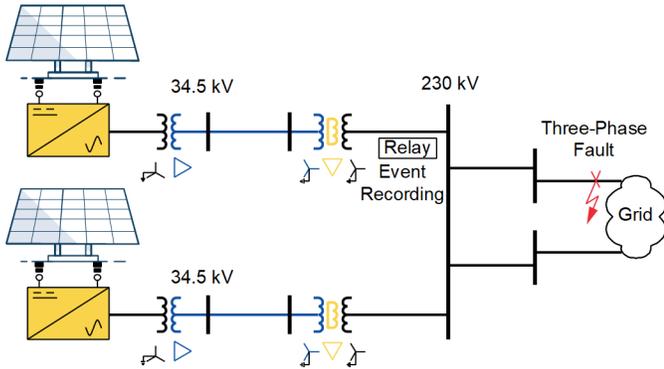
Fig. 27. 225 MW solar facility interconnected to the 230 kV system

Fig. 27 shows an external three-phase fault that occurred on a remote 230 kV transmission line interconnecting two solar generation facilities totaling 225 MW. These facilities, based on full-converter inverters, were integrated into the utility transmission grid via step-up transformers.

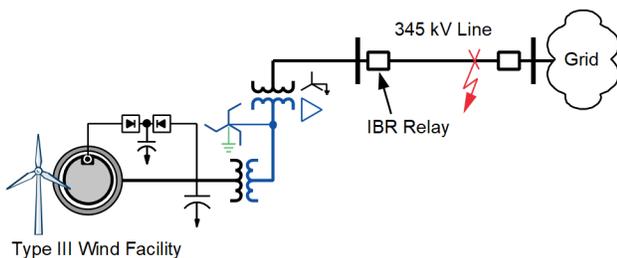
Fig. 30. One-line diagram for a July 2000 Phase-C-to-ground fault

A Phase-C-to-ground fault occurred on a 345 kV line near a Type III WTG facility, shown in Fig. 30. The fault was cleared by the line protective relays in approximately 3 cycles. The unfiltered oscillography of the IBR relay is shown in Fig. 31. The vertical dashed line separates the initial 150 ms following fault inception (left) and the reclosing following 550 ms (right). The voltages are measured on the line side of the WTG facility breaker.

When the breaker closes on the de-energized line, transients in the currents and voltages can be seen, indicating that the WTG facility was still energized.

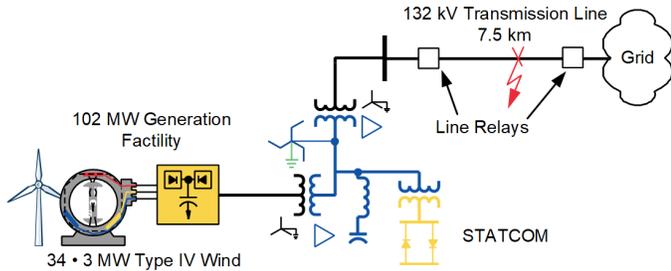
Fig. 32. A 132 kV radial transmission network integrating a Type IV wind generation facility

As shown in Fig. 32, this event occurred on a short 132 kV radial transmission system connecting a 102 MW Type IV wind generation facility, comprising 34 units rated at 3 MW each. A tree contact on the short transmission line linking the wind facility to a utility switching station triggered a Phase-C-to-A fault.

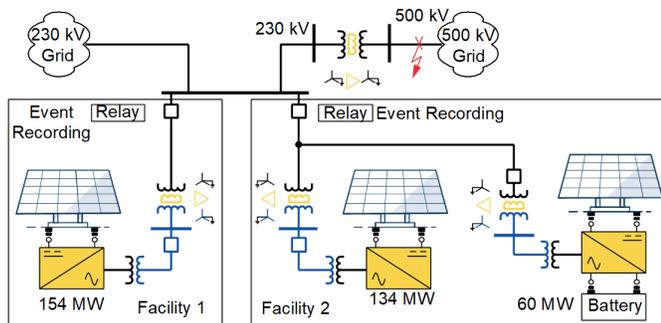
Fig. 34. A utility transmission system, 230 kV and 500 kV, integrating two IBR facilities

A Phase-B-to-ground fault occurred upstream on the 500 kV system. Fig. 35 captures the markedly different fault current responses from the two facilities immediately after the fault was cleared. Fig. 35(a) and Fig. 35(b) display the three-phase currents from Facility 1 and Facility 2, respectively. Fig. 35(c) and Fig. 35(d) display the three-phase voltages, measuring identical voltages at the shared 230 kV bus by Facility 1 and Facility 2.

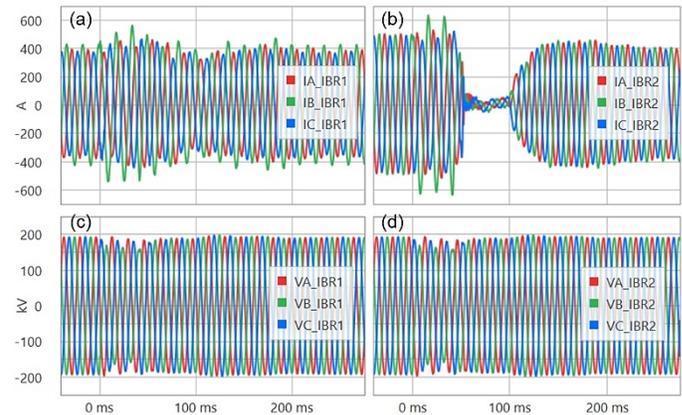
During the fault, the Phase B voltage (V_B) remained higher than 85 percent of the nominal, i.e., the voltage at the IBR terminals did not drop significantly. Both facilities continued injecting close to pre-fault current levels during the fault, which was cleared in approximately 50 ms by primary protection, followed by differing responses from the two facilities:

- **Facility 1** showed a slight reduction in current output between 70–140 ms, after which it resumed injecting its pre-fault current.
- **Facility 2** entered momentary cessation at around 50 ms and remained in that state until approximately 100 ms. Although it began ramping up its output thereafter, its current remained lower than pre-fault levels through the end of the event (1.8 s, not shown).

Fig. 35. Fault responses of two IBR facilities connected to the same 230 kV bus: a) Facility 1 current response, b) Facility 2 current response, c) Facility 1 measured voltages, and d) Facility 2 measured voltages

This event revealed Facility 2's non-compliance with grid code requirements and exposed inconsistencies in dynamic performance between the two IBR sites. Although both were designed to meet the same interconnection requirements, their actual field behaviors differed due to different implementations.

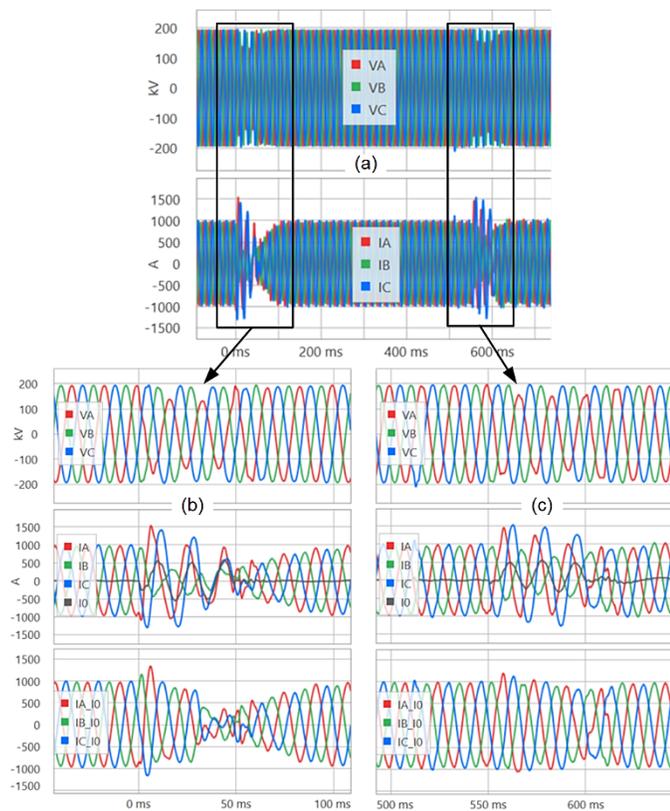
Fig. 39 shows the IBRs' responses to a permanent single-phase-to-ground fault about 40 miles away from the station on a 500 kV transmission line. The 500 kV transmission line had high-speed protection and reclosing, clearing the fault in about three cycles and ensuing autoreclose after 500 ms on the permanent fault. The three phase currents in the figure are the sum of the currents from the three IBR facilities. The three phase voltages are measured on the 230 kV bus.

For the initial fault, the minimum phase voltage dropped to 0.73 pu. I_0 is filtered out from the phase currents and shown in the bottom panel in Fig. 39. It appears that the IBR current increased from 680 A (0.23 pu) to 945 A (0.33 pu) for half a cycle. The current output then decreased to 560 A (0.19 pu) before entering into complete cease mode during the fault.

Fig. 39. Remote ground fault response of IBR facility showing a) the overall record, b) the initial fault, and c) the high-speed reclose

Following the autoreclose that occurred 0.5 seconds later, the maximum IBR current output was 840 A (0.29 pu), and the IBR remained in the partial cease mode for the same fault location. Based on the installed generation and rated current, the expected IBR fault current response was approximately 1.3 pu. However, the actual contribution was significantly lower, confirming that IBRs did not deliver the expected short-circuit current response under fault conditions.

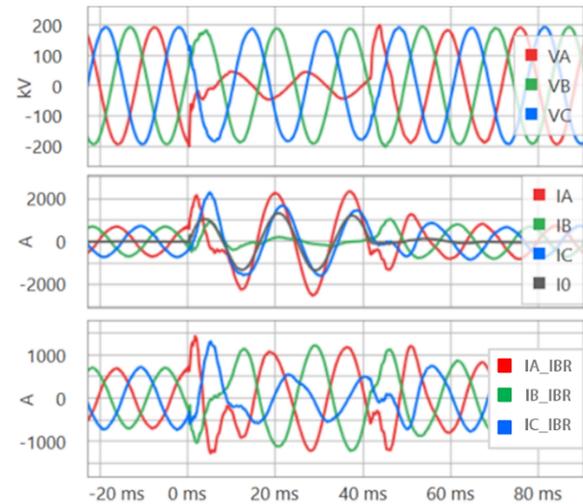
Fig. 40 illustrates the response of the same IBR facilities shown in Fig. 38 during a more severe phase-to-ground fault. The fault occurred on the same 500 kV transmission line as the previous event but was located approximately one mile from the 500 kV/230 kV station. During this fault, the Phase A voltage dropped significantly to about 0.34 pu. A notable increase in the IBR's Phase A and Phase B currents was observed, reaching a maximum of approximately 0.7 pu.

Fig. 40. Close-in ground fault response of IBR facility

This event occurred early in the morning, around 6:30 a.m., when the solar facilities were not generating. With all the BESSs still online and assumed to have a sufficient state of charge, the expected short-circuit response from the BESSs should have been approximately 1.3 pu (or 1,560 A) based on a rated continuous current of 1,200 A. However, the actual current contribution from the BESS was only about 860 A (0.7 pu).

This event further demonstrates the tendency of IBRs to enter partial cease mode or to otherwise underperform during fault conditions, failing to deliver the anticipated 1.3 pu current even during severe, close-in faults.

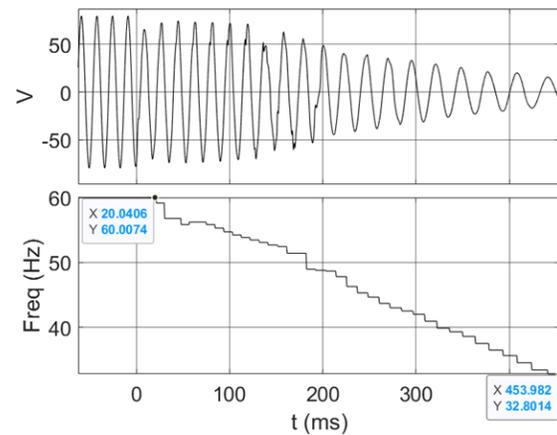
Fig. 43 shows that the frequency dropped rapidly from 60 Hz to 56.7 Hz, with a ROCOF exceeding 60 Hz/s. The fast ROCOF can be attributed to:

- Generation-load unbalance in the islanded network.
- Lack of frequency control by low-inertia, grid-following IBR.

Most digital relays track frequency using bandpass filters tuned around 60 Hz. The relay used in this event could track frequency changes up to 20 Hz/s. Beyond that, it reverted to a fixed 60 Hz estimation. Therefore, the high ROCOF exceeded the relay's tracking capability and degraded its filtering performance.

Fig. 43. Fast ROCOF of an islanded IBR

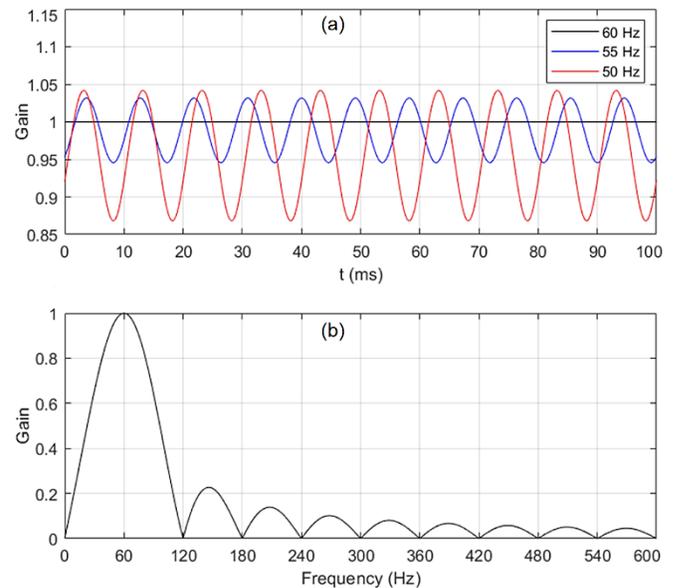
Fig. 44 illustrates the response of a Discrete Fourier Transform (DFT) filter under different input frequencies. While the 60 Hz input produces a stable output, inputs at 55 Hz and 50 Hz exhibit oscillatory responses. Furthermore, the magnitude of the 50 Hz signal is significantly reduced due to the filter's attenuation. The oscillatory behavior and attenuation at off-nominal frequencies can significantly compromise the overvoltage element's dependability.

Fig. 44. Response of a 60 Hz DFT-based bandpass filter to a) 60 Hz, 55 Hz, and 50 Hz signals and b) the mean gain at different frequencies

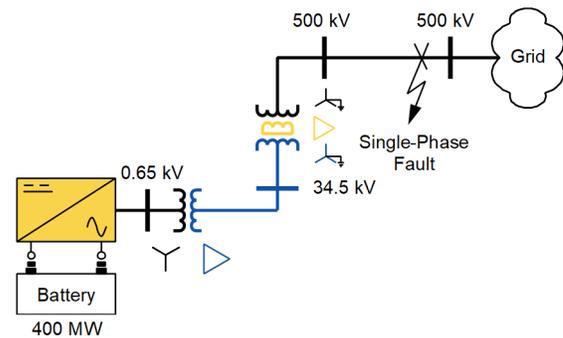
In the system shown in Fig. 47, there was a Phase-B-to-ground fault on a 500 kV tie line connecting to a 400 MW BESS facility. The tie-line current differential protection tripped the BESS offline. After the tie-line trip, the inverters attempted to boost the terminal voltage (instead of shutting down), as shown in Fig. 48. There was also a decrease in frequency from 60 Hz to 58.8 Hz. The increased voltage and reduced frequency together resulted in a substantial increase in volts per hertz (V/Hz), which caused the 34.5/500 kV interconnection transformer to overexcite. The bipolar current spikes, which are characteristic waveforms of overexcitation, are evident in Fig. 48. The voltages and currents were severely distorted and had high harmonic components. The condition lasted longer than three seconds, even though one might expect grid-following IBRs to have shut down earlier.

Moderate overexcitation, as seen in the later part of this event, can cause overheating and dielectric stress, eventually degrading insulation. Damage from moderate overexcitation

can occur within tens of seconds to minutes. Severe excitation, as seen in the earlier part of this event, can additionally break down interlaminar insulation, followed by rapid localized core melting and failure [15]. Damage from severe overexcitation events can occur within seconds.

Fig. 47. Simplified one-line diagram of a 400 MW BESS connected to a 500 kV line that had a ground fault

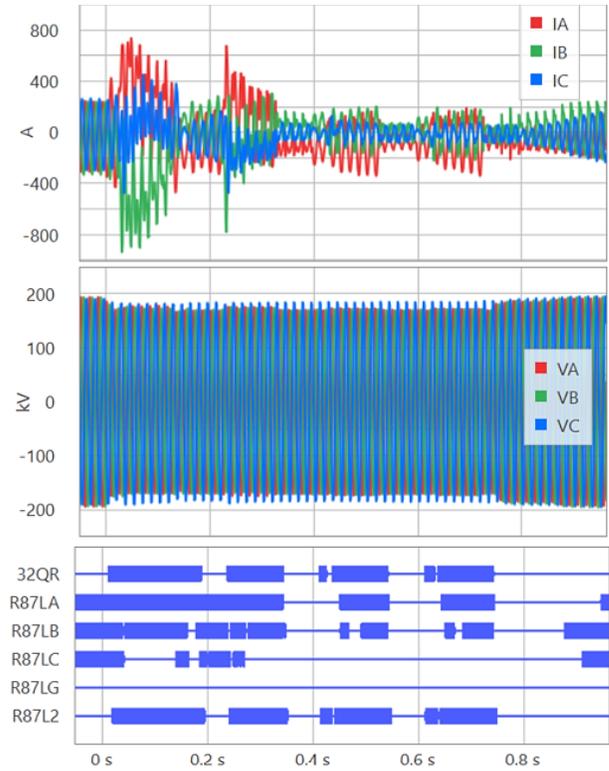
The entire record corresponding to the oscillography in Fig. 58 is shown in Fig. 59. In addition to the dc and harmonics discussed earlier, this oscillography shows subharmonic current oscillations, with each oscillation lasting approximately 100 ms. During the event, the nominal 230 kV voltage dropped to approximately 0.9 pu due to this external fault on the 115 kV line, indicating the fault was electrically remote. The assertion

Fig. 59. Controller response captured by a 230 kV line relay for a remote AB fault

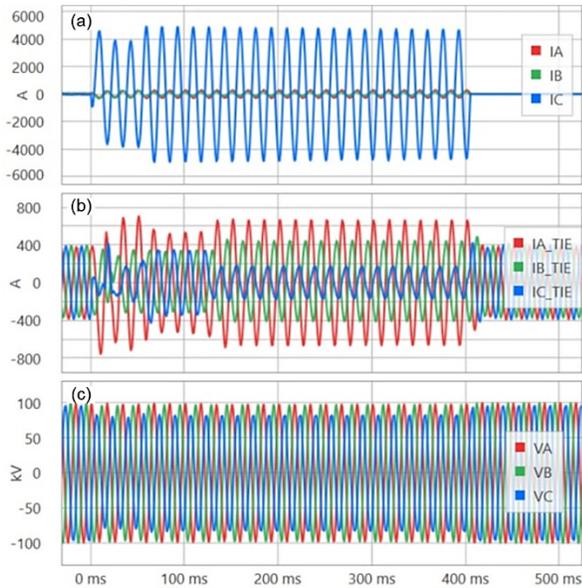
The faulted line current shown in Fig. 65(a) indicated that the remote end tripped in about 3 cycles, while the local end cleared the fault after approximately 24 cycles. Over this 24-cycle period, the gen-tie line current exhibited three distinct behavioral stages [14]:

- The **first three cycles** showed pronounced unbalance.
- The **next four cycles** resembled pre-fault load conditions.
- The **final 17 cycles** exhibited a new steady-state behavior.

Fig. 65. Fault quantities measured by the DFR: a) phase currents from faulted line, b) phase currents from gen-tie line, and c) 115 kV DFR bus voltages

Pinpointing the exact causes of such a current pattern is challenging and requires a deep dive into the inverter's proprietary design and settings. One possible explanation is the changes of the 115 kV and 34.5 kV bus voltages when the remote end tripped shortly after three cycles. The voltages from Fig. 65(c) are magnified in Fig. 67. The voltage changes likely triggered IBR controllers to respond and change the current output. Although the 34.5 kV voltage was not recorded, it is reasonable to assume that it experienced similar changes to the 115 kV bus voltage.

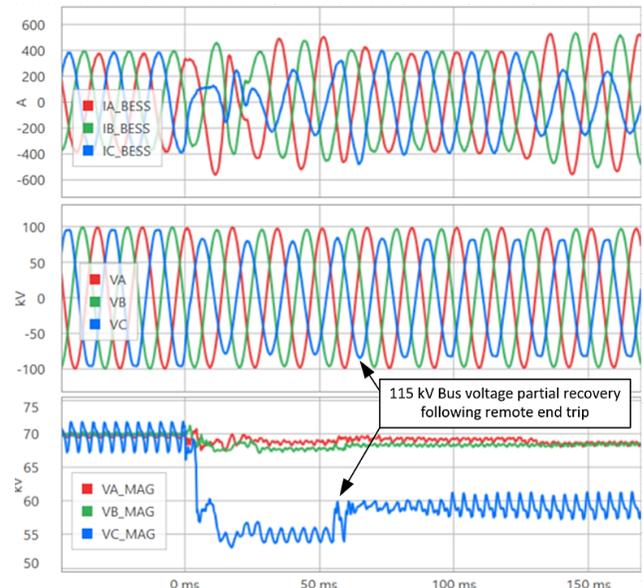
Fig. 67. 115 kV bus voltage change upon a remote-end trip
