# Resolving Digital Line Current Differential Relay Security and Dependability Problems: A Case History

Debra Carroll and John Dorfner  
*Tacoma Power*

Tony Lee and Ken Fodero  
*Schweitzer Engineering Laboratories, Inc.*

Originally presented at the  
29th Annual Western Protective Relay Conference, October 2002

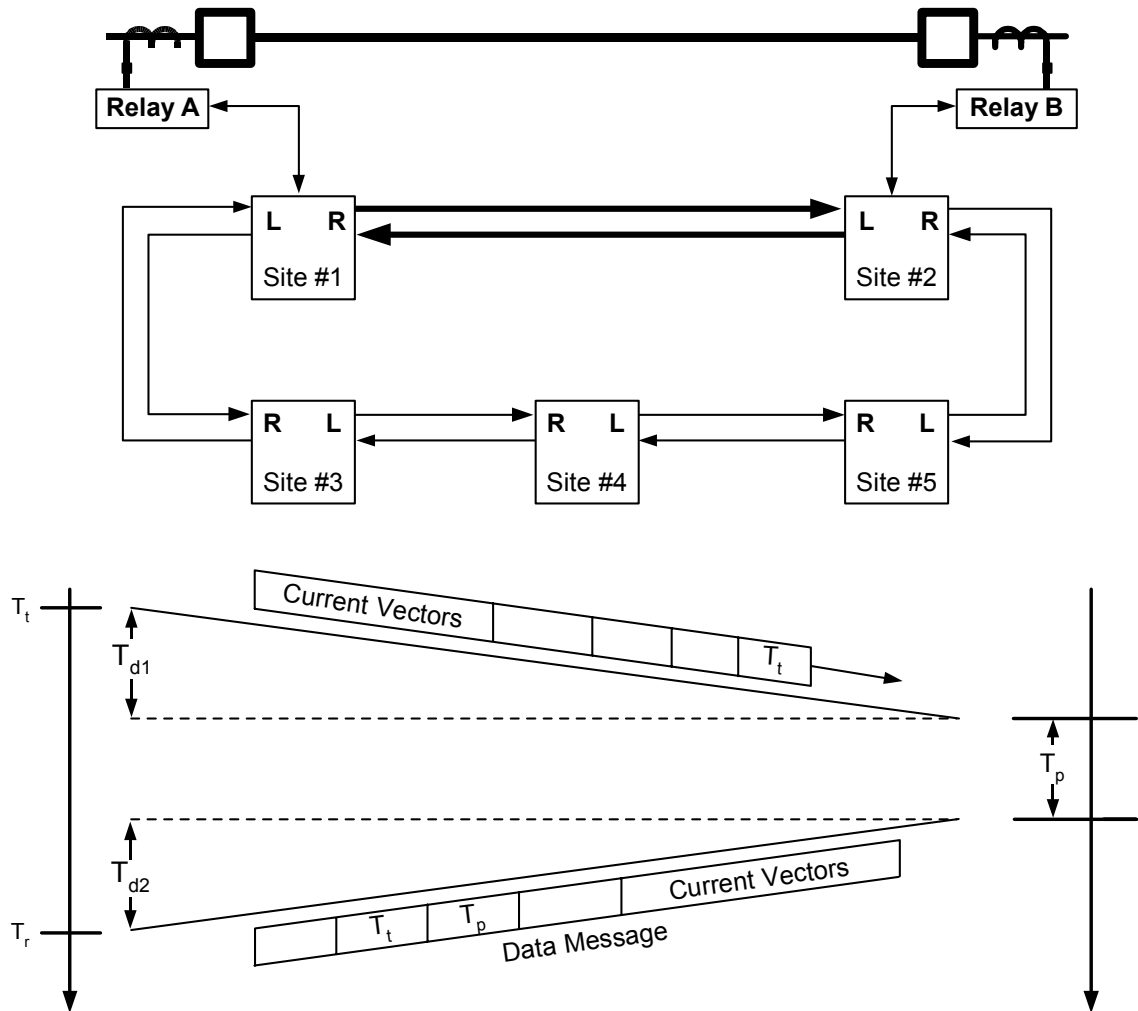
**Figure 2** Normal SONET Operation Has Equal Transmit and Receive Delays

Data sent from Relay B to Relay A uses the same path, and passes through the same equipment, as data passed from Relay A to Relay B. This causes the transmission delay from Relay A to Relay B to be very nearly equal to the delay from Relay B to Relay A. The relays use this fact to compensate for the transmission delays, as shown at the bottom of Figure 2.

To compensate for the transmission delay from Relay B to Relay A, Relay A must know the delay from Relay B to Relay A. When the transmission delays are equal,  $T_{d1} = T_{d2}$ , as shown in the bottom of Figure 2. In that case, Relay A can simply measure the round-trip time from Relay A to Relay B and back to Relay A ( $T_r - T_t$ ), subtract any processing delay at Relay B ( $T_p$ ), and divide by two, as shown in Equation 1.

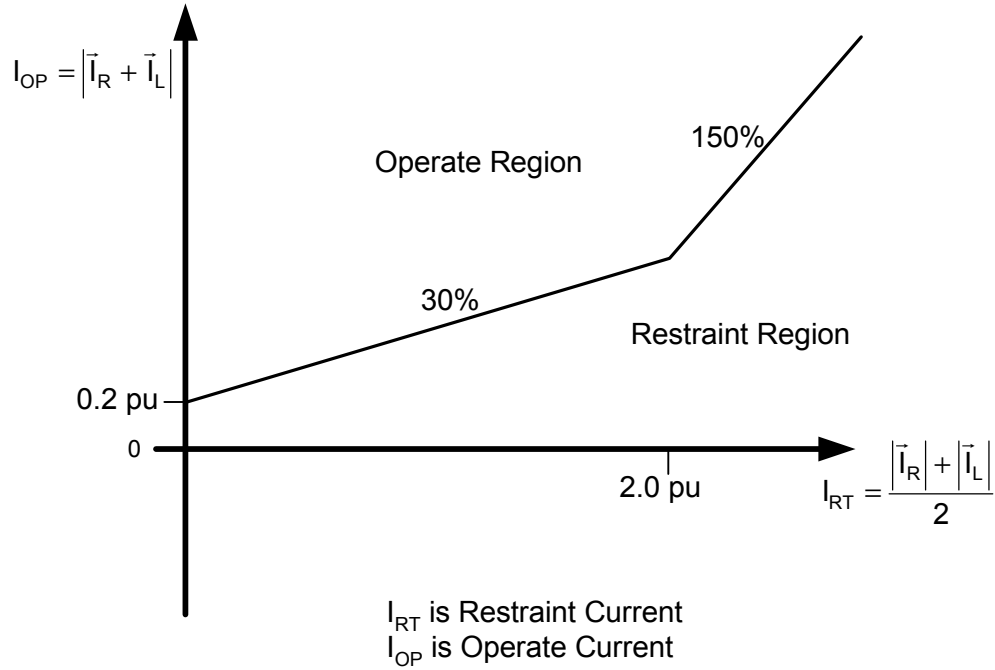
**Figure 9** Operate Characteristic of Relays In Service in Spring 2001

Is this rotation enough to cause a relay to misoperate? A typical current differential relay operates on a dual slope characteristic. Figure 9 shows the operate characteristic and settings of the relays that misoperated at Tacoma Power in the spring of 2001.

The method described by Roberts et al. [5] translates the operate characteristic shown in Figure 9 to a restraint region on the alpha plane, as shown in Figure 10. Figure 9 and Figure 10 are different representations of the same characteristic. In Figure 9, the relay trips if the locus moves above the line. In Figure 10, the relay operates if the locus that normally resides at  $-1$  moves outside the restraint region shown by the black circles. The size and shape of the restraint region of this relay is a function of local current as shown in Figure 10.

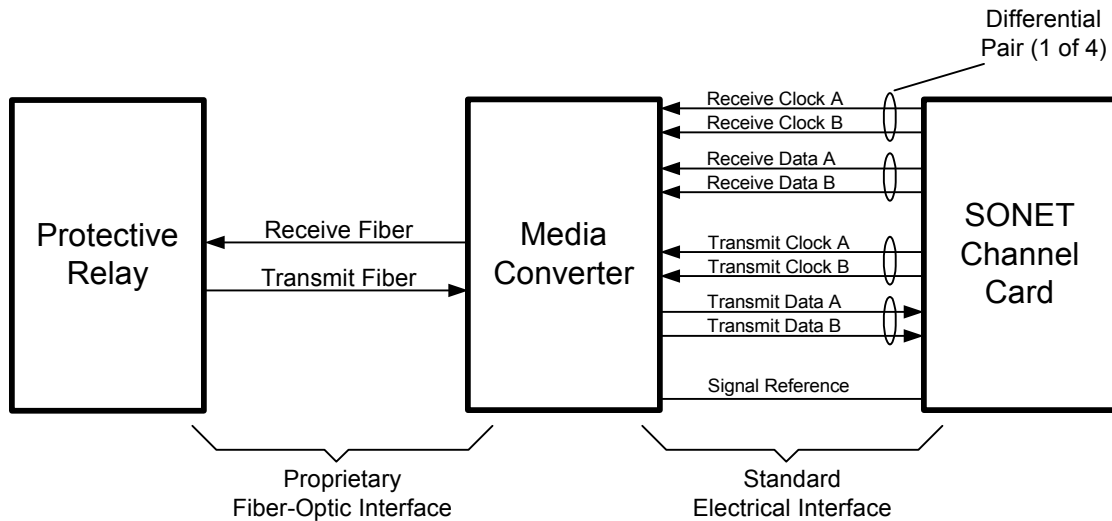
**Figure 14** Details of One Relay and Media Converter Interface From Figure 13

Immediately after installation, multiple communication alarms occurred. A thorough examination of the transmit and receive timing on the SONET channel card revealed an incompatibility with the relay and the media converter. Figure 14 shows the interface in more detail.

In synchronous mode, the SONET channel card supplies the media converter with two clocks. The receive clock is phase-synchronous with the receive data output from the SONET channel card, and essentially tells the media converter when to sample the bits in the serial receive data stream. The SONET channel card also supplies the media converter with a transmit clock. The transmit clock tells the media converter when to change the transmit data output from the media converter. If the media converter does not sample the incoming receive data on the appropriate edge of the receive clock, or does not change the outgoing transmit data on the appropriate edge of the transmit clock, the interface does not work properly.
