Lessons Learned From Generator Destructive Testing

Calvin Howard, Beth Andrews, and Douglas Taylor
Avista Utilities

Normann Fischer, Dale Finney, and Matchyaraju Alla
Schweitzer Engineering Laboratories, Inc.

Presented at the
74th Annual Georgia Tech Protective Relaying Conference
Virtual Format
April 28–30, 2021

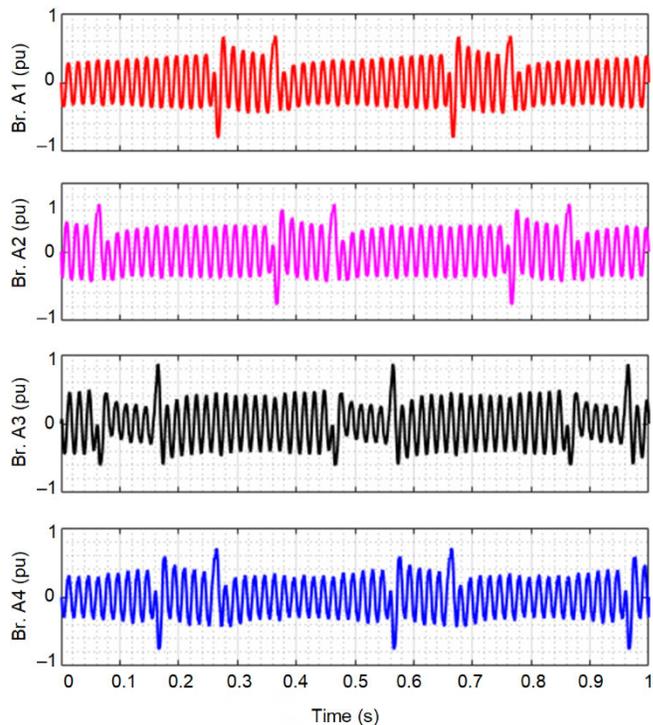
An interesting observation from this test is that the asymmetry in the air-gap flux introduced by the rotor turn-to-turn fault caused a disturbance in the split-phase currents, as can be seen in Fig. 6.

This was an unexpected and interesting result from this test. As a result, we recommend that when a split-phase protection element operates, the integrity of rotor windings be tested. If we examine Fig. 6, we observe that the asymmetry in the air-gap flux caused a disturbance in the branch currents every 100 ms. This can be easily explained because the generator rotates at 150 rpm (48-pole generator), or 2.5 revolutions per second. The generator stator winding is made up of four parallel branches; therefore, the shorted pole passes a branch every 100 ms. When the shorted pole enters a branch, it changes the flux density in that branch, and this gives rise to the change in the branch current.

Fig. 6. A-phase branch currents during a 2 percent rotor turn-to-turn fault on the generator.

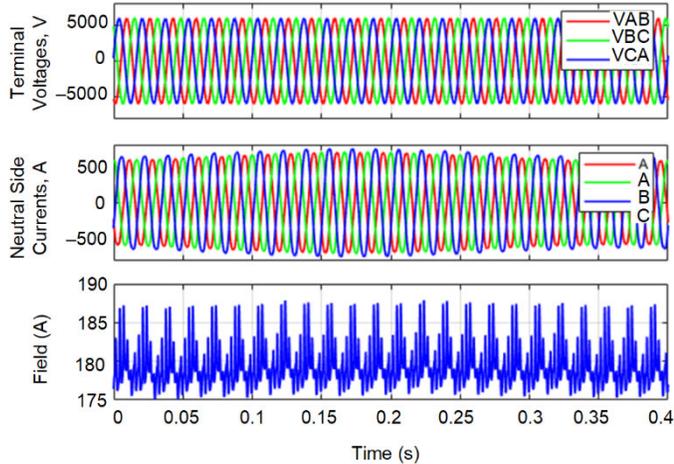
A rotor turn-to-turn fault involving a few turns is not readily observable by monitoring the voltage terminals, the phase currents, or the field current, as can be seen by examining Fig. 7.

Fig. 7. Generator terminal voltages, phase currents, and field current during a rotor turn-to-turn fault on the generator.

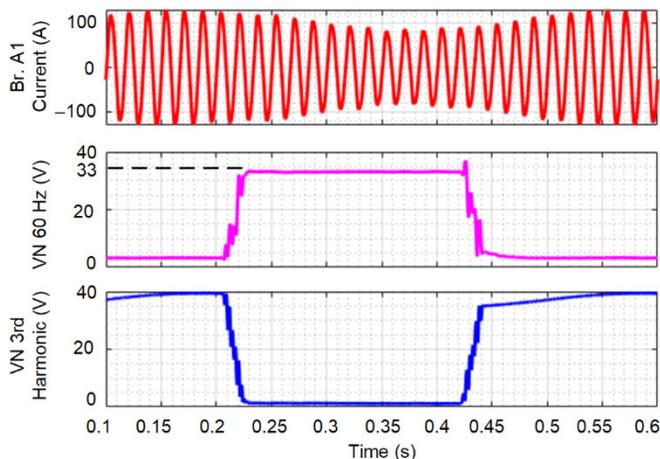
Fig. 8. A-phase Branch 1 current, neutral fundamental voltage magnitude, and third harmonic voltage magnitude for a stator turn-to-ground fault one turn from the neutral of the generator.

If we examine Fig. 8 and Fig. 9, we can make the following observations. The closer the ground fault is to the neutral of the generator, the larger the collapse of the third harmonic voltage at the neutral of the generator and the lower the fundamental voltage drop developed across the grounding resistor of the generator. The further the ground fault is from the neutral, the smaller the collapse of the third harmonic voltage at the neutral of the generator and the higher the fundamental voltage drop developed across the grounding resistor of the generator. These results are as expected and help give the team confidence in the equipment and the test methodology. As expected, there were no changes in the faulted branch current.

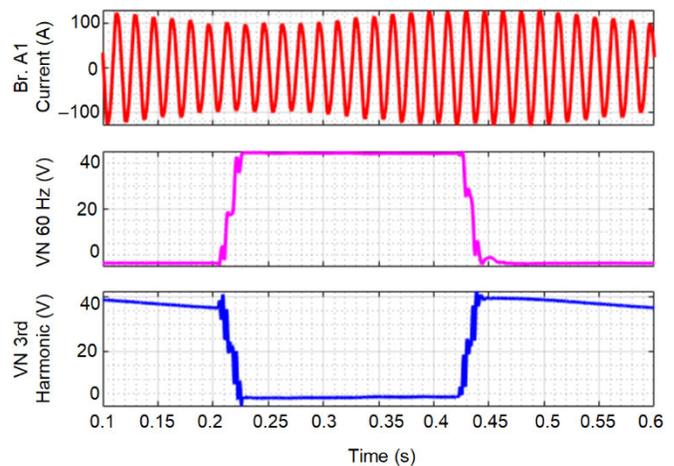
Fig. 9. A-phase Branch 1 current, neutral fundamental voltage magnitude, and third harmonic voltage magnitude for a stator turn-to-ground fault three turns from the neutral of the generator.

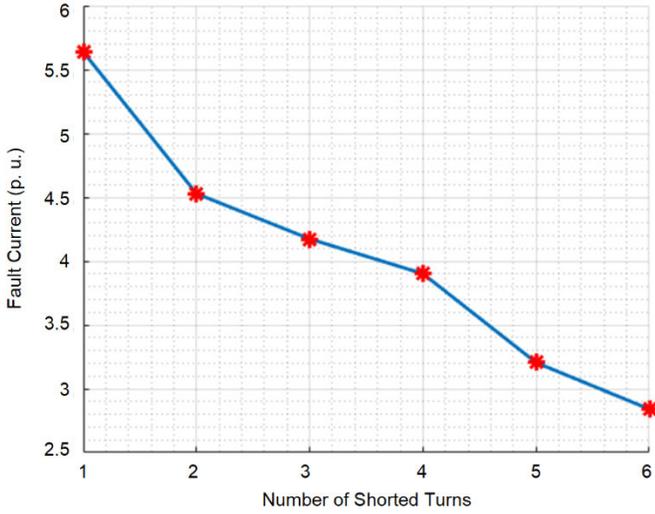
The fault current magnitudes for the turn-to-turn fault series of tests are shown in Fig. 10. A single turn-to-turn fault produces approximately 5.6 pu of fault current (7.19 kA). From Fig. 10, we see that the higher the number of turns involved in the fault, the lower the fault current that develops. For this test series, the maximum number of turns involved in a turn-to-turn fault was limited to six, the maximum number of turns in a coil group for this generator.

Fig. 10. Plot of the fault current magnitudes for turn-to-turn fault involving one to six turns in a coil group.

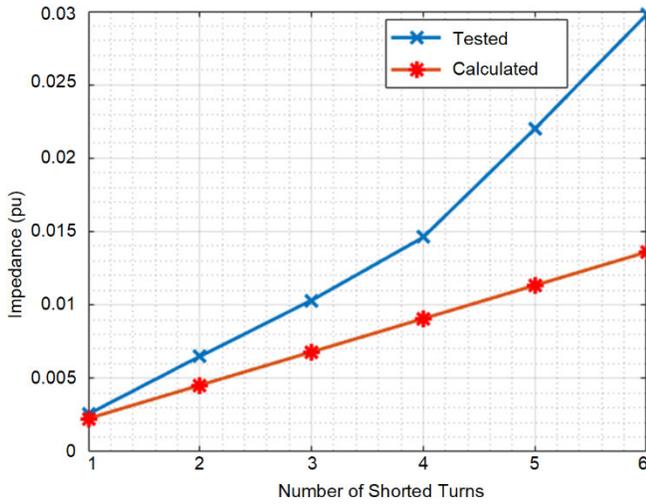
Using the approach discussed in Section III to calculate the leakage impedance (X_L) for each winding turn, we calculated X_L for each of the fault conditions. Fig. 11 is a plot of the comparison between the calculated and the tested X_L values. We calculated the tested X_L values by using the fault current from Fig. 10 and the voltage developed per turn, neglecting the resistance of the turn.

Fig. 11. Comparison of impedance for the number of turns in a coil group involved in the fault between the tested and calculated values.

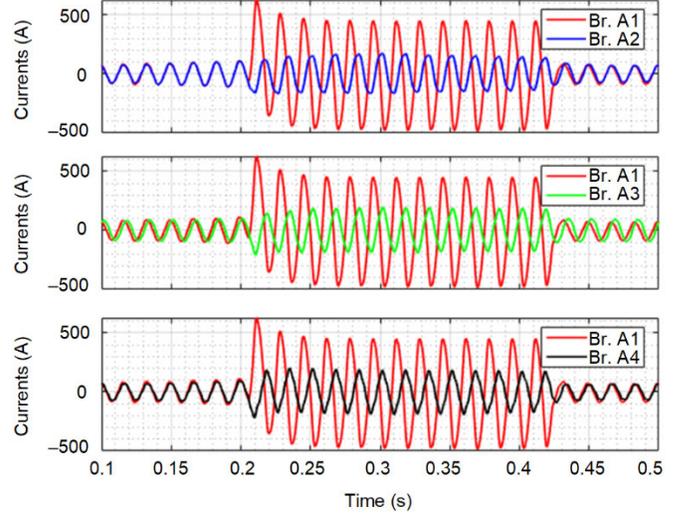
Because of their nature, turn-to-turn faults cannot be readily observed by observing the phase current, i.e., by using the current information supplied by the terminal and neutral-side CTs of the phase that experiences the turn-to-turn fault. For this reason, on multi-branch generators, split-phase protection is employed where CTs are installed in each of the branches that make up a phase. During normal operation of the generator, the current in each of the branches is shared almost equally. The small difference in current or standing current between the branches is caused by the slight differences in the inductance of the different branches [11] [13]. In this test series, we created turn-to-turn faults on Branch 1 of the A-phase of the generator. The branch current of the faulted branch is plotted against that of an unfaulted branch for a turn-to-turn fault involving four turns in Fig. 12. Before the fault at $t = 0.21$ s, the branch currents of the four branches are almost identical. However, when the turn-to-turn fault occurs, the branch currents in all four branches change. The faulted branch experiences the highest increase in current (3.9 times the pre-fault current) and is of opposite polarity to the currents of the unfaulted branches.

Fig. 12. Plot of the current in the faulted branch versus the current in each of the unfaulted branches for a turn-to-turn fault involving four turns.

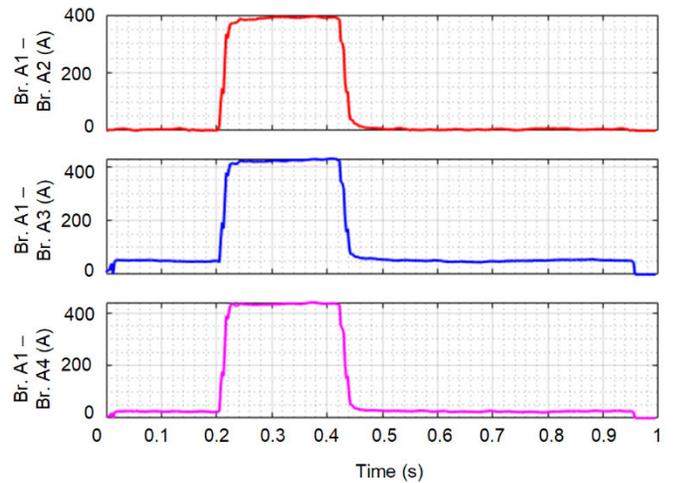
The average circulating current magnitude observed in the test increased by 0.3 pu, as shown in Fig. 13.

Fig. 13. Plot of the differential current magnitude between the faulted branch and the unfaulted branches for a turn-to-turn fault involving four turns.

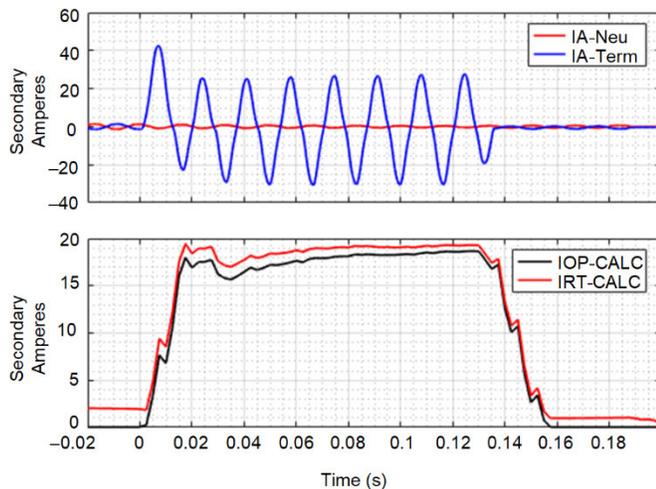
For this test, we connected the generator to the power system (i.e., the generator breaker was closed). The fault switch was connected between the A-phase, one turn from the neutral (F2) and the B-phase, and two turns from the neutral (F9). This is effectively a phase-to-phase fault close to the neutral of the generator. Fig. 14 shows a plot of the fault current in the A-phase generator and neutral CTs. A plot of the calculated operating and restraint is also shown in Fig. 14.

Fig. 14. Plot of the A-phase neutral and terminal CTs for a phase-to-phase fault close to the neutral of the generator. Also shown is a plot of the calculated operating (IOP-CALC) and restraint (IRT-CALC) currents.

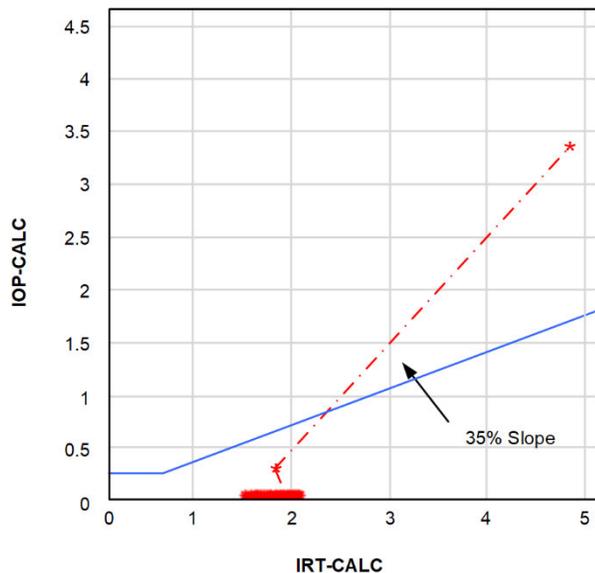
Fig. 15. Plot of the percentage differential for the phase-to-phase fault close to the neutral of the generator using a slope of 35 percent.

Fig. 15 shows that the differential element will readily detect a phase-to-phase fault at this location.

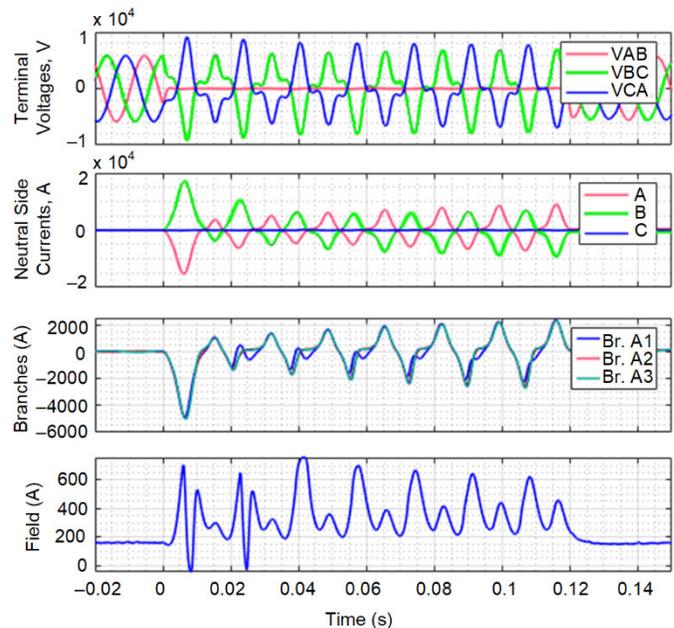
100 percent AB fault. The generator was disconnected from the power system (i.e., the generator breaker was opened). The fault switch was connected between the A-phase terminal connection and the B-phase terminal connection (T1-to-T3) in Fig. 3. Fig. 16 shows that the V_{AB} voltage collapsed and the V_{BC} and the V_{CA} voltages increased when the fault was initiated.

Fig. 16. Plot of the terminal voltages, the phase currents measured by the neutral-side CT of the generator, the current measured by the individual branch CTs involved in the phase, and the field current for a 100 percent AB fault with the generator offline.

At first glance, it appeared as if the generator went into saturation, but this was not the case. Recall that the PT at the generator terminal is an open-delta PT. Pre-fault, the phase-to-phase voltages were of equal magnitude and balanced, as can be seen in Fig. 17a. However, when the fault was initiated, the line-to-ground voltages of the A and B phases decreased. The generator automatic voltage regulator (AVR) was in auto mode. When the AVR detected the drop in terminal voltage (i.e., below 1 pu), it boosted the field current as can be seen in Fig. 16, to increase the terminal voltage of the generator back to 1 pu. This increase in the field current increased the generator internal voltage (EMF), which increased the voltage magnitude of all three phases. It is this increase of the generator voltage that ultimately resulted in the saturation of the open-delta PT. The A- and B-phase voltages also shifted into phase with one another so that the potential difference between them became zero (as is expected for a phase-to-phase fault at the measuring point.) This shift in the line-to-neutral voltages resulted in an increase in the V_{BC} and V_{CA} voltages, as can be seen in Fig. 17b. This increase of V_{BC} and V_{CA} resulted in the PT becoming saturated and the voltage becoming distorted.

We observed that the CTs in the generator neutral (used for differential protection) also saturated. The fault was initiated close to voltage zero; therefore, the current had a large dc offset, which contributed to the rapid saturation of the CTs. However, we observed that as the fault progressed, the CTs began to pull out of saturation and the steady-state values approached the

value calculated in Section III. We can see from the branch CT that the peak fault current was in the range of 5 kA, giving an approximate total fault current of 20 kA.

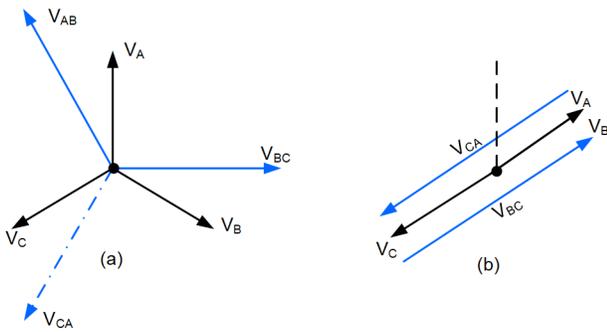
Fig. 17. Plot of the pre-fault phase-to-neutral and phase-to-phase voltages (a) and the fault phase-to-neutral and phase-to-phase voltages (b).

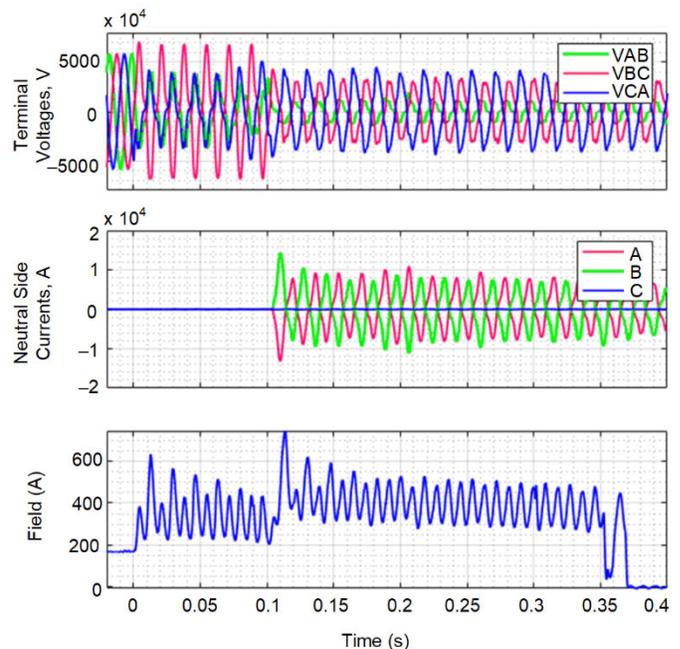
Fig. 18 shows the oscillography for the inter-branch fault. The fault was initiated at $t = 0.0$ s. We can see the distortion in the phase voltages but, as expected, the differential CTs located at the neutral of the windings do not register any of the fault current even though the fault current was in the excess of 10 kA.

At $t = 0.1$ s (Fig. 18), the bolt head of one of the bolts sheared off and vaporized. The plasma formed during this vaporization resulted in the inter-branch fault evolving into a phase-to-phase fault because the drilled and tapped connection for Fault F9 (on

the B-phase winding) was located only two slots above Fault Points F8 and F2. When the fault evolved into a phase-to-phase fault, current flowed in the A- and B-phase CTs located at the neutral side of the generator. The generator differential relay (an electromechanical relay) tripped and cleared the fault in 250 ms. The damage caused by this evolving fault is shown in Fig. 21.

Fig. 18. Plot of the terminal voltages, neutral-phase CT currents and the field current for a double-phase-to-ground fault.

The second major lesson we learned is to not leave an unused fault point exposed because, if for some reason a fly lead breaks loose or a piece of metal breaks loose and vaporizes, that vapor can become a plasma which can then result in an unanticipated fault condition. During the inter-branch fault, we did not anticipate that a sheared-off copper bolt could vaporize and create a plasma that would change the inter-branch fault into a phase-to-phase fault. This omission in our planning resulted in a premature end to the destructive testing.

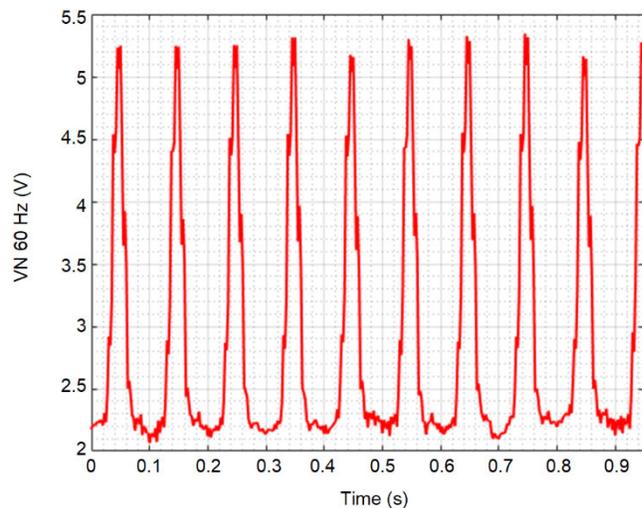
During the rotor turn-to-turn fault testing, we observed that the voltage across the generator grounding resistor (shown in Fig. 22) followed the same pattern as the branch currents shown in Fig. 6. The magnitude of the voltage across the generator grounding resistor spiked periodically at an interval of every 100 ms.

The authors hypothesize that a rotor turn-to-turn fault may appear as a stator ground fault. Therefore, the authors recommend also inspecting the rotor upon any generator trip caused by a perceived stator ground fault.

Fig. 22. Magnitude of neutral fundamental voltage during a 2 percent rotor turn-to-turn fault on the generator.

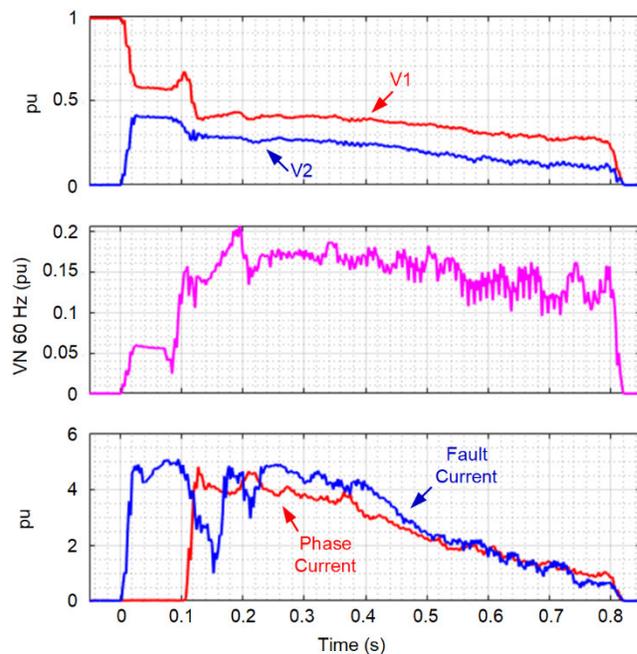
voltage (V_N) measured during the branch fault (double-phase-to-ground fault) is 0.06 pu, which corresponds to the voltage developed for a stator ground fault 6 percent from the neutral, as shown in Fig. 23. However, if we consider the speed at which this stator ground fault protection operates (i.e., several hundreds of milliseconds), the generator will be exposed to severe stress and potential damage. Examining Fig. 23, we can see that if the V_N and negative-sequence voltage (V_2) are above a set threshold, then the generator is experiencing an inter-branch fault or a double-phase-to-ground fault and tripping can be accelerated.

Fig. 23. Positive-, negative-, and neutral fundamental voltages along with currents during branch-to-branch fault.
