Root-Cause Analysis of Simultaneous Faults on an Offshore FPSO Vessel

ROOT-CAUSE ANALYSIS OF SIMULTANEOUS FAULTS ON AN OFFSHORE FPSO VESSEL

Abstract—The paper “Simultaneous Faults on the 11 kV System of an Offshore FPSO Vessel” by Derrick Haas, Frederick D. Painter II, and Malcolm Wilkinson provides a case study of simultaneous faults that occurred December 5, 2009, on the 11 kV power system of a floating production, storage, and offloading vessel located in the Norwegian sector of the North Sea. The event resulted in severe damage to a 12,000-horsepower compressor motor, damage to the transformer feeding an adjustable speed drive, and interruption of many loads on the ship.

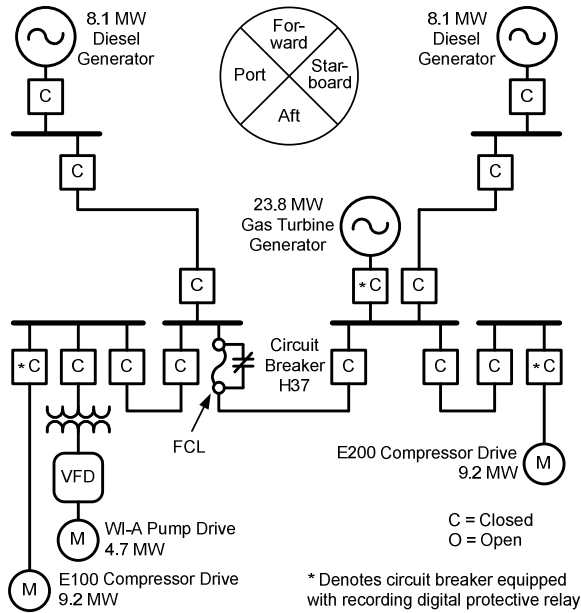
Fig. 1 Simplified Configuration Prior to Incident

On the morning of December 5, 2009, a complex incident occurred within the FPSO 11 kV power system [2]. Just prior to the incident, production operations were stable, with no switching or other unusual activities underway. The total ship load was approximately 22 MW. A simplified one-line diagram showing relevant online equipment at the time of the incident is shown in Fig. 1 (online loads unrelated to this paper are not depicted).

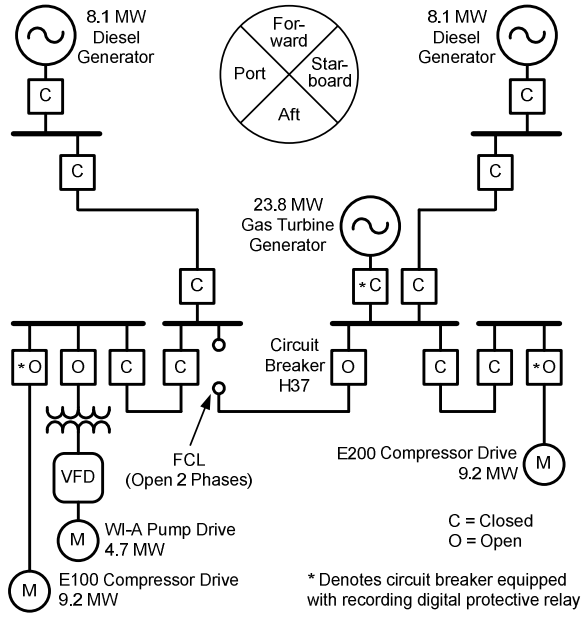
Fig. 2 Simplified Configuration Following Incident

As with most power system faults, the incident began and ended within a few milliseconds. When the incident concluded, 11 kV power remained in service on all 11 kV switchboards, but all production and process operations were offline. The active configuration following the incident is shown in Fig. 2.

With circuit breaker H37 open, the power system had separated into two independent islands (i.e., port and starboard island separation). Within a short time, offshore

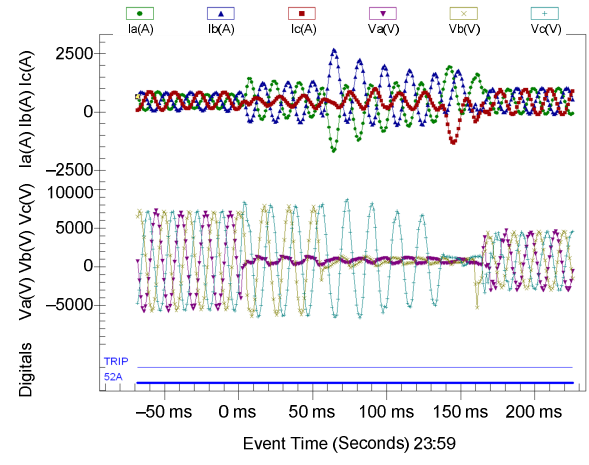
Fig. 3 Event Profile From E100 Protective Relay

Early engineering observations were crucial to further understanding. First, the ground fault current recorded by the E200 protective relay was over 17,000 A, which is well in excess of the system design maximum of 112 ground fault amperes. Hence, it was quickly concluded that this was not an incident involving a single zero-sequence current source. Second, high fault current had flowed through the FCL, causing it to activate on Phases A and B. This supported a conjecture that a second zero-sequence current source had existed on the port side of the power system (i.e., on the opposite side of the FCL from the E200 motor). Event profiles from the E100 and E200 protective relays can be seen in Fig. 3 and Fig. 4, respectively. Note that the currents and voltages displayed in these figures are divided by a factor of $\sqrt{2}$.

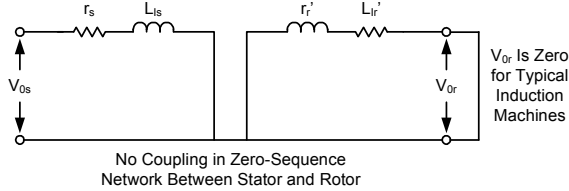
Fig. 10 Zero-Sequence Network for an Induction Machine Whose Windings Are Connected in a Grounded Star Configuration

We can recall that for a motor whose windings are connected in a star configuration with the neutral point ungrounded, no zero-sequence current can flow in the windings. However, if for some reason the machine became a grounded machine, then the zero-sequence equivalent circuit for the motor would be as shown in Fig. 10 [3].

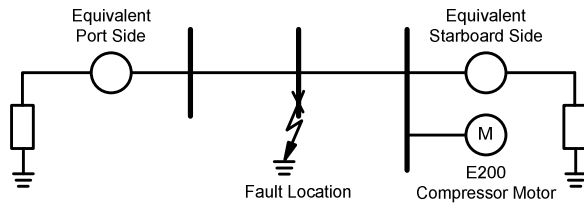
Fig. 11 Simplified One-Line Diagram With Thévenin Equivalent Circuits for Port- and Starboard-Side Power Systems

Because the machine is intended to be an ungrounded motor, one possible explanation is that a fault occurred at or near the neutral point of the machine. To help illustrate how a grounded induction machine can supply zero-sequence current to a second fault elsewhere in the power system, consider the simplified one-line diagram shown in Fig. 11.

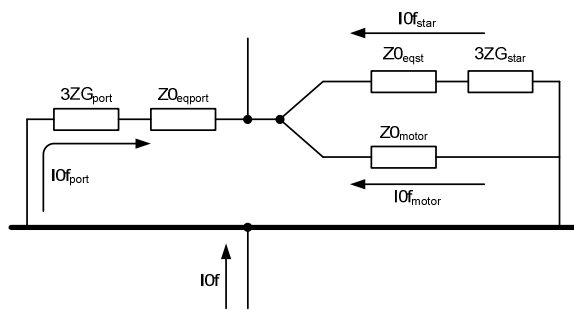
Fig. 12 Equivalent Zero-Sequence Network

If we consider only the zero-sequence network, use Thévenin equivalent circuits for the port- and starboard-side power systems, and include the equivalent circuit for the induction machine shown in Fig. 10, we arrive at the zero-sequence network shown in Fig. 12. Because the motor impedance $Z_{0\text{motor}}$ is much less than the port or the starboard equivalent impedances (because of the grounding resistors), the motor provides a low-impedance path for the zero-sequence current to flow. Again, this path is only present when the machine is either a grounded star machine or there is a ground fault near or at the neutral point of the machine.
