Steady-State Protection Study for the Application of Series Capacitors in the Empangeni 400 kV Network

Graeme Topham Eskom Enterprises Technology Services International

Presented at the 31st Annual Western Protective Relay Conference Spokane, Washington October 19–21, 2004

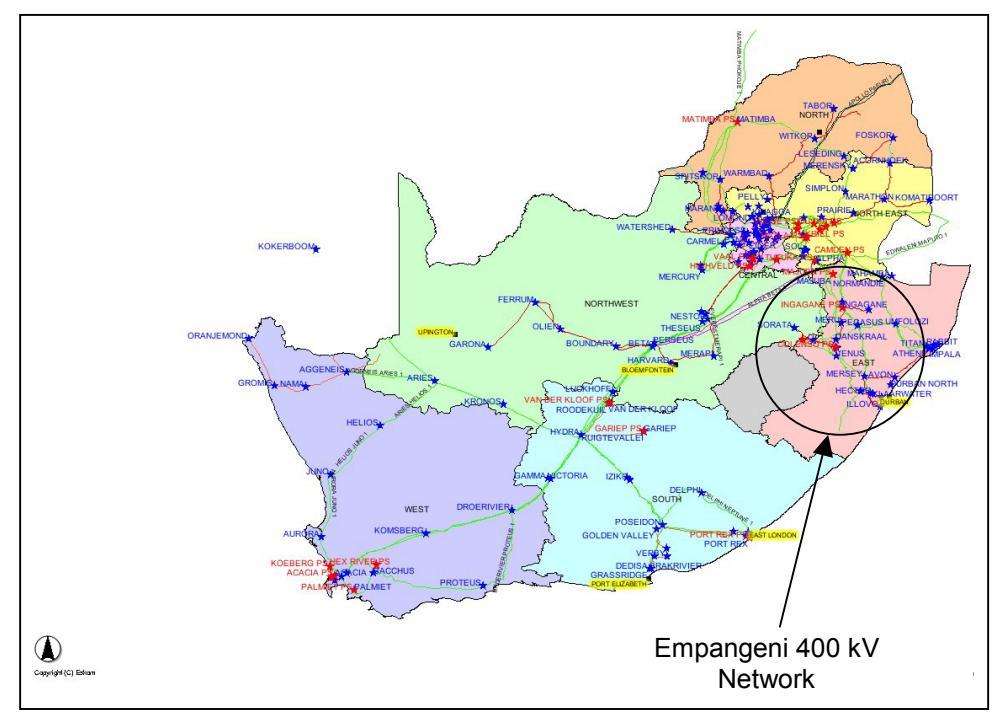
Eskom is the electricity utility of South Africa. The utility has been in existence for over 81 years. The currently installed generation capacity is 42 GW, which includes 6 GW of reserve (mothballed) generation, consisting mainly of coal-fired power stations concentrated in the northeastern part of the country. There is also a 1,800 MW nuclear plant in the southwestern tip of the country. A 765 kV, 400 kV, and 275 kV transmission network spans the country, providing the transmission backbone. The relevant portion of the network, to which this paper refers, is in the South African Kwazulu Natal region in the southeastern part of the country.

Most of the study focused on fault-throwing exercises on the proposed series-compensated feeders (refer to Figure 1):

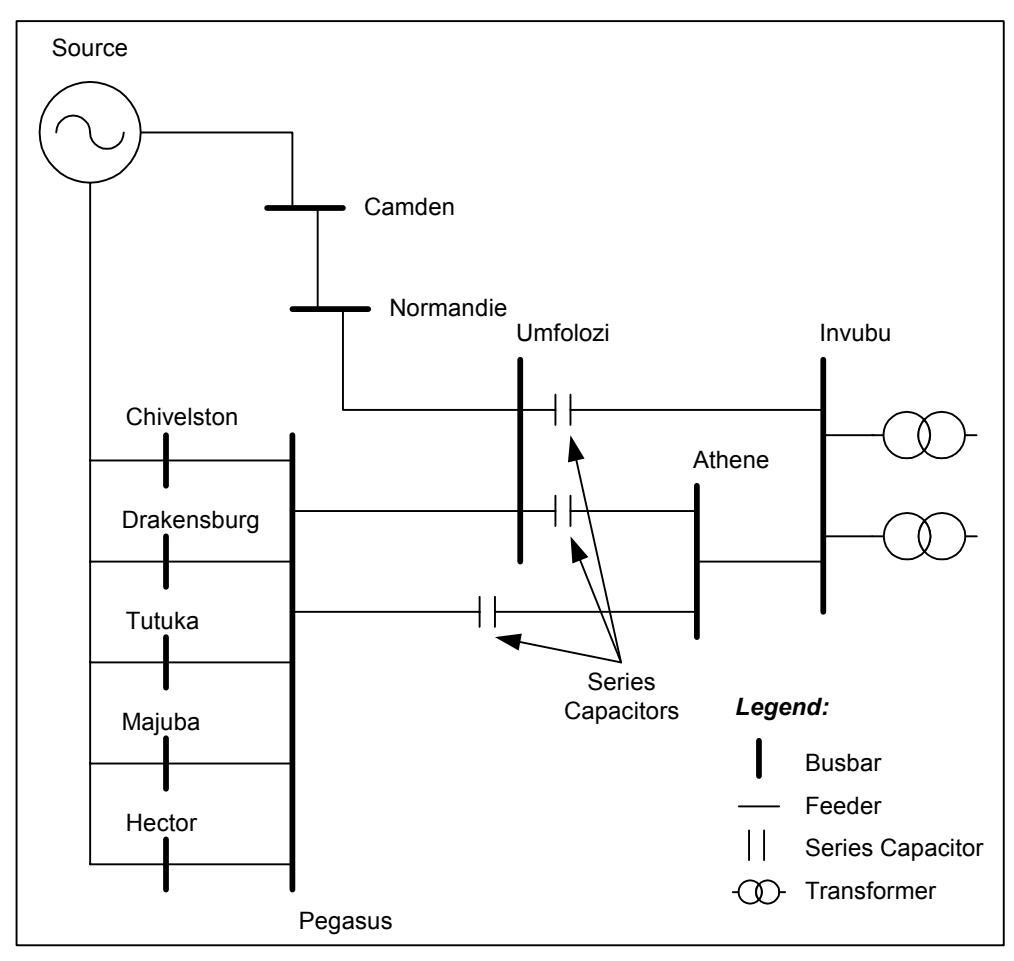
Figure 2 Network diagram 2—Empangeni 400 kV network single-line diagram

The protection study was divided into two main groups: steady-state and transient protection performance analysis. The protection performance of feeders (indicated in Figure 2) as analyzed under steady-state conditions is represented in this paper. The aim of this paper is to share information about the steady-state protection study; e.g., theoretical background, method, results, and recommendations.

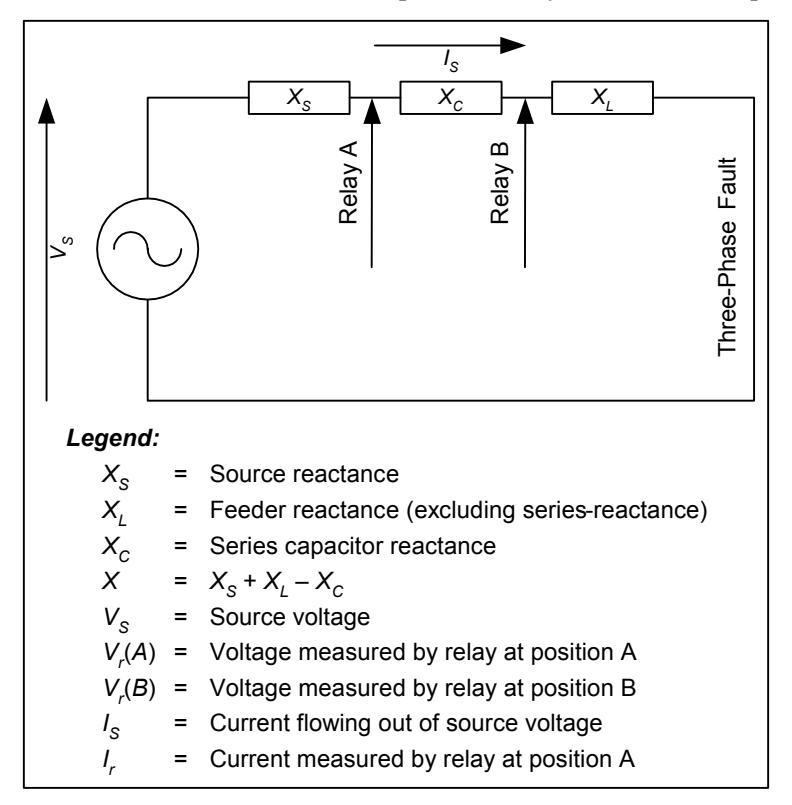
Figure 3 illustrates a typical single-line diagram of a network with series compensation and a fault applied at the end of the feeder. Distance impedance relays are situated at positions A and B.

Figure 3 Single-line diagram of series-compensated network

For simplicity, assume X_S and X_L represent a series-inductive reactance value, and thus for the above circuit, where X is the total network reactance, we have:

$$I_{S} = \frac{V_{S}}{j(X_{S} + X_{L} - X_{C})} = \frac{V_{S}}{jX}$$
(1)

In Figure 3, the current I_S lags or leads the voltage by 90 degrees, depending on the sign of X, because X is a pure reactance value.

For the protective relay at position A, $I_r = I_S$, where I_r is the fault current. The current I_S will reverse direction when $(X_C > X_S + X_L)$. Both the relays at positions A and B will experience current reversal should this occur.

$$V_r(A) = jI_s - (X_C + X_L) = j\left(\frac{V_s}{jX}\right) (-X_C + X_L)$$
$$= V_s\left(\frac{-X_C + X_L}{X}\right)$$

The voltage measured by the relay $V_r(A)$, will reverse its sign when $(X_C > X_L)$ and (X > 0) and $(X_C < X_S + X_L)$.

Voltage reversal is not possible under the same criteria as for position A, because $V_r(B) = jI_S X_L$. However, voltage reversal can occur as a consequence of current reversal.

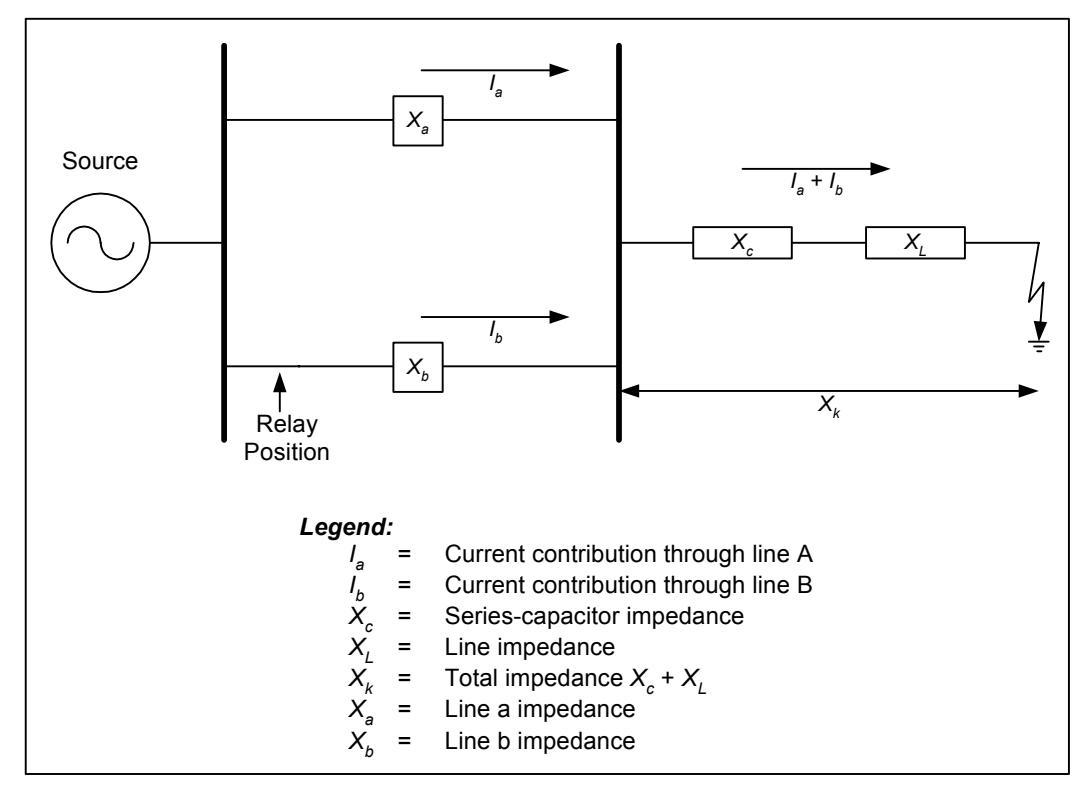
The effect of remote busbar infeeds, as illustrated in Figure 4, may result in apparent impedance problems for distance impedance relays.

Figure 4 Effect of remote busbar infeeds on distance relays

The actual impedance to the fault is equal to $(X_b + X_k)$. The relay is presented with an impedance equal to $(X_b + \left(\frac{I_b + I_a}{I_b}\right) \cdot x \cdot X_k)$, where x is the error factor and is equal to $\frac{I_b}{(I_b + I_a)}$. Therefore, the effective reach for the impedance relay is equal to $(X_b + \left(\frac{I_b}{I_b + I_a}\right)X_k)$.

Under normal network conditions, the effective relay reactive reach is smaller than the actual impedance to the fault namely $(X_b + X_k)$. The effect is reversed when $(X_c > X_L)$.

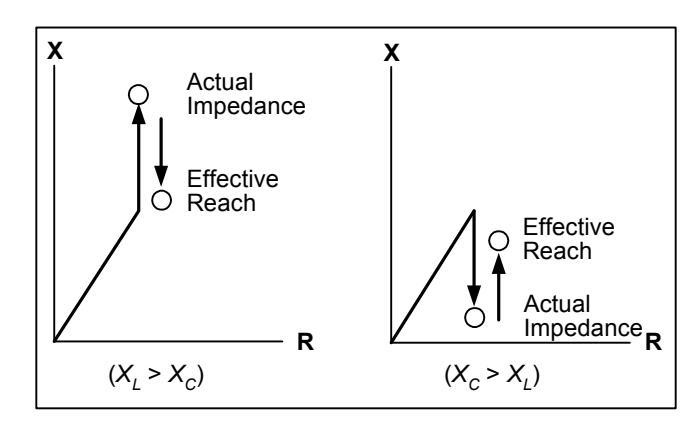
Figure 5 Effect of remote busbar infeeds on impedance measurement

Care should be taken when coordinating backup protection to ensure that the relays will see the fault but will not operate for load conditions.

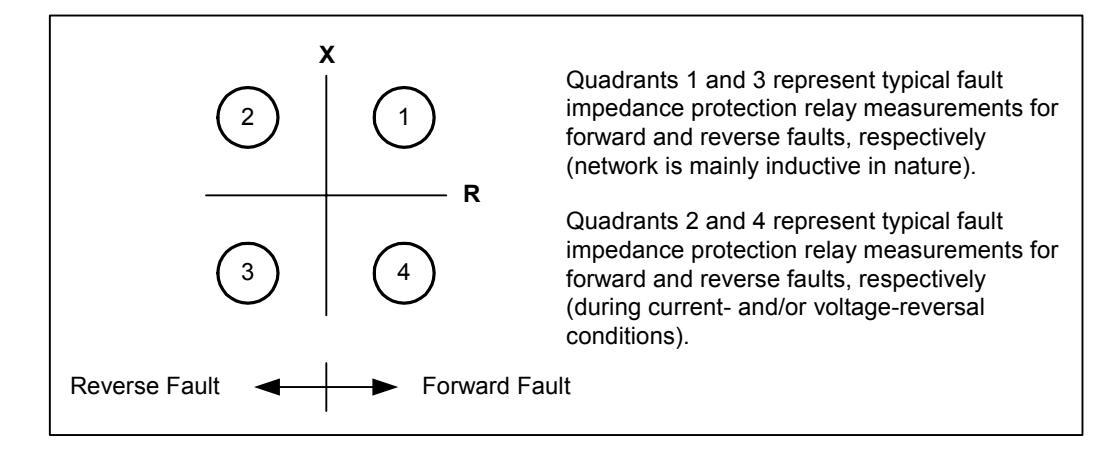
For network conditions with $(X_L > X_C)$, faults in front of the relay would typically be measured to fall within the first quadrant of the positive-sequence impedance plain. Similarly, faults behind the relay would typically be measured in the third quadrant.

During voltage and/or current reversal conditions (with no series capacitor bypassing), the measured steady-state impedance may also fall within the second or fourth quadrants of the positive-sequence impedance plain, depending on the exact network impedance parameters and conditions.

Figure 6 Typical positive-sequence impedance measured by impedance relays under different network conditions

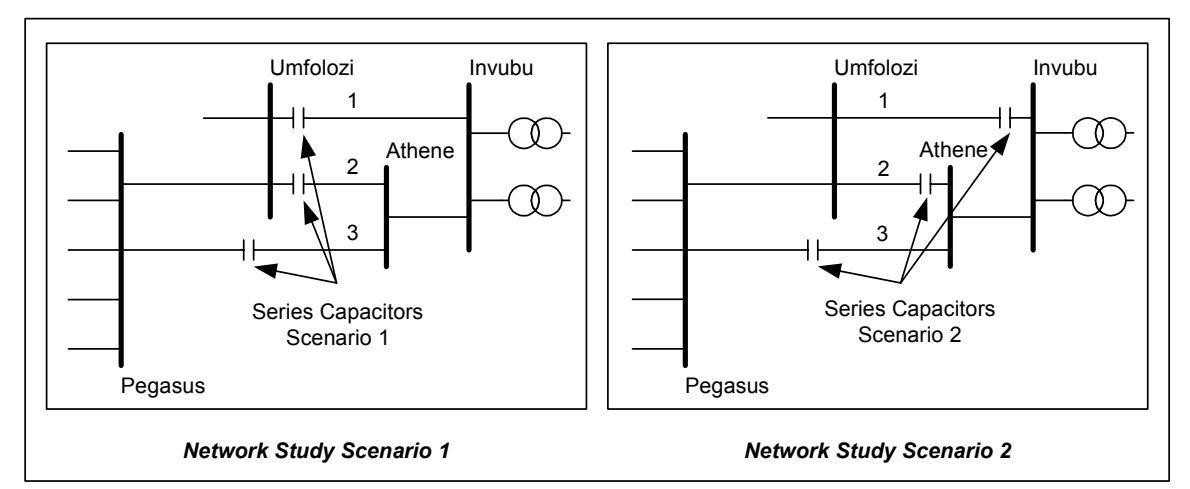
The proposed and studied series capacitor compensation locations are indicated in the following two diagrams, where Network Study Scenario 1 illustrates the series compensation situated at the source end of the proposed feeders and Network Study Scenario 2 illustrates the series compensation situated at the load end.

Figure 7 Network study scenario diagrams

The descriptive numbers 1 or 2 (or 3) as indicated in Figure 7, are used in Figure 9, Figure 10, Figure 13, Figure 14, and Figure 15 (refer to legends) to reference the series-compensated feeder numbers as follows:

- 1 = Umfolozi-Invubu feeder
- 2 =Umfolozi-Athene feeder
- 3 = Pegasus-Athene feeder

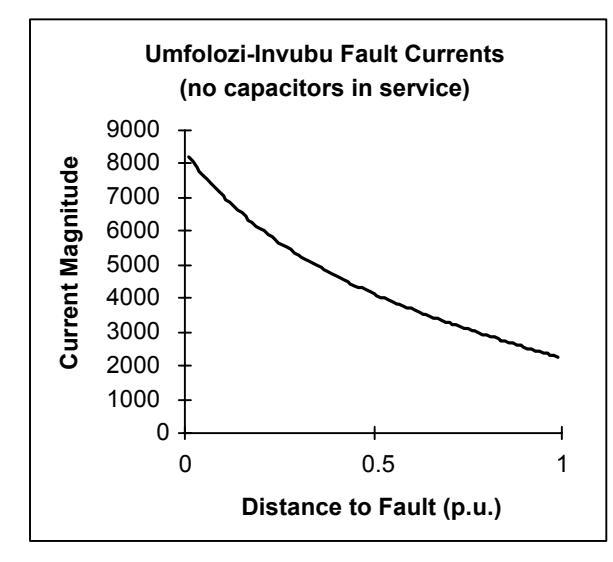
As an example of typical relay measurement behavior, Figure 8 illustrates the maximum fault currents flowing through the Umfolozi-Invubu 400 kV current transformer (CT) for faults at different locations on the same feeder.

Figure 8 Maximum fault current through Umfolozi-Invubu 400 kV CT prior to the addition of series compensation

The distance to fault value indicated on the X axis relates to the per unit (p.u.) value of the position of the fault location with respect to the feeder length and referenced to the local end (Umfolozi or Pegasus). The same applies to Figure 9, Figure 10, Figure 11, and Figure 12.

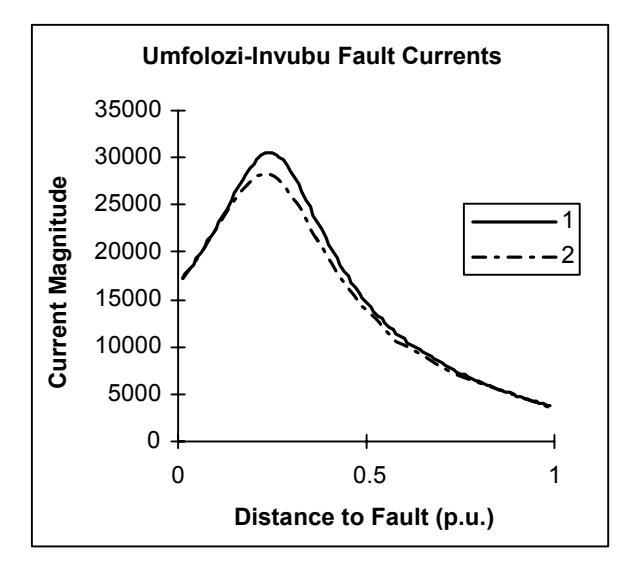
The maximum fault current through the series-compensated Umfolozi-Invubu 400 kV CT changes drastically, from 8 kA to 30 kA, as shown in Figure 9.

The maximum fault current is reached for faults at a distance of approximately 25% of the feeder length from Umfolozi. At this point, the value of X_c is almost equal to the sum of X_s and X_L and the equivalent network impedance is almost completely resistive. This is obviously slightly different from our basic theory discussions earlier (where we only focused on reactance and excluded resistance), because resistance is included in the network under consideration.

Because $(X_C > X_S + X_L)$, current reversal is possible, a phenomenon not previously experienced on the Eskom transmission network.

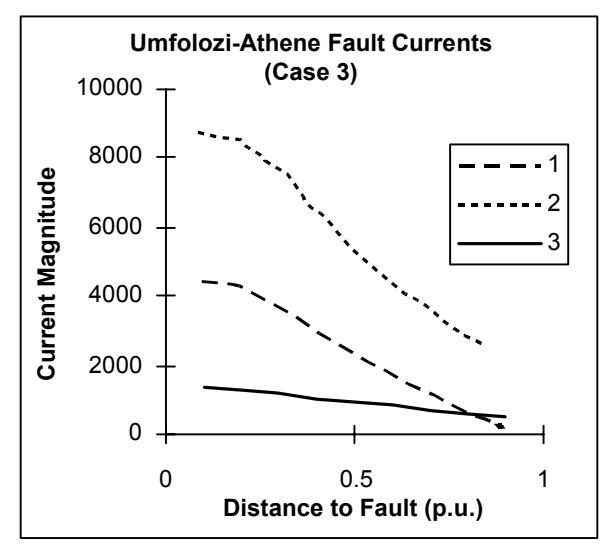
Four different network scenarios were studied to analyze the protection performance during minimum fault conditions (see Figure 10 as an example). These were:

Figure 10 Minimum fault current (case 3) through Umfolozi-Athene 400 kV CT, with series compensation

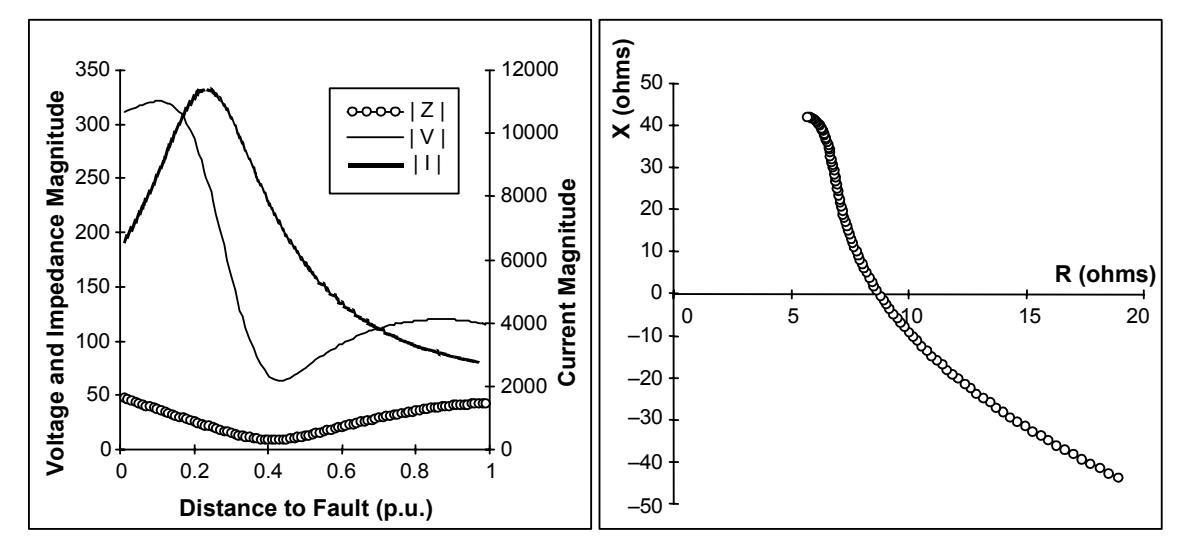
The relays with directionality toward the fault tend to see the apparent impedance in quadrant 1 or quadrant 4 on the positive-sequence impedance plain, depending on whether or not the current reversal occurs (see Figure 11).

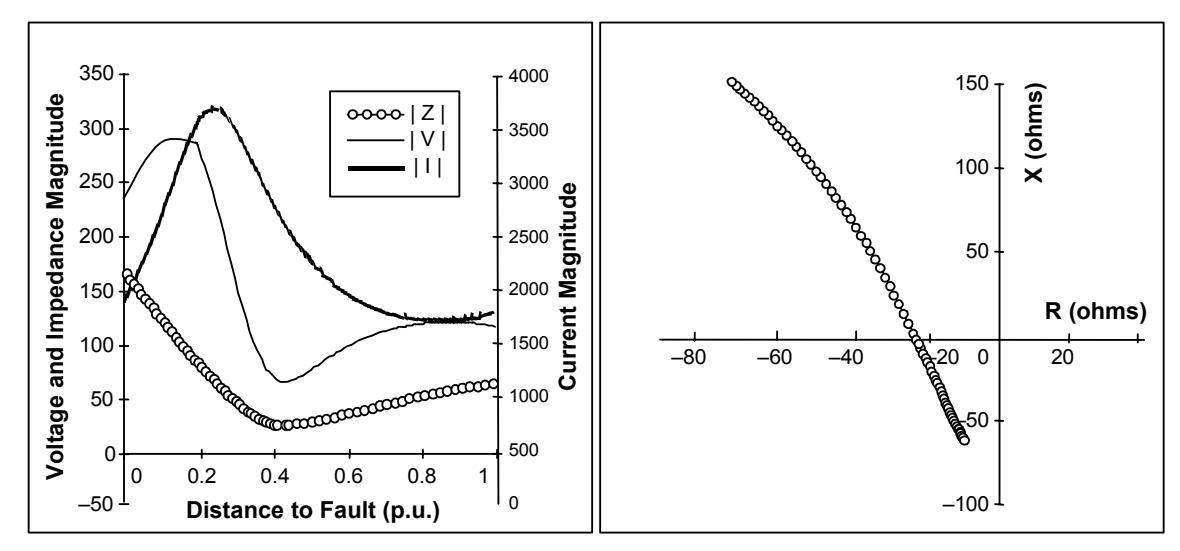
Similarly, relays with directionality away from the fault tend to see the fault in quadrant 2 or quadrant 3 on the impedance plain, as indicated in Figure 12.

Figure 12 Measurement values by Pegasus-Chivelston impedance relay for faults at various distances on the Umfolozi-Athene 400 kV feeder during maximum fault conditions

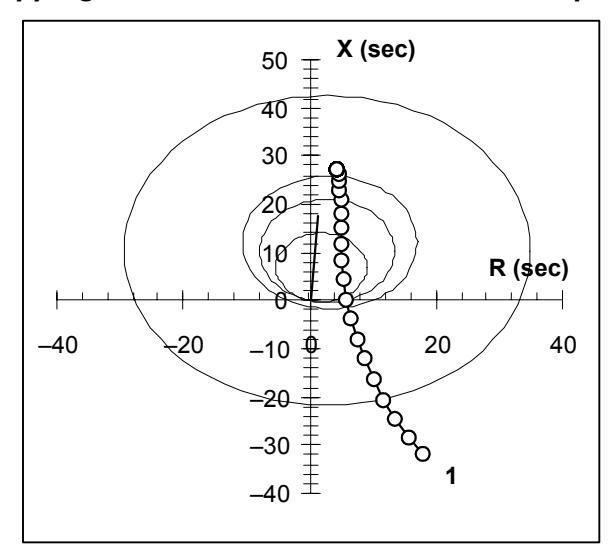
Area 1—Incorrect tripping in Zone 1 for faults on series-compensated feeders

Figure 13 Incorrect Zone 1 measurement

As the fault distance on series-compensated feeder number 1 moves from Umfolozi to Invubu, the measured positive-sequence impedance by the protection relays not located on this same feeder changes. This movement of impedance measurement is illustrated in Figure 13 and referenced by the number 1. Figure 13 indicates not one but multiple impedance measurements

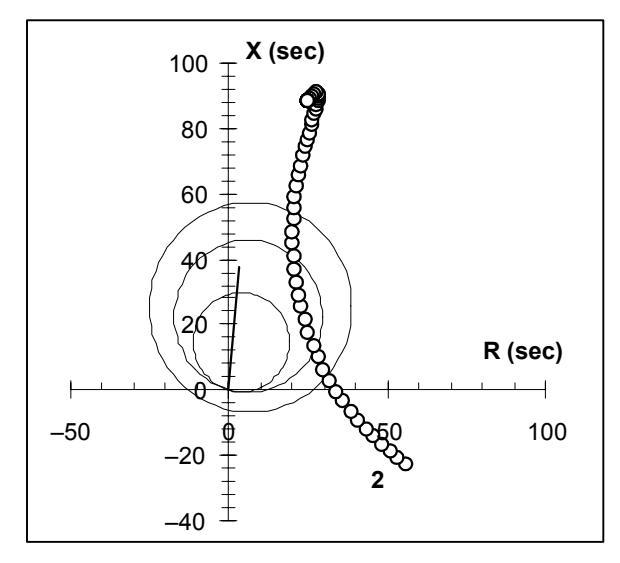
Polarized impedance protection relays can extend the resistive impedance coverage under different fault conditions. This has the advantage of greater coverage for high-resistance faults and results in faster protection operation. This additional fault resistance coverage, under these network conditions, creates problems for the relays concerned, due to the fact that both reactance and resistance criteria are incorrectly satisfied and may result in tripping.

Figure 14 Incorrect operation due to extended resistive coverage of relay characteristics

Problems may also be experienced, should some relays be replaced by relays with quadrilateral impedance characteristics.

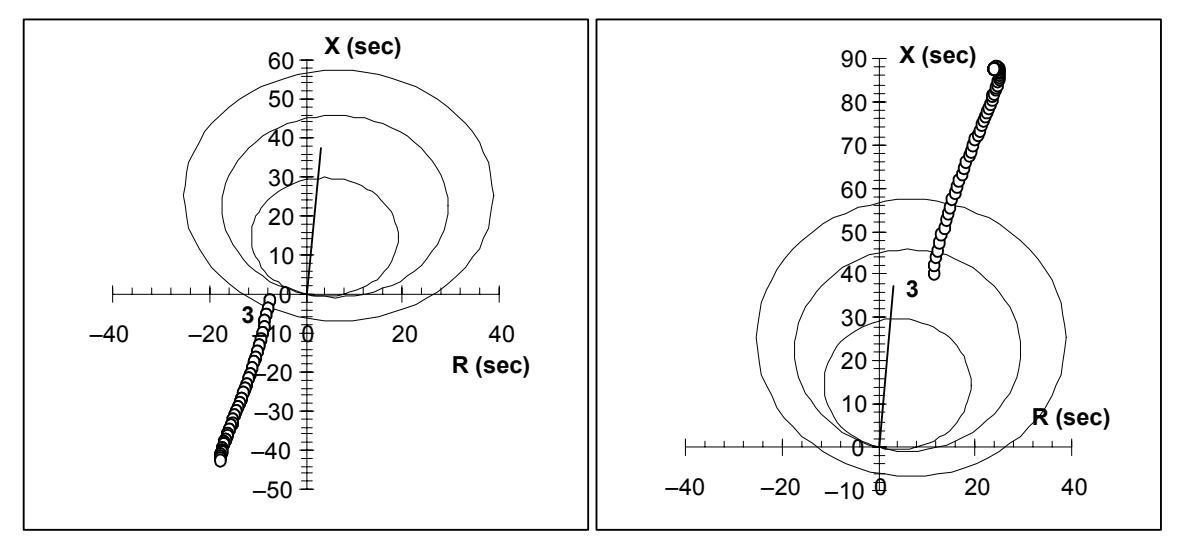
Area 3—Incorrect permissive tripping

Figure 15 Incorrect permissive tripping

Incorrect operation of the protection starter elements may occur and cause protection carrier signals to be transmitted, depending on the particular protection settings. This may result in incorrect permissive tripping protection operations.
