Stanford University, Palou Substation Modernization Project

Revised edition released November 2004

Originally presented at the
31st Annual Western Protective Relay Conference, October 2004

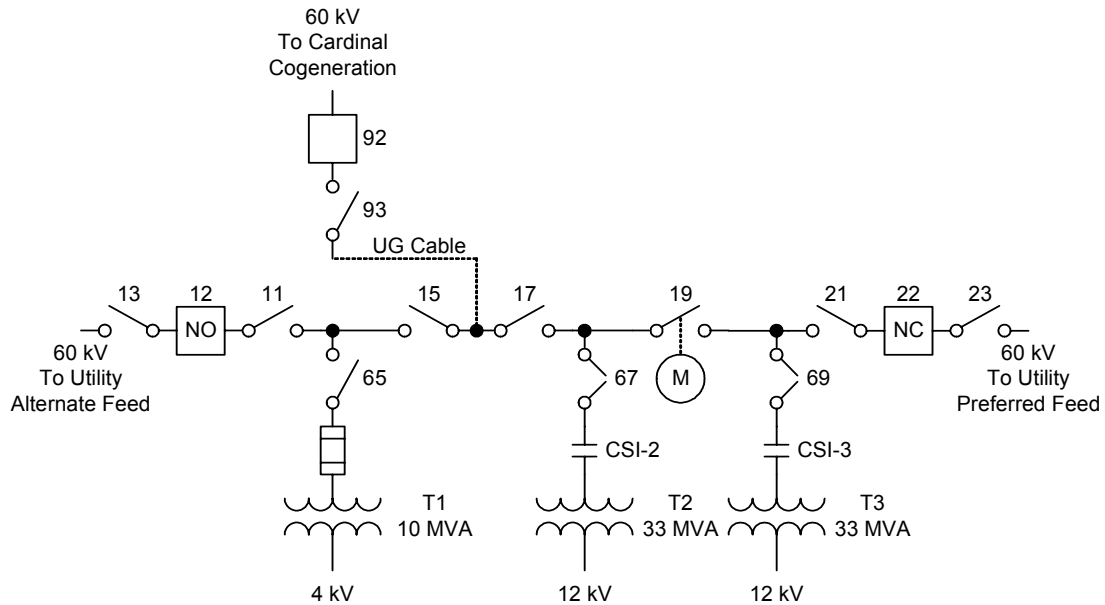
The Palou Substation provides the main interconnection point between the utility grid and the Stanford University distribution system. Figure 1 shows the final single-line arrangement of the substation. There are three sources into the bus: preferred utility tie line, standby utility tie line, and the cogeneration facility. There are three loads tapped off the bus: one small 4.16 kV transformer and two larger 12.47 kV transformers.

Figure 1 Palou Substation Single-Line Diagram

Figure 1 shows the final configuration of the Stanford Palou Substation.

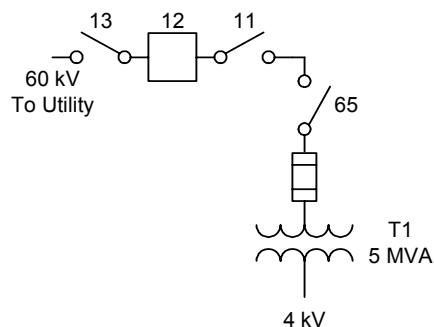
The Palou Substation was initially installed in 1943. At that time, only one 5 MVA, 60 to 4.16 kV transformer was installed. Only 4160-volt distribution was available on campus.

Figure 2 Stanford Palou Substation, 1947

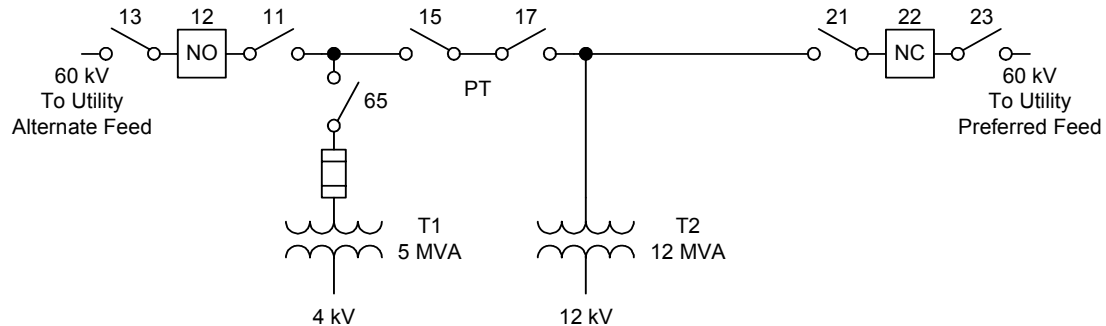
In the 1950s, the addition of one 12 MVA (FOA), 60 to 12.47 kV bank provided the power for six additional distribution circuits across the campus (Figure 3). A second interconnection point was made to the local utility.

Figure 3 Stanford Palou Substation, 1954 Additions

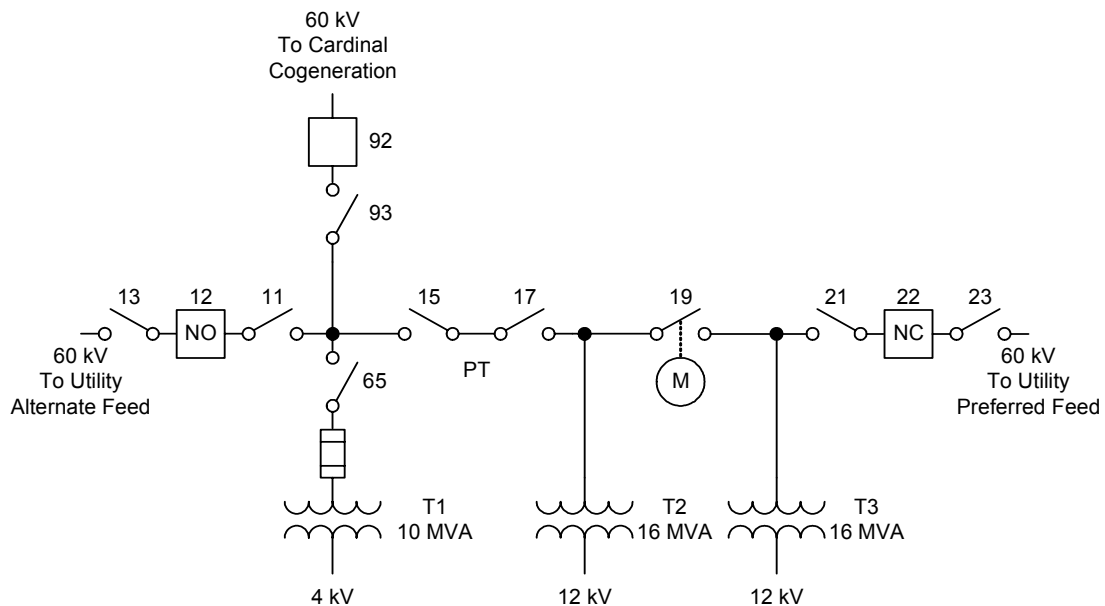
In 1986, in anticipation of the project to install a campus 50 MW cogeneration unit, an additional 16 MVA (FOA) transformer was installed, and the original 12 MVA transformer was replaced with a 16 MVA (FOA) (Figure 4). The 4160-volt, 5 MVA transformer was also replaced with a 10 MVA unit. Total available capacity at that time was 42 MVA.

Figure 4 Stanford Palou Substation, 1987 Additions

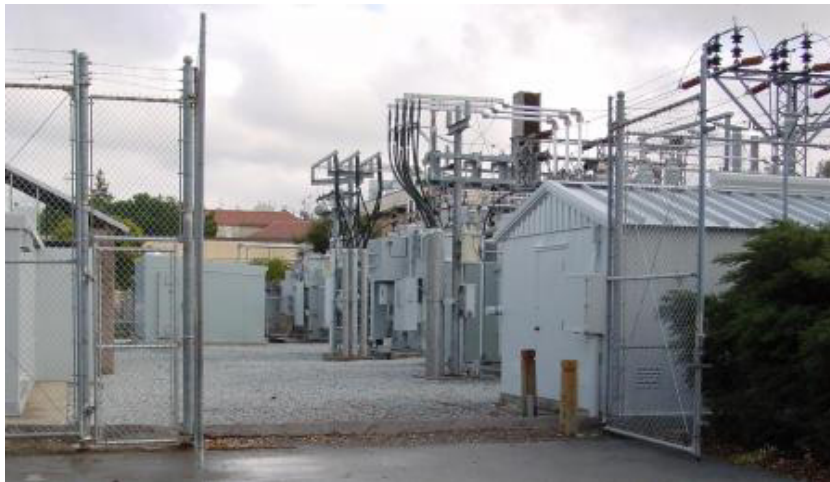
Figure 5 Palou Substation, February 2004 (Transformer Banks 1, 2, and 3, Left to Right)

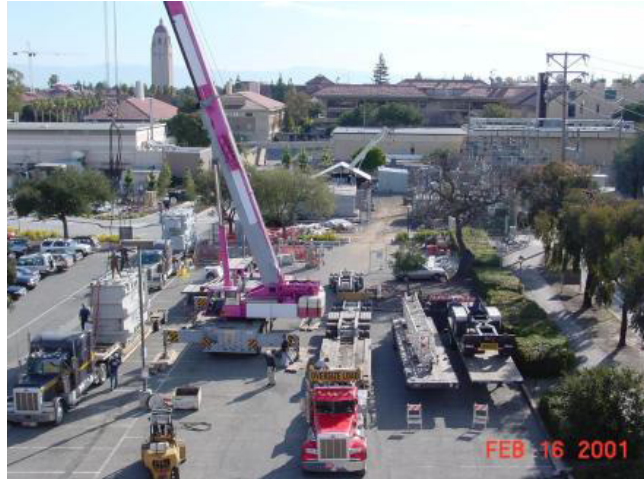
Increasing the fast firm capacity of the transformer banks required the removal of the two 16 MVA units for 33 MVA units. This project was accomplished with zero campus electrical outages. Load was transferred to other sources. Transformers were replaced and commissioned back into service, one at a time. Construction crews worked in an energized substation for the duration of the project.

Figure 6 33 MVA Transformer During Installation

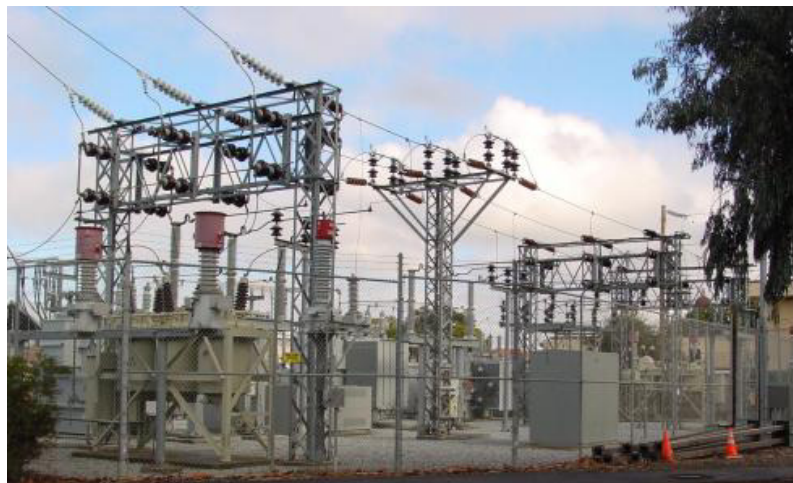
Figure 7 Palou Substation—Obsolete Oil Circuit Breaker (OCB) on Left

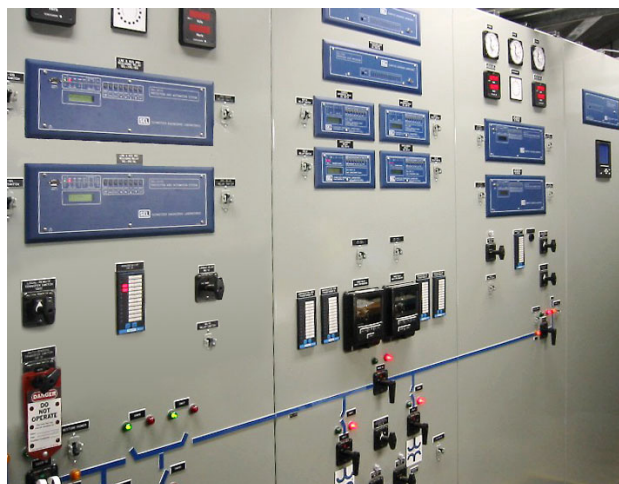
Like the substation equipment, the six sections of existing control and relay panels were piecemealed together, in stages, over the life of the substation. In 1954, the original two sections were installed, followed in 1974 with two more, and the final two sections were installed in 1987. The 50-year old wiring insulation was dry and crumbled at the touch.

Figure 9 Palou Substation—New Protection and Control Panels

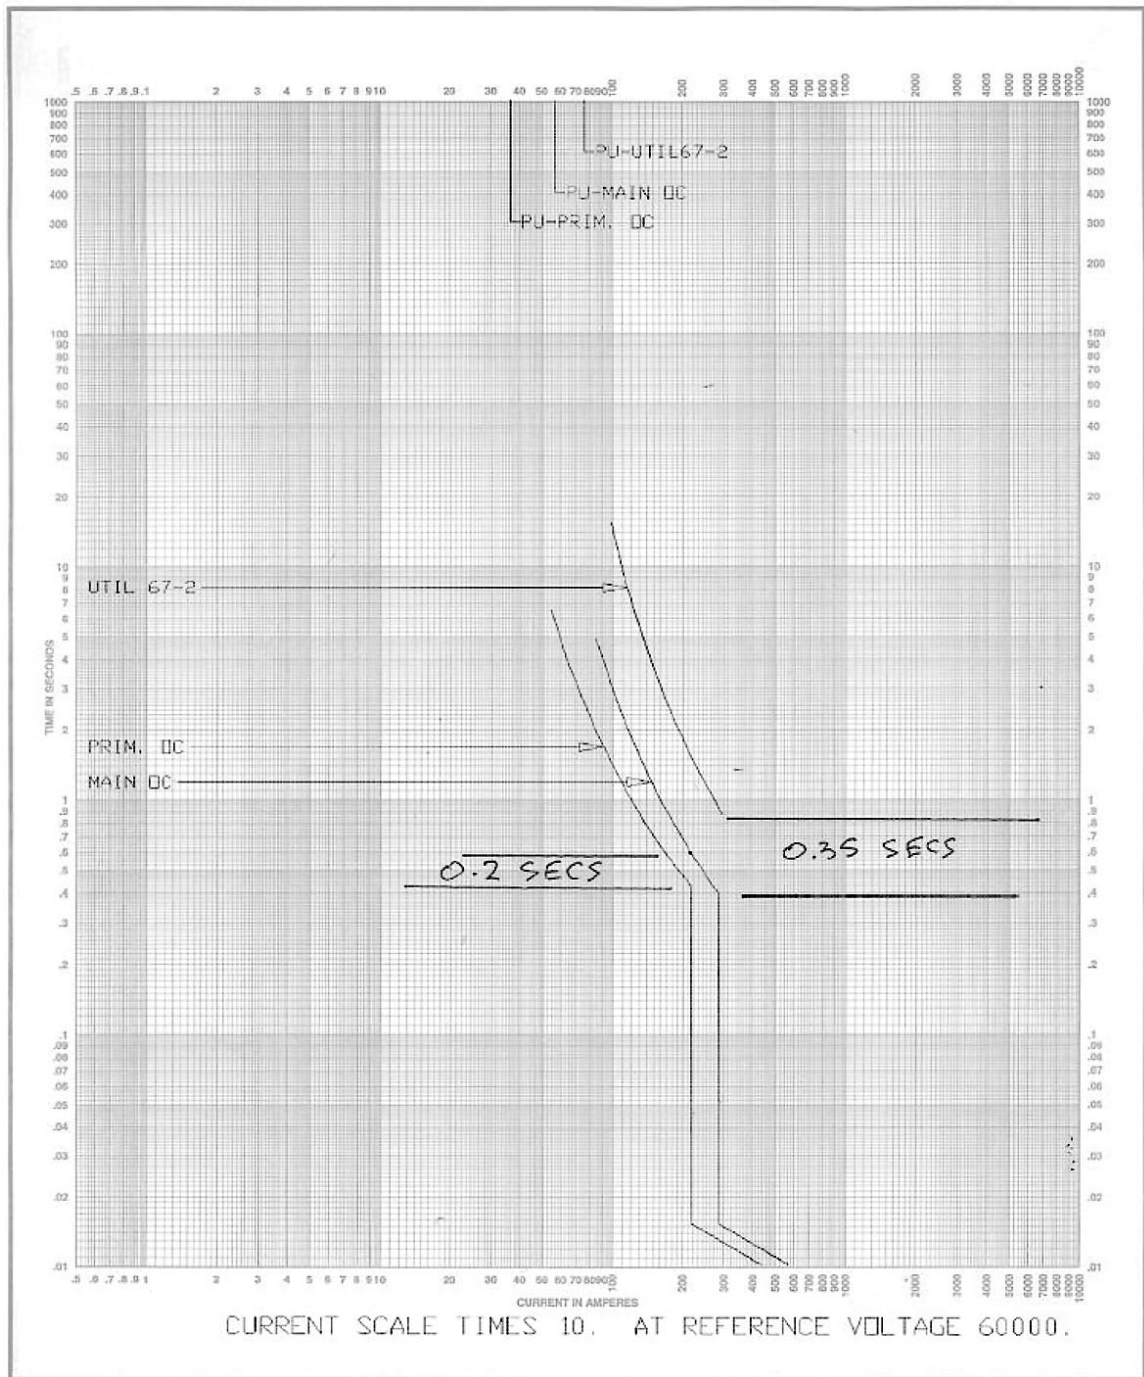
In most instances, this requires the consumer to use instantaneous trips in order to coordinate with the time-overcurrent relays of the utility. As illustrated in Figure 10, the utility requires a 0.35-second time differential between their station relays and the consumer's relays.

In the case of Palou, this would mean adding instantaneous trips to the two utility tie-line circuit breakers. Because the transformer feeders are also equipped with instantaneous trips, there would be no selective tripping for bus faults between the utility tie-line breakers and the feeder breakers. For this reason, it was necessary to upgrade the bus protection system to provide high-speed, selective tripping for faults in this zone.

Figure 10 Overcurrent Coordination Challenges

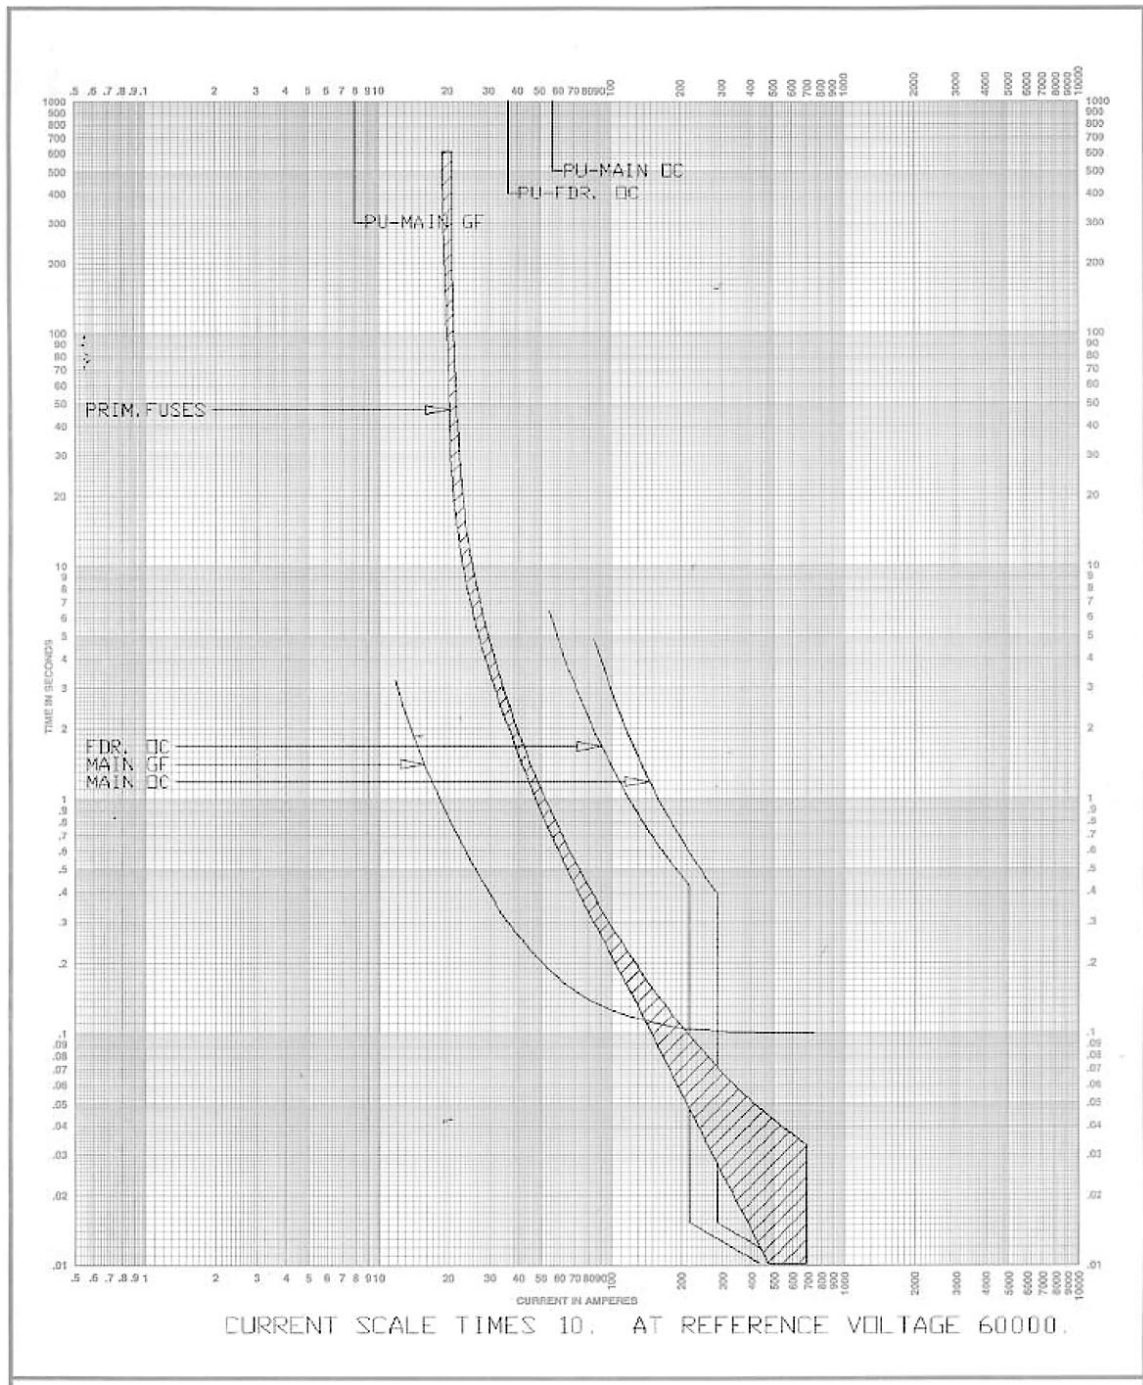
Figure 12 shows a typical coordination curve where the industrial user is forced to use instantaneous trips on the phase relays, and the ground relay is only time overcurrent. As can be seen from this typical time current curve, even though the time-overcurrent phase elements are coordinated with the fuses, there is an area of nonselectivity between the instantaneous trips and the feeder fuses. In addition, there is no coordination between the time-overcurrent ground relay and the fuse curve above one tenth of a second.

Figure 12 Phase and Ground Overcurrent Coordination Challenges

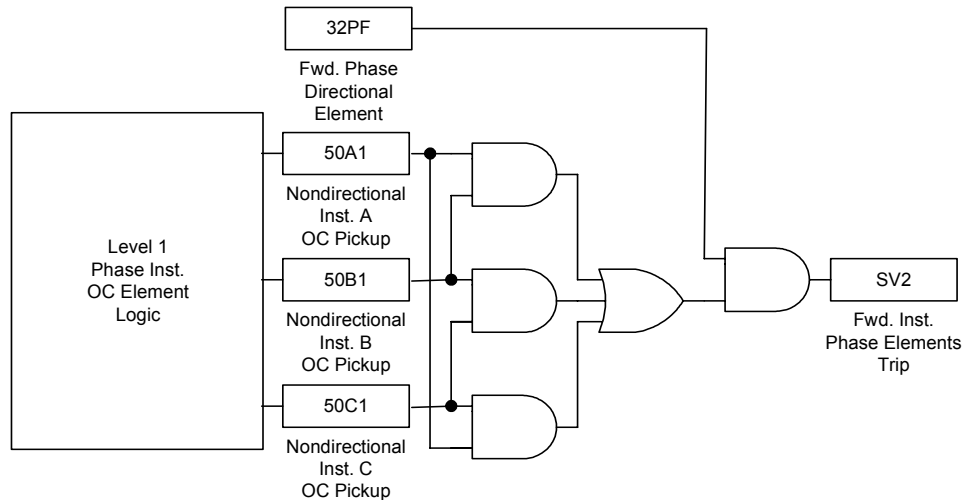
Programming the main and/or feeder phase overcurrent relays to respond only to multiphase faults removes the area of nonselectivity from the tripping sequence. This now allows a chance for the fuses to clear the ground fault and allow the feeder (or main) to stay online. With modern programmable relays, this is easily accomplished. Figure 13 shows logic that allows a phase overcurrent trip only if more than one phase element picks up.

Figure 13 Phase Overcurrent Element Logic

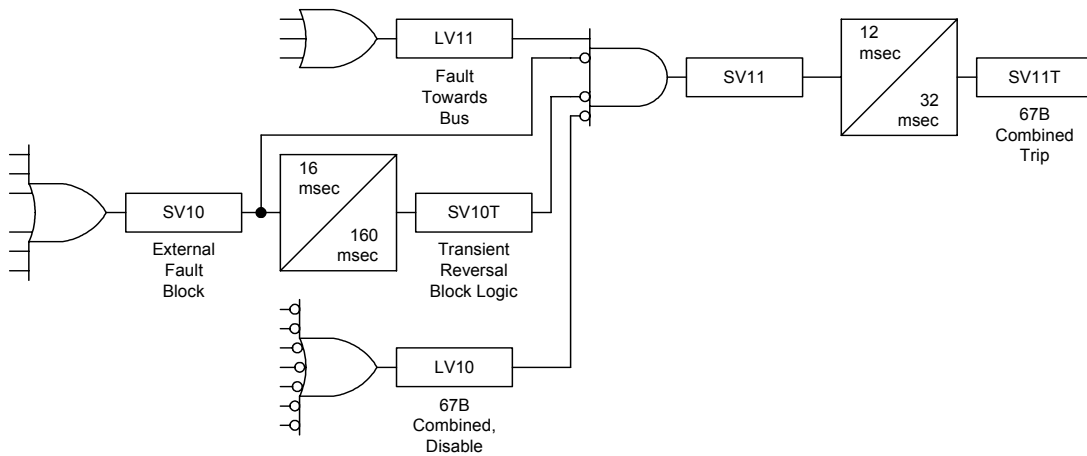
The basic scheme is shown in Figure 15. It works very much like a traditional directional comparison blocking (DCB) line protection scheme. If any relay sees a fault towards the protected zone (LV11) and no relay sees a fault away from the protected zone (SV10), tripping occurs. The 12 ms pickup, PU, timer (SV11T) is a communications coordination delay. The “fault towards the bus” (tripping) logic must wait 12 ms to allow any blocking signal to arrive. The 32 ms dropout, DO, timer is there to ensure that the trip signal is transmitted for a minimum amount of time required for tripping to occur. The 16 ms PU/160 ms DO timer (SV10T) provides security to prevent tripping when an external fault is cleared. If a block signal is received for 16 ms, the block is held up for 160 ms upon reset to prevent tripping if the blocking relay resets before the tripping relay does. This is another common feature borrowed from traditional DCB line-protection schemes. Notice that there are only three inputs to the LV11 OR gate—one for each source breaker. There are six inputs into the SV10 OR gate—one for each circuit.

Figure 15 Directional Comparison Bus Protection Logic

In any blocking scheme, communications reliability is important. If a block signal is not received for an external fault, the scheme can overtrip. OR gate LV10 provides logic to disable the scheme. This logic asserts if communication is lost to any of the relays. Under this condition, the scheme would not know the status of that circuit and would be prone to overtrip for an external fault on that circuit. The scheme is also disabled if the directional relays on the source breakers have a loss-of-potential (LOP) condition. Under this condition, the directional decisions might be unreliable.

The load circuit relays do not need to be directional. They send a “fault away from bus” (blocking) signal only if they pick up for a fault on their circuit. If any of the load circuit protective devices do pickup momentarily due to rotating loads backfeeding an internal fault, the block signal may slightly delay tripping. This spurious block signal would have to be present for 16 ms before the block is sealed in by the transient block logic (SV10T).

Another advantage of a drafted logic diagram is that it can be adequately annotated. Logic can be grouped into easily digestible functional groups. Many logic variable names within a device can be quite cryptic. Variables such as intermediate logic variables and general-purpose timers may have no inherent meaning at all. A brief name or description can be associated on the diagram with the logic variable, making it much easier to understand. Figure 13 and Figure 15 show examples of annotation of user programmable logic.

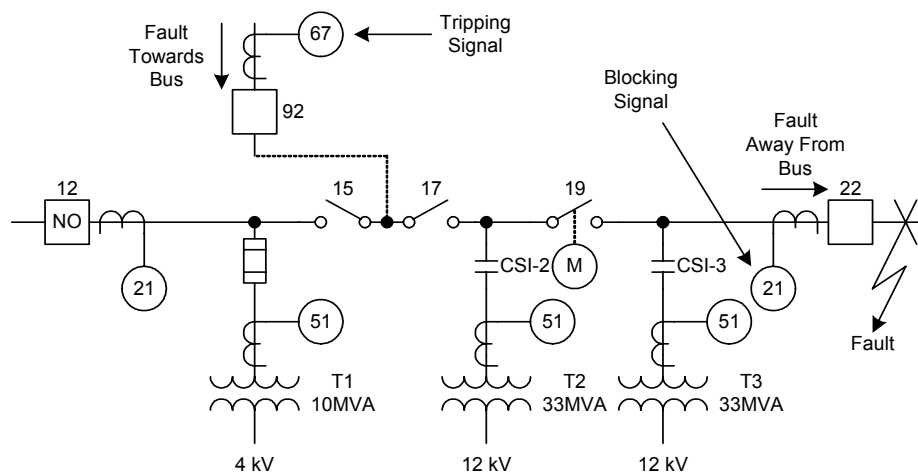
Figure 16 illustrates how the system would work for a fault on the utility system. For this fault, Device 67–92 would see the fault as towards the bus and send a tripping signal. Device 21–22 would see the fault as away from the bus and send a blocking signal. Device 21–12 would not operate because its breaker is open. Devices 51–T1, 51–T2, and 51–T3 would not operate because there are no sources on these circuits.

Figure 16 Bus Protection Operation for an External Fault

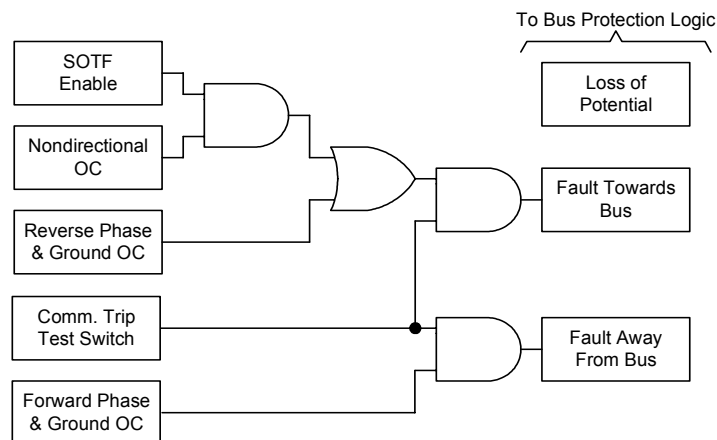
Each of the source breaker relays must send three bits of data, as shown in Figure 17:

- Loss-of-potential status
- Fault towards bus
- Fault away from bus

These relays must be directional. The “fault towards bus” (tripping) elements must be coordinated with the “fault away from bus” (blocking) elements. In other words, no tripping element can be set more sensitively than the least sensitive blocking element.

Figure 17 Source Circuit Transmit Logic

Additional features need to be included in the source circuit relay logic to make the scheme dependable and secure. Because the potential transformers for these relays are on the bus, it is necessary to include switch-on-to-fault (SOTF) trip logic in the tripping signal, in case the bus is energized onto a bolted fault where the lack of polarization may prevent the relay from operating.

The logic scheme shown in Figure 17 is one of four in each logic processor. This one is for the “bus combined” condition. If any of the bus-sectionalizing switches is open, this logic is disabled. When the bus is sectionalized, each source circuit has its own logic. Depending upon the sectionalizing switch status, only the branch circuits that are connected to that source circuit’s bus section are included in the scheme. And only the source breakers for the faulted section of the bus are tripped. This provides the desired selectivity to prevent tripping unfaulted sections of the bus.

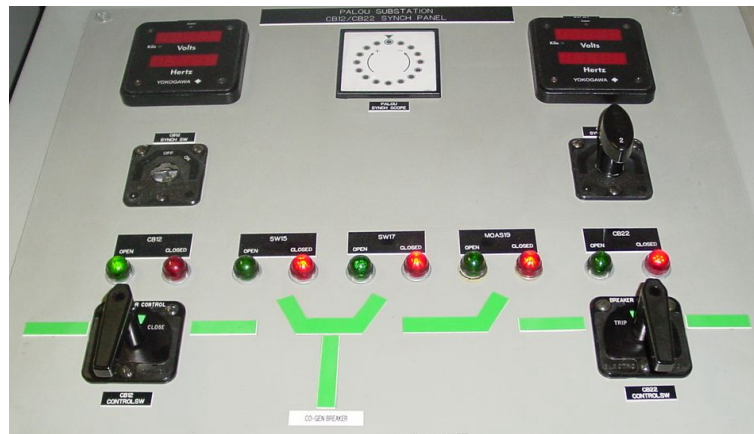
A remote synchronizing panel is installed at the cogeneration facility (Figure 18). Output contacts on the RIO modules are wired to indicating lights that show the operator the status of the utility tie-line breakers and the bus-sectionalizing switches. Close control switch contacts for each of the utility tie-line breakers are wired to contact inputs on the RIO modules. When the operator determines that conditions are appropriate to resynchronize the two systems, the contact closure from the remote control switch results in a contact closure on the logic processors at Palou

Substation. At Palou Substation, a local/remote switch, an auto/manual switch, and local synchronism check from the line relays supervise remote closing.

Figure 18 Remote Synchronizing Panel
