Lessons Learned Analyzing Transmission Faults

David Costello
Schweitzer Engineering Laboratories, Inc.

Published in the
SEL Journal of Reliable Power, Volume 1, Number 1, July 2010

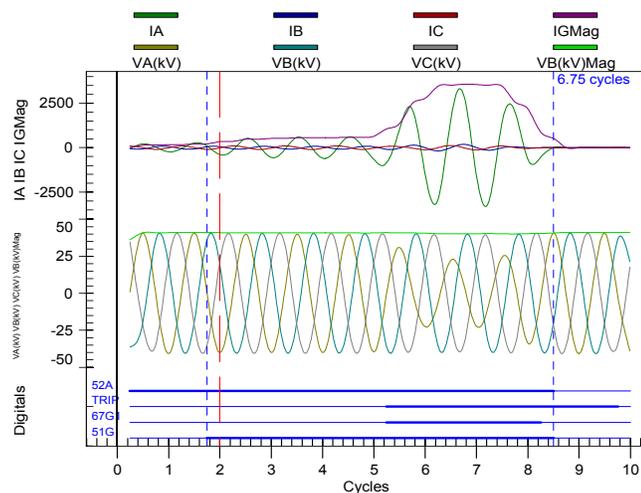
Fig. 1. Event Data From 69 kV Transmission Line Relay

Event data from the local relay are shown in Fig. 1. Ground current (3I0) reached a maximum magnitude of 3600 amperes. The actual fault location was validated using this information and an ASPEN OneLiner power system model. In OneLiner, a line-to-ground fault was simulated and slid along the line until the 3I0 current matched the maximum value from the event data. The estimated location of this simulated fault matched the actual fault location from the field.

The event data capture was triggered at Cycle 2 by an inverse-time ground overcurrent element (51G). The 3I0 current is small (200 amperes 3I0) at the fault inception because of arcing or fault impedance. In the fifth cycle, the ground fault evolves into a bolted fault (3600 amperes 3I0). The instantaneous ground overcurrent element (67G1) asserts and calls for a trip, and the breaker opens 3 cycles later.

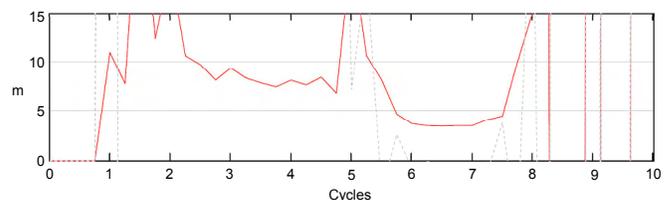
Fig. 2. Fault Location MathCad Simulation

An offline analysis of this event is required so one can manipulate where in the event data the fault algorithm extracts voltages and currents. In Fig. 2, a relay fault location algorithm is plotted using a MathCad simulation. At Cycle 6.75, the midpoint of the bolted fault data, the fault location estimate matches the actual fault location.

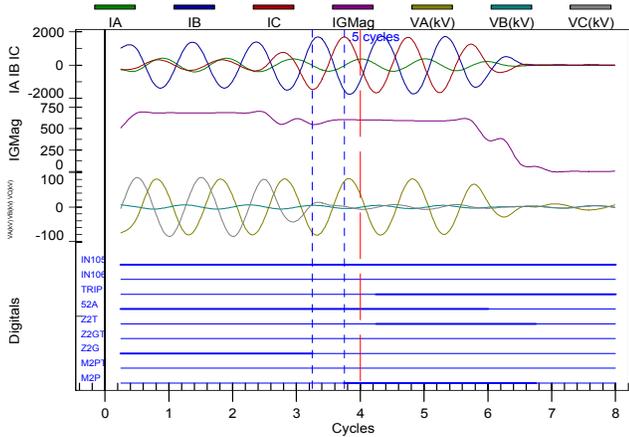
Fig. 3. Event Data From 138 kV Transmission Line Relay

Event data from the local relay are shown in Fig. 3. The event data capture was triggered at Cycle 4 by the Zone 2 phase distance element (M2P). The relay tripped and reported Zone 2 and time targets 0.5 cycles later.

Unlike the ground fault in Section I, which evolved into a larger magnitude fault of the same type, this fault evolved from a single-line-to-ground fault to a phase-phase-ground fault.

We can deduce from the data in Fig. 3 that the initial fault had been present, and the Zone 2 ground distance element (Z2G) had been timing for 24.5 cycles before the fault evolved. All distance elements dropped out for 0.5 cycles

during the fault transition period, and the common zone timer was suspended. The M2P element then asserted, the common zone timer resumed timing, and a trip was issued 0.5 cycles later. In this example, the benefit of common zone timing was a total relay response time of 25.5 cycles instead of the expected 50.5 cycles if we had chosen to use independent timing.

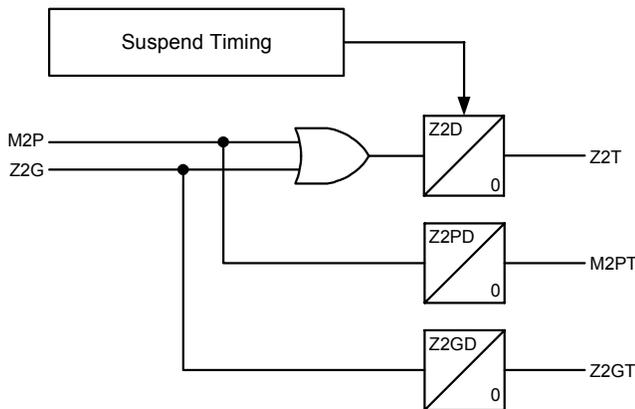
Fig. 4. Independent and Common Zone Timing Schemes

Distance relays support two philosophies of zone timing: independent or common timing (see Fig. 4). For the independent timing mode, the phase and ground distance elements for each zone initiate independent timers. For the common mode, the phase and ground distance elements for each zone drive a common timer. The common zone timer is suspended for 1 cycle if the timer input drops out. This feature prevents timer reset when a fault evolves [3].

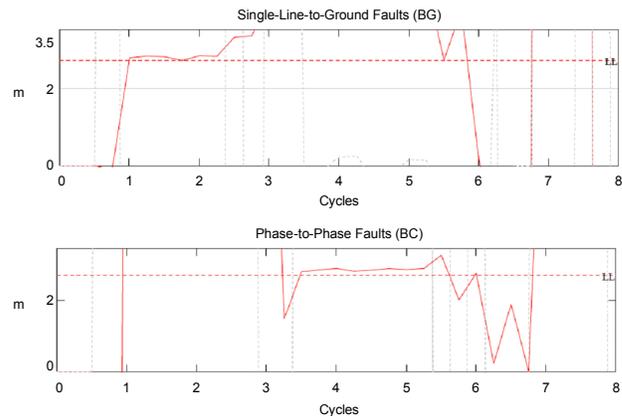
Fig. 5. MathCad Fault Location Estimates for BG and BC Fault Types

In Fig. 5, the fault location estimate is plotted for the two different fault types experienced. Both estimates produce roughly the same fault location when data are stable. But from Cycle 2.5 to 3.5 you can see where both estimates veer wildly from the actual location because of the fault type evolution. The reported location from the relay would have been in error if it had selected data from that time.

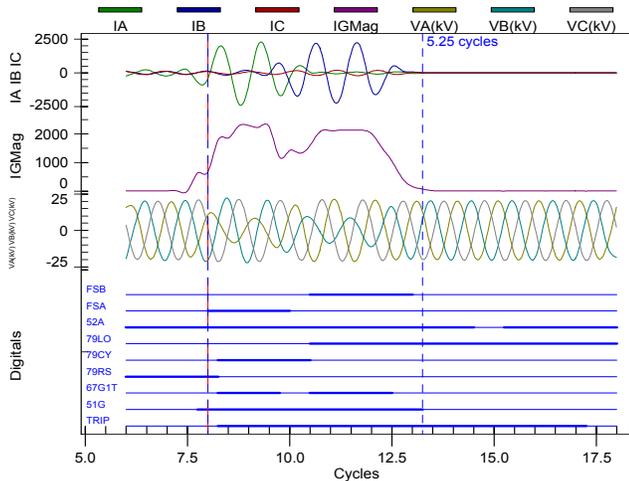
Fig. 6. Reclosing Interrupted by Evolving Fault

Event data from the relay are shown in Fig. 6. The event started as an A-phase-to-ground (AG) fault and evolved to a B-phase-to-ground (BG) fault. This was most likely caused by a slapping conductor or tree contact. At fault inception, an instantaneous ground overcurrent element (67G1) asserts and produces a trip output. At this same time, the relay enters the reclosing cycle state (79CY), indicating that reclosing open-interval timing has been initiated. However, we can see that as the AG fault progresses to a BG fault, the 67G1 element drops out for 0.75 cycles before reasserting. When the 67G1 element

reasserts, the relay advances to lockout (79LO). The root cause can be found in the relay operation and user settings [1].

A programmable logic equation (79RI) defines the conditions that initiate reclose. 79RI is set equal to the rising edge of 67G1 plus a number of other conditions logically ORed together. Once 79RI asserts, the relay enters its cycle state (79CY) and begins to time to reclose. However, the reclose timer is interrupted when 79RI reasserts. The relay immediately assumes something has gone awry, such as a flashover during a breaker opening, and the relay immediately goes to lockout (79LO) to prevent further trouble.

To prevent this from happening in the future, reclosing must not be reinitiated before reclose open-interval timing is complete and the breaker has been reclosed. Use the trip element to initiate reclose. Relays have a minimum trip duration time, so trip outputs remain asserted throughout evolving faults.

An interesting breaker problem is also evident by the data in Fig. 6. Notice that the breaker status contact (52A) changes state shortly after the main breaker interrupts current. This is consistent with breaker operations in the previous two examples. However, we see that while the main breaker contacts remain open, the breaker auxiliary status contact bounces closed after 0.75 cycles and remains closed for 3.5 cycles before opening again. Bouncy auxiliary contacts can cause reclosing failures. If 52A asserts before the relay calls for a close, relay logic assumes a manual or remote **CLOSE** command asserted. The auxiliary contacts of this breaker need maintenance to prevent future problems.

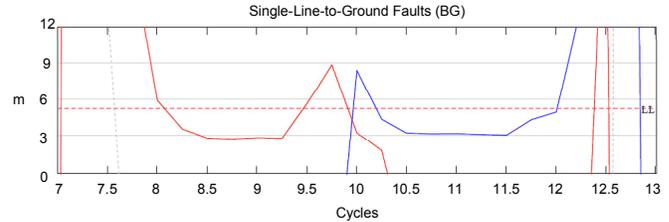
Fig. 7. MathCad Fault Location Estimates for AG and BG Fault Types

A fault location algorithm MathCad simulation is shown in Fig. 7. We can see the fault location error during the fault type change, but before and after that transition the location estimate is consistent.

The relay fault location algorithm selected data just prior to Cycle 10.5, where the B-phase current is still increasing to its maximum value. Therefore, its estimate is slightly further away from the local terminal because of the lower current magnitude used. The actual fault location is closer to 3.0 miles.

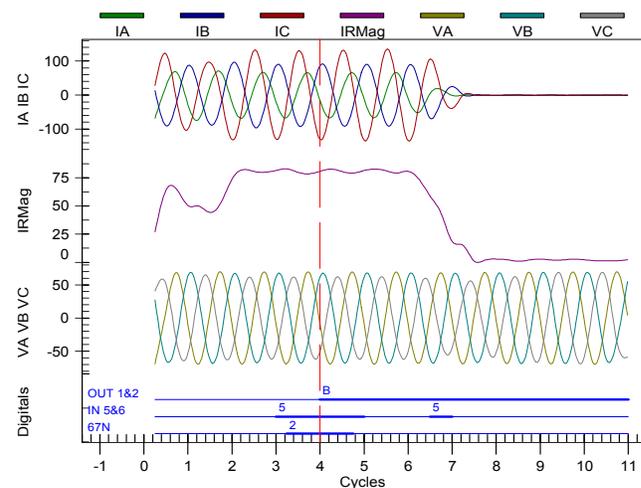
Fig. 8. Four Samples-per-Cycle Data From a DCB Scheme Trip

The event data recorded from the local relay are shown in Fig. 8. The received blocking signal was wired to a programmable input on the relay (IN5) and appears to have been asserted at the time of the trip.

The relay is set so that overreaching phase and ground elements are allowed to trip after a one-cycle carrier coordination delay if no block is received. However, the relay tripped by overreaching ground directional overcurrent ele-

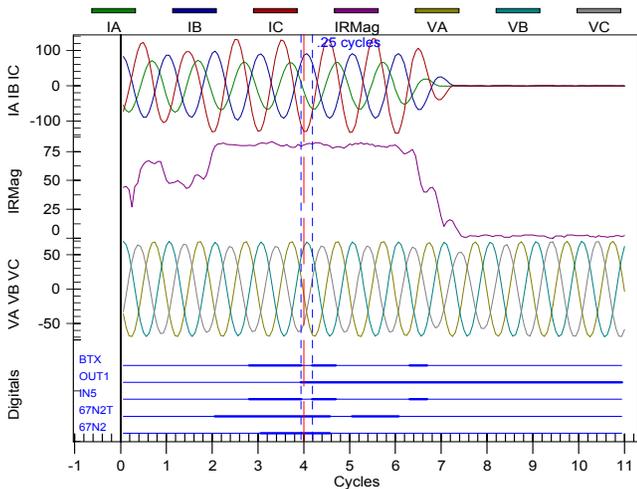
Fig. 9. Sixteen Samples-per-Cycle Raw Data From a DCB Scheme Trip

Higher resolution data from the same relay for the same event are shown in Fig. 9. The better resolution illuminates a 0.25-cycle carrier hole that allowed the local relay to trip.

The received blocking input must remain asserted to block the forward-looking elements after the coordination timer expires. If the blocking signal drops out momentarily because of noise or other channel-related problems, the local relay will trip for out-of-section faults.

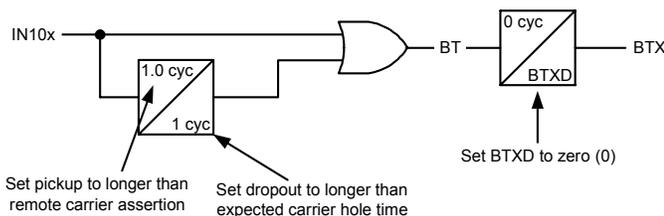
Fig. 10. BT Extension for Nondirectional Carrier Start Applications

To avoid this delay, use programmable logic in the relay to extend the blocking signal (see Fig. 10).

In this logic, we extend the BT only if the carrier has been initially picked up longer than the remote carrier assertion. The typical BT extension timer setting can then be set equal to 0 cycles [4].

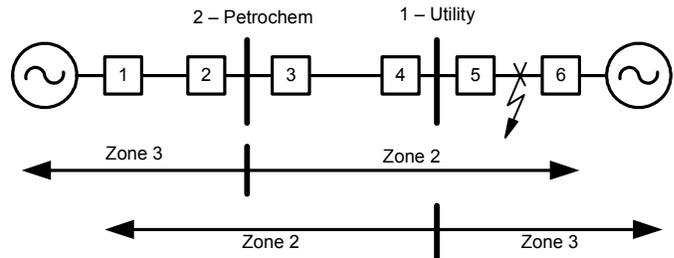
Fig. 11. Simplified One-line Diagram of System With Relay Sensitivities

A simplified system one-line diagram with fault location is shown in Fig. 11. The tie line that is in parallel with Line 3–4 and other infeeds to the petrochemical plant and utility bus are not shown. The utility is designated 1, and the petrochemical plant is designated 2. The actual fault location was behind the utility terminal (reverse to Terminal 1 and forward to Terminal 2).

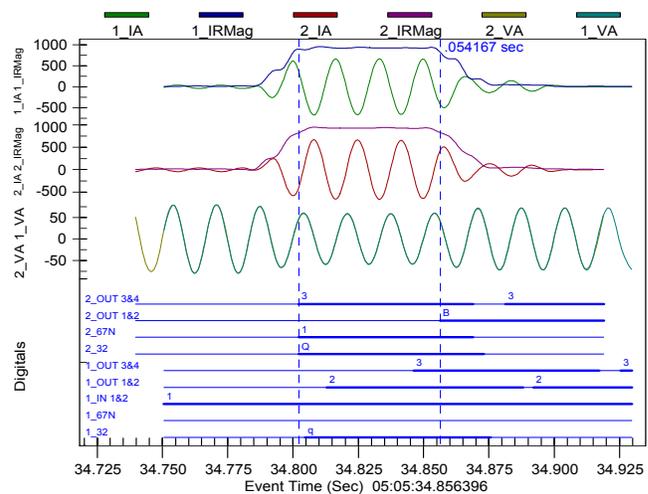
Fig. 12. Utility and Plant Relay Data for Fault

Event data from both ends of one tie line are shown simultaneously in Fig. 12. The event data match the designations above, i.e., the utility data are designated 1, and the petrochemical plant data are designated 2.

Terminal 2 responds to the forward AG fault by asserting its forward directional element (2_32Q) and its overreaching forward directional ground overcurrent element (2_67N2). The digital trace in Fig. 12 is identified with a 2_67N1, which is correct. Settings for the level one (67N1) and level two (67N2) ground elements are set to the same value, and the relay reports the assertion of the nearest zone. Terminal 2 keys a permission-to-trip (PTT) signal to the remote utility relay (2_OUT3).

Terminal 1 correctly sees the fault as reverse according to its directional element (1_32q). The PTT signal sent by Terminal 2 is received 10 ms later by Terminal 1 (1_OUT2). OUT2 is programmed to follow the local PT logic bit (PTT received).

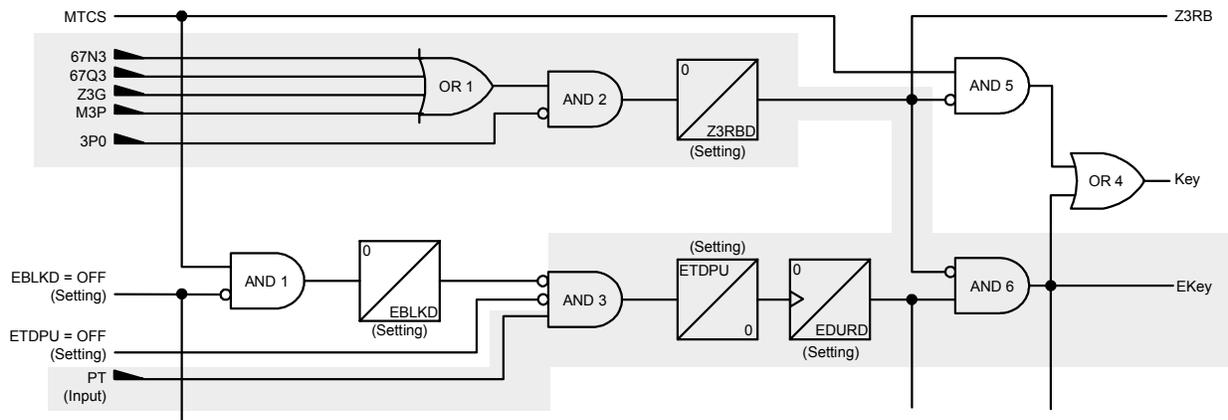
Fig. 13. Partial Relay POTT Scheme Logic Diagram

A portion of the relay POTT scheme logic diagram is shown in Fig. 13. The relays include logic that permits rapid clearing of end-of-line faults when one line terminal is open or has a very weak source. This is referred to as “echo” logic [5]. The open breaker or weak source terminal is allowed to echo the received permission signal as long as two main conditions are met:

In this event, we also notice that once an echo key condition was established, it continued indefinitely until stopped by personnel intervention. In Fig. 13, if echo pulse duration EDURD is set longer than pickup ETDPU, the local and remote relays will establish a permanent echo key condition. To prevent this from occurring, set ETDPU to 2 cycles and EDURD to 1 cycle. Limiting the echo duration to less than the echo time-delay pickup ensures that a permanent echo key condition will not occur. A one-cycle duration is more than adequate for recognition by modern relays. The traditional criteria that the echo signal be longer than the remote breaker tripping time is not required if relays include an appropriate minimum trip duration time. The echo signal only needs to be long enough to initiate the high-speed trip, after which the trip duration delay determines how long a local trip signal is maintained to the breaker. A typical trip duration setting is 9 cycles.

When installing a POTT scheme, the need for echo logic should be considered carefully. Do you even have the possibility of a weak infeed condition? If you enable echo logic, it is critical that reverse-looking Zone 3 elements are enabled so that they can supervise the echo decision. Local and remote line relay sensitivities should be coordinated, i.e., if ground overcurrent elements are enabled at the local end (forward 67N2, reverse 67N3), they should be enabled at the remote end as well [6].

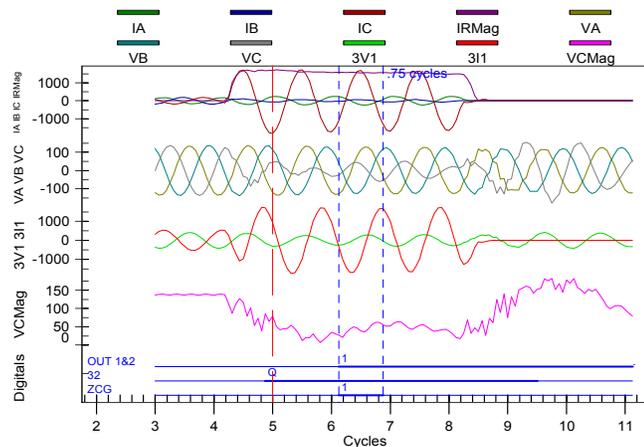
Fig. 14. CG Fault Produces CVT Transient

The unfiltered event data from this misoperation are shown in Fig. 14. The event shows a severe transient in the C-phase voltage just before the Zone 1 CG distance element operation. This transient makes the C-phase voltage magnitude appear smaller to the relay than the actual voltage value. The apparent impedance calculated by the relay is smaller (or closer to the terminal) than actual. The CG distance element asserted in less than 1 cycle. When the fault clears, the C-phase voltage has another transient that makes it appear higher in magnitude than the other nonfault-affected phases.

Equation (1) and the data from the event allow us to calculate the source impedance ratio (SIR) for this application. CVTs with an active ferroresonance-suppression circuit (FSC) and applications with a high SIR limit secure Zone 1 reach settings [7]. The positive-sequence source impedance for this application is 11 ohms secondary and the line impedance is 0.59 ohms secondary, giving an SIR of over 18.

For an SIR of 18 and an active FSC, the maximum recommended Zone 1 reach is 0.07 pu of the line. With such a short line (small impedance), this results in a secondary setting below the minimum value allowed by the relay (0.05 ohms secondary). In this application, the Zone 1 element needs to be completely disabled or time-delayed by at least 1.5 cycles. In some applications, another option is to split Zone 1 into two zones; one zone with reduced reach and set to trip instantaneously, and the other zone set to the desired or normal reach with time delay. This is a more complex solution, but it gives faster tripping for close-in faults and takes advantage of the multiple zones available in relays.

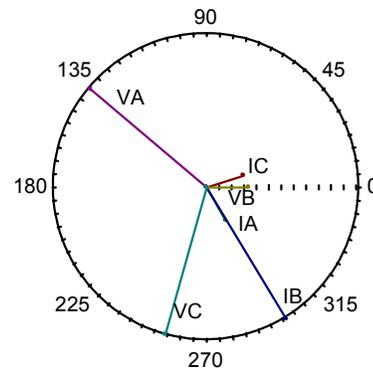
Fig. 15. Forward BG Fault as Viewed by Remote Line Relay

For a BG fault that is forward to both terminals, we would expect the phase angle relationships shown in Fig. 15. However, voltage during the fault at the local end does not match that at the remote terminal.

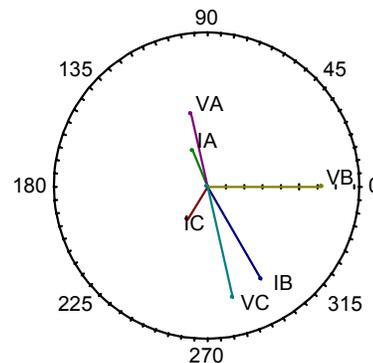
Fig. 16. Forward BG Fault as Viewed by Local Line Relay

Multiple CVT secondary grounds were suspected because the local prefault voltages were balanced and the fault voltages were corrupt. Technicians found two grounds, one at the CVT secondary wiring in the yard and another in the control building at the relay panel.

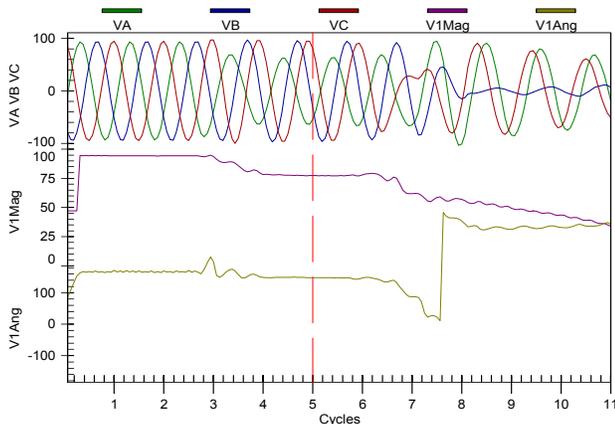
Fig. 17. Forward BG Fault as Viewed by Local Line Relay (Filtered Data)

Oscillography from the local relay is shown in Fig. 17. The relay's polarizing voltage has a memory of about one second. The CVT transient response and long-time decay are evident. This decaying voltage continues to feed the relay positive-sequence (V1) memory and corrupts V1 magnitude and angle. When the line terminal attempts a reclose, the V1 memory has not reset, and inrush current from a tapped transformer load is present (see Fig. 18). The high current combined with the memory voltage error produces a Zone 1 distance element trip.

The CVT transient coupled with a fast reclose attempt caused the reclose failure. Fault detectors that supervise distance elements should be set above transformer inrush currents [8]. Reclose-open intervals must take into account CVT transient response and decay and V1 memory in relays.

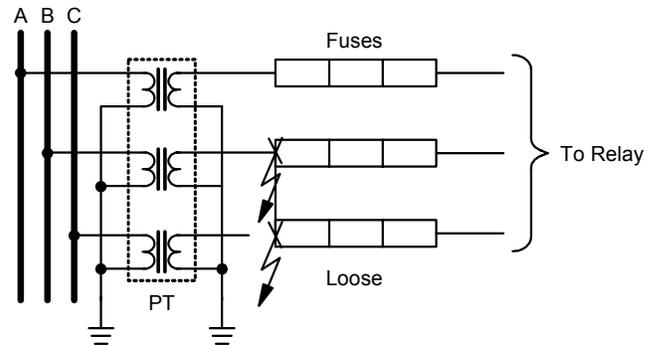
Fig. 20. PT Fuse Problem

The false apparent impedance created by abnormal voltages and load currents caused the apparent impedance to encroach on the reach of the distance relays (see Fig. 20). The same bus potentials serve both relays.

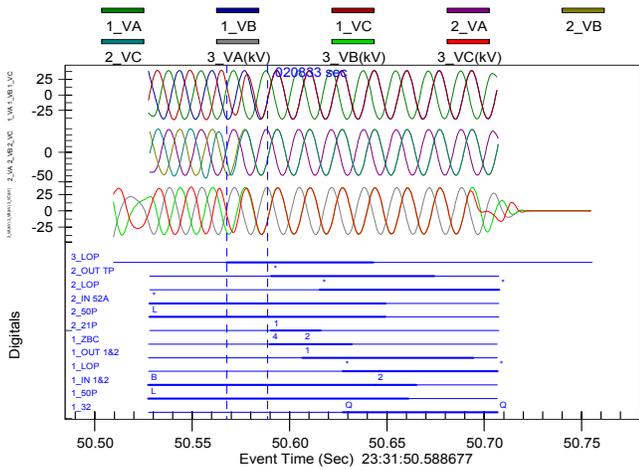
Fig. 21. Response of Primary (1), Backup (2), and Relay With Improved LOP Logic (3) to PT Fuse Problem

Because a blown fuse results in a loss of polarizing inputs to the relays, detection of this condition is desirable and was enabled in both relays (see Fig. 21). The event data show that the loss-of-potential (LOP) detection asserts after the phase distance element trips. In both relays, there is a three-cycle delay before the LOP element asserts for unbalanced conditions to ensure LOP does not block protective elements during a fault.

This event emphasizes that early LOP logic was designed to protect distance elements from misoperating for system faults that occurred some time after an initial LOP condition was detected. Overcurrent fault detectors, set above load, were used to prevent distance element misoperation when the LOP condition first occurred. In this event, the fault detector (50L) was picked up during balanced load flow. Ideally, fault detectors should be set above expected load currents and below minimum fault levels to ensure correct distance relay operation.

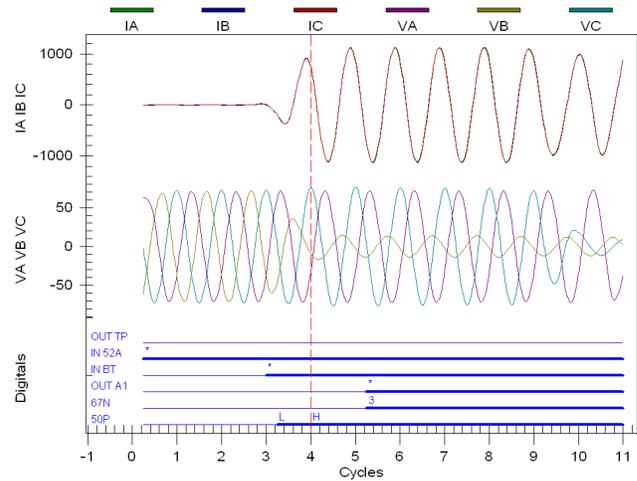
Fig. 22. Fault Data From Relay

A BG fault then occurred on the line. The relay at the generator end of the line saw this fault as reverse and sent a blocking signal to the utility terminal, delaying fault clearing. Event data from the relay at the generator end of the line are shown in Fig. 22. The phase currents are all in phase.

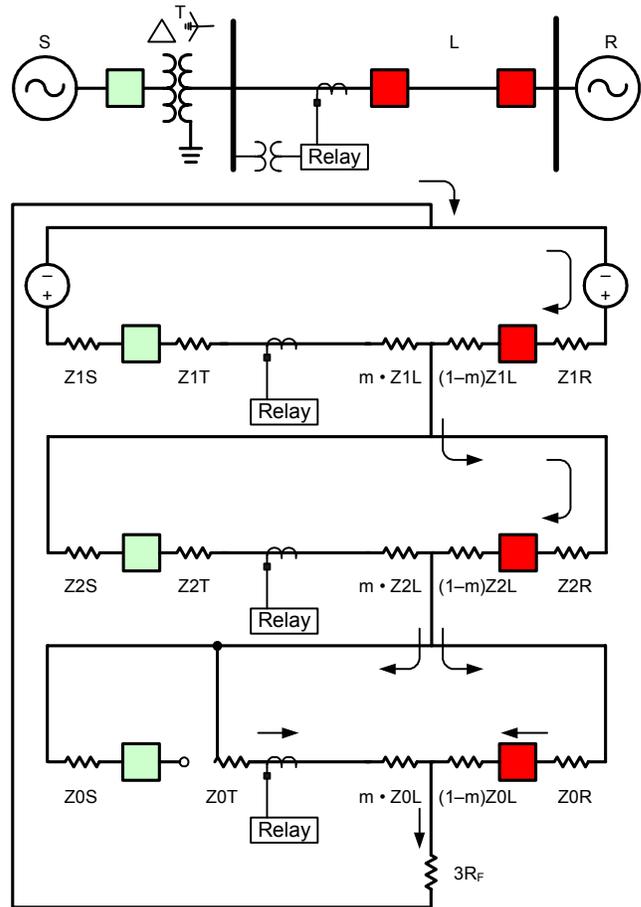
Fig. 23. Symmetrical Components Diagram for BG Line Fault

A one-line and symmetrical-components diagram for the fault is shown in Fig. 23. With the generator breaker open, there is a pure zero-sequence source behind the relay.

The user can choose to change the polarization quantity. This decision, however, sacrifices a more reliable directional element in order to trip faster during a rare operating condition. A practical improvement would be to wire a 52b contact from the generator breaker in parallel with the carrier squelch contact from the relay. This would allow high-speed clearing from the utility source for faults that occur when the generation is offline.

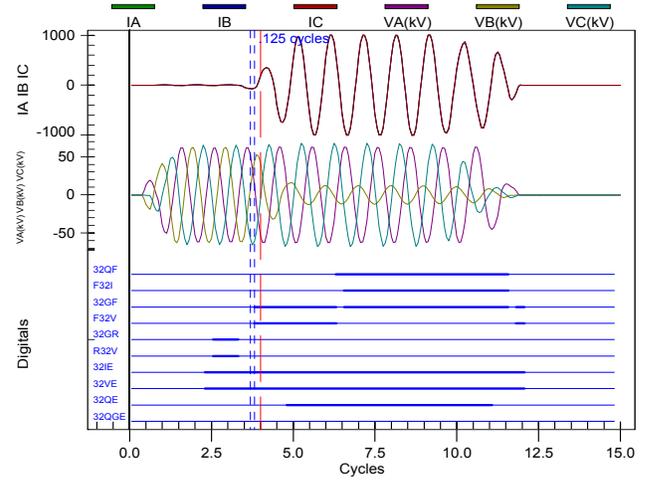
Fig. 24. Best Choice Ground Directional Element Logic for BG Fault

In the simulation, we chose an order that always gives preference to negative-sequence polarization (Q, V, I). In this case, there is little negative-sequence, so the relay checks zero-sequence and makes the proper forward directional declaration. This secure operation comes at the expense of a slight processing delay. Overall, this directional logic results in faster operating times for all system states. When the generation is online, the negative-sequence directional element operates most reliably, and when generation is offline, the zero-sequence element operates correctly.

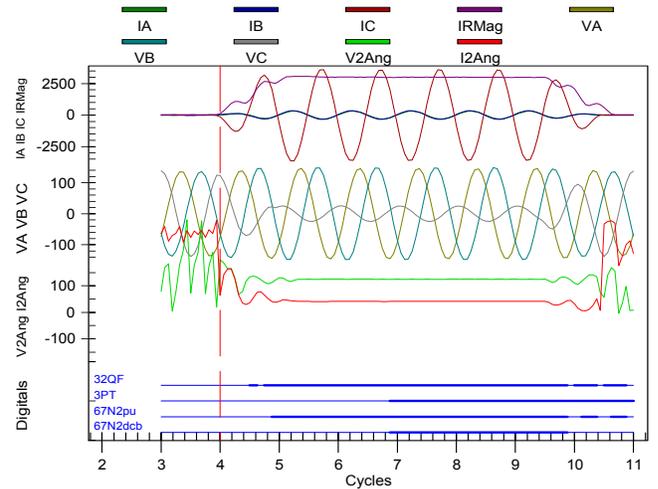
Fig. 25. Forward Fault Declaration for Reverse CG Fault

The fault data from the event are shown in Fig. 25. During the fault, V2 leads I2 by 83 degrees and has a magnitude of 15 volts secondary. The fault current magnitude is 3700 amperes primary. The forward directional element (32QF) asserts incorrectly and allows a trip by the directional ground overcurrent element (67N2dcb).

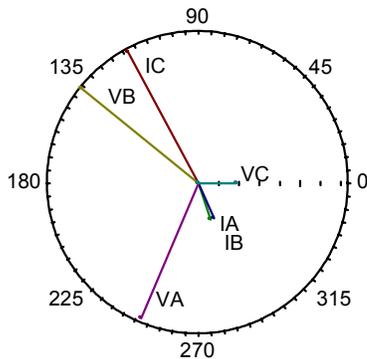
Fig. 26. CG Reverse Fault Phasors

The phasors during the fault are shown in Fig. 26. C-phase fault current leads a reduced-magnitude C-phase voltage as expected for a reverse fault. The expected operation would have been for the relay to see this fault as reverse and send a blocking signal to the remote terminals.

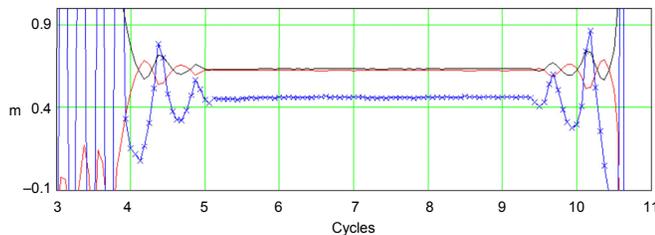
Fig. 27. Directional Element Response With As-Set Settings

Fig. 27 shows a MathCad simulation of the directional element. The directional element measures the negative-sequence impedance (Z_2) during the fault and compares it to settings to determine the fault direction.

The initial root cause theory blamed the forward and reverse threshold settings for the misoperation. The original forward threshold (Z_2F) was set at one-half Z_{1MAG} (positive-sequence line impedance in secondary ohms). The original reverse threshold (Z_2R) was set at Z_2F plus 0.1 ohms secondary. This is typical and is used by some relays that calculate thresholds automatically.

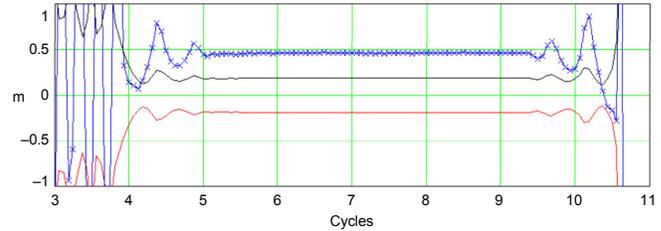
Fig. 28. Directional Element Response With $Z_2F = -0.1$ Ohms and $Z_2R = +0.1$ Ohms

There are four reasons this theory seemed credible. First, the directional decision made by the relay was incorrect. Second, by modifying the Z_2F and Z_2R settings the directional decision made by the relay would have been correct (reverse). Fig. 28 shows a MathCad simulation of the directional element with Z_2F set to -0.1 ohms and Z_2R set to $+0.1$ ohms secondary. Third, the engineers experienced a few cases where the standard settings did not work. Lastly, a subsequent reverse fault operated correctly with the modified settings.

Standard settings offer convenience but should not be applied blindly. Directional element performance is critical and should be checked, especially for extreme conditions. Run fault studies for very strong or very weak sources, and check Z_2 against thresholds Z_2F and Z_2R for proper operation.

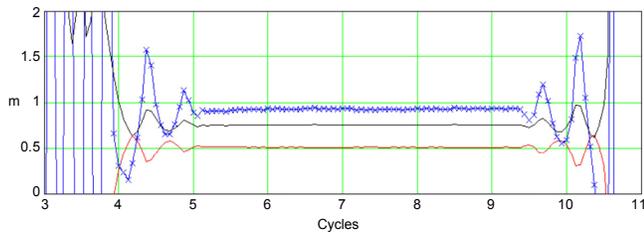
Fig. 29. Directional Element Response With CT Tap Lower Than CTR Setting

Upon closer inspection of these event data, however, it appears that the Z_2F and Z_2R thresholds may not be the culprits at all. Several data anomalies are present. Standard settings tend to give us problems when V_2 is small, such as in the transformer inrush example above. In this event, however, we have plenty of V_2 (15 volts secondary). The line impedance and line length settings in the relay give us an estimate of 1.6 ohms per mile for a 230 kV line, which appears too large (half that value would be more reasonable). Z_2 measured during a reverse fault should equal at least the line impedance; the data show a Z_2 measurement of 0.5 ohms, less than half of the line impedance setting. This led to an alternative theory. Perhaps the standard thresholds were just fine, but the measured impedance was wrong. An incorrect CT ratio (CTR) setting or an incorrect CT tap could do just that. The CTR setting in the relay is 40 (200:5) for a 230 kV line. Assume that the CT is tapped at 100:5, while the relay settings expect 200:5. If we leave directional thresholds at their original standard settings, we get a correct reverse decision for the original fault (see Fig. 29).

It is suspected that the CTR setting in the relay does not match the actual CT tap in the field. However, this is part of an ongoing investigation and, at the time of publication, root cause is yet to be determined.

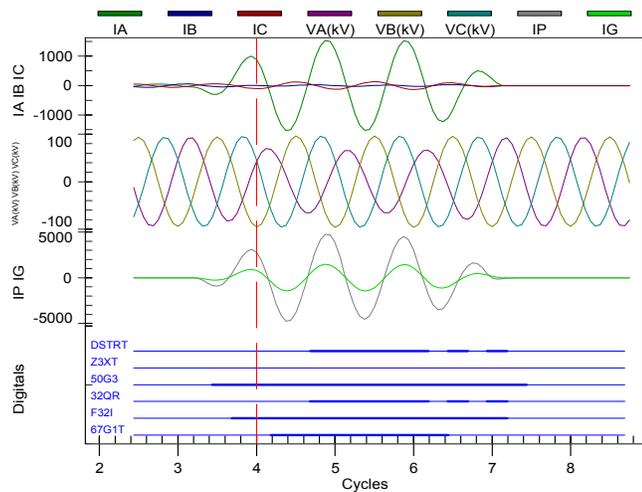
Fig. 30. Directional Element Misoperation due to IP Wiring Mistake

The event data from the misoperation are shown in Fig. 30. For a reverse fault, we expect the polarizing current (IP) and the terminal ground current (IG) to be 180 degrees out of phase. In the event data, however, IP and IG were in phase. A wiring error was found; the polarizing current CT was connected reverse polarity. This allowed the local breaker to trip.

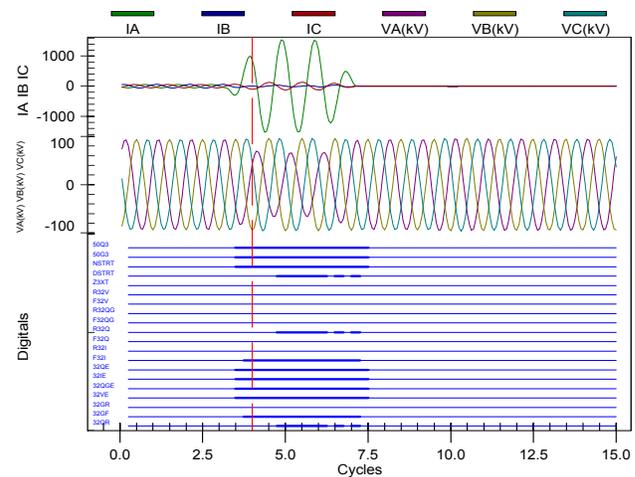
Fig. 31. Detailed Relay Response to Fault

In Fig. 31, the ground-polarized directional elements (F32I and 32GF) assert because of the directional logic order and wiring error. The phase angle of the faulted phase current varies wildly during the beginning of the fault because of the fault arcing and evolution. This delays the voltage-based directional elements but has little effect on the current-based directional element. Also in Fig. 31, negative-sequence directional elements (32QR and R32Q) asserted later in the fault. 32QR and R32Q supervise phase distance and negative-sequence overcurrent elements. Their ground logic equivalent (R32QG) is controlled by best choice logic. R32QG did not assert because the IP-based element has priority, but the directional decision it would make would match that of 32QR and R32Q when enabled. From this, we realize that the order and best choice logic processing did not delay the R32QG element; the evolving fault did.

The evolving fault should delay a directional decision for all the relays. Remote relays additionally include a carrier coordination delay for tripping. How fast the directional element sent blocking is not the real issue in this fault; it is how fast we enable carrier extension. Setting the carrier extension pickup delay (Z3XPU) to a lower value, even zero, is recommended [13].

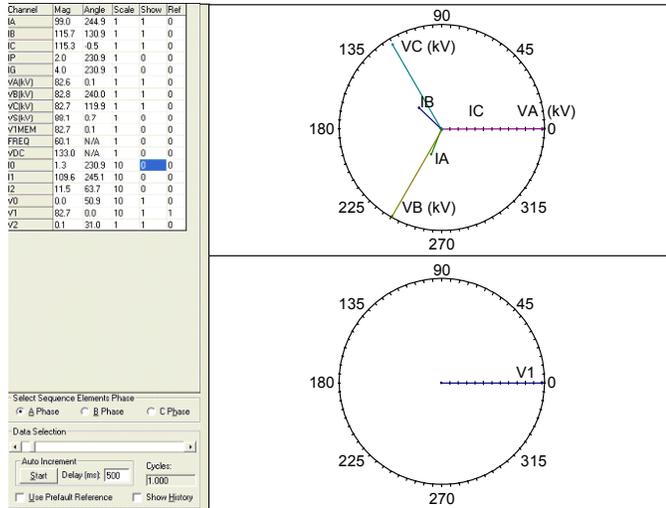
Fig. 32. Prefault Data From Backup Relay

The pre-fault data from the backup relay are shown in Fig. 32, and the pre-fault data from the primary relay are shown in Fig. 33. The phase voltages seen by the primary relay in the pre-fault state did not look normal or balanced, and a significant standing zero-sequence voltage was present. The backup relay, on the contrary, reported normal pre-fault voltages.

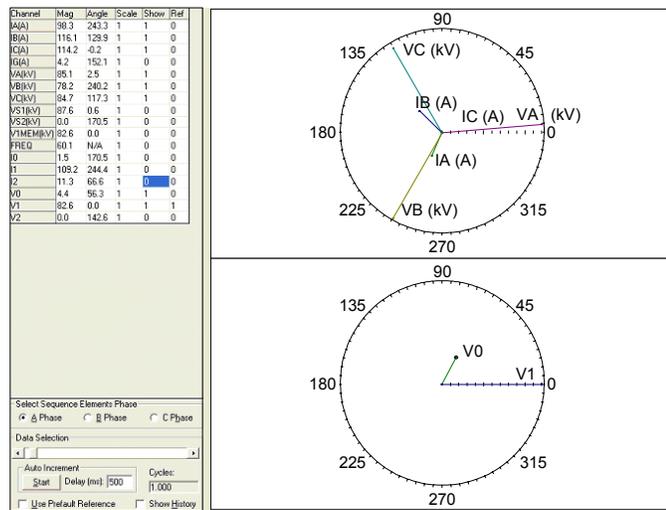
Fig. 33. Prefault Data From Primary Relay

The neutral bus of the primary relay three-phase voltage connections should have been connected at a terminal block to station ground; this wire was missing. The result was that the primary relay voltages were floating, and this distorted phase-to-neutral magnitudes, angles, and sequence components both before the fault and during the fault. The backup relay had properly terminated voltages and, therefore, its zero-sequence voltage polarized directional element performed correctly.

Synchronized phasor measurement during commissioning is a useful tool for finding mistakes like these before they cause misoperations. When relays are connected to a common voltage or current source, automation systems can be easily designed to periodically retrieve metering data, compare them, and alarm when differences are discovered. Troubleshooting and repair can then be performed to fix problems before they are discovered by misoperations.

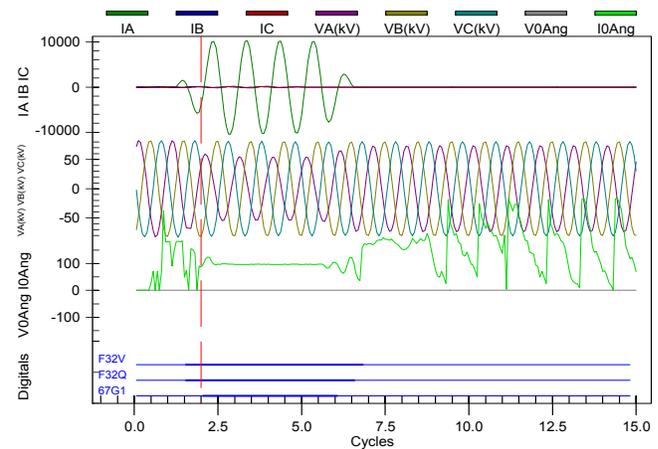
Fig. 34. Fault Data From Backup Relay

sequence directional element used (F32V) and the disabled negative-sequence directional element (F32Q) both made the correct directional decision.

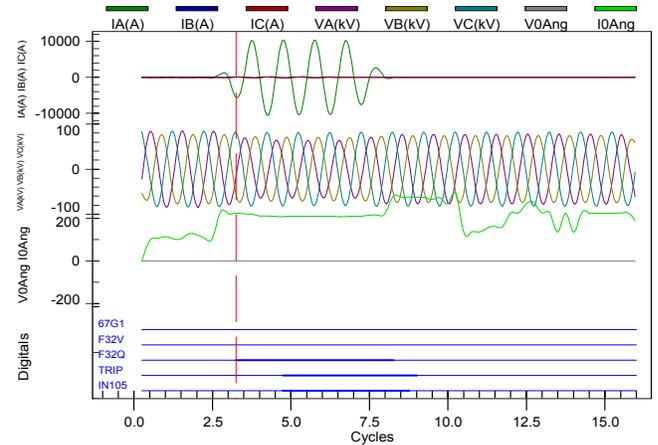
Fig. 35. Fault Data From Primary Relay

The fault data collected from the primary relay are shown in Fig. 35. The zero-sequence current leads the zero-sequence voltage by about 210 degrees, which causes the zero-sequence directional element misoperation. Negative-sequence relationships match those reported by the backup relay and are correct. The relay is set by the user to enable only zero-sequence quantities for directional decisions. However, the data show that the disabled negative-sequence directional element (F32Q) made the correct directional decision.
