Lessons Learned Through Commissioning and Analyzing Data From Transformer Differential Installations

David Costello, *Schweitzer Engineering Laboratories, Inc.*

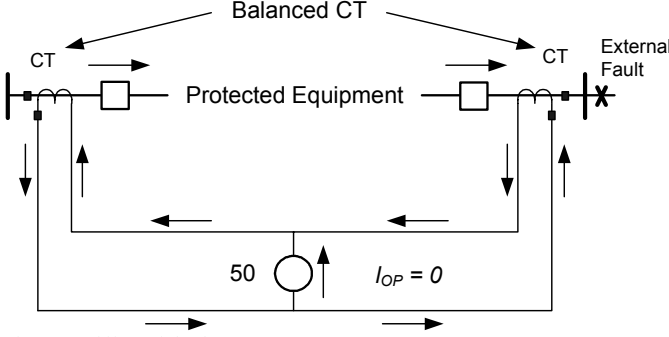
Fig. 1 Differential relay concept

external fault. If, however, the fault is internal to the CTs, the currents have the same phase angle, add together, and pass through the overcurrent relay; i.e., the relay measures difference current for an internal fault.

In a microprocessor-based differential relay, there is no overcurrent operate coil such as in Fig. 1. Instead, the relay samples and extracts the fundamental instantaneous magnitude and phase angle of the currents. From these values, the relay mathematically calculates the phasor sum of the currents, which we call operate or difference current. Fig. 2 shows a percentage-restraint differential relay. Instead of comparing the operate current to a simple threshold or pickup, the relay calculates the ratio of operate current to a restraint quantity. When the ratio of operate-to-restraint current exceeds a certain percentage, the relay operates. In addition, the relay has a variable sensitivity dependent on restraint. Relay design determines what constitutes restraint current, but it typically is the scaled scalar sum of the CT currents, for example the average of the current magnitudes.

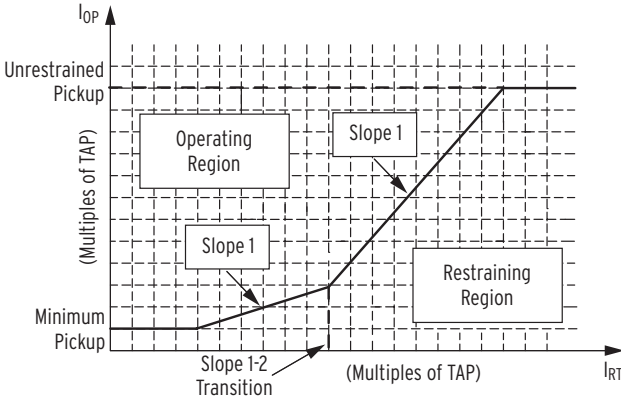
Fig. 2 Percentage-restraint concept

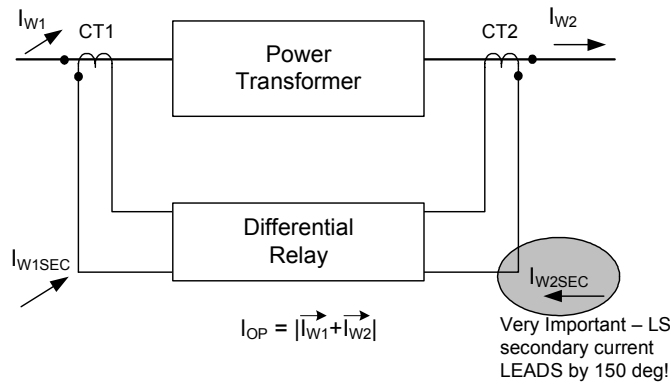
Fig. 3 Phase-angle shift across a transformer

See Fig. 3 for an important but easy-to-overlook observation. The current the relay detects on the secondary of the CT on Winding 2 will be 180 degrees out of phase with the current on the primary of the CT. When one takes phase-angle measurements during commissioning for a through-load condition on the transformer we have been discussing, the relay

secondary terminal block will detect the low-side current *leading* the high-side current by 150 degrees. *This is normal and expected.*

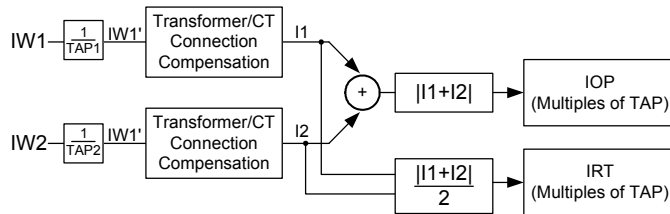
Fig. 4 Development of operate and restraint

Fig. 4 shows the development of operate and restraint quantities after tap and phase-angle compensation.

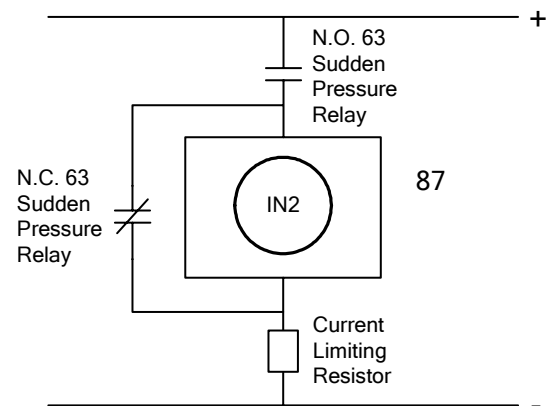
Fig. 5 Interface to sudden pressure relay

It is common to interface indicating contacts from these relays to a microprocessor-based relay for tripping, trip seal-in, event report triggering, and SCADA indication. One must take great care, however, when implementing direct trip applications; sudden pressure relays have a reputation for poor security and lack of dielectric strength. As Fig. 5 illustrates, use both the normally open and normally closed contacts from these devices to indicate a trip. Also use debounce delays on any digital relay inputs monitoring these devices, to provide necessary security.

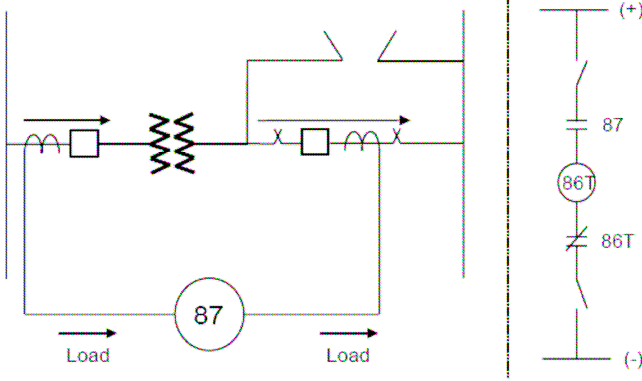
Fig. 6 Bus main breaker with breaker bypass switch

Operating conditions that bypass CTs are a common threat to differential relay security. Consider the one line diagram in Fig. 6. If the bus main breaker is in need of maintenance, it is possible to bypass the breaker by closing the parallel switch. However, possibly as soon as current switches from the bus main breaker, and definitely when the bus main breaker opens, the transformer differential relay will trip. Before and during this maintenance, therefore, one must isolate the differential relay from the lockout relay it operates.

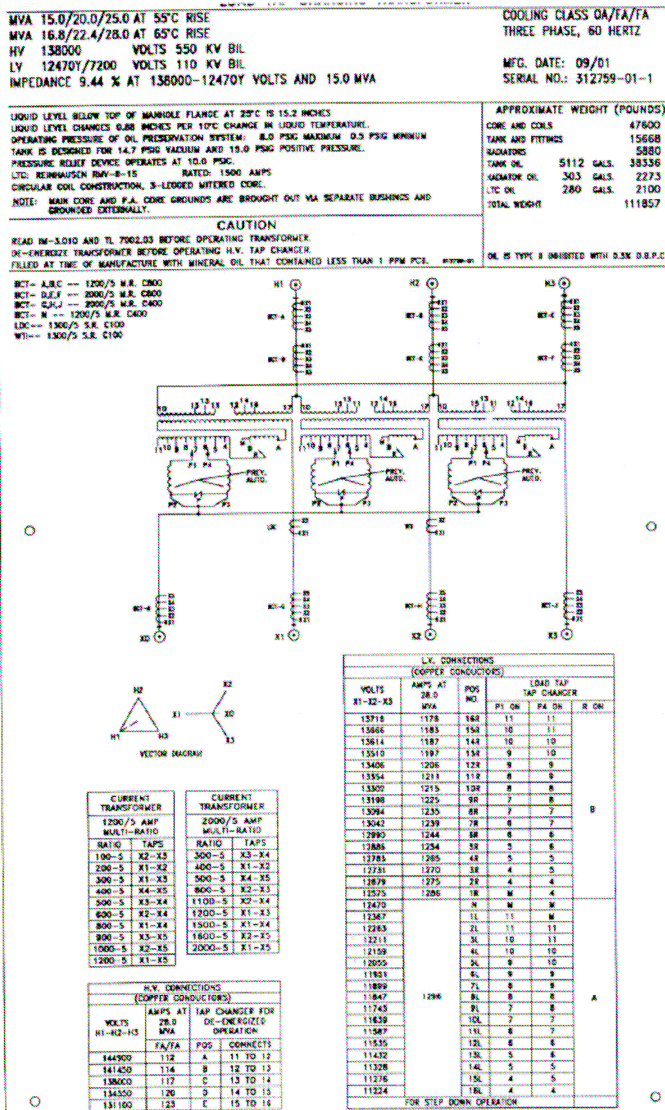
Fig. 7 Example transformer nameplate

Assume that we are developing settings for the transformer shown in Fig. 7. In this first example, our system phase rotation is ABC. The system phase-to-bushing connections are B-to-H1, C-to-H2, and A-to-H3. Recognize that BCA phase-to-bushing connections are the same as a positive or ABC connection sequence. Combination of the nameplate and the phase-to-bushing information produces the simplified three-line diagram in Fig. 8.

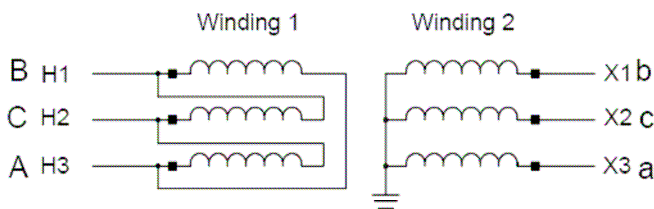
Fig. 8 Simplified three-line diagram

one can determine the phase angles of the currents inside the delta windings on the high side. The current passing through the winding at the top left in Fig. 8 is a delta current, or the difference between the system B-phase and the system A-phase (1.73 p.u. @ -150 degrees). This winding corresponds to the low-side winding shown at the top right in Fig. 8, so you can transpose this phasor (1.73 p.u. @ -150 degrees) to the low-side X1 bushing of the transformer.

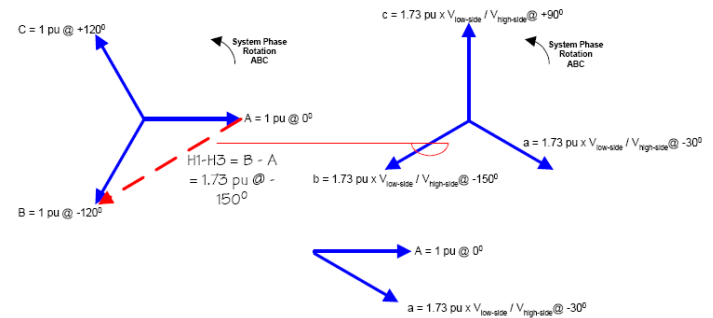
Fig. 9 Derivation of phase-angle relationship (1)

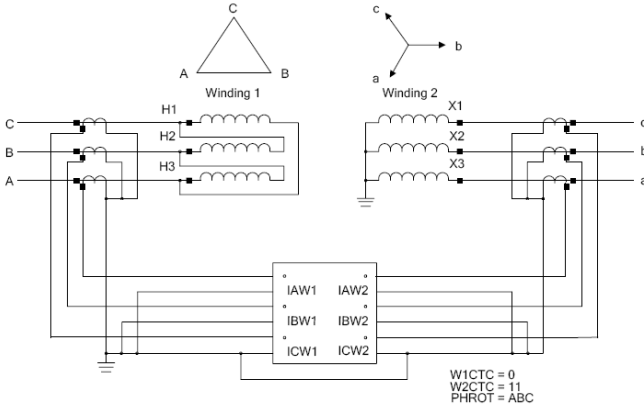
Fig. 10 Complete connection example

Now that we have all the appropriate information (system phase rotation, phase-to-bushing connections, transformer nameplate, and CT secondary wiring), we can set phase-angle compensation settings for the relay. Most microprocessor-based relays apply some form of matrix mathematics to the measured phase currents to correct for transformer and CT phase-angle shifts and zero-sequence sources. A complete example will be helpful to demonstrate how this works.

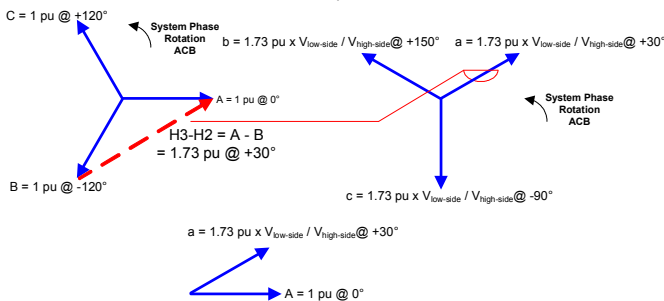
Fig. 11 Development of phase-angle relationship (2)

Assume that a power system with system phase rotation ABC incorporates the transformer with the nameplate shown in Fig. 7. The phase-to-bushing connections are C-to-H1, B-to-H2, and A-to-H3. The CT secondaries are wired such that the system phases connect to the corresponding relay inputs: A-phase on the system to A-phase on the relay, B to B, C to C. Fig. 10 shows the complete three-line diagram. Follow the process we discussed previously for developing the phase-angle relationship across the transformer, as shown in Fig. 11.

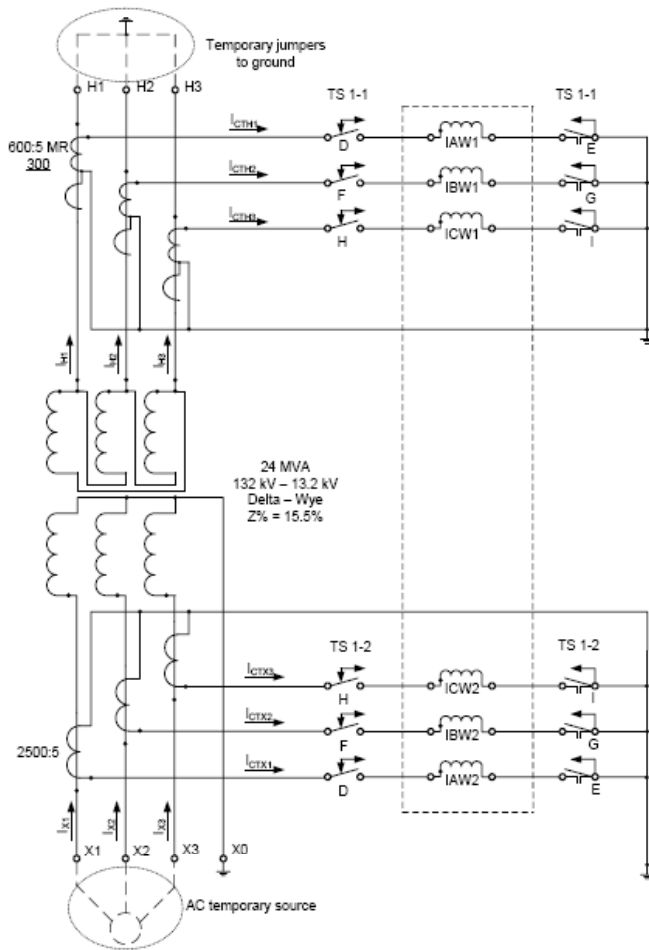
Fig. 14 Three-line diagram

To illustrate the procedure, we calculate a test plan for the transformer application shown in Fig. 14.

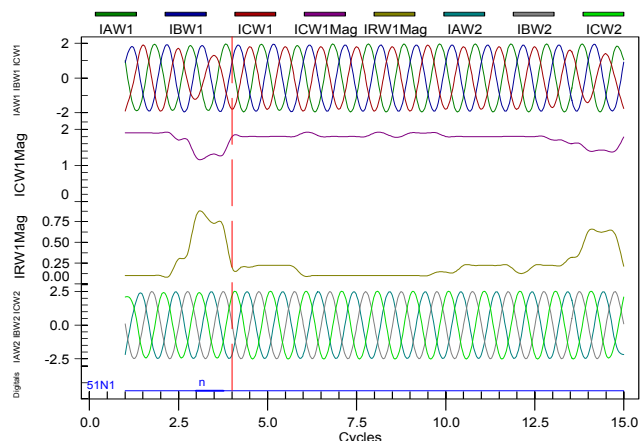
Fig. 15 Residual ground element asserting briefly

A 69 kV delta high-side, 12.47 kV grounded wye low-side power transformer was installed and operating correctly for some time. Then, the residual ground time-overcurrent element (51N1) on the delta high-side winding began triggering a number of event reports. See Fig. 15. There was no corresponding change in low-side currents during each of these events, only balanced three-phase load flow. Therefore, we could rule out a power system fault. We would not expect to see any zero-sequence current on the high-side delta of the transformer, except for a fault between the Winding 1 CTs and the transformer bushings, or possibly as a result of CT saturation during a fault.

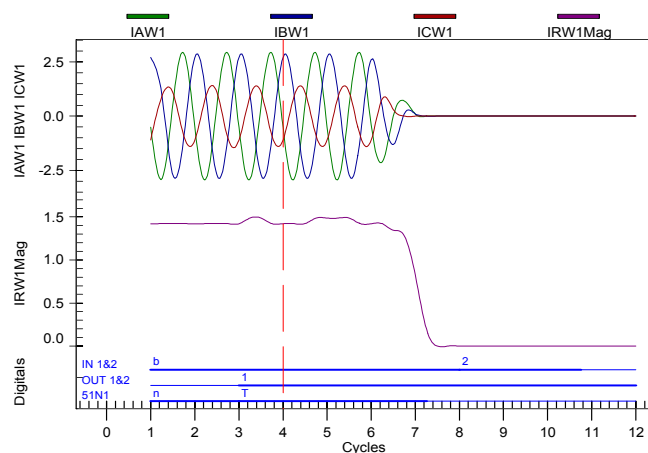
Fig. 16 Residual ground element times out and trips

What field condition could cause a decrease of one phase current? A short circuit, either in the CT secondary wiring or internal to the relay, could cause this decrease. By checking the relay status, and testing the relay analog input metering, we could rule out the relay as the root cause. Suspecting the CT wiring, we inspected the C-phase Winding 1 circuit and found a short circuit-to-ground. There was a loose terminal connection in the junction box on the top of the transformer, with evidence of considerable arcing. Every time the loose connection arced, C-phase current from the CT shunted away from the relay to ground. This caused the residual 3I0 ground current we measured at the relay.

Lesson Learned – A pattern of momentary loss or decrease in current at the relay location can indicate an upstream short-circuit or arcing condition in the CT secondary wiring. Despite our best efforts during commissioning, wiring problems can develop over time and can best be identified with event report analysis.

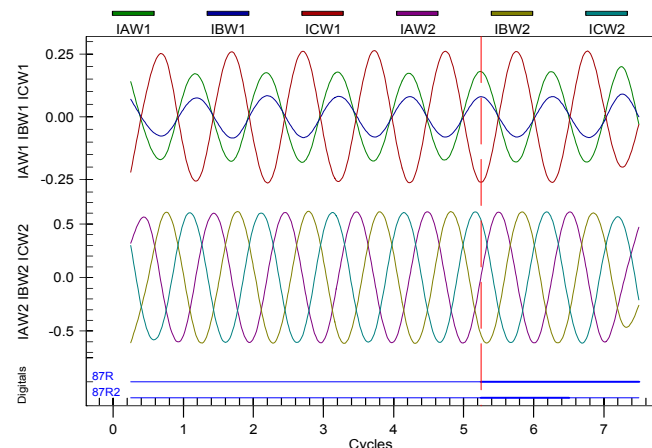
Fig. 17 Differential element trips with balanced load

Fig. 17 shows the trip during balanced load. The restrained differential element 87R2 caused the trip. The high-side currents look strange, while the low-side or generator-side currents look normal and balanced. Because we have verified proper commissioning, and the relay status is OK, we again suspect a wiring failure.

Consider the Winding 1 currents in Fig. 17. IAW1 and IBW1 are in phase, but have different magnitudes, while ICW1 is 180 degrees out of phase. A closer inspection of the magnitudes and angles indicates that $IAW1 + IBW1 = -ICW1$.

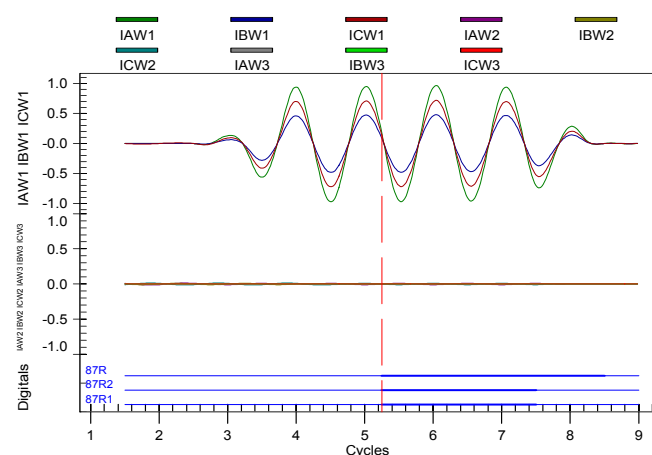
Fig. 18 High-side line-to-ground fault with no generation online

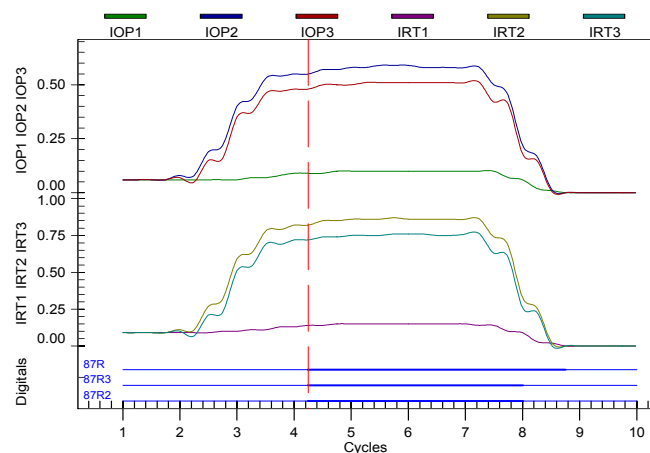
Fig. 20 Operate current increases for external fault

We would expect the restraint current to increase significantly during the fault, but we would expect the operate current to not increase or to increase only slightly. Instead, in Fig. 20, we note that the operate current in two differential elements increased substantially. Before the fault, however, we also notice that significant operate current exists in all three differential elements (the ratio of operate to restraint in each element exceeds 66 percent).

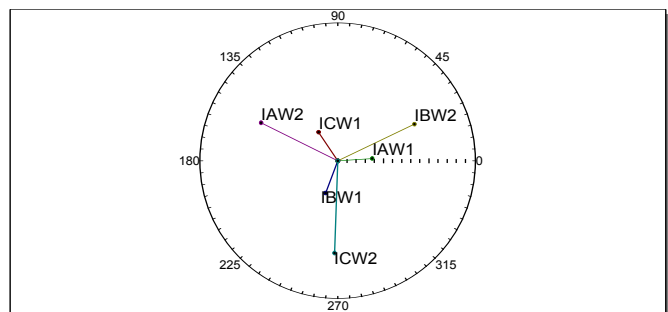
Fig. 21 Prefault phasors show expected angles

When a relay captures event data, it stores several cycles of prefault information. One can use the prefault data to perform an “offline” commissioning test. We can see prefault phasors in Fig. 21.

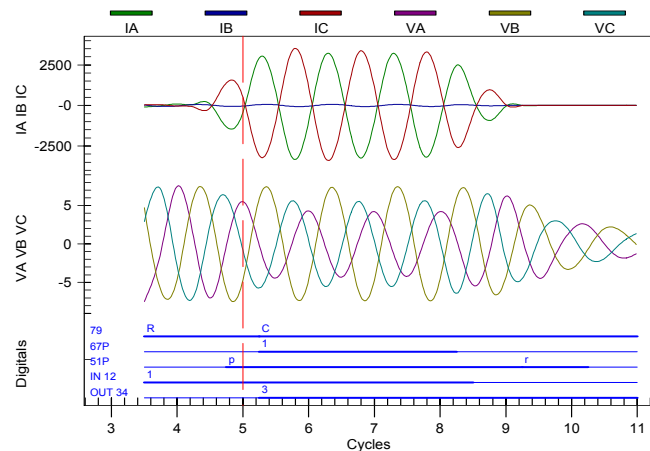
Fig. 22 Downstream feeder relay confirms fault out-of-section to the Transformer differential

An 87R element causes a delta-wye power transformer differential relay to trip for a low-side feeder fault. We confirm the location of the fault by looking at the feeder relay-generated event data, shown in Fig. 22. According to data time stamps, both the feeder relay and the transformer differential relay operated at the same time.

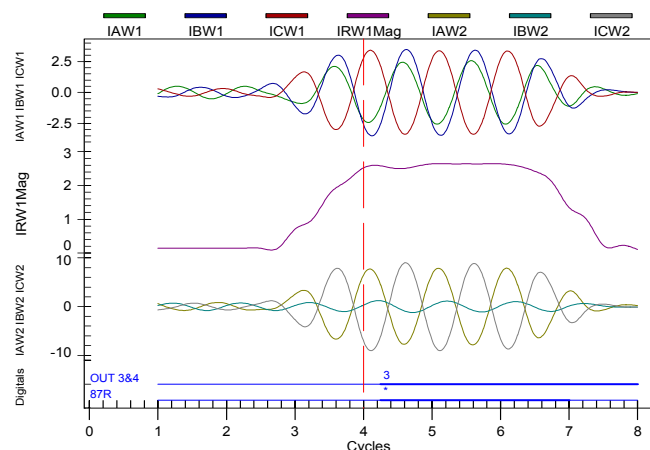
Fig. 23 Transformer differential trip for out-of-section feeder fault

We suspect that the feeder relay operated correctly, but that the transformer differential relay should not have tripped. In Fig. 23, the transformer low-side Winding 2 currents agree with the feeder relay in indicating that the fault was an A-phase-to-C-phase fault. The high-side delta winding currents, however, produce unexpected results. There is residual ground current present on the delta side of the transformer for a low-side fault. The presence of this current implies a CT wiring problem.

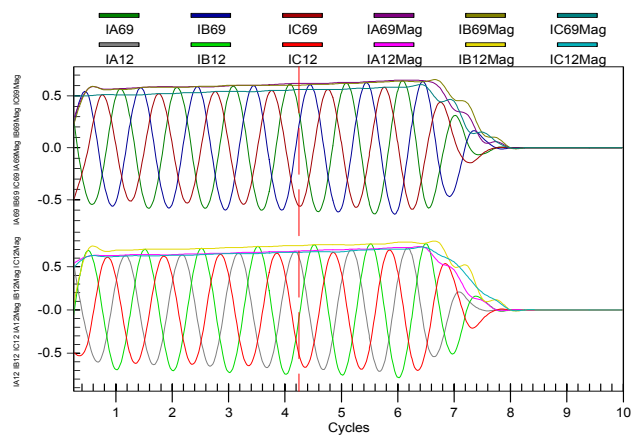
Fig. 25 Differential relay trips while balanced load is steadily increased

As load increases during first-time energization of a new transformer, the transformer differential relay trips. The low current magnitudes and balanced conditions, shown in Fig. 25, confirm that there was no system fault. The power transformer is 69 kV delta to 12 kV grounded-wye, with ABC system phase rotation and ABC phase-to-bushing connections. We would expect the high side to lead the low side by 30 degrees for this transformer, and the phase-angle compensation to be $W1CTC = 0$ or 12 and $W2CTC = 1$.

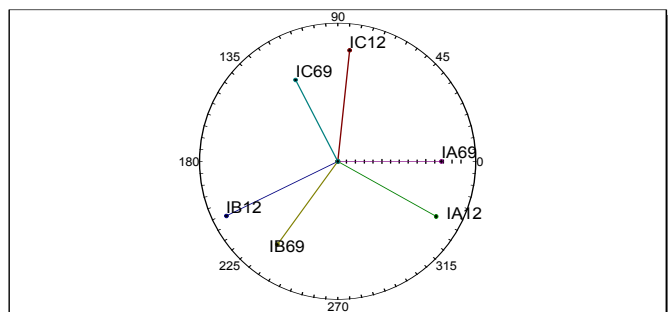
Fig. 26 Differential relay trips while balanced load is steadily increased

Fig. 26 shows the current phase angles at cycle two of the event data. The high side does indeed lead the low side by 30 degrees, but we expect this only on the primary of the CTs. Remember, as Fig. 3 demonstrated, that we would expect the secondary current from the low-side CT to be 180 degrees out of phase for a through-load condition. Therefore, the relay should observe low-side currents leading high-side currents by 150 degrees. We can use the operate currents from differential event reports to confirm that this is a problem involving all three phases. Upon inspection of the low-side CTs, we found that these CTs had been connected with reverse polarity.

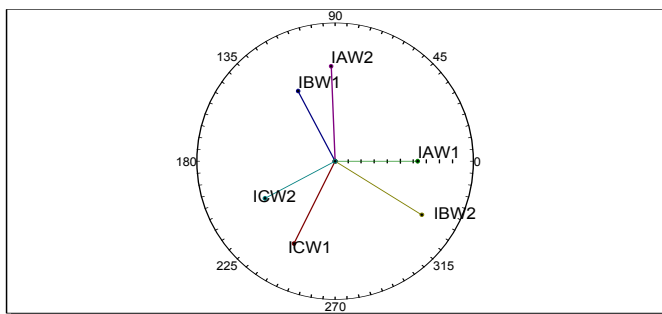
Fig. 28 Phase angles show different phase rotation

Fig. 28 shows the prefault current phasors. We immediately notice one problem. The Winding 1 phase rotation is ACB, while the Winding 2 phase rotation is ABC. The relay settings indicate that we should expect an ABC system phase rotation, so we suspect a wiring problem somewhere in the Winding 1 CT circuit.

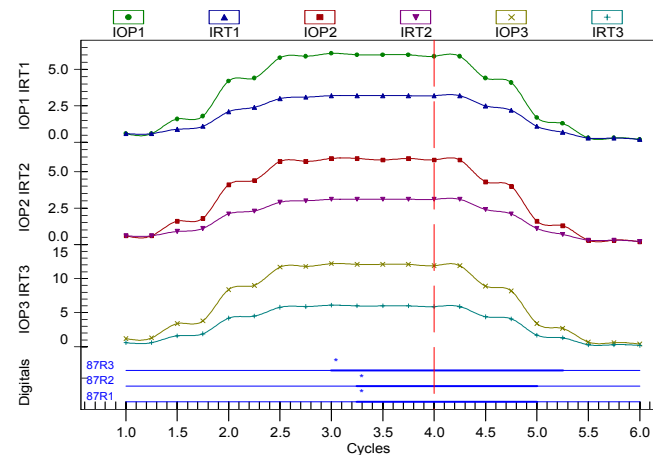
Fig. 29 All three differential elements see operate current

The differential element information shown in Fig. 29 confirms that all three differential elements are affected and that all three elements operated.

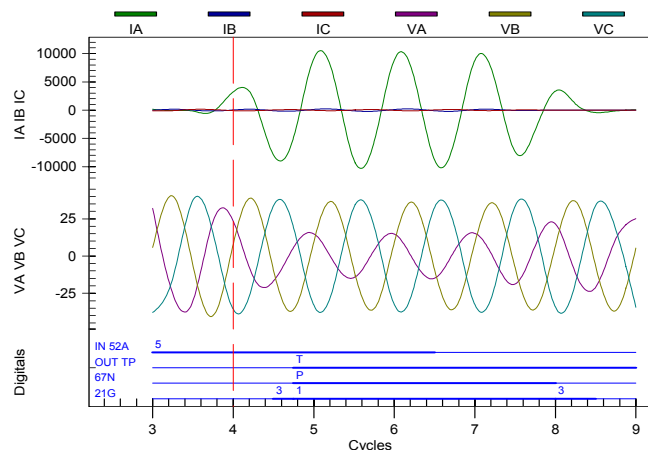
Fig. 31 AG fault on 69 kV transmission line

A single line-to-ground fault occurred on a 69 kV transmission line. Fig. 31 shows the event report the relay captured on that line. At the same time the fault occurred, a transformer differential relay misoperated. The differential relay protects a generator step-up transformer located behind or on the source side of the transmission relay. The step-up transformer is delta-connected on the generator low side, and those CT inputs are wye-connected to Winding 2 of the relay. The step-up transformer is grounded-wye connected on the high side, and those CT inputs are wye-connected to Winding 1 of the relay. The generator was online during the fault.

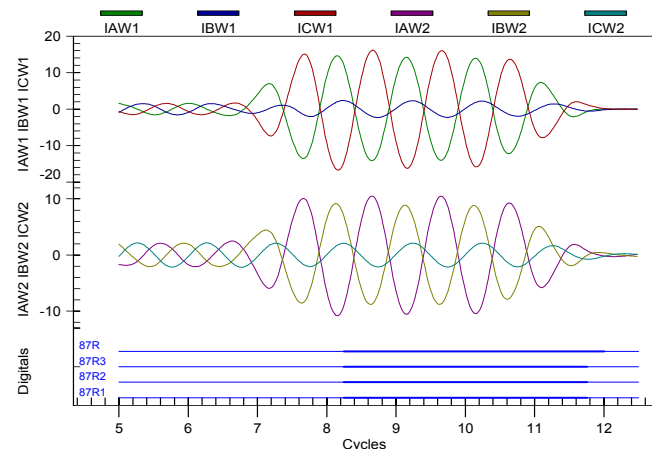
Fig. 32 Misoperation of generator step-up transformer differential relay

If the differential relay were installed correctly, we would expect it to restrain for this out-of-zone fault. The data from the transmission line terminal confirm that the fault was an out-of-zone fault for the differential relay. Fig. 32 shows the unexpected operation of the differential relay.

For a high-side line-to-ground fault on a grounded-wye transformer winding with the generator online, we would expect to see the faulted phase current magnitude increase dramatically relative to the other phase currents on Winding 1. We see, instead, an increase in magnitude for two currents on Winding 1. The fault should appear as a phase-to-phase fault on the low side, and it does. As we see in Fig. 32, however, the Winding 1 currents appear also as a phase-to-phase fault. The root-cause investigation found that the neutral wire was open-circuited, isolating the neutral of the wye-connected CT from the grounded neutral point at the relay. The CT had been changed from a delta to wye connection, but the addition of the neutral wire run back to the relay had been overlooked during commissioning tests.

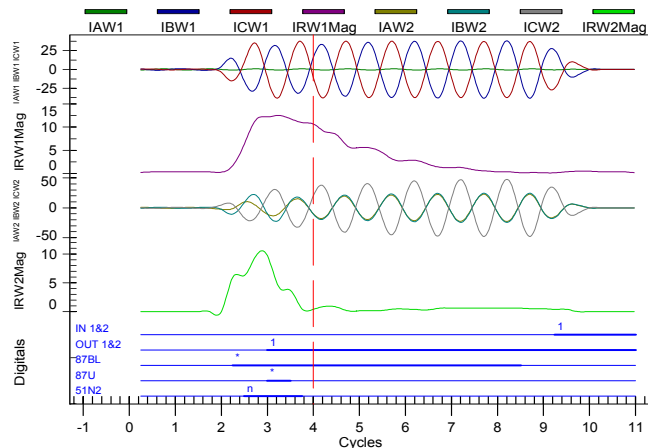
Fig. 33 Winding one (low-side) and winding two (high-side) currents for feeder fault

tection. The low-side fault was B-to-C phase. We would therefore expect IAW2 and IBW2 to be about equal on the high side (Winding 2) and in phase with ICW1 on the low side. The magnitude of ICW2 on the high side should equal the sum of IAW2 and IBW2, and the ICW2 phase angle should be opposite those two currents and in phase with IBW1 on the low side. In Fig. 33, these observed relationships match expectations.

Fig. 33 shows four unexpected items. First, the unrestrained 87U element operated for an external fault. Second, second-harmonic blocking is asserted throughout the fault. Third, there is significant residual 3I0 ground current present on the low side (during a phase-to-phase fault) and on the high side (a delta-connected winding). Fourth, the residual current magnitude decreases over time, even while the fault persists. Similarly, in Fig. 34, there is significant operate current in all differential elements, but this operate current decreases over time even while the phase fault current persists.

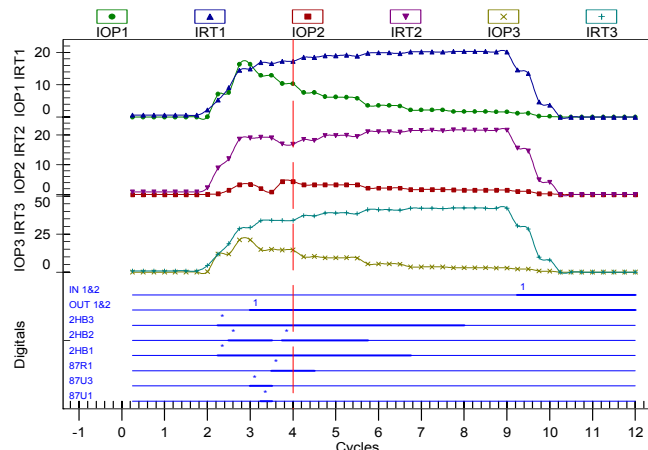
Fig. 34 Significant operate current exists for an external fault, but decays over time

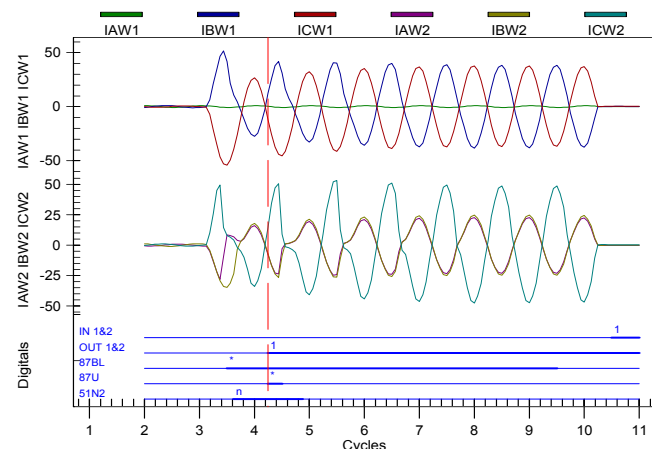
Fig. 35 CT saturation visible on both windings

We suspect that saturating CTs are the root cause of the unexpected and diminishing zero-sequence and operating current. The only way to prove this theory, however, is to view the raw or unfiltered event data.

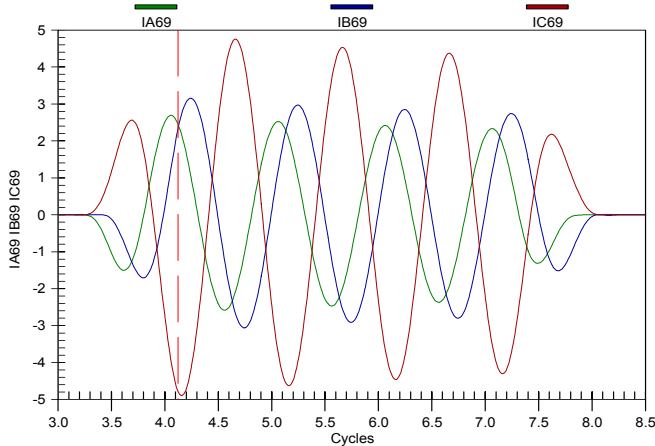
Fig. 36 Filtered 60 Hz high-side currents during energization

An ANSI standard 50 MVA power transformer is connected 69 kV delta to 12 kV grounded-wye. Upon first energization of the transformer, with the low side open, the differential relay tripped. Fig. 36 shows the digitally filtered 60 Hz phase currents on the high side during energization. The current magnitudes are low. We suspect a problem with inrush restraint settings.

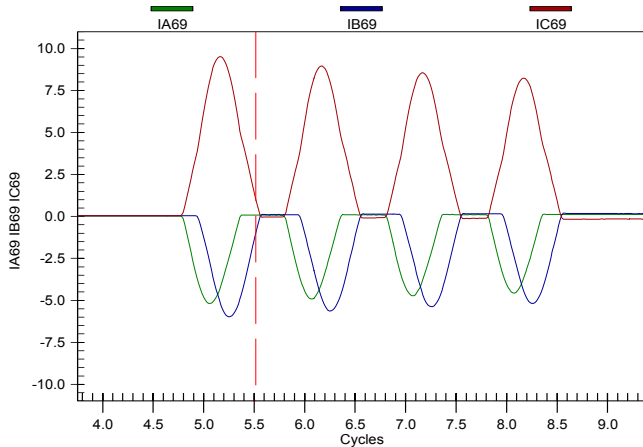
Fig. 37 Raw or unfiltered high-side currents during inrush

To verify our suspicion, we must analyze the raw data. The raw or unfiltered waveforms in Fig. 37 are textbook-perfect examples of magnetizing inrush current. Investigation of the installed settings finds that independent second-harmonic blocking was enabled as the inrush restraint. The second-harmonic threshold was set to 15 percent, a common value. Independent blocking means that second-harmonic content in excess of 15 percent of the fundamental frequency on A-phase will only block the 87R1 differential element. Likewise, B-phase second-harmonic content will block 87R2, and C-phase second-harmonic content will block 87R3. This mode emulates a traditional scheme of three discrete, or independent, differential relays.

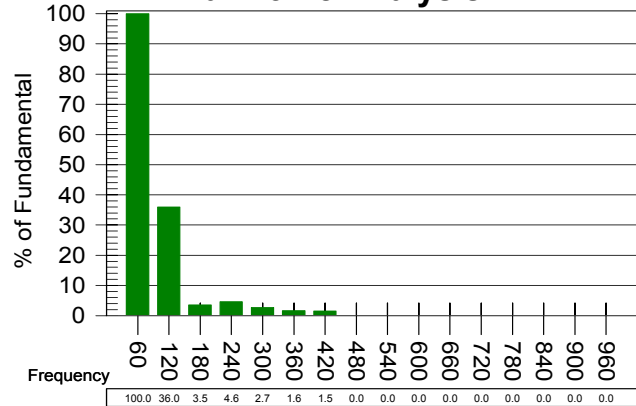
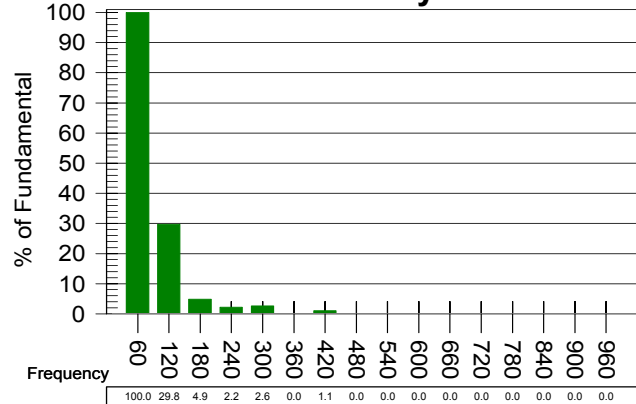
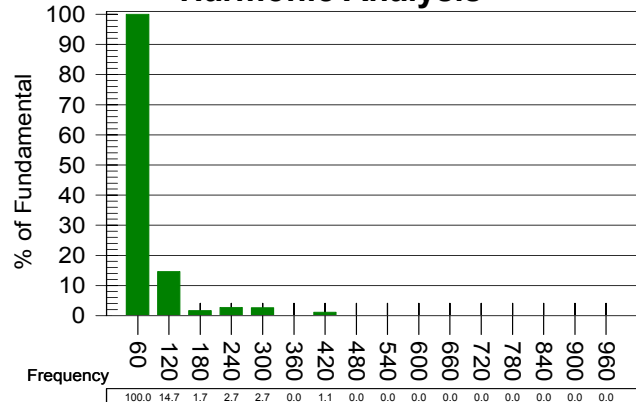
Fig. 38 C phase second-harmonic < 15 percent

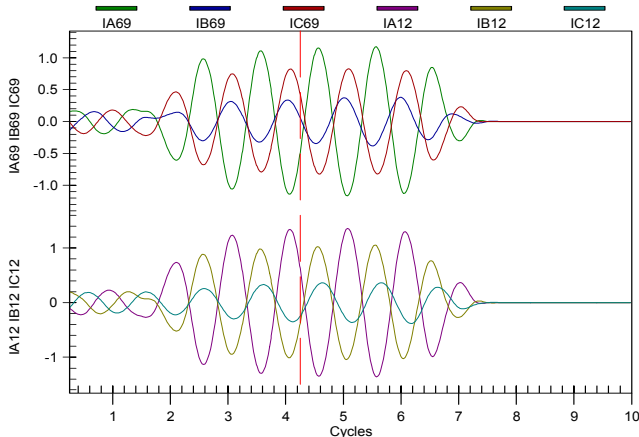
Fig. 39 External fault causes differential trip

After being in service for some time, the differential relay trips during the external phase-to-phase fault shown in Fig. 39.

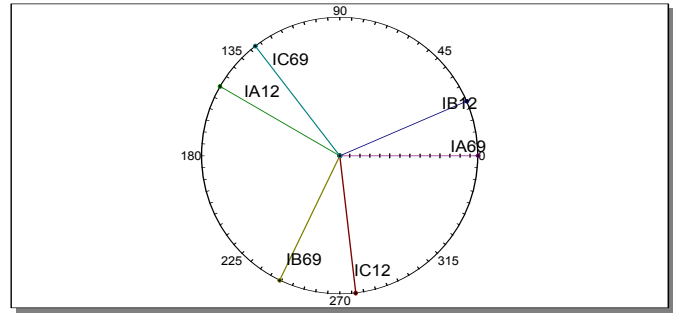
Fig. 40 High leads low side by 30 degrees as expected

Using the prefault data to perform an “offline” commissioning test, we find that phasor magnitudes, angle relationships, and rotation are as expected for through load. See Fig. 40. The 12 kV A-phase current, IA12, leads the 69 kV A-phase current, IA69, at the relay by 150 degrees. This corresponds to the 69 kV primary leading the 12 kV primary currents by 30 degrees.

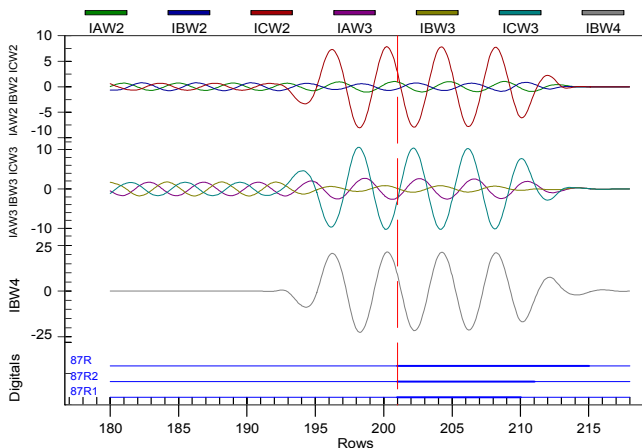
Fig. 42 Autotransformer neutral is a source of 3I0 current

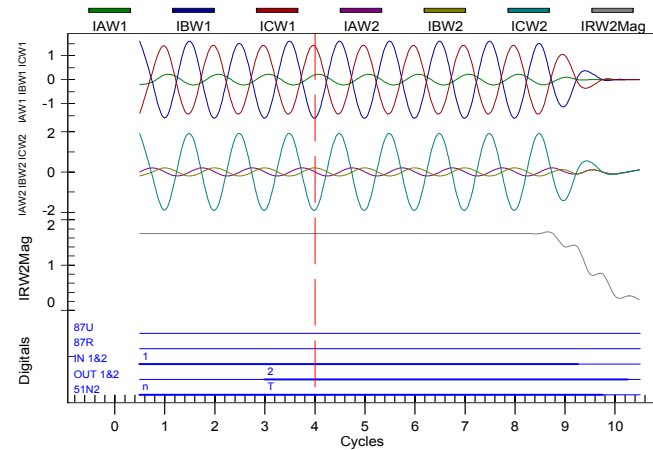
Fig. 47 Downstream C-ground fault confirmed

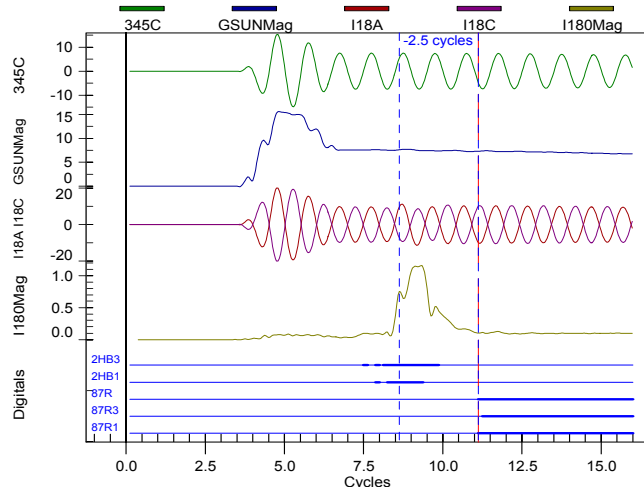
Fig. 49 Flashover on high-side caused differential trip

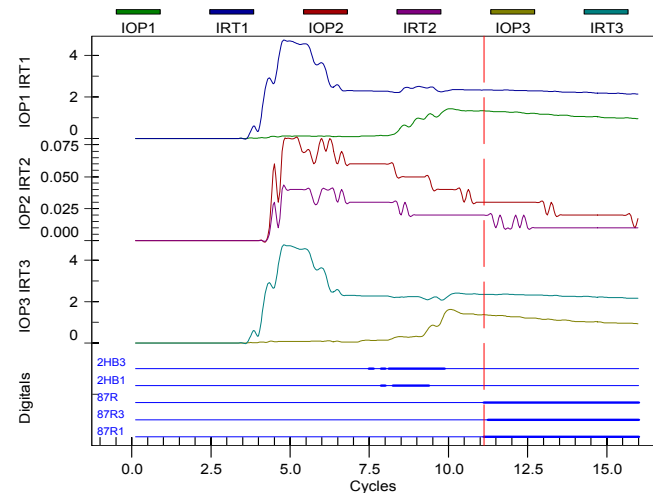
Fig. 51 Ratio of operate to restraint exceeds 50 percent in elements 87R1 and 87R3

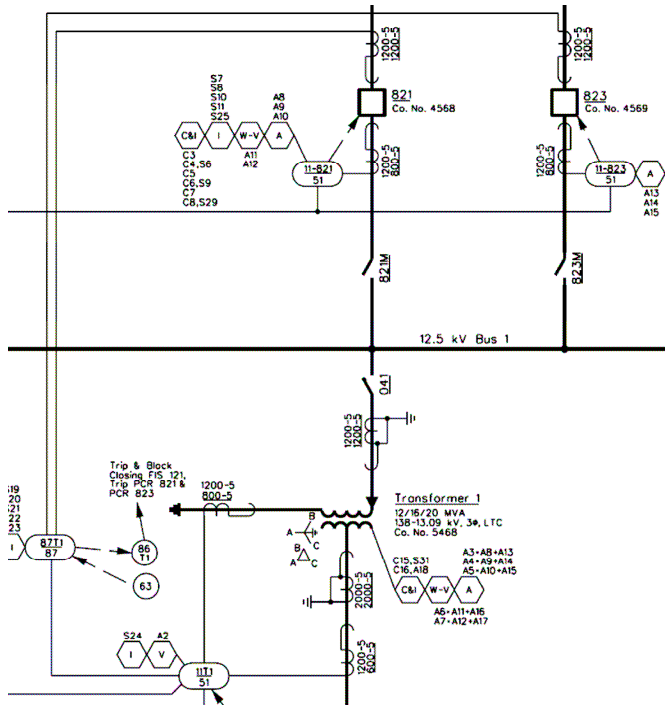
Fig. 52 Differential application online

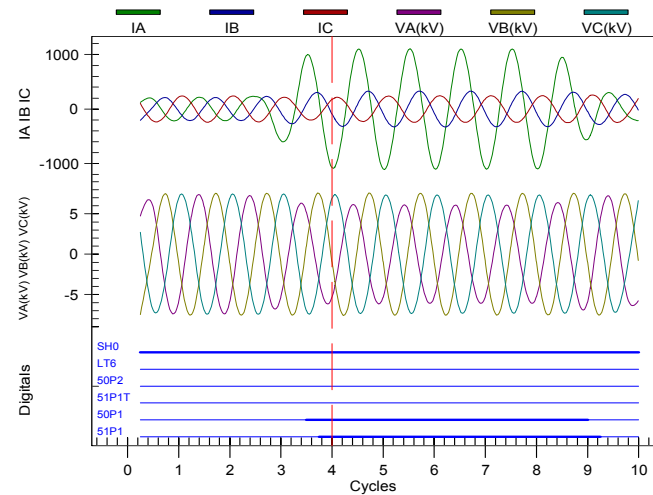
Fig. 53 Faulted feeder relay event data

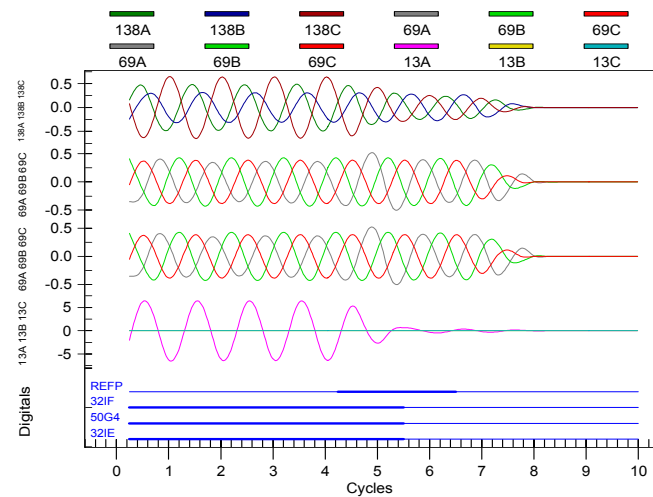
Fig. 54 Differential relay information

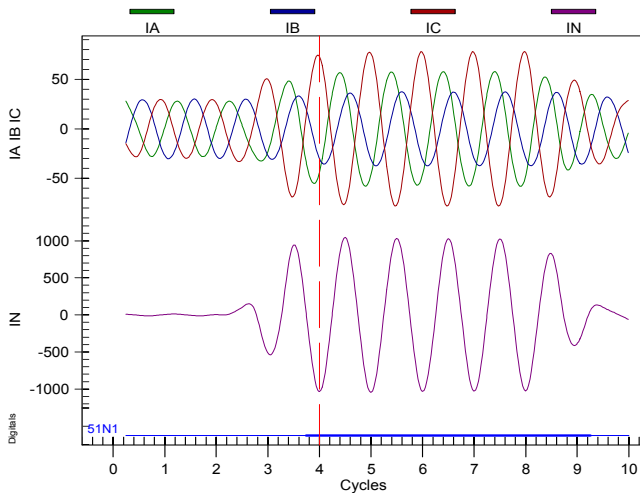
Fig. 55 High-side back-up relay information

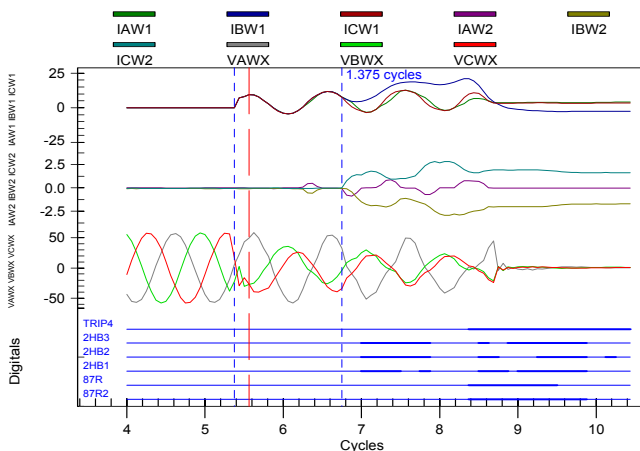
Fig. 56 Raw waveforms from differential relay

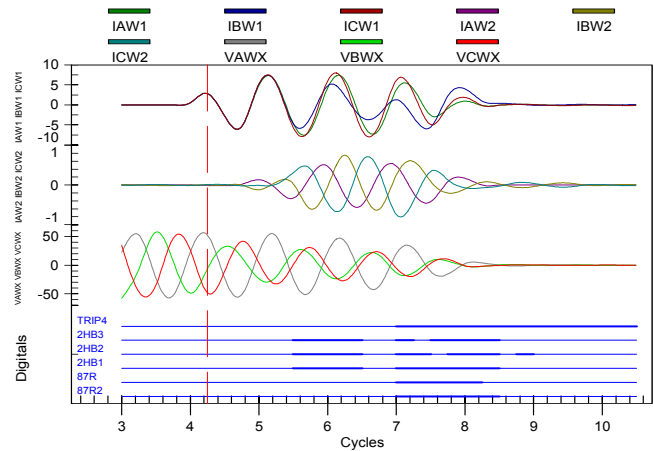
Fig. 57 Filtered waveforms from differential relay

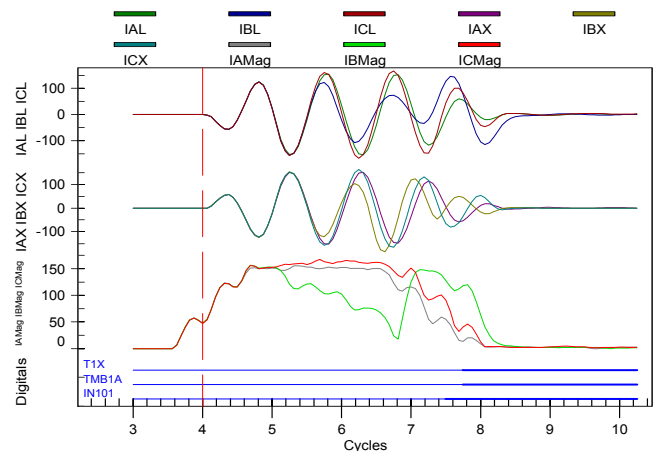
Fig. 58 Line current differential upstream

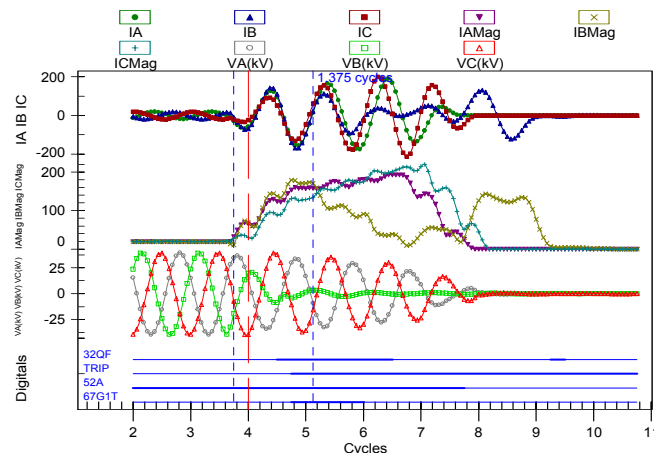
Fig. 59 Distance relay closest to fault

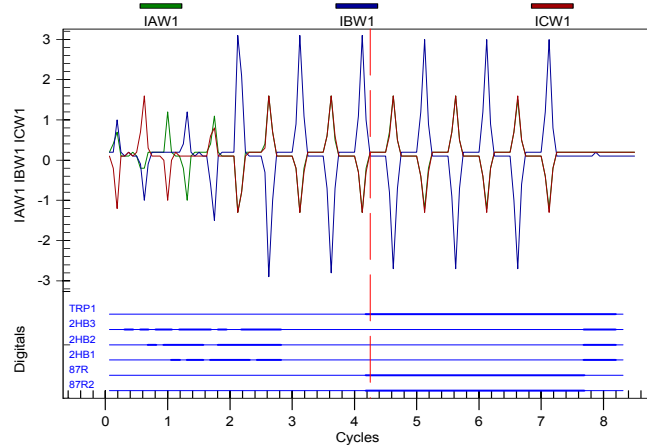
Fig. 60 Overexcitation waveform captured by relay

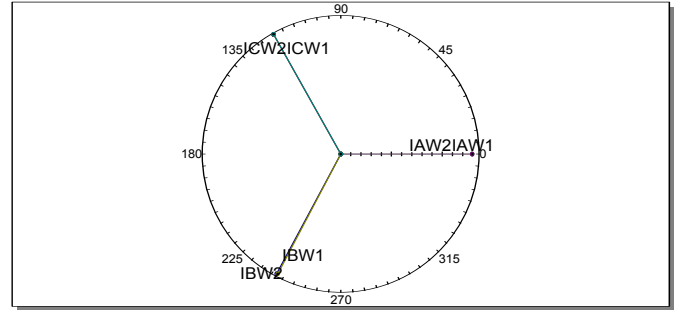
Fig. 61 High-side CT polarities found reversed

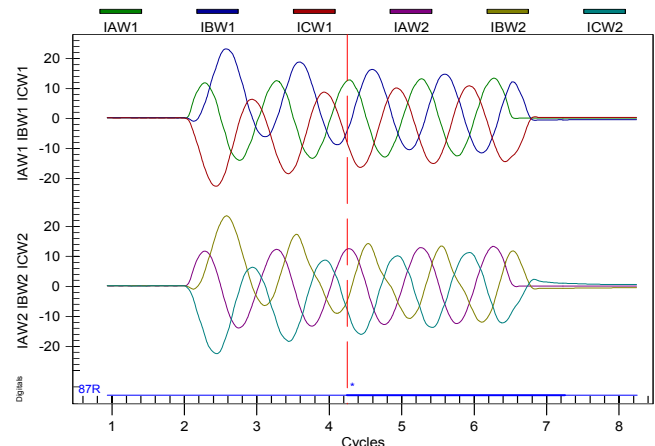
Fig. 62 Second trip shows some CT saturation

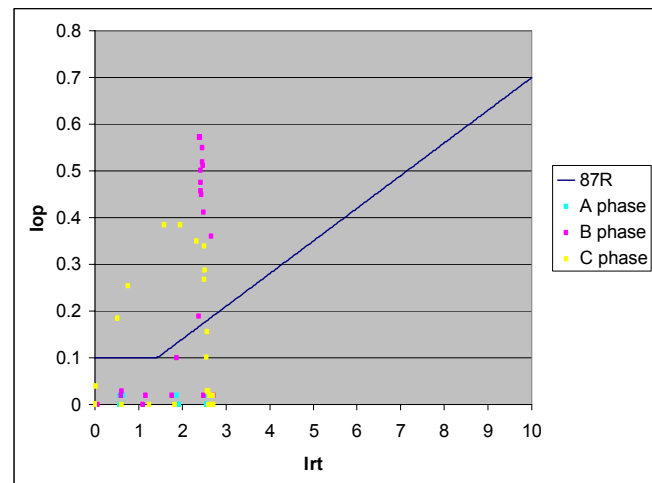
Fig. 63 Operate and restraint at all points in event
