Lessons Learned Through Commissioning and Analyzing Data From Transformer Differential Installations

David Costello, *Schweitzer Engineering Laboratories, Inc.*

Abstract—Ensuring correct setting and installation of a transformer differential relay is critical. A transformer differential relay must detect internal faults, damaging overloads, and through-fault currents while remaining secure against misoperation. The ability to use wye-connected CTs with microprocessor-based relays has simplified installations, and these relays provide better commissioning tools than those available with traditional relays. However, installations and commissioning remain complicated. Installation and settings errors continue to be widespread, implying a need for more rigorous commissioning tests. Even with greater commissioning effort, occasional wiring problems develop over time, and these can best be resolved through analysis of relay event report data. In the interest of reducing transformer differential misoperations, we share in this technical paper practical lessons we have learned through experience with commissioning and relay event report analysis.

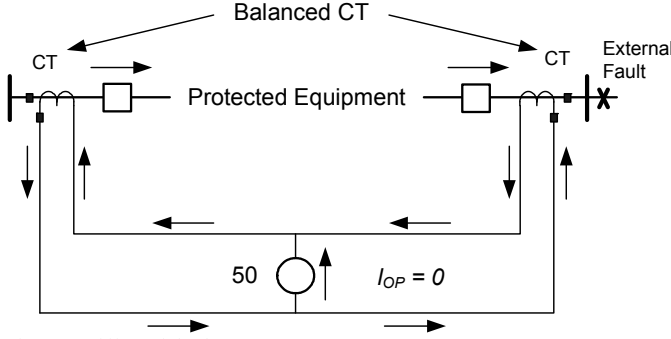
Fig. 1 Differential relay concept

external fault. If, however, the fault is internal to the CTs, the currents have the same phase angle, add together, and pass through the overcurrent relay; i.e., the relay measures difference current for an internal fault.

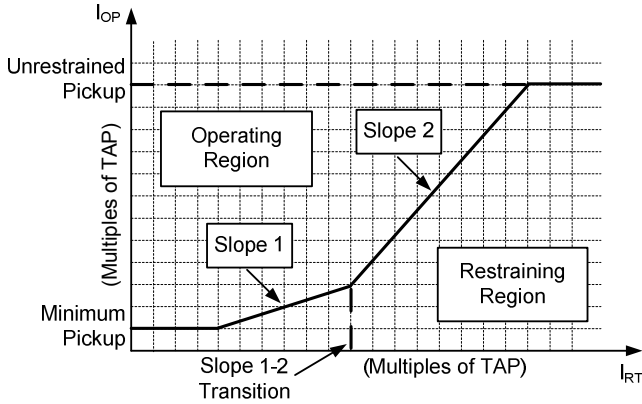
Fig. 2 Percentage-restraint concept

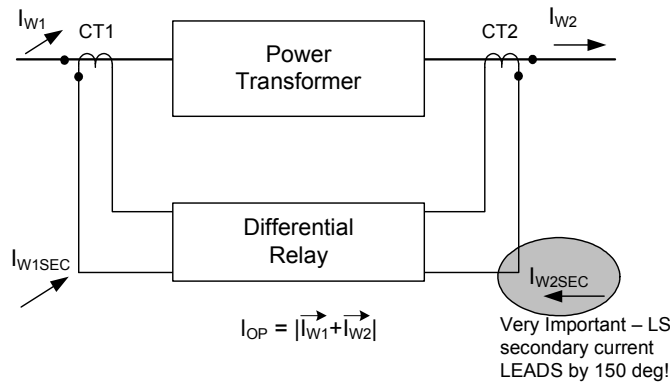
Fig. 3 Phase-angle shift across a transformer

See Fig. 3 for an important but easy-to-overlook observation. The current the relay detects on the secondary of the CT on Winding 2 will be 180 degrees out of phase with the current on the primary of the CT. When one takes phase-angle measurements during commissioning for a through-load condition on the transformer we have been discussing, the relay

secondary terminal block will detect the low-side current *leading* the high-side current by 150 degrees. *This is normal and expected.*

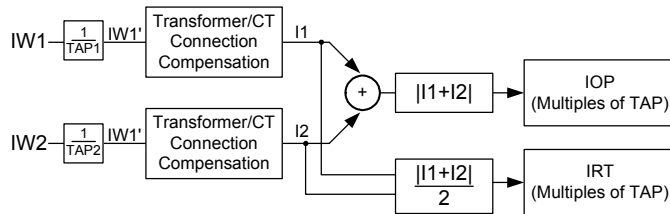
Fig. 4 Development of operate and restraint

Fig. 4 shows the development of operate and restraint quantities after tap and phase-angle compensation.

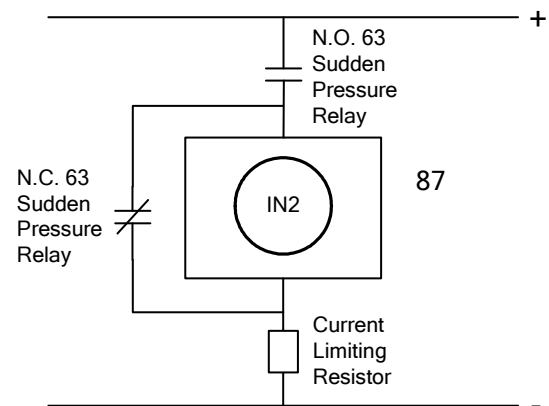
Fig. 5 Interface to sudden pressure relay

It is common to interface indicating contacts from these relays to a microprocessor-based relay for tripping, trip seal-in, event report triggering, and SCADA indication. One must take great care, however, when implementing direct trip applications; sudden pressure relays have a reputation for poor security and lack of dielectric strength. As Fig. 5 illustrates, use both the normally open and normally closed contacts from these devices to indicate a trip. Also use debounce delays on any digital relay inputs monitoring these devices, to provide necessary security.

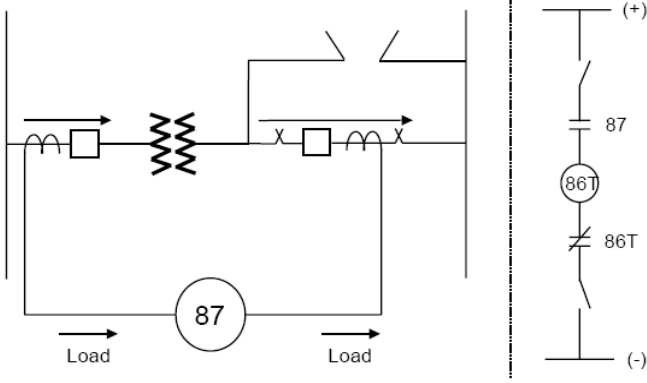
Fig. 6 Bus main breaker with breaker bypass switch

Operating conditions that bypass CTs are a common threat to differential relay security. Consider the one line diagram in Fig. 6. If the bus main breaker is in need of maintenance, it is possible to bypass the breaker by closing the parallel switch. However, possibly as soon as current switches from the bus main breaker, and definitely when the bus main breaker opens, the transformer differential relay will trip. Before and during this maintenance, therefore, one must isolate the differential relay from the lockout relay it operates.

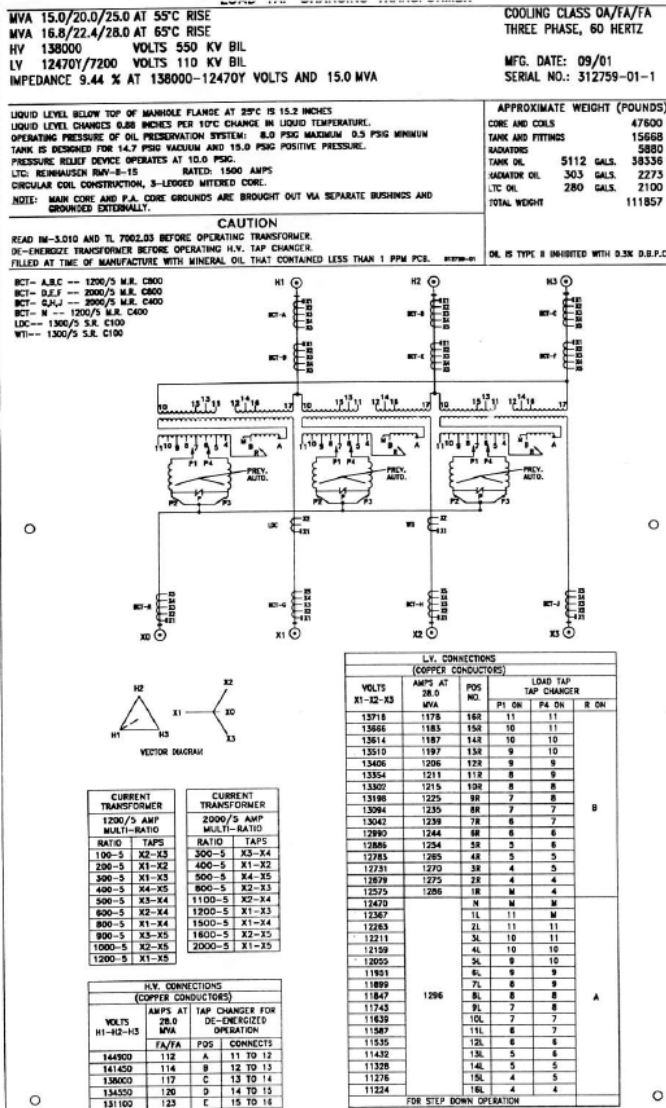
Fig. 7 Example transformer nameplate

It is a requirement that the transformer nameplate show how each winding is connected. Through use of the nameplate, the system phase rotation, and the phase-to-bushing connections, one can quickly sketch the phase-angle relationship one should expect between transformer windings.

Assume that we are developing settings for the transformer shown in Fig. 7. In this first example, our system phase rotation is ABC. The system phase-to-bushing connections are B-to-H1, C-to-H2, and A-to-H3. Recognize that BCA phase-to-bushing connections are the same as a positive or ABC connection sequence. Combination of the nameplate and the phase-to-bushing information produces the simplified three-line diagram in Fig. 8.

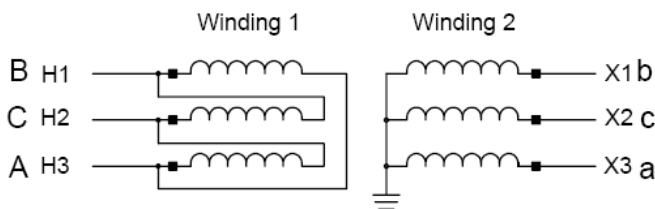
Fig. 8 Simplified three-line diagram

one can determine the phase angles of the currents inside the delta windings on the high side. The current passing through the winding at the top left in Fig. 8 is a delta current, or the difference between the system B-phase and the system A-phase (1.73 p.u. @ -150 degrees). This winding corresponds to the low-side winding shown at the top right in Fig. 8, so you can transpose this phasor (1.73 p.u. @ -150 degrees) to the low-side X1 bushing of the transformer.

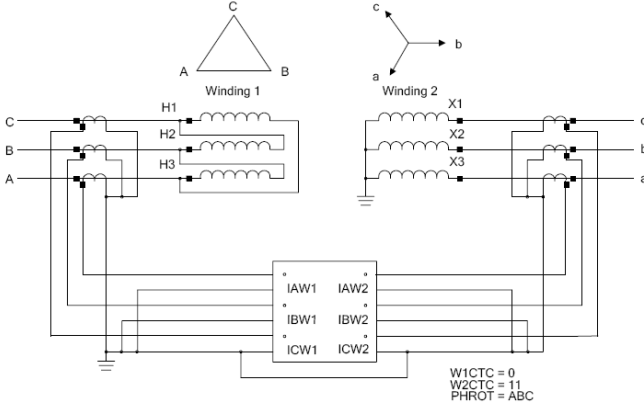
Fig. 10 Complete connection example

Now that we have all the appropriate information (system phase rotation, phase-to-bushing connections, transformer nameplate, and CT secondary wiring), we can set phase-angle compensation settings for the relay. Most microprocessor-based relays apply some form of matrix mathematics to the measured phase currents to correct for transformer and CT phase-angle shifts and zero-sequence sources. A complete example will be helpful to demonstrate how this works.

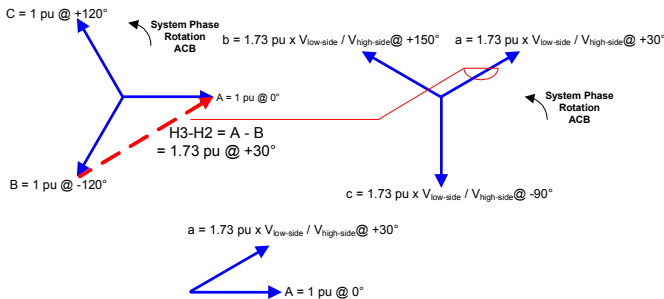
Fig. 11 Development of phase-angle relationship (2)

Assume that a power system with system phase rotation ABC incorporates the transformer with the nameplate shown in Fig. 7. The phase-to-bushing connections are C-to-H1, B-to-H2, and A-to-H3. The CT secondaries are wired such that the system phases connect to the corresponding relay inputs: A-phase on the system to A-phase on the relay, B to B, C to C. Fig. 10 shows the complete three-line diagram. Follow the process we discussed previously for developing the phase-angle relationship across the transformer, as shown in Fig. 11.

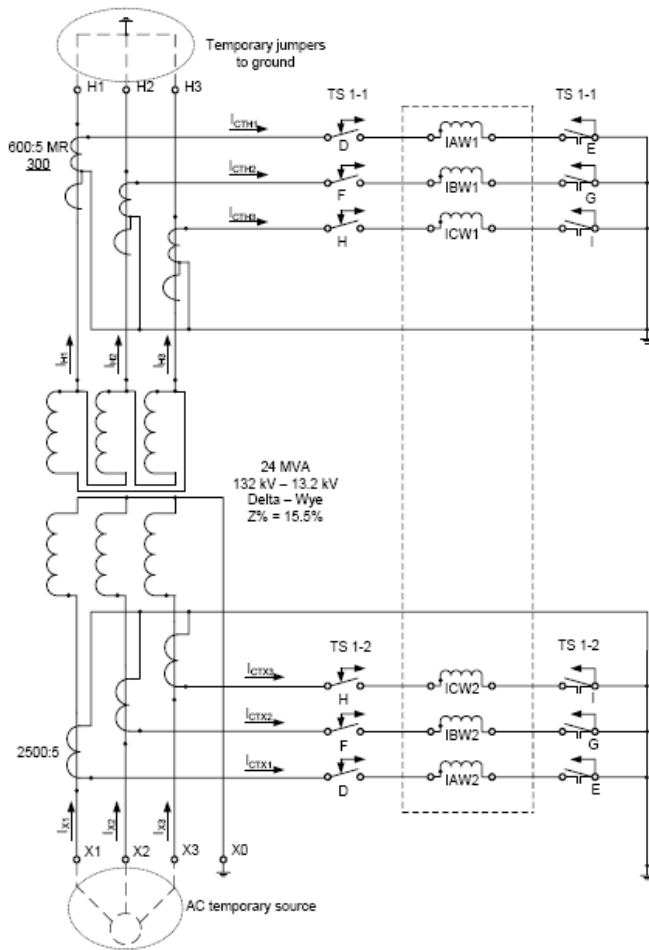
Fig. 14 Three-line diagram

To illustrate the procedure, we calculate a test plan for the transformer application shown in Fig. 14.

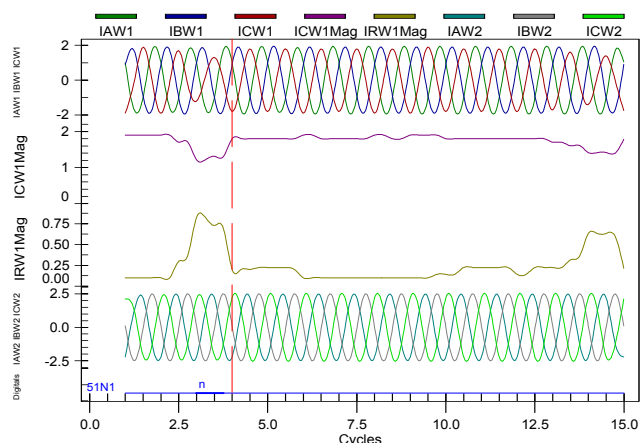
Fig. 15 Residual ground element asserting briefly

A 69 kV delta high-side, 12.47 kV grounded wye low-side power transformer was installed and operating correctly for some time. Then, the residual ground time-overcurrent element (51N1) on the delta high-side winding began triggering a number of event reports. See Fig. 15. There was no corresponding change in low-side currents during each of these events, only balanced three-phase load flow. Therefore, we could rule out a power system fault. We would not expect to see any zero-sequence current on the high-side delta of the transformer, except for a fault between the Winding 1 CTs and the transformer bushings, or possibly as a result of CT saturation during a fault.

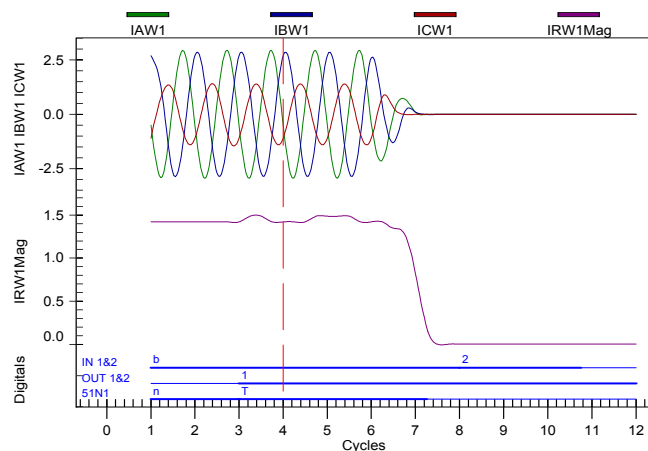
Fig. 16 Residual ground element times out and trips

What field condition could cause a decrease of one phase current? A short circuit, either in the CT secondary wiring or internal to the relay, could cause this decrease. By checking the relay status, and testing the relay analog input metering, we could rule out the relay as the root cause. Suspecting the CT wiring, we inspected the C-phase Winding 1 circuit and found a short circuit-to-ground. There was a loose terminal connection in the junction box on the top of the transformer, with evidence of considerable arcing. Every time the loose connection arced, C-phase current from the CT shunted away from the relay to ground. This caused the residual 3I0 ground current we measured at the relay.

Lesson Learned – A pattern of momentary loss or decrease in current at the relay location can indicate an upstream short-circuit or arcing condition in the CT secondary wiring. Despite our best efforts during commissioning, wiring problems can develop over time and can best be identified with event report analysis.

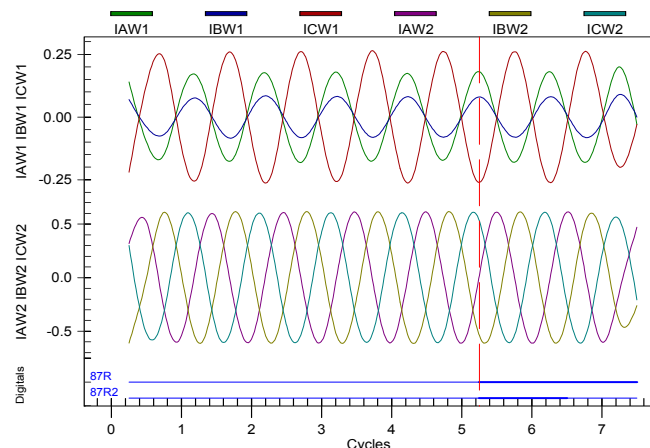
Fig. 17 Differential element trips with balanced load

Fig. 17 shows the trip during balanced load. The restrained differential element 87R2 caused the trip. The high-side currents look strange, while the low-side or generator-side currents look normal and balanced. Because we have verified proper commissioning, and the relay status is OK, we again suspect a wiring failure.

Consider the Winding 1 currents in Fig. 17. IAW1 and IBW1 are in phase, but have different magnitudes, while ICW1 is 180 degrees out of phase. A closer inspection of the magnitudes and angles indicates that $IAW1 + IBW1 = -ICW1$.

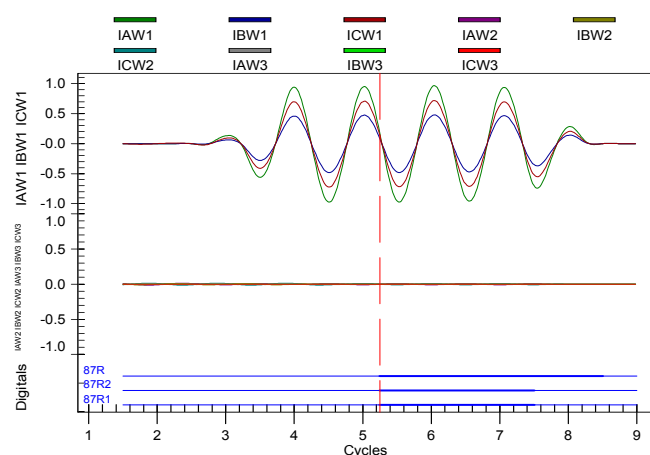
Fig. 18 High-side line-to-ground fault with no generation online

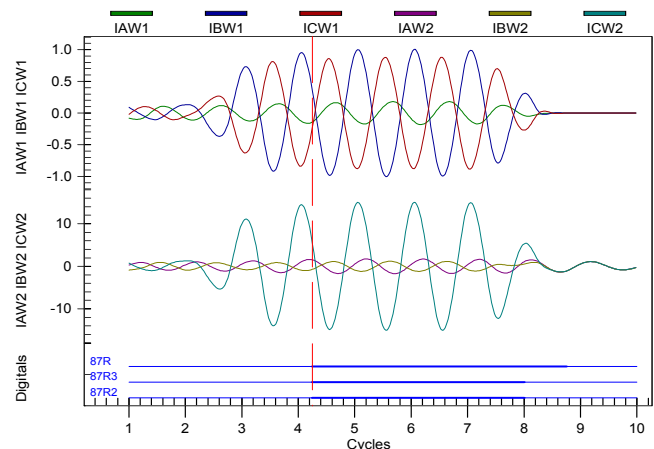
Fig. 19 C-Gnd fault on wye side of delta-wye bank

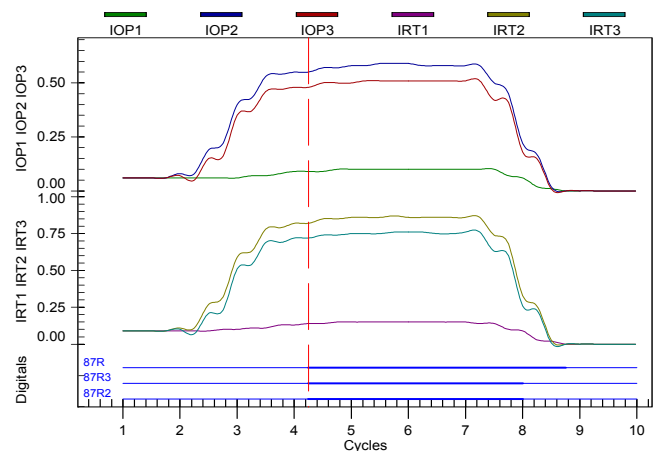
Fig. 20 Operate current increases for external fault

We would expect the restraint current to increase significantly during the fault, but we would expect the operate current to not increase or to increase only slightly. Instead, in Fig. 20, we note that the operate current in two differential elements increased substantially. Before the fault, however, we also notice that significant operate current exists in all three differential elements (the ratio of operate to restraint in each element exceeds 66 percent).

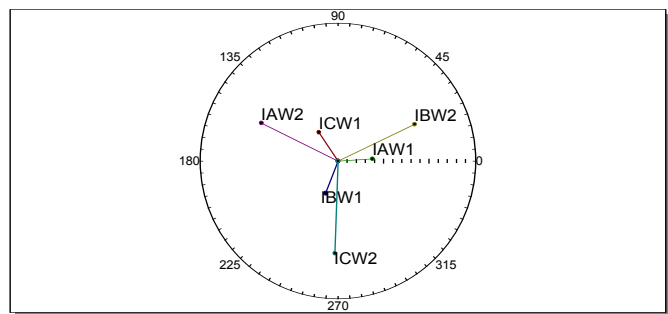
Fig. 21 Prefault phasors show expected angles

When a relay captures event data, it stores several cycles of prefault information. One can use the prefault data to perform an “offline” commissioning test. We can see prefault phasors in Fig. 21.

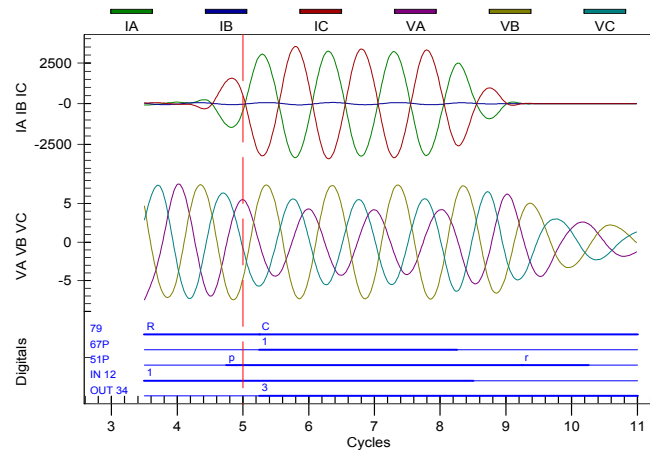
Fig. 22 Downstream feeder relay confirms fault out-of-section to the Transformer differential

An 87R element causes a delta-wye power transformer differential relay to trip for a low-side feeder fault. We confirm the location of the fault by looking at the feeder relay-generated event data, shown in Fig. 22. According to data time stamps, both the feeder relay and the transformer differential relay operated at the same time.

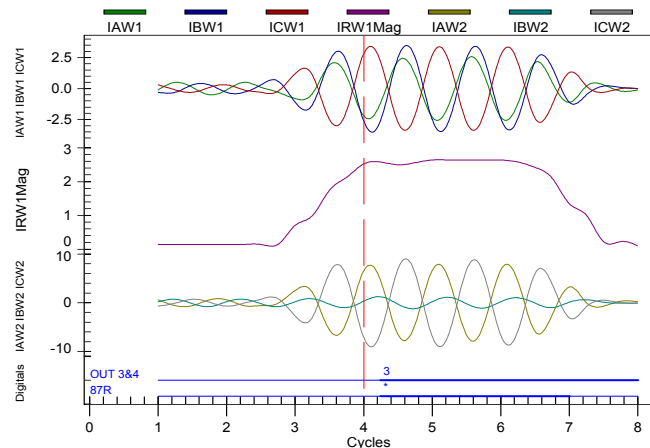
Fig. 23 Transformer differential trip for out-of-section feeder fault

We suspect that the feeder relay operated correctly, but that the transformer differential relay should not have tripped. In Fig. 23, the transformer low-side Winding 2 currents agree with the feeder relay in indicating that the fault was an A-phase-to-C-phase fault. The high-side delta winding currents, however, produce unexpected results. There is residual ground current present on the delta side of the transformer for a low-side fault. The presence of this current implies a CT wiring problem.

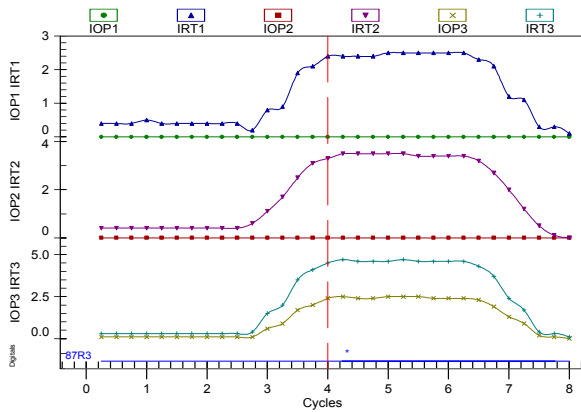
Fig. 24 Only 87R3 sees operate current during fault

An A-phase-to-C phase fault on the low side of a delta-wye transformer should produce a high-side C-phase current equal to the sum of, and 180 degrees out of phase with, the A-phase and B-phase currents. In other words, $IAW1 + IBW1 = -ICW1$. In Fig. 23, notice that the C-phase current angle appears to be correct, but the C-phase magnitude is less than we would expect.

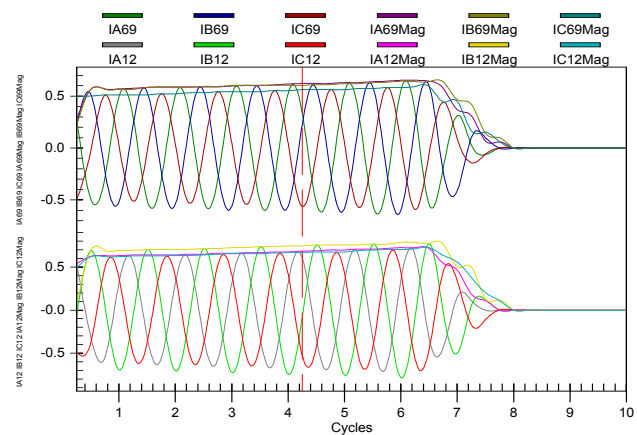
Fig. 25 Differential relay trips while balanced load is steadily increased

As load increases during first-time energization of a new transformer, the transformer differential relay trips. The low current magnitudes and balanced conditions, shown in Fig. 25, confirm that there was no system fault. The power transformer is 69 kV delta to 12 kV grounded-wye, with ABC system phase rotation and ABC phase-to-bushing connections. We would expect the high side to lead the low side by 30 degrees for this transformer, and the phase-angle compensation to be $W1CTC = 0$ or 12 and $W2CTC = 1$.

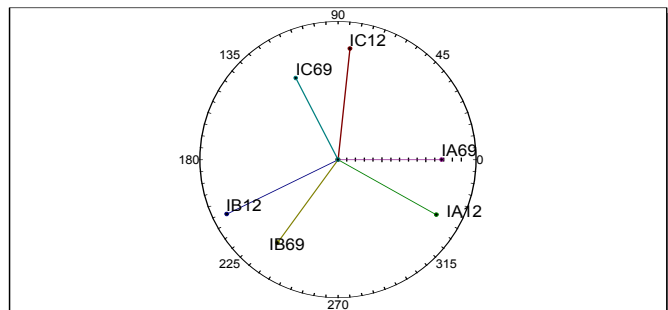
Fig. 26 Differential relay trips while balanced load is steadily increased

Fig. 26 shows the current phase angles at cycle two of the event data. The high side does indeed lead the low side by 30 degrees, but we expect this only on the primary of the CTs. Remember, as Fig. 3 demonstrated, that we would expect the secondary current from the low-side CT to be 180 degrees out of phase for a through-load condition. Therefore, the relay should observe low-side currents leading high-side currents by 150 degrees. We can use the operate currents from differential event reports to confirm that this is a problem involving all three phases. Upon inspection of the low-side CTs, we found that these CTs had been connected with reverse polarity.

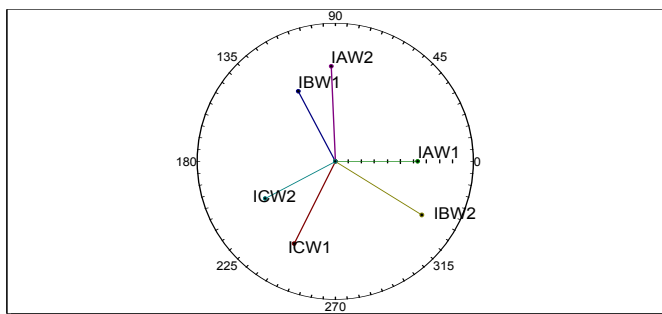
Fig. 28 Phase angles show different phase rotation

Fig. 28 shows the prefault current phasors. We immediately notice one problem. The Winding 1 phase rotation is ACB, while the Winding 2 phase rotation is ABC. The relay settings indicate that we should expect an ABC system phase rotation, so we suspect a wiring problem somewhere in the Winding 1 CT circuit.

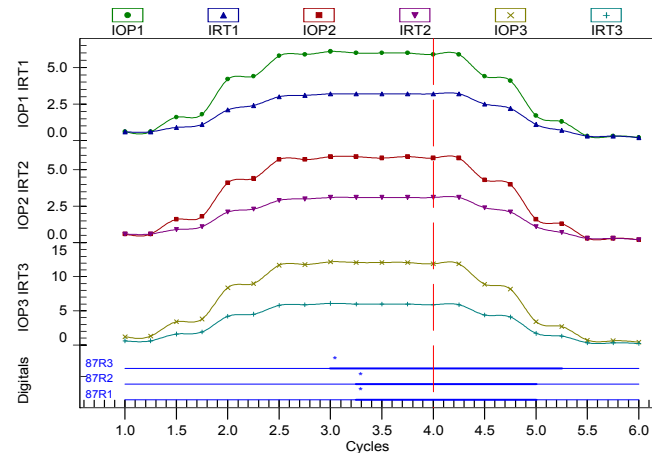
Fig. 29 All three differential elements see operate current

The differential element information shown in Fig. 29 confirms that all three differential elements are affected and that all three elements operated.

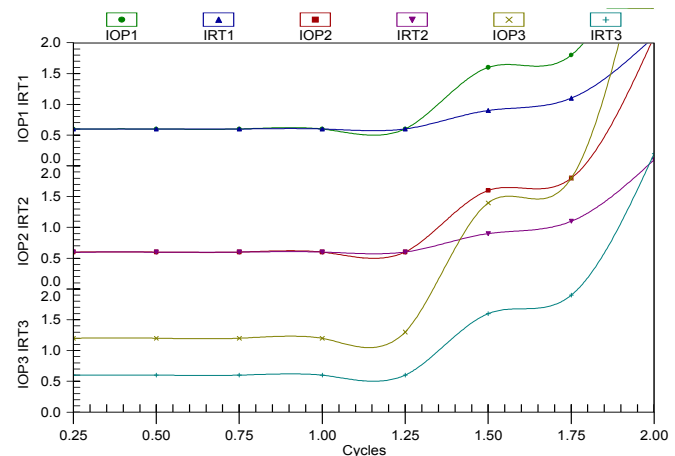
Fig. 30 Prefault data shows mismatch of 100 percent or more in all elements

The Winding 1 phase rotation definitely looks incorrect. For this transformer, we expect, on the primary side of the CTs, for the high side to lead the low side by 30 degrees. We expect to see the Winding 2 relay phase currents leading Winding 1 relay phase currents by 150 degrees. In Fig. 28, no phase-current pair exhibits this proper relationship.

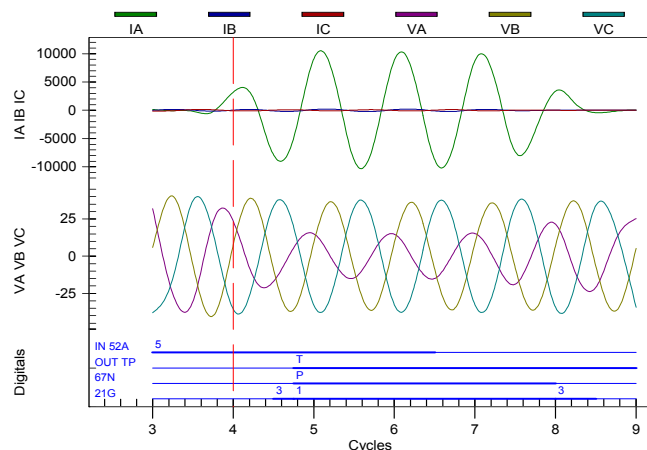
Fig. 31 AG fault on 69 kV transmission line

A single line-to-ground fault occurred on a 69 kV transmission line. Fig. 31 shows the event report the relay captured on that line. At the same time the fault occurred, a transformer differential relay misoperated. The differential relay protects a generator step-up transformer located behind or on the source side of the transmission relay. The step-up transformer is delta-connected on the generator low side, and those CT inputs are wye-connected to Winding 2 of the relay. The step-up transformer is grounded-wye connected on the high side, and those CT inputs are wye-connected to Winding 1 of the relay. The generator was online during the fault.

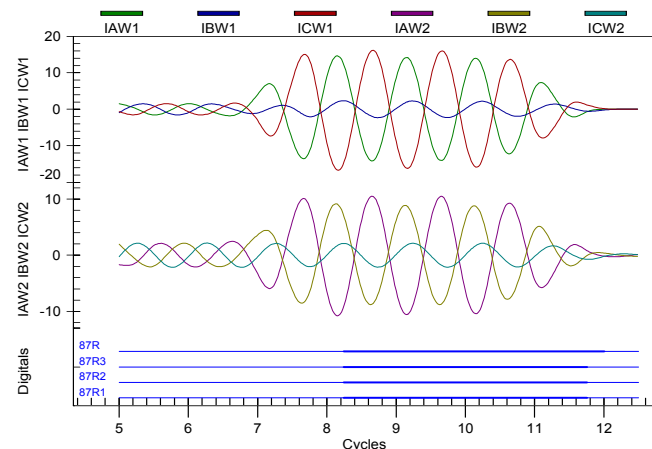
Fig. 32 Misoperation of generator step-up transformer differential relay

If the differential relay were installed correctly, we would expect it to restrain for this out-of-zone fault. The data from the transmission line terminal confirm that the fault was an out-of-zone fault for the differential relay. Fig. 32 shows the unexpected operation of the differential relay.

For a high-side line-to-ground fault on a grounded-wye transformer winding with the generator online, we would expect to see the faulted phase current magnitude increase dramatically relative to the other phase currents on Winding 1. We see, instead, an increase in magnitude for two currents on Winding 1. The fault should appear as a phase-to-phase fault on the low side, and it does. As we see in Fig. 32, however, the Winding 1 currents appear also as a phase-to-phase fault. The root-cause investigation found that the neutral wire was open-circuited, isolating the neutral of the wye-connected CT from the grounded neutral point at the relay. The CT had been changed from a delta to wye connection, but the addition of the neutral wire run back to the relay had been overlooked during commissioning tests.

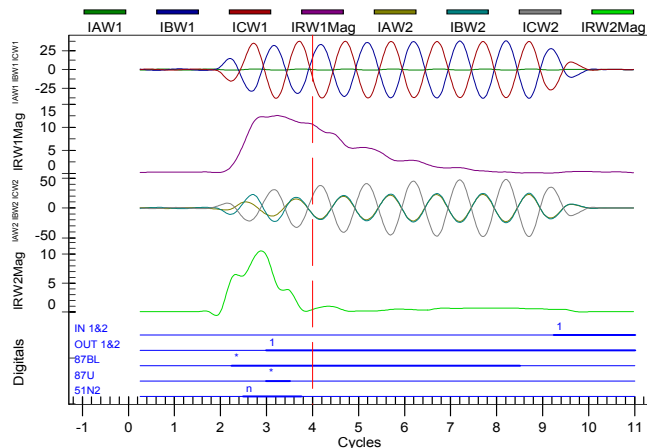
Fig. 33 Winding one (low-side) and winding two (high-side) currents for feeder fault

tection. The low-side fault was B-to-C phase. We would therefore expect IAW2 and IBW2 to be about equal on the high side (Winding 2) and in phase with ICW1 on the low side. The magnitude of ICW2 on the high side should equal the sum of IAW2 and IBW2, and the ICW2 phase angle should be opposite those two currents and in phase with IBW1 on the low side. In Fig. 33, these observed relationships match expectations.

Fig. 33 shows four unexpected items. First, the unrestrained 87U element operated for an external fault. Second, second-harmonic blocking is asserted throughout the fault. Third, there is significant residual 3I0 ground current present on the low side (during a phase-to-phase fault) and on the high side (a delta-connected winding). Fourth, the residual current magnitude decreases over time, even while the fault persists. Similarly, in Fig. 34, there is significant operate current in all differential elements, but this operate current decreases over time even while the phase fault current persists.

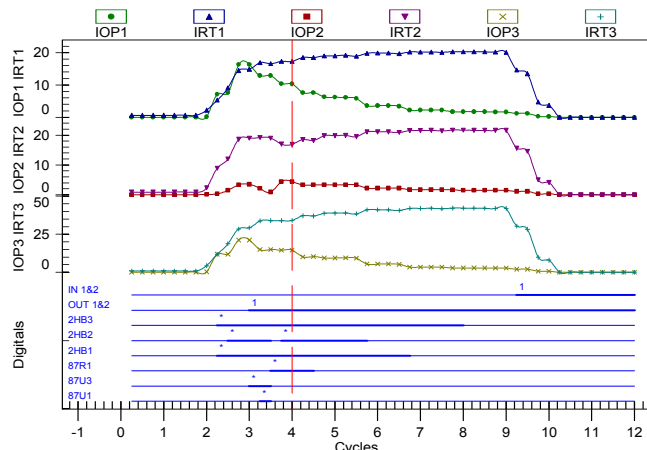
Fig. 34 Significant operate current exists for an external fault, but decays over time

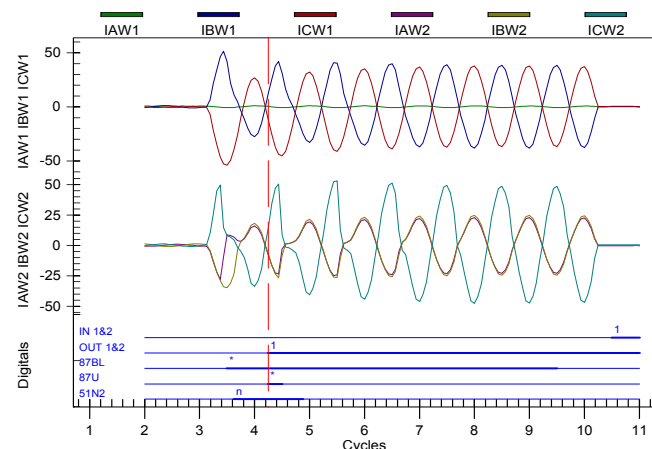
Fig. 35 CT saturation visible on both windings

We suspect that saturating CTs are the root cause of the unexpected and diminishing zero-sequence and operating current. The only way to prove this theory, however, is to view the raw or unfiltered event data.

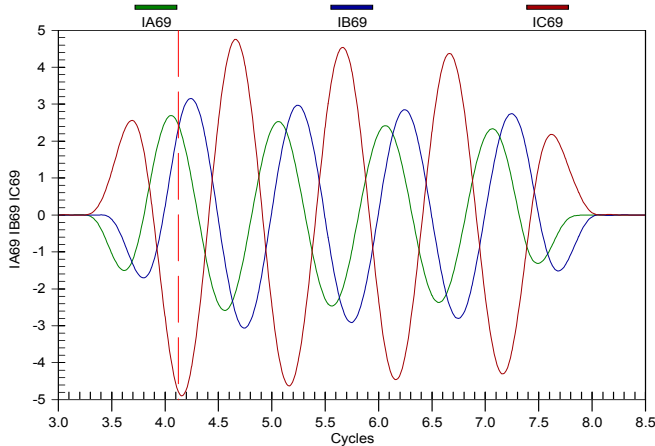
Fig. 36 Filtered 60 Hz high-side currents during energization

An ANSI standard 50 MVA power transformer is connected 69 kV delta to 12 kV grounded-wye. Upon first energization of the transformer, with the low side open, the differential relay tripped. Fig. 36 shows the digitally filtered 60 Hz phase currents on the high side during energization. The current magnitudes are low. We suspect a problem with inrush restraint settings.

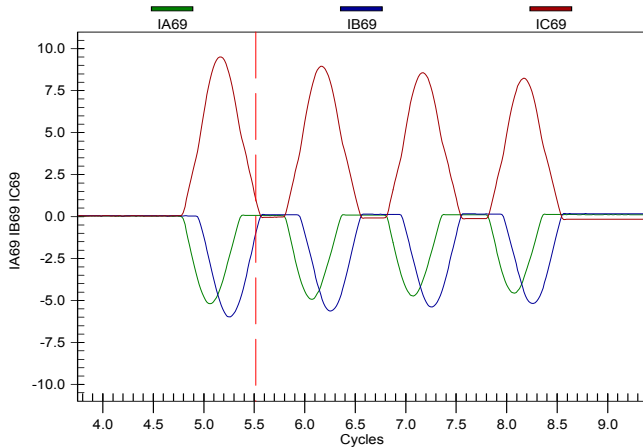
Fig. 37 Raw or unfiltered high-side currents during inrush

To verify our suspicion, we must analyze the raw data. The raw or unfiltered waveforms in Fig. 37 are textbook-perfect examples of magnetizing inrush current. Investigation of the installed settings finds that independent second-harmonic blocking was enabled as the inrush restraint. The second-harmonic threshold was set to 15 percent, a common value. Independent blocking means that second-harmonic content in excess of 15 percent of the fundamental frequency on A-phase will only block the 87R1 differential element. Likewise, B-phase second-harmonic content will block 87R2, and C-phase second-harmonic content will block 87R3. This mode emulates a traditional scheme of three discrete, or independent, differential relays.

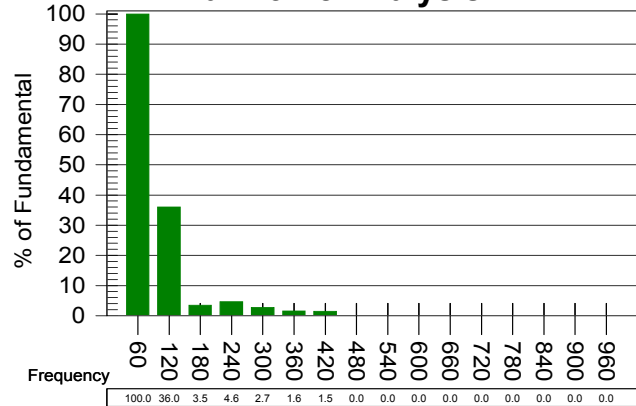
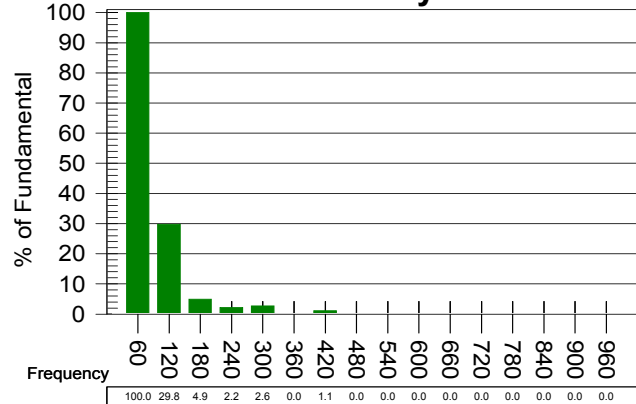
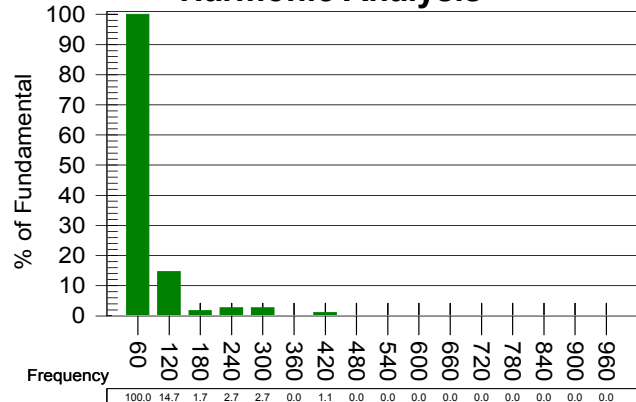
Fig. 38 C phase second-harmonic < 15 percent

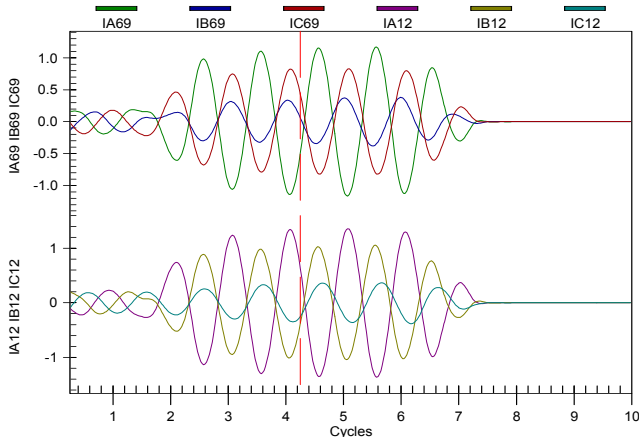
Fig. 39 External fault causes differential trip

After being in service for some time, the differential relay trips during the external phase-to-phase fault shown in Fig. 39.

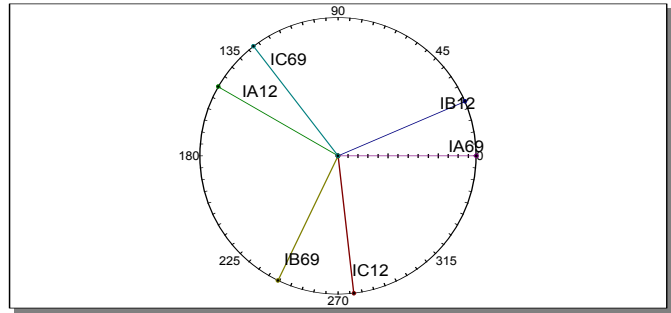
Fig. 40 High leads low side by 30 degrees as expected

Using the prefault data to perform an “offline” commissioning test, we find that phasor magnitudes, angle relationships, and rotation are as expected for through load. See Fig. 40. The 12 kV A-phase current, IA12, leads the 69 kV A-phase current, IA69, at the relay by 150 degrees. This corresponds to the 69 kV primary leading the 12 kV primary currents by 30 degrees.

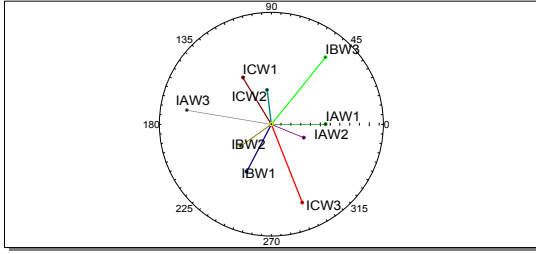
Fig. 41 Load current enters the autotransformer on Windings 1 and 2, and exits on Winding 3

relationships, and rotation are as expected for through load. See Fig. 41.

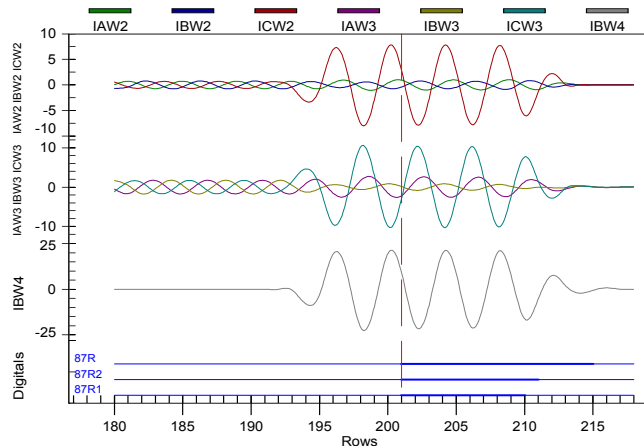
Fig. 42 Autotransformer neutral is a source of 3I0 current

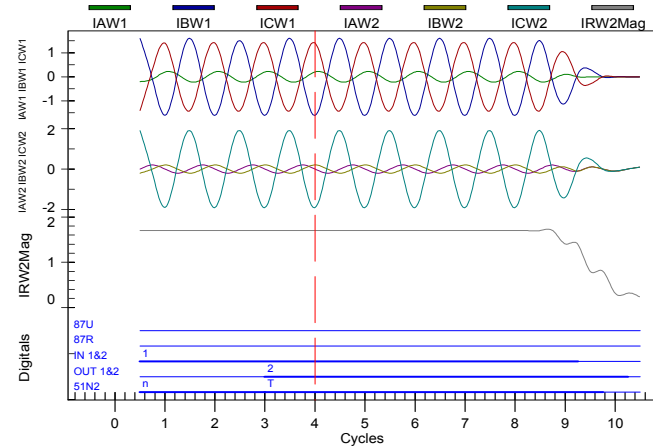
Fig. 47 Downstream C-ground fault confirmed

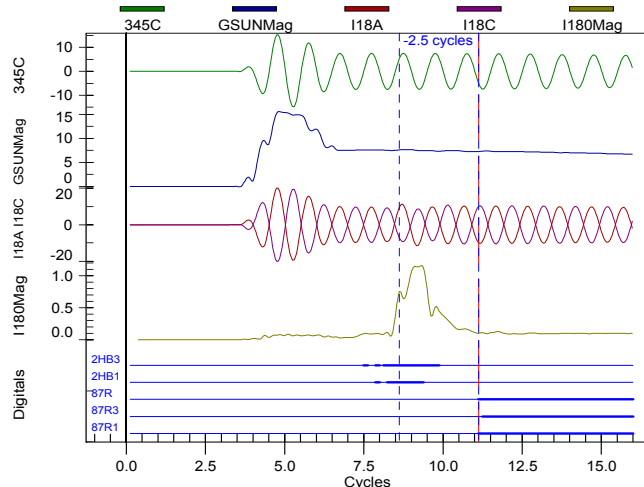
Fig. 49 Flashover on high-side caused differential trip

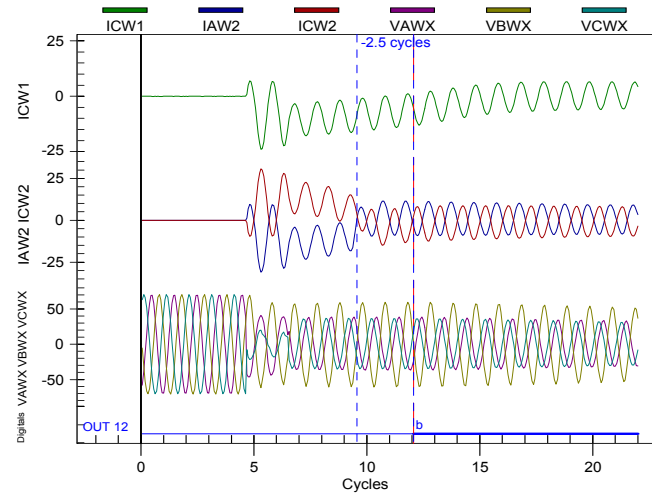
Fig. 50 Flashover on high-side caused differential trip

We must adjust the minimum operate setting O87P and the slope settings to make this application more secure.

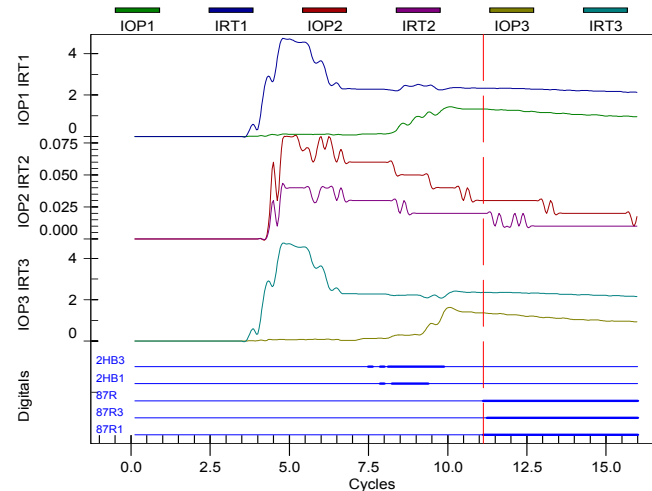
Fig. 51 Ratio of operate to restraint exceeds 50 percent in elements 87R1 and 87R3

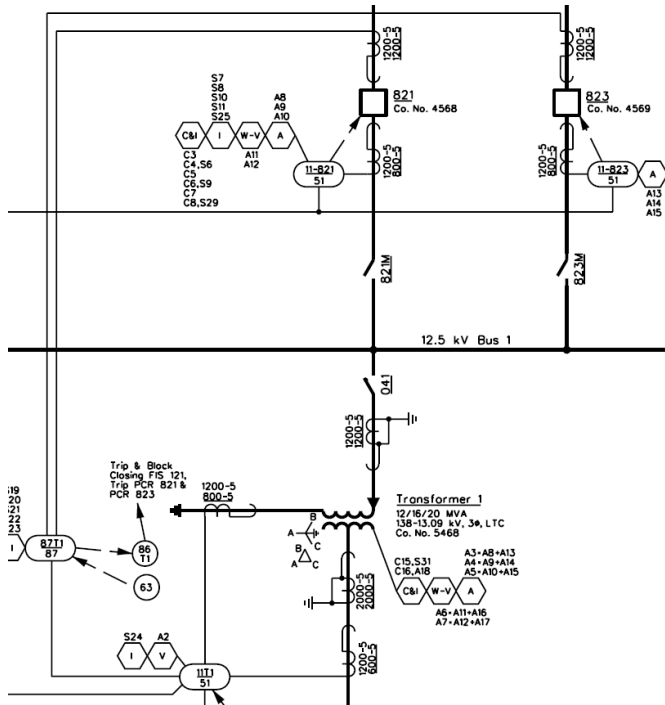
Fig. 52 Differential application online

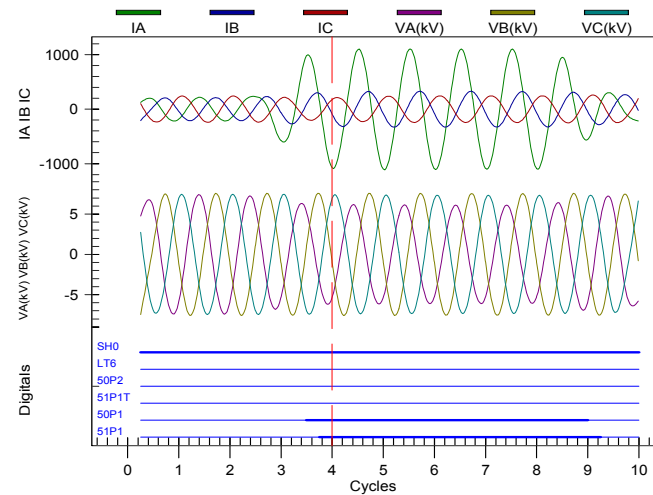
Fig. 53 Faulted feeder relay event data

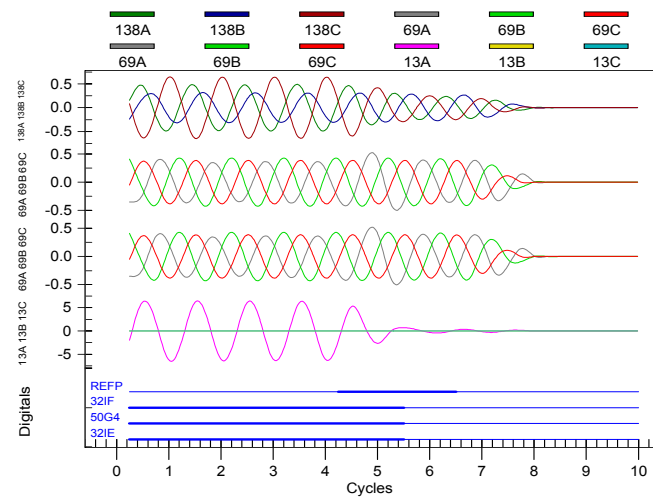
Fig. 54 Differential relay information

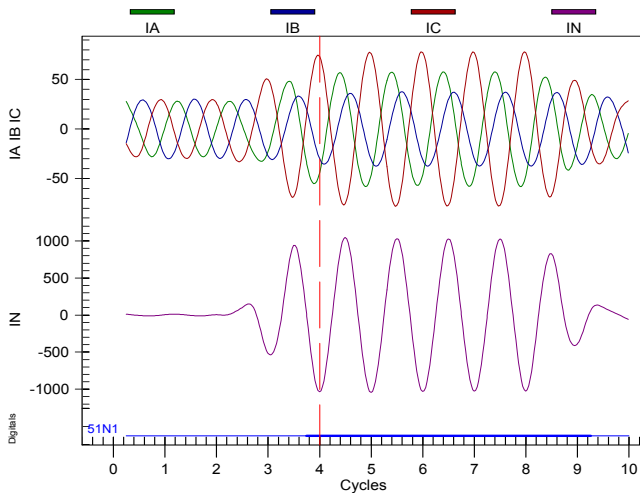
Fig. 55 High-side back-up relay information

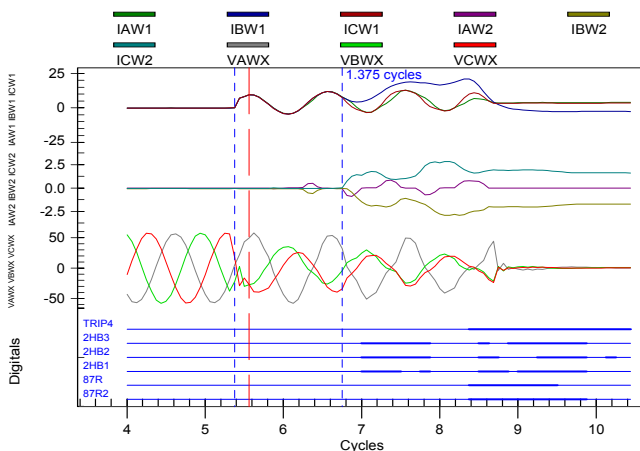
Fig. 56 Raw waveforms from differential relay

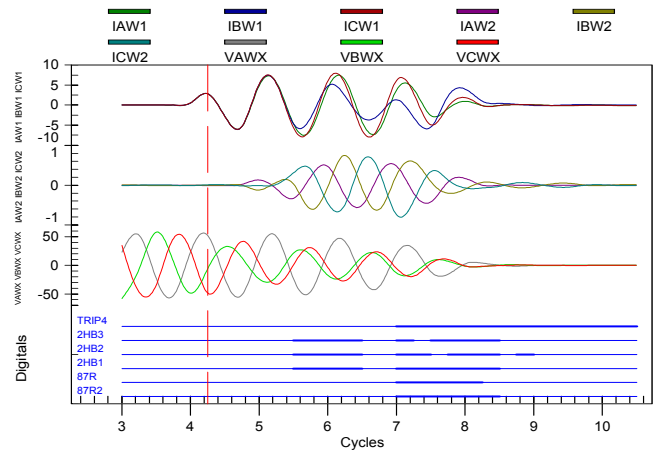
Fig. 57 Filtered waveforms from differential relay

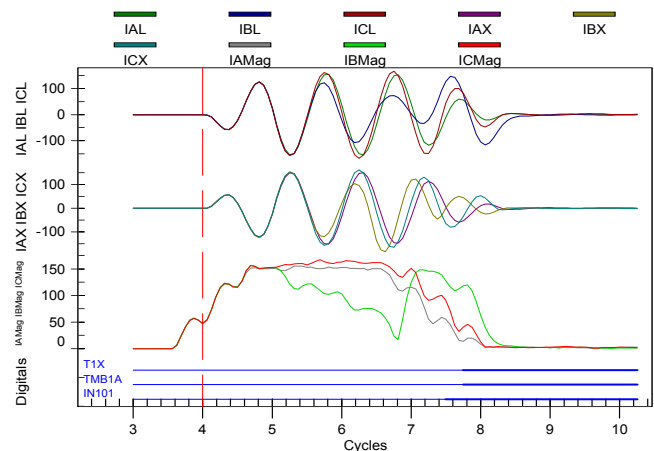
Fig. 58 Line current differential upstream

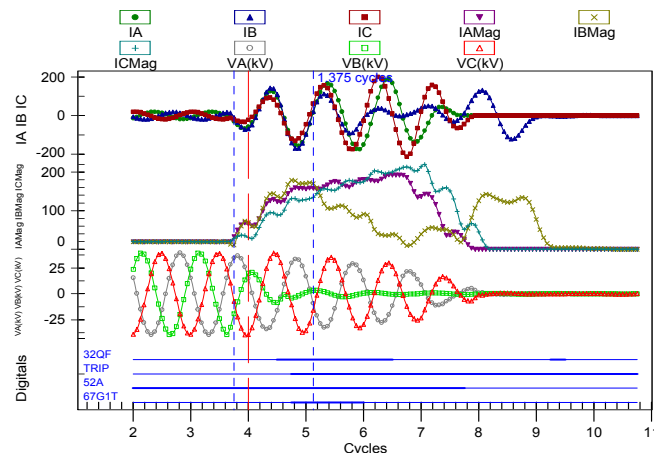
Fig. 59 Distance relay closest to fault

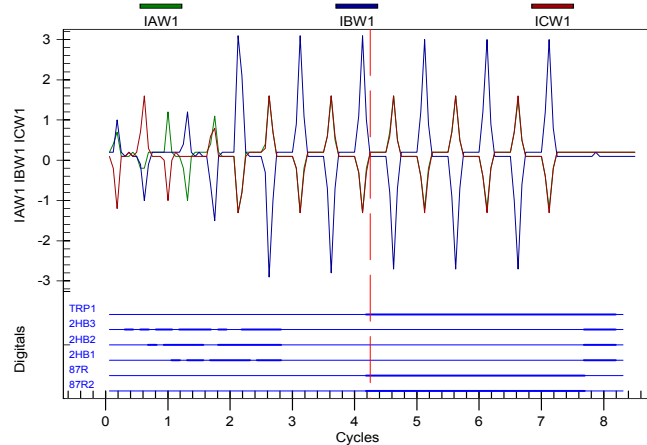
Fig. 60 Overexcitation waveform captured by relay

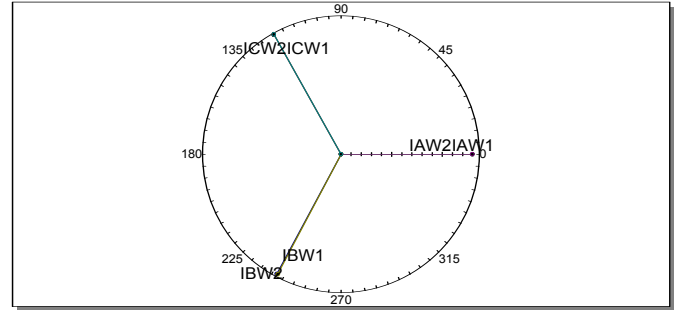
Fig. 61 High-side CT polarities found reversed

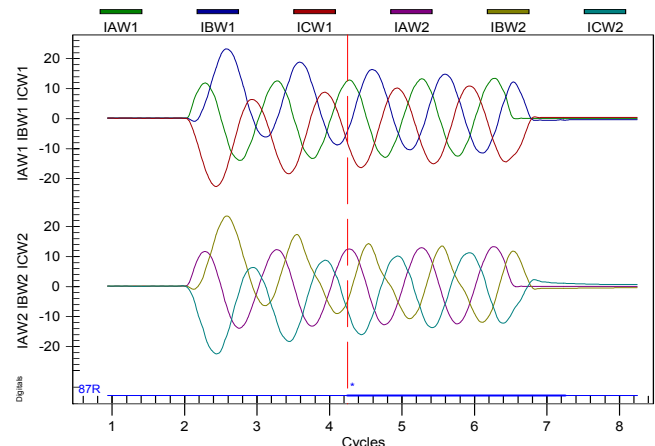
Fig. 62 Second trip shows some CT saturation

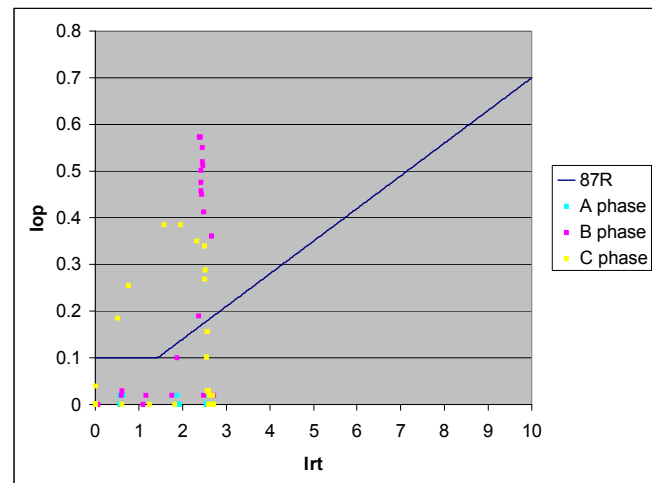
Fig. 63 Operate and restraint at all points in event
